COLORADO DIVISION OF RECLAMATION, MINING AND SAFETY COAL PROGRAM INSPECTION REPORT

Permit Number: C-1981-013 Mine Name: Golden Eagle Mine Operator: New Elk Coal Company, LLC Operator Address: Mr Mark Haywood 12250 State Highway 12 Weston, CO 81091	County: Las Animas Operation Type: Underground Permit Status: Permanent Cessation Ownership: Private
	Operator Representative Present: Vince Masarotti
Operator Representative Signature: (Field Issuance Only)

Inspection Start Date: October 1, 2013 Inspection Start Time: 15:00 Inspection End Date: October 2, 2013 Inspection End Time: 10:00	Inspection Type: Coal Complete Inspection Inspection Reason: Normal I&E Program Weather: Clear
Joint Inspection Agency: None	Joint Inspection Contacts:
Post Inspection Agency: None	Post Inspection Contacts:
Inspector(s): Leigh D. Simmons	Inspector's Signature:

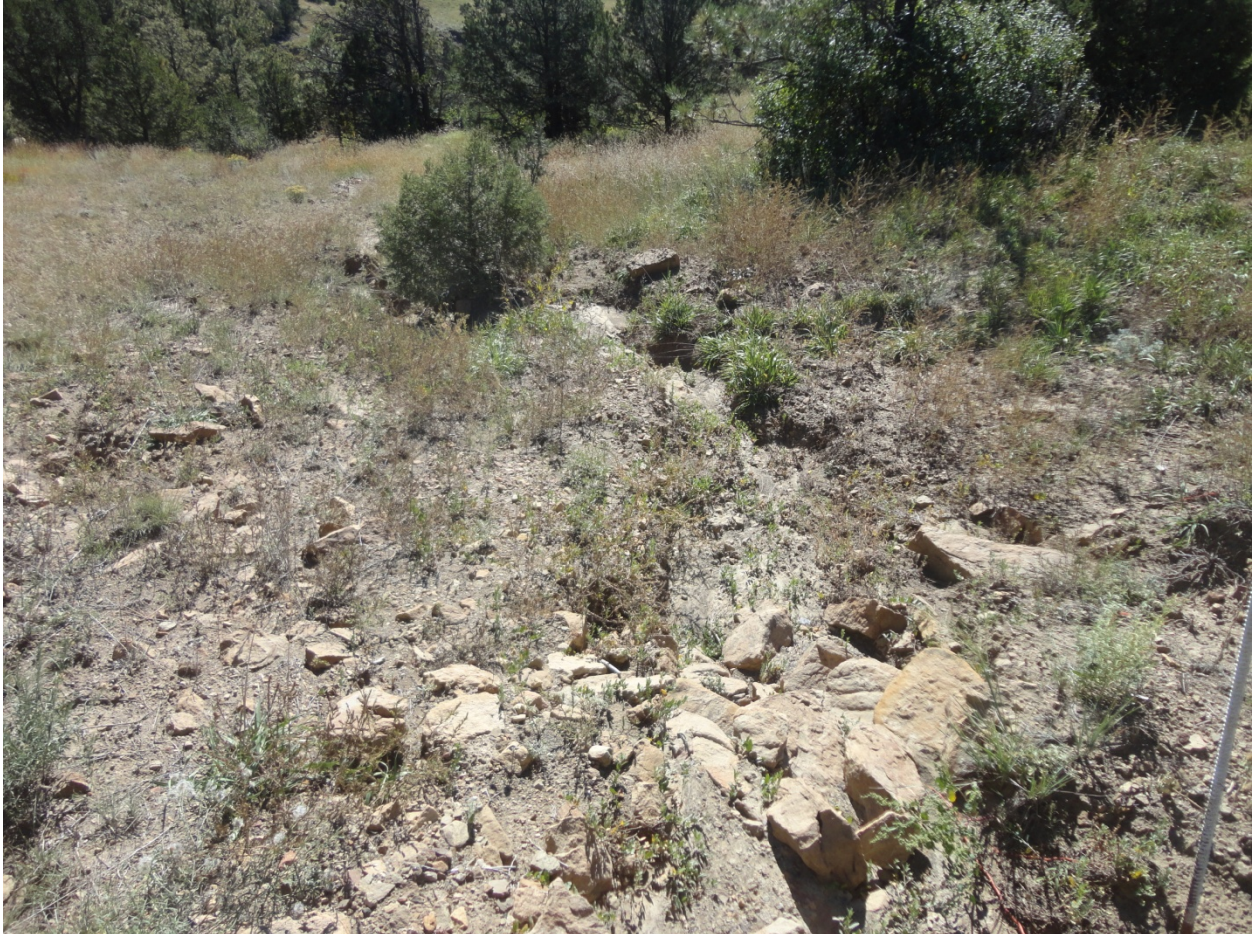
The erosive area at the north eastern edge of the permit boundary had not yet been addressed. **Mr Masarotti plans to use some bales to slow down flow. The area will continue to be monitored to determine if further repairs are necessary.**

Photo 1: Erosion to be controlled with bales and monitored
