COLORADO DIVISION OF RECLAMATION, MINING AND SAFETY
MINERALS PROGRAM INSPECTION REPORT
PHONE: (303) 866-3567

MINE NAME: Fryrear Gravel Pit	MINE/PROSPECTING ID#: M-1998-071	MINERAL: Sand and gravel	COUNTY: Yuma
INSPECTION TYPE: Monitoring	INSPECTOR(S): Eric C. Scott	INSP. DATE: November 6, 2013	INSP. TIME: 12:00
OPERATOR: Richard Fryrear	OPERATOR REPRESENTATIVE: Richard Fryrear	TYPE OF OPERATION: 112c - Construction Regular Operation

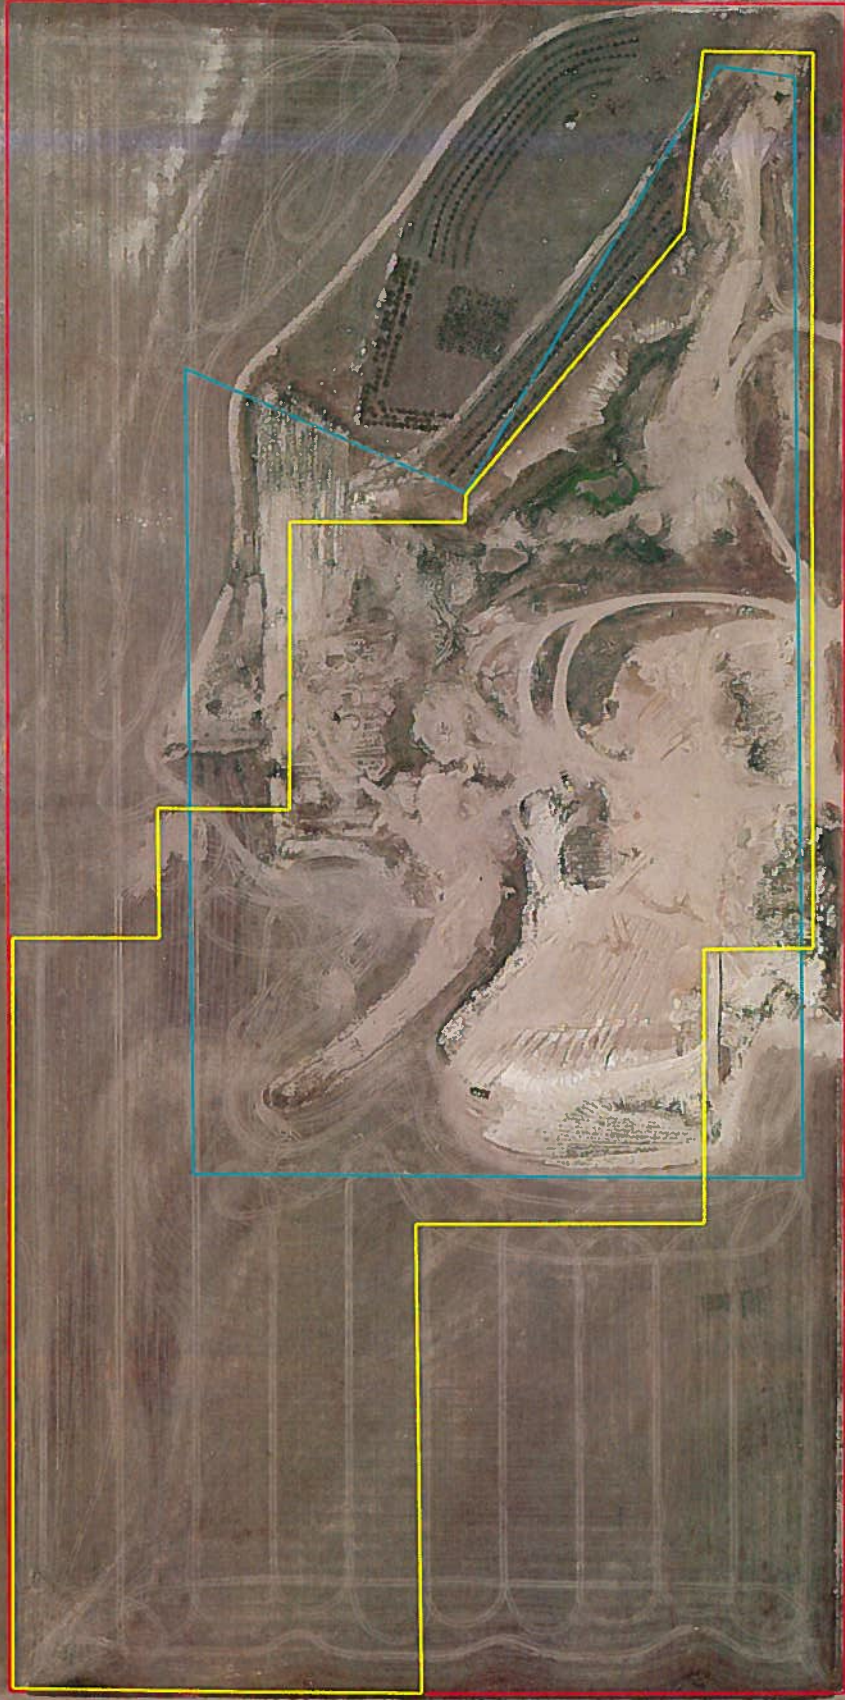
M1998-071 Fryrear Pit

PROBLEM/POSSIBLE VIOLATION: Problem: The affected area boundary markers are missing or incorrectly placed. This is a problem for failure to maintain boundary markers around the affected area as required by Section 3.1.12(2) of the rule. As shown on the attached map, This issue has resulted in several acres of affected area outside of the approved permit boundary.

There were several steel posts placed on the property that roughly encompassed the disturbed area associated with the mining activity to date. The locations of these posts were documented using a handheld Trimble GPS unit during the inspection. The attached map shows the approximately 29 acre boundary defined by the steel posts as a light blue line. The currently approved permit boundary (40 acres) is shown on the attached map by a yellow line. The property boundary delineating the S1/2 of the S1/4 of Section 2, Township 5 North, Range 47 West is shown by a red line. As can be seen on the attached map, the locations of the marker posts observed during the inspection do not correspond with the permit boundary approved by the Division. There are currently several acres of disturbed area that are outside of the approved permit boundary shown in yellow.

CORRECTIVE ACTIONS: The operator shall submit to the Division a complete permit amendment within 90 days of the date of this report. The amendment shall incorporate all currently disturbed areas into the new permit boundary. If a complete amendment is not received by the Division by the corrective action due date listed below, enforcement actions will be initiated for affecting land outside of the approved permit boundary.

As stated on the first page of this report, DRMS will allow 90 days from the date of this report for the permittee to submit a complete permit amendment to incorporate all the currently disturbed area into a new permit boundary. If a complete amendment has not been received by the Division by February 13, 2014, the Division will initiate enforcement action for the disturbance of areas outside of the approved permit boundary. Enforcement will consist of a Mined Land Reclamation Board hearing that may result in corrective actions and civil penalties if a violation is found.
