**COLORADO DIVISION OF RECLAMATION, MINING AND SAFETY**  
**MINERALS PROGRAM INSPECTION REPORT**  
**PHONE: (303) 866-3567**

<b>MINE NAME:</b> Caldwell-Nesselhuf Pit No. 1	<b>MINE/PROSPECTING ID#:</b> M-1997-071	<b>MINERAL:</b> Sand and gravel	<b>COUNTY:</b> Crowley
<b>INSPECTION TYPE:</b> Mineral Prospect Inspection	<b>INSPECTOR(S):</b> Tyler V. O'Donnell	<b>INSP. DATE:</b> November 26, 2013	<b>INSP. TIME:</b> 10:20
<b>OPERATOR:</b> William & Beverly Caldwell and Albert & Lc	<b>OPERATOR REPRESENTATIVE:</b> None	<b>TYPE OF OPERATION:</b> 112c - Construction Regular Operation

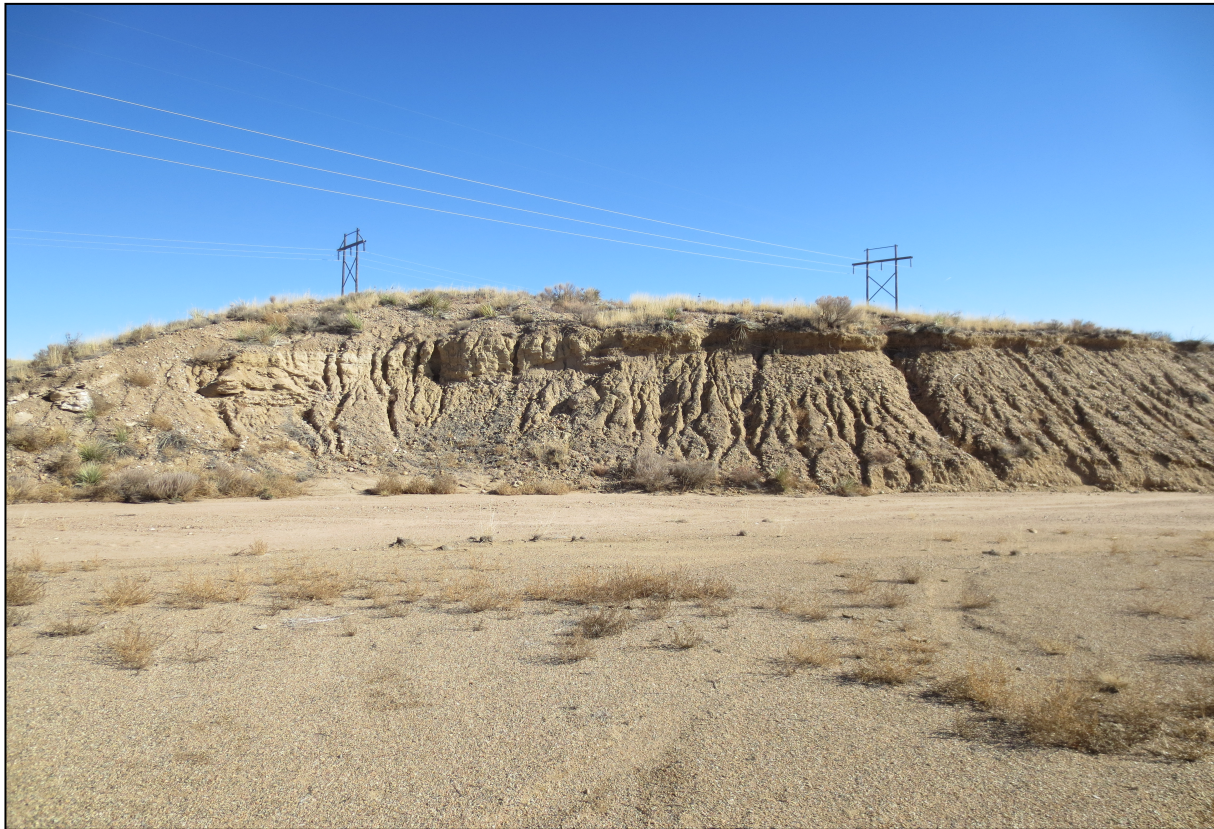
No backfilling or grading has occurred on this site, slopes are 2H:1V or steeper in the majority of the site. The highwalls have been damaged by erosion (see photo 1).

Rills and gullies have developed on the pit slopes, stockpiles and the road(see photos 1, 3, and 4). The Operator will need to repair damaged slopes and stabilize the road to prevent future erosion. The Operator has failed to protect the surface areas of the affected land from erosion; this will be cited as a problem in the inspection report. The Operator shall stabilize and protect the affected land to effectively control erosion.

**Photo 1:** Rills and gullies on the highwall.

**CORRECTIVE ACTIONS:** The Operator shall provide photo documentation to the Division verifying erosion damage has been repaired, and that the site has been reconstructed and stabilized to prevent erosion damage.

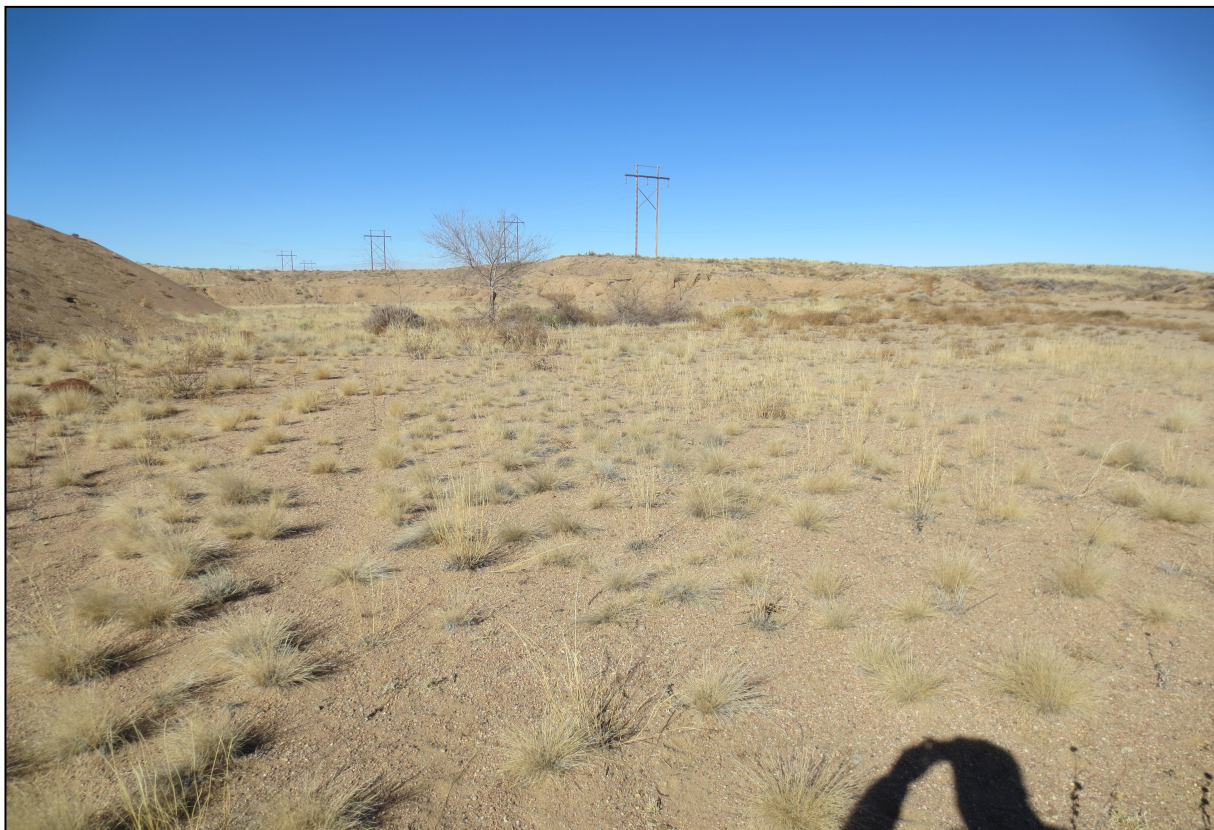
The sky was clear. The ground was dry. No mining equipment was present at the time of the inspection. The site appears to have been inactive for a long period of time. Vegetation has volunteered through the majority affected land (see photo 2). There was a large stockpile of product located along the southern edge of the affected land (see photo 3). It appears that material has not been removed from the site in recent years.

There was plant growth on the pit slopes, the pit floor, and the stockpiles. This growth within the affected area appeared to be volunteer vegetation.

**Photo 2:** Pit floor with volunteer vegetation.

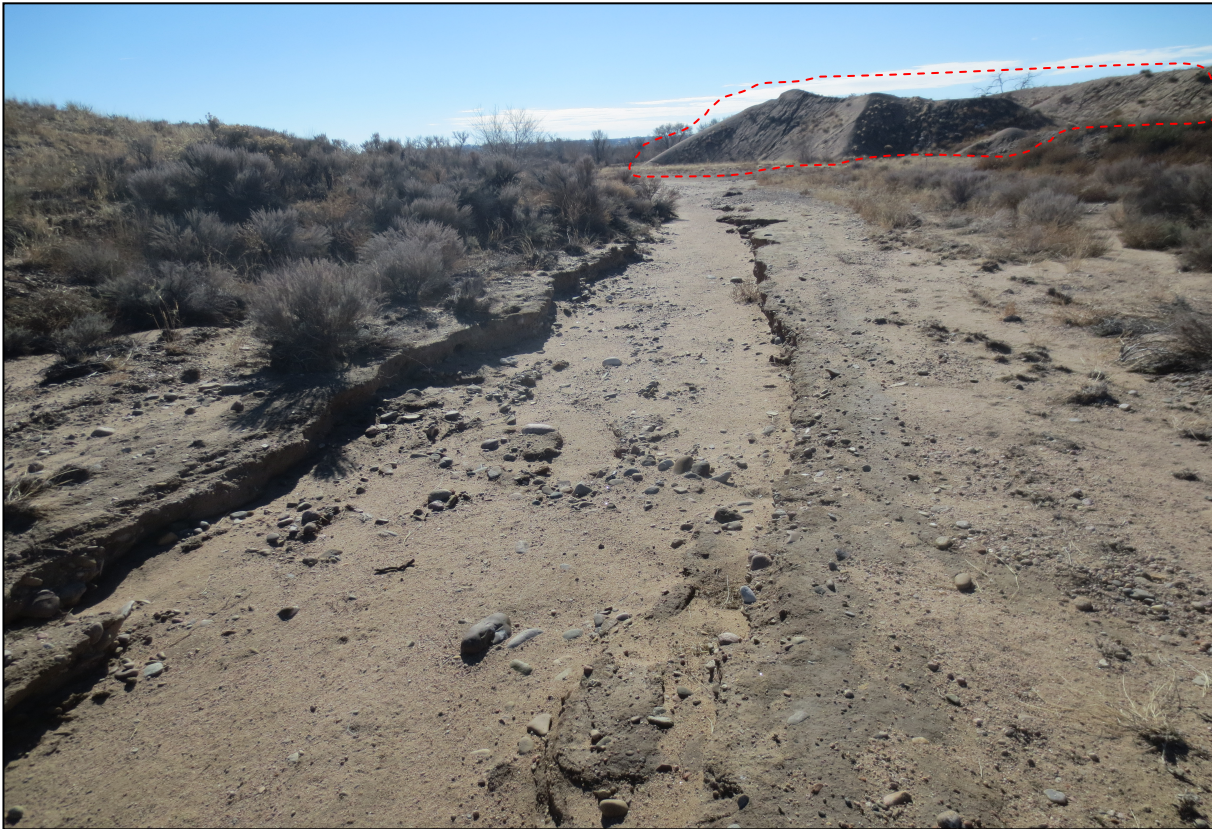
The access road has been damaged by erosion, the Operator must stabilize the road and prevent future erosion.

**Photo 3:** Access road, damaged by erosion. Product stockpile in the background outlined by red dashed line.

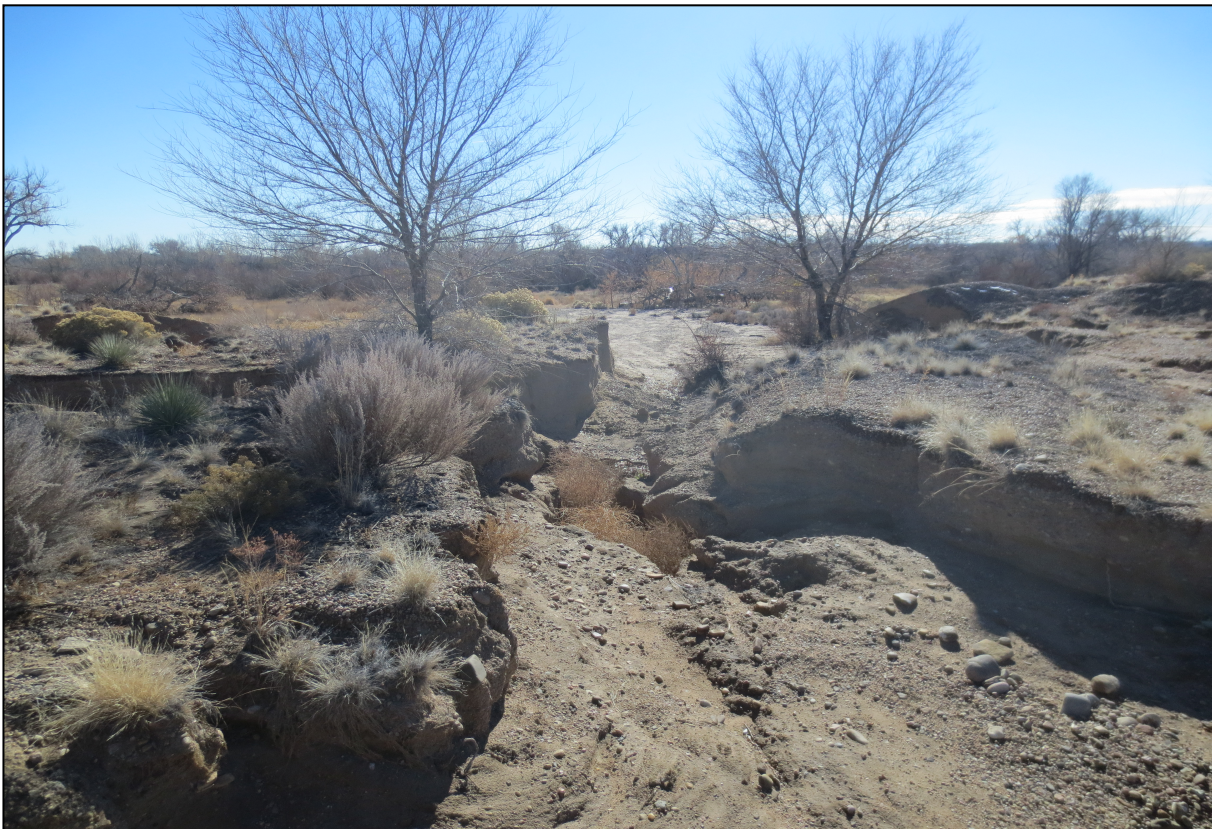
**Photo 4:** Affected land damaged by erosion along the southern portion of the affected land.
