COLORADO DIVISION OF RECLAMATION, MINING AND SAFETY
MINERALS PROGRAM INSPECTION REPORT
PHONE: (303) 866-3567

MINE NAME: Sand Arroyo	MINE/PROSPECTING ID#: M-1978-283	MINERAL: Sand and gravel	COUNTY: Huerfano
INSPECTION TYPE: Monitoring	INSPECTOR(S): Tyler V. O'Donnell	INSP. DATE: December 3, 2013	INSP. TIME: 13:00
OPERATOR: Walsenburg Sand & Gravel Co., Inc.	OPERATOR REPRESENTATIVE: Gary Vezzani	TYPE OF OPERATION: 112c - Construction Regular Operation

Sand Arroyo Pit DRMS File No. M-1978-283

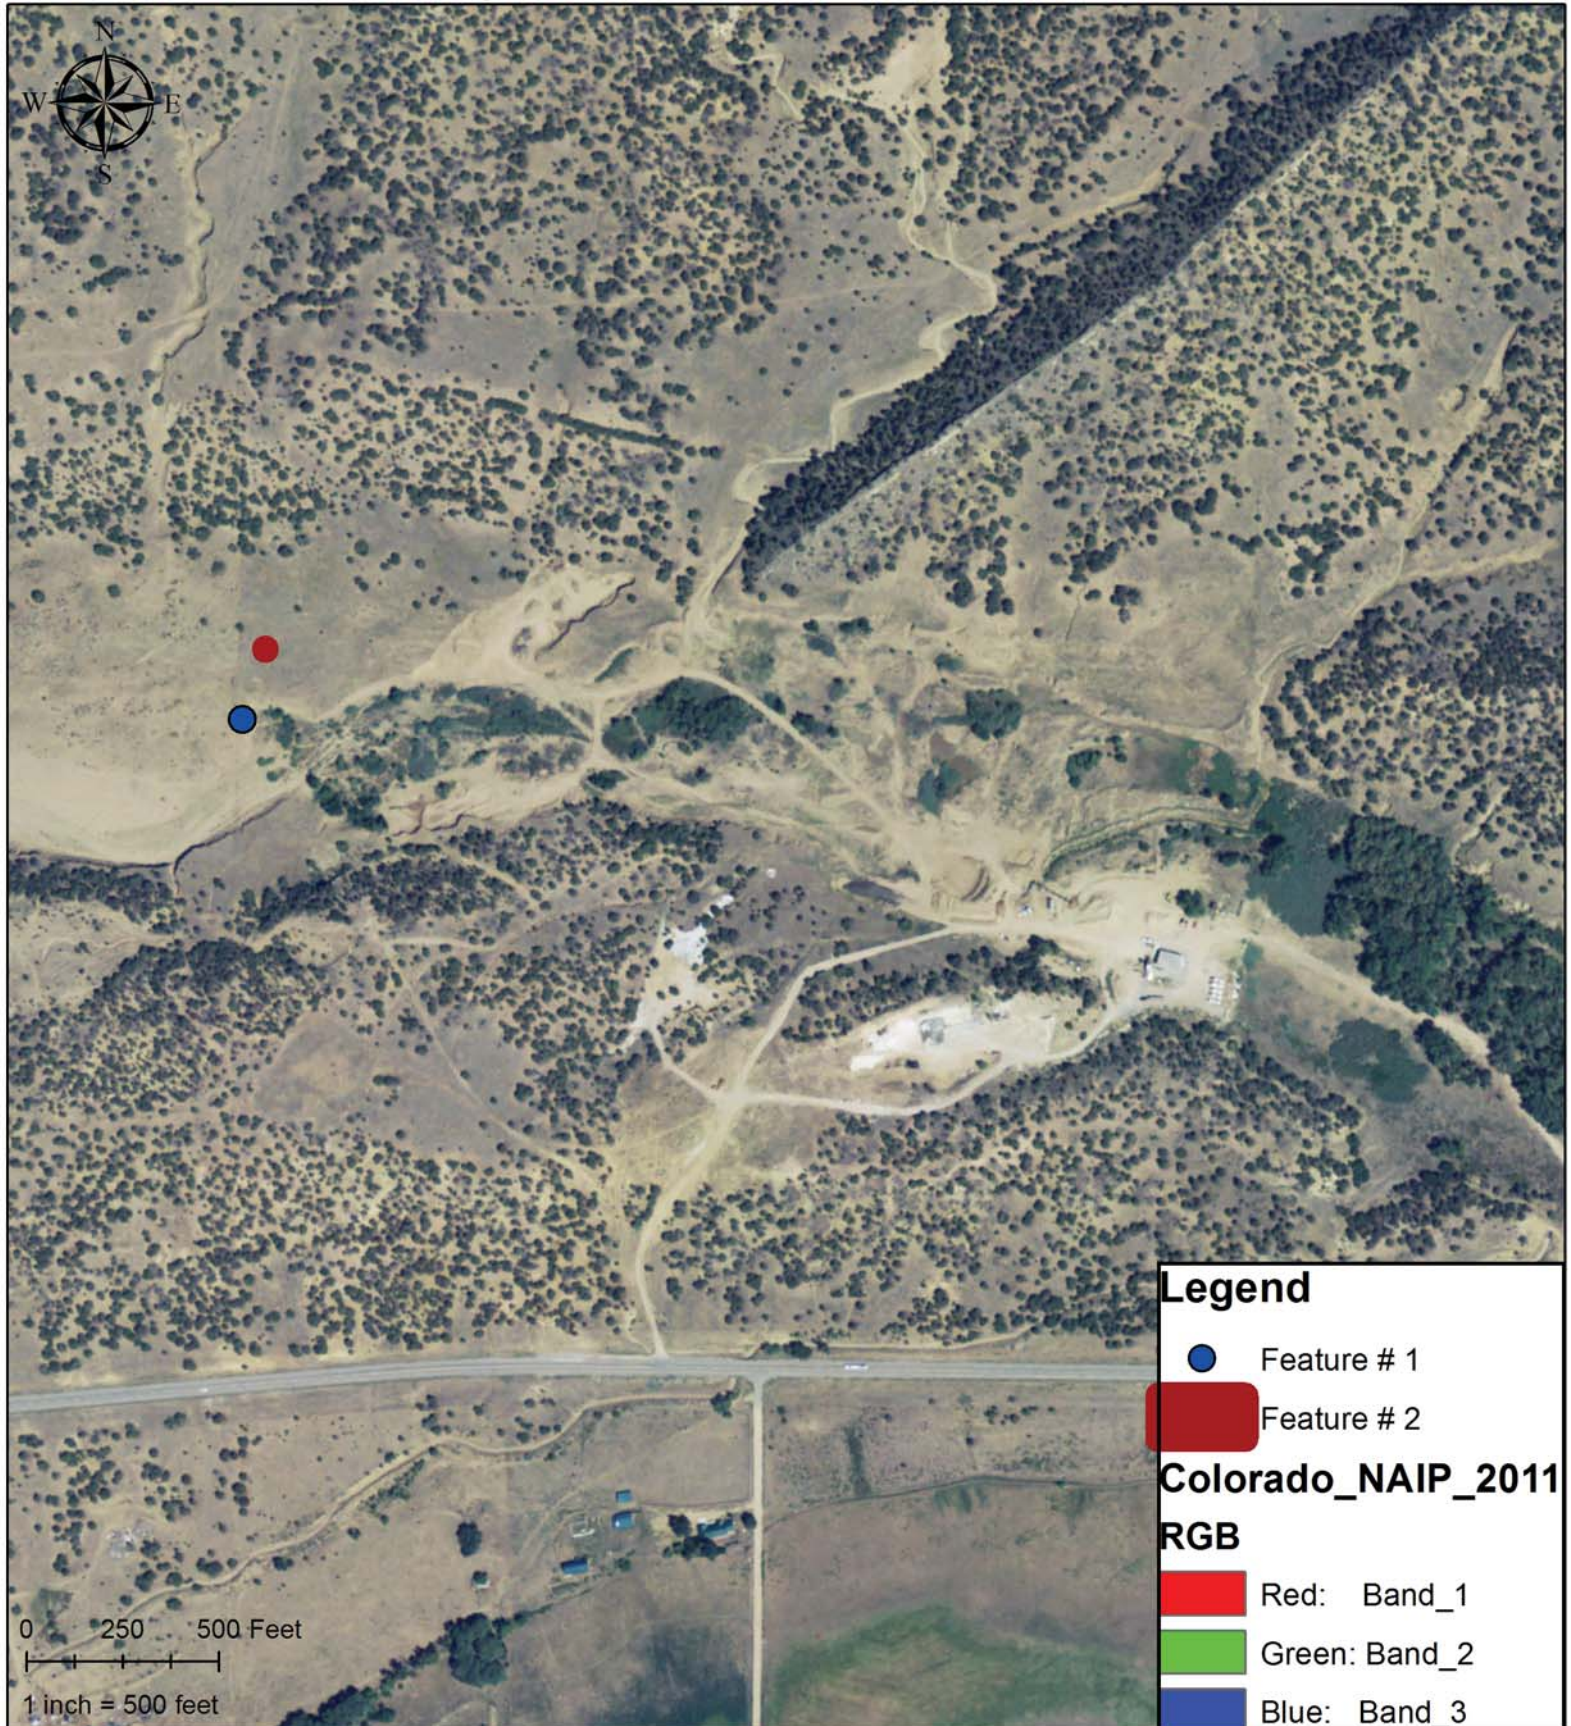
Figure 1: Map of the Sand Arroyo Pit (Colorado NAIP 2011 Imagae)

This inspection was conducted in response to a citizen complaint about possible mining outside of the approved permit boundary at the Sand Arroyo pit, DRMS File No. M-1978-283. The Division of Reclamation, Mining and Safety (Division/DRMS) received the citizen complaint on November 27, 2013. The inspection was conducted by Tyler O'Donnell of the Division. Walsenburg Sand and Gravel Company, the operator, was represented by Gary Vezzani during the inspection. The Sand Arroyo pit is located approximately 6 miles west of Walsenburg, Colorado. The Sand Arroyo pit is permitted as a sand and gravel pit. The approved permit area is 52.00 acres. The approved post-mining land use is rangeland.

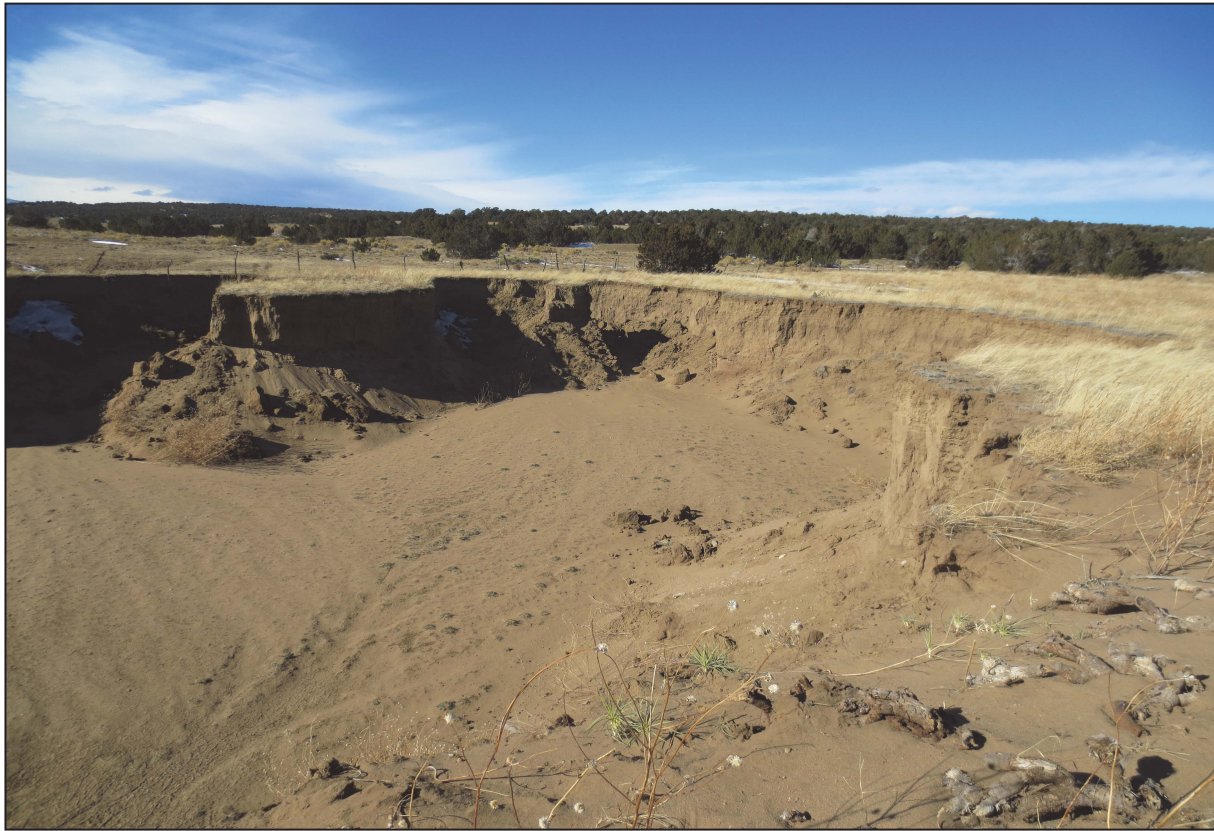
Photo 1: Feature # 2.

Another erosion feature was found approximately 125 feet north of the gully along the fence line (feature # 2). This feature is a ravine that is approximately 100 feet wide and 8 to 12 feet deep. This feature has begun to head-cut and, has started to expand northward. A sediment fan was observed at the outflow of feature # 2 (see photo # 2).

The Division believes that feature # 1, the gully under the fence, was most likely not the result of a mining operation. It appears that the gully is the result of natural erosion processes. Feature # 2 also appears to be a naturally occurring erosion feature. This feature appears to have been expanded recently by natural erosion processes. No tool marks or tire tracks from heavy equipment were found at either location. The shapes of both features do not appear to have been caused by man-made means. Neither of the features appeared to have been caused by recent mining activities outside of the approved permit boundary. The Division encourages the landowners and the operator to take measures to prevent further erosion at both locations.

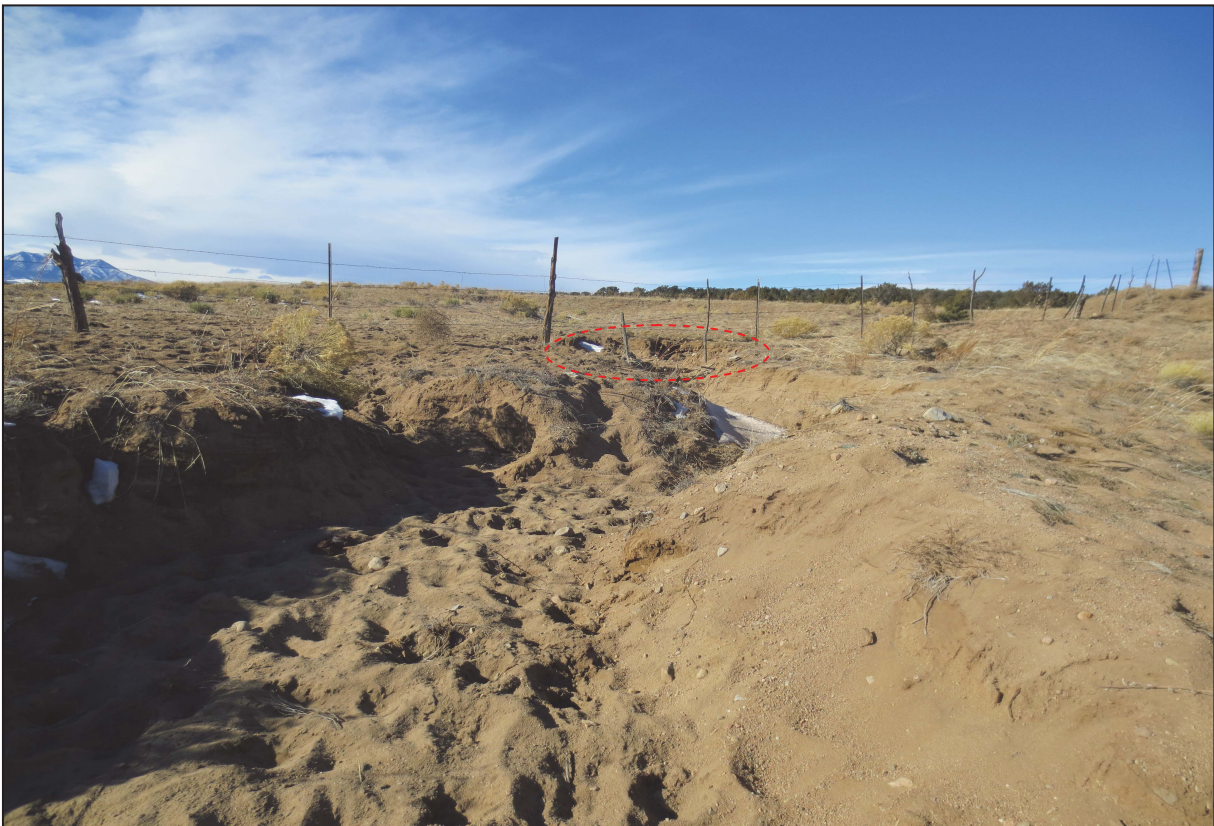
Photo 4: Feature # 1, damaged portion of fence circled in red.

On November 27, 2013 the Division received a citizen complaint, about the operator mining outside of the western permit boundary which runs north-south, and is offset approximately 200 feet from the property line. The citizen complaint explained that mining outside of the permit boundary has damaged the fence that runs roughly north-south, approximately along the boundary between the two properties. On December 3, 2013 the Division inspected the area outside of the western permit boundary of the Sandy Arroyo pit. The fence was undermined by a gully, allowing livestock to walk underneath the fence (feature # 1) (see photos # 4 and 5). The compromised fence was allowing livestock to exit the pasture and gain access to the adjacent Sand Arroyo pit and subsequently Highway 160. The citizen who filed the complaint is concerned about livestock getting hit by traffic on the highway. During the inspection the Division observed livestock tracks going underneath the fence between the two properties and extending into the Sand Arroyo pit. The livestock were walking under the fence through erosion feature # 1. The Division also observed that attempts had been made to mend the fence in this location to prevent livestock from getting underneath the fence (see photo # 5).
