Reference: Cripple Creek & Victor Gold Mining Company,
Cresson Project Squaw Gulch (VLF), Hwy 67 Realignment

Subject: ✓ Weekly Construction Quality Assurance ("CQA") Report:
AMEC: Squaw Gulch (VLF), Hwy 67 Realignment - Weeks ending 03/01/14 and
03/08/14.

CRIPPLE CREEK & VICTOR GOLD MINING Co.
Squaw Gulch (VLF), HWY 67 Realignment Field Monitoring Summary Weekly Report

Reporting Period: 2.23.14 through 3.1.14

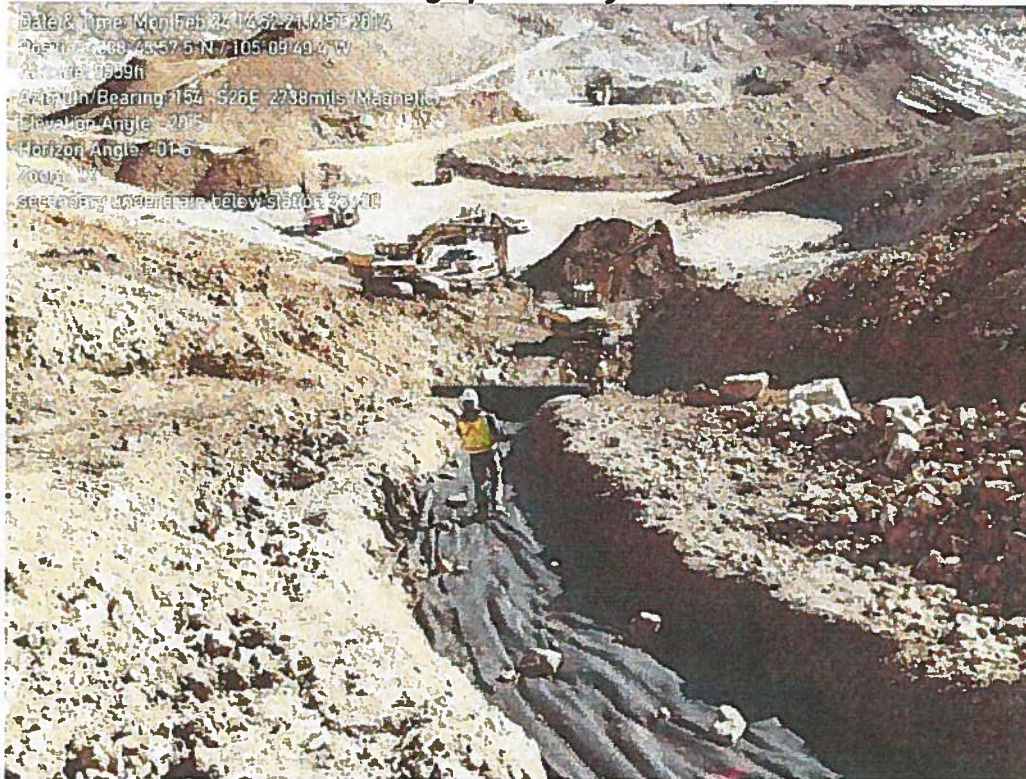
Photo 1: Secondary underdrain below ADR Haul Road station 23+00.

Secondary Underdrain: Approximately, 175 feet of secondary underdrain was installed and tied into existing underdrain below ADR haul road station 23+00.

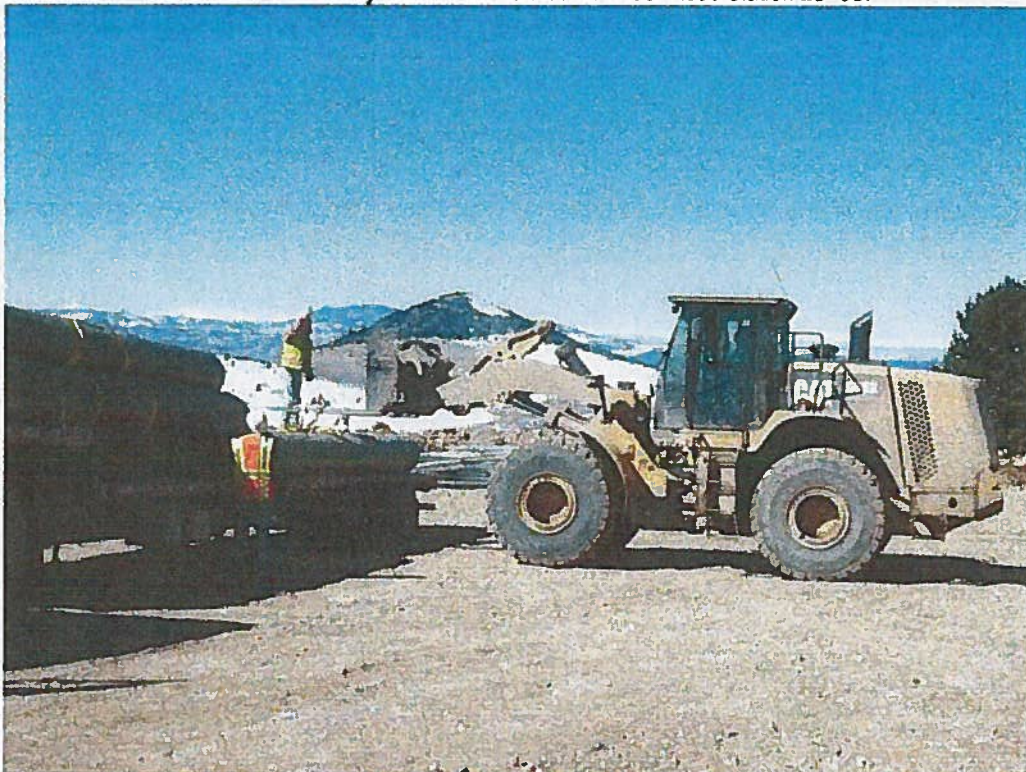
Photo 2: Liner delivery (100-mil smooth LLDPE).

Deliveries: Eight (8) truckloads consisting of 96 total rolls of 100 mil, smooth geomembrane liner were delivered to the site, recorded, and inventoried.

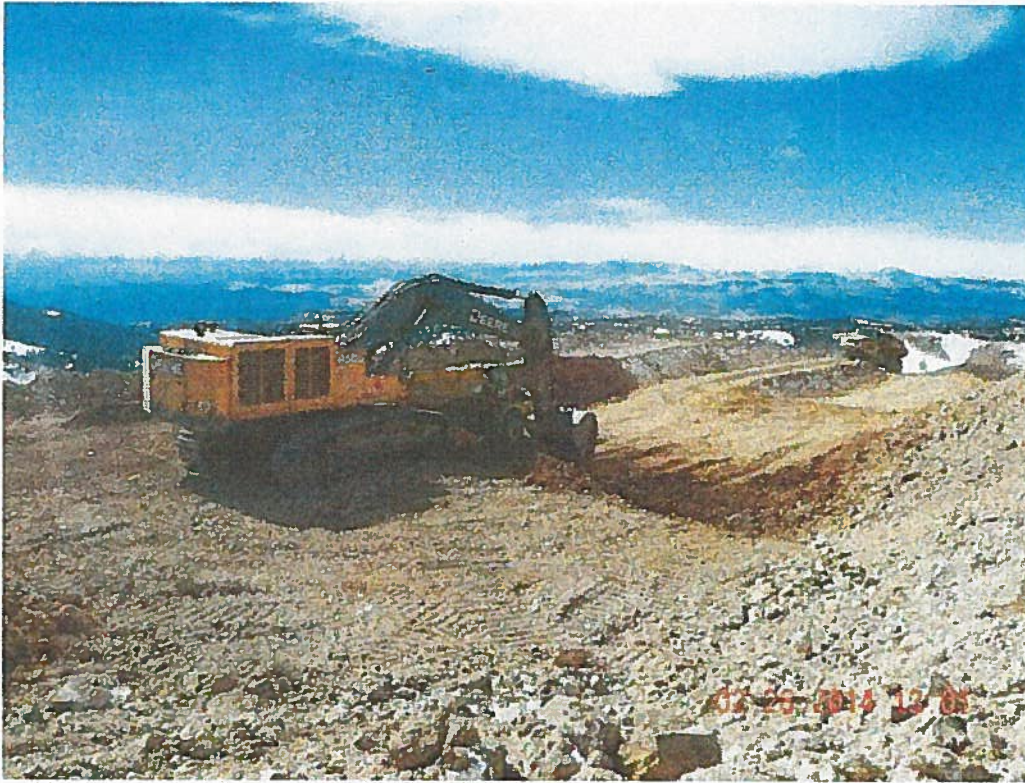
Photo 3: Material removal at Dump 4 for use as structural fill.

A John Deere 850 excavator loaded Cat 740 haul trucks with material from Dump 4 to the south of Ames' mechanic shops. The material was placed as structural fill near station I36+00 adjacent to Dump 4 in the Phase 2 Diversion Channel area. The structural fill was placed and compacted per method specification.

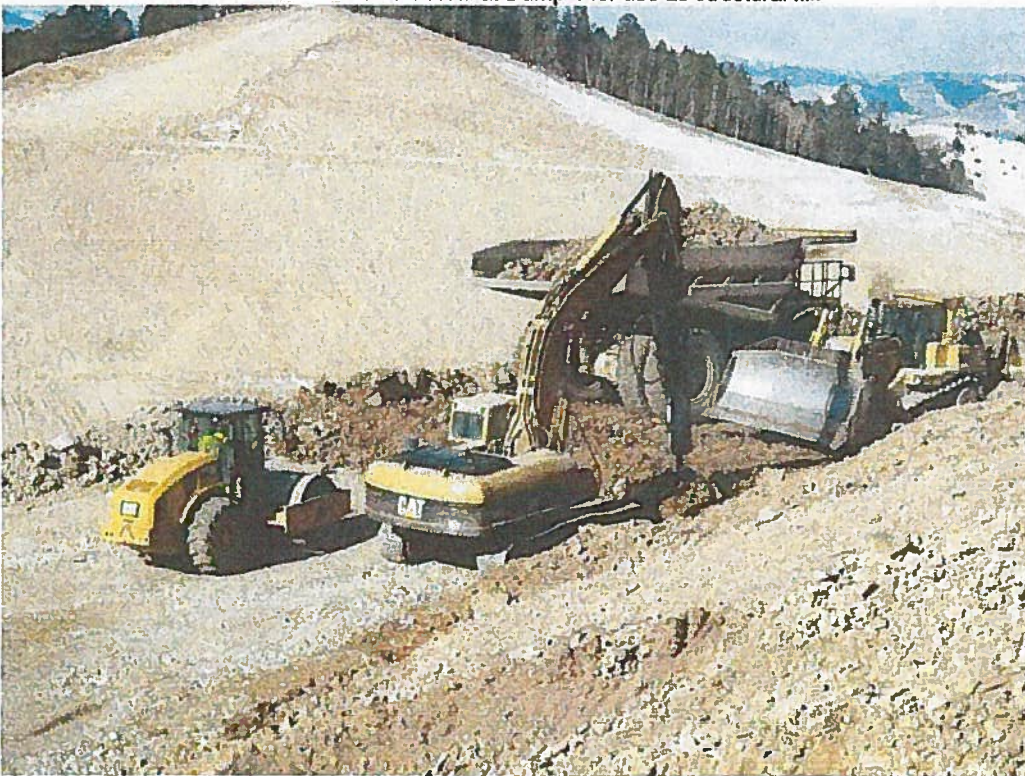
Photo 4: Fill placement at the ADR Haul Road.

A Cat 992 loader removed material from near stations B13+00 to B14+00. The material was hauled to the ADR haul road fill near stations 39+00 to 65+00 in 777 haul trucks and was placed as structural fill by a Cat D9 dozer. Cat dozers also cut material from the slopes above the ADR Haul Road fill areas. The material was pushed down to the fill area, placed as structural fill, and compacted per the project specification.

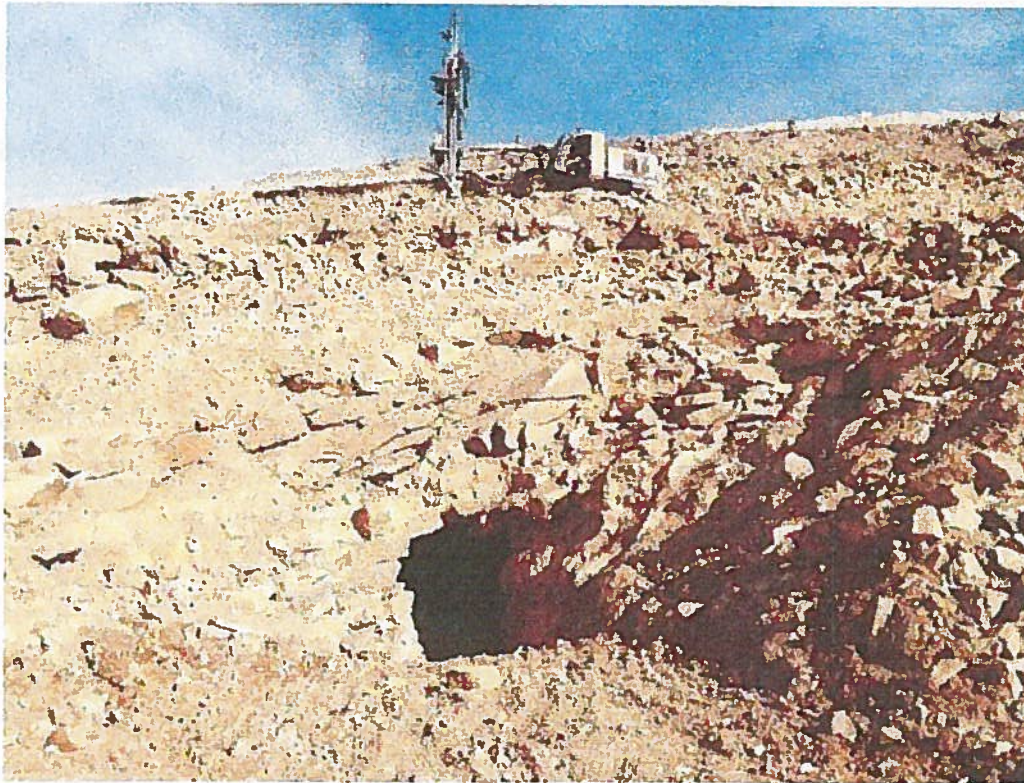
Photo 3: Confirmatory drilling; UG# 6274.

Confirmatory drilling was conducted at underground working UG#6274. Additional remediation work will be required.

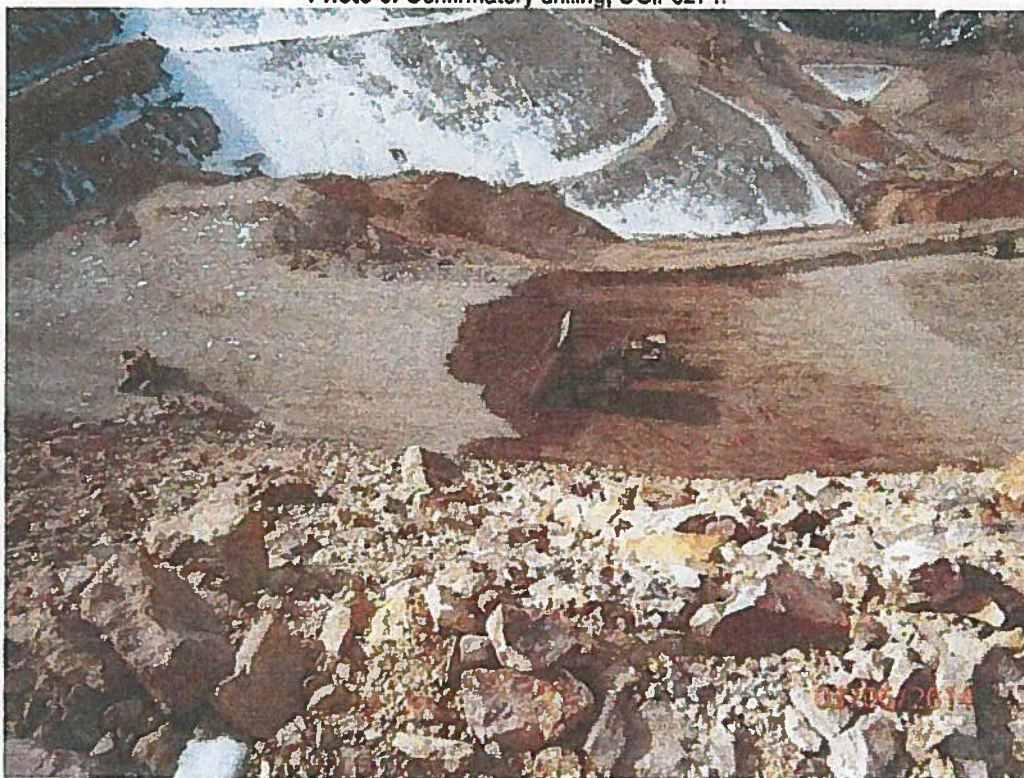
Photo 4: Fill placement at the buttress fill.

A Cat 992 loader removed material from near stations B10+00 to B16+00. The material was hauled to the ADR haul road fill; near STA 49+00 to 50+00, 57+00 to 62+00 and in the buttress fill area adjacent to Dump 4, in 777 haul trucks and was placed as structural fill by a Cat D9 dozer. Cat dozers also cut material from the slopes above the ADR Haul Road fill areas. The material was pushed down to the fill area; dozers keyed into the bank for subsequent lift placement, and a Cat 330 hammer broke down oversize material. The structural fill was placed and compacted per method specification.
