COLORADO DIVISION OF RECLAMATION, MINING AND SAFETY
MINERALS PROGRAM INSPECTION REPORT
PHONE: (303) 866-3567

MINE NAME: Zellitti Pit	MINE/PROSPECTING ID#: M-1980-246	MINERAL: Gravel	COUNTY: La Plata
INSPECTION TYPE: Monitoring	INSPECTOR(S): Kate A. Pickford	INSP. DATE: March 17, 2014	INSP. TIME: 14:00
OPERATOR: Anthony Zellitti	OPERATOR REPRESENTATIVE: Anthony Zellitti	TYPE OF OPERATION: 112c - Construction Regular Operation

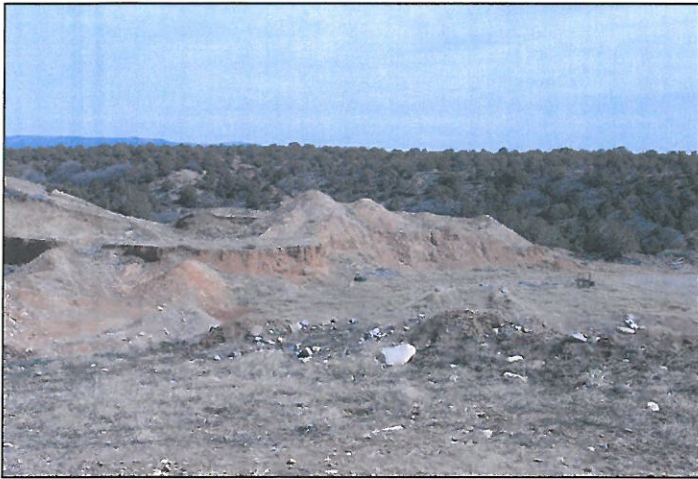
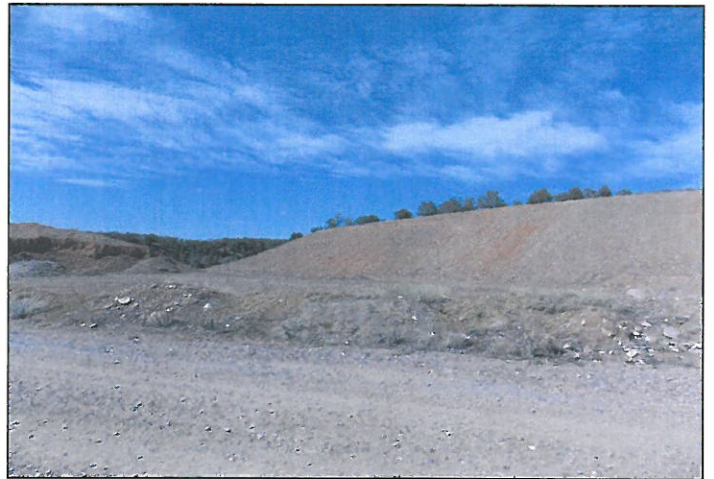
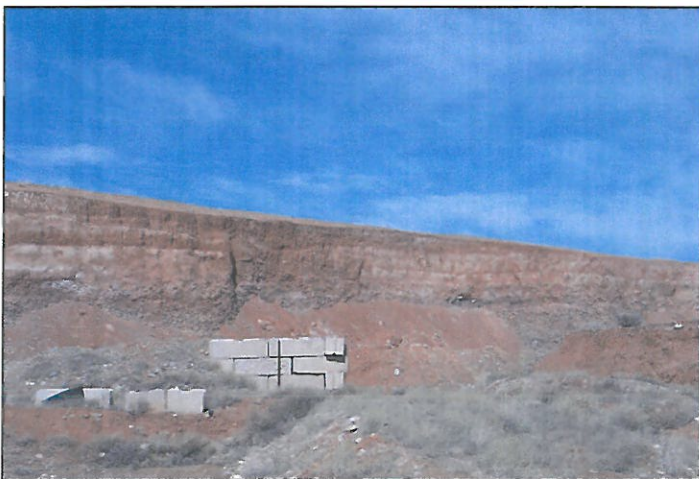
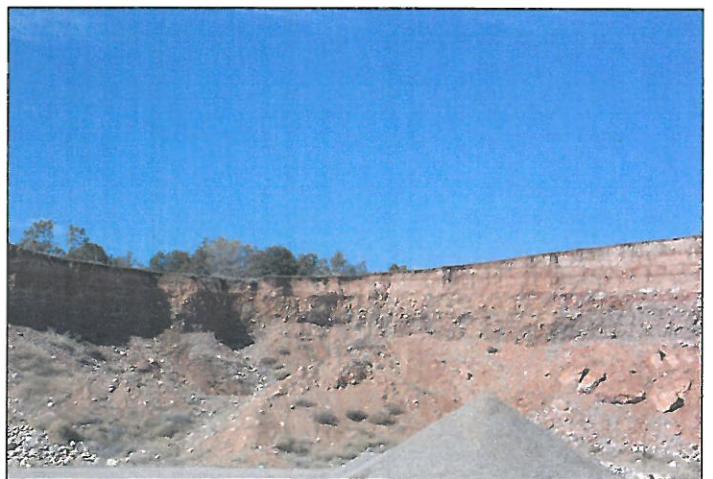
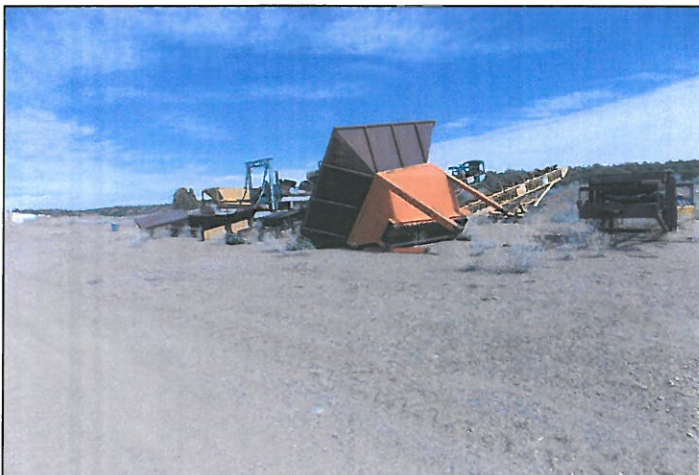
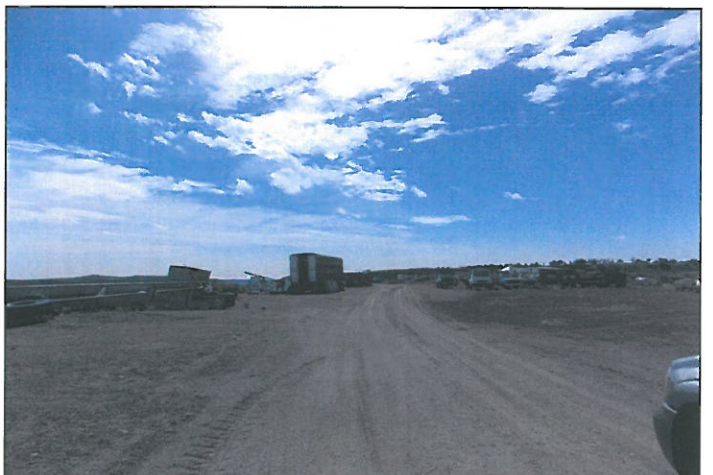
PHOTOGRAPHS

There is a highwall along the north side of the site, adjacent to the access road. Stockpiles of material are being stored on the pit floor. Various other stockpiles are stored in other areas within the permit. Only a small portion of the site has been reclaimed, the same slope that was reclaimed before 2009, and it does not appear that any additional reclamation has been done. A large amount of debris and scrap are being stored on the site.
