**COLORADO DIVISION OF RECLAMATION, MINING AND SAFETY**  
**MINERALS PROGRAM INSPECTION REPORT**  
**PHONE: (303) 866-3567**

<b>MINE NAME:</b> WRC Gravel Pit	<b>MINE/PROSPECTING ID#:</b> M-2008-070	<b>MINERAL:</b> Gravel	<b>COUNTY:</b> Rio Blanco
<b>INSPECTION TYPE:</b> Monitoring	<b>INSPECTOR(S):</b> Travis H. Marshall	<b>INSP. DATE:</b> April 8, 2014	<b>INSP. TIME:</b> 11:00
<b>OPERATOR:</b> Western Gravel, LLC	<b>OPERATOR REPRESENTATIVE:</b> Don Silva	<b>TYPE OF OPERATION:</b> 112c - Construction Regular Operation	
<b>REASON FOR INSPECTION:</b> Normal I&E Program	<b>BOND CALCULATION TYPE:</b> None	<b>BOND AMOUNT:</b> \$75,430.00	
<b>DATE OF COMPLAINT:</b> NA	<b>POST INSP. CONTACTS:</b> None	<b>JOINT INSP. AGENCY:</b> None	
<b>WEATHER:</b> Clear	<b>INSPECTOR'S SIGNATURE:</b>

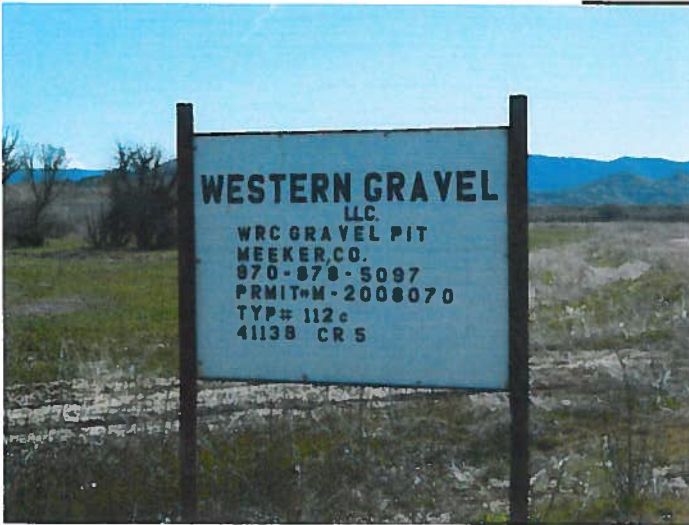
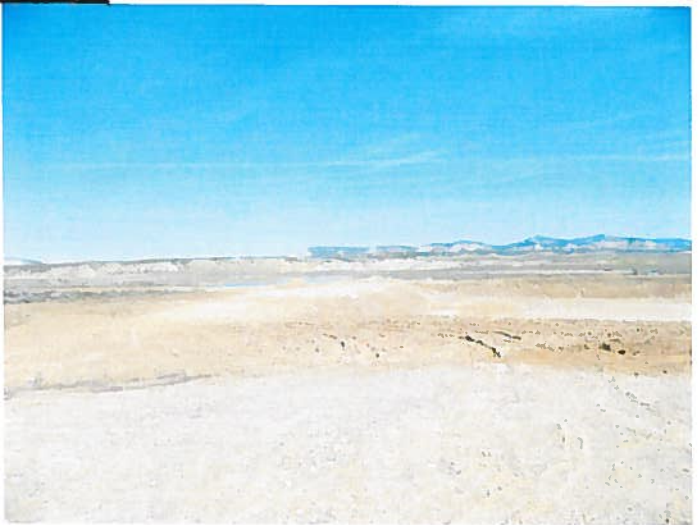
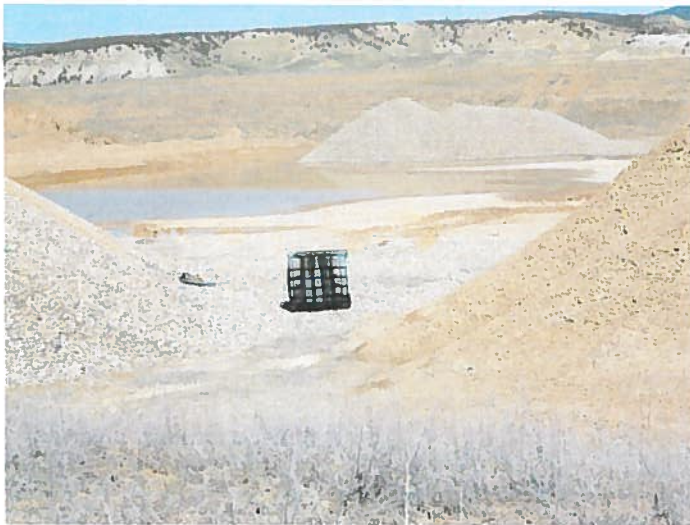
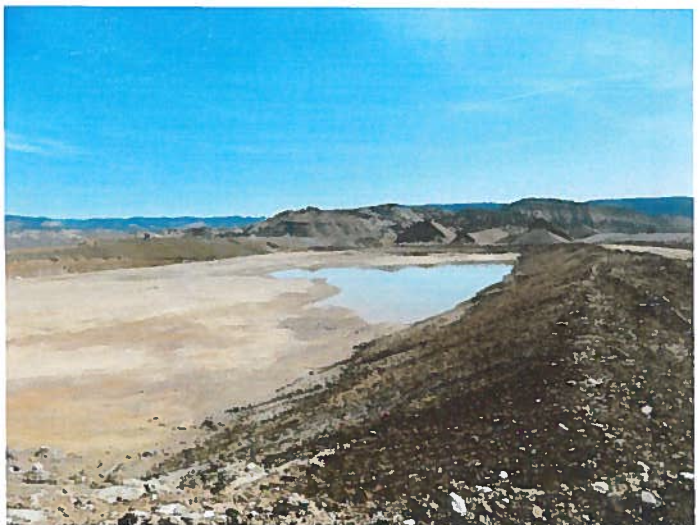
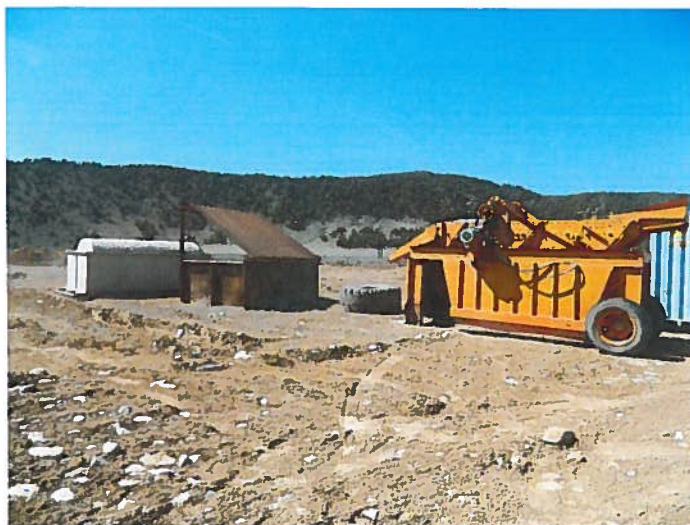
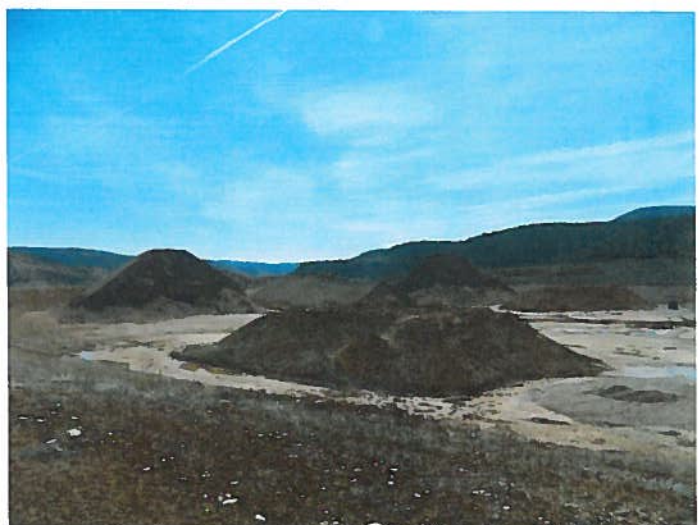
**PHOTOGRAPHS**

The site was inactive during the inspection. Various stockpiles of construction material were observed.

A waste oil container lacking secondary containment was observed within the permit area. This is noted as a problem. **The corrective action required is to construct secondary containment or remove the container from the permit area. Please provide photo-documentation of the corrective action no later than May 26, 2014 to avoid enforcement action.**

The operator has started the final grading for the solid waste disposal cell in Phase 1.

Photos that show the conditions observed during the inspection are included at the end of this report.

**CORRECTIVE ACTIONS:** All storage tanks, petroleum and any hazardous materials on site for any period of time shall have appropriate secondary containment. The site will also have to comply with all applicable SPCC requirements. Please supply photo documentation that any fuel or hazardous materials containers are stored properly - including applicable secondary containment structures by the corrective action date. Note that secondary containment structures shall consist of an impermeable containment which could contain all contents of the tanks and various containers (when full) plus 10% of the total capacity. The operator may also provide photo documentation that all containers have been removed from the site on or before the corrective action date.
