COLORADO DIVISION OF RECLAMATION, MINING AND SAFETY
MINERALS PROGRAM INSPECTION REPORT
PHONE: (303) 866-3567

MINE NAME: Gallegos Pit	MINE/PROSPECTING ID#: M-1983-164	MINERAL: Sand and gravel	COUNTY: Conejos
INSPECTION TYPE: Monitoring	INSPECTOR(S): Wallace H. Erickson	INSP. DATE: April 10, 2014	INSP. TIME: 11:10
OPERATOR: George F. Gallegos	OPERATOR REPRESENTATIVE: George Gallegos	TYPE OF OPERATION: 112c - Construction Regular Operation	
REASON FOR INSPECTION: Normal I&E Program	BOND CALCULATION TYPE: Complete Bond	BOND AMOUNT: \$28,034.00	
DATE OF COMPLAINT: NA	POST INSP. CONTACTS: None	JOINT INSP. AGENCY: None	
WEATHER: Cloudy	INSPECTOR'S SIGNATURE:

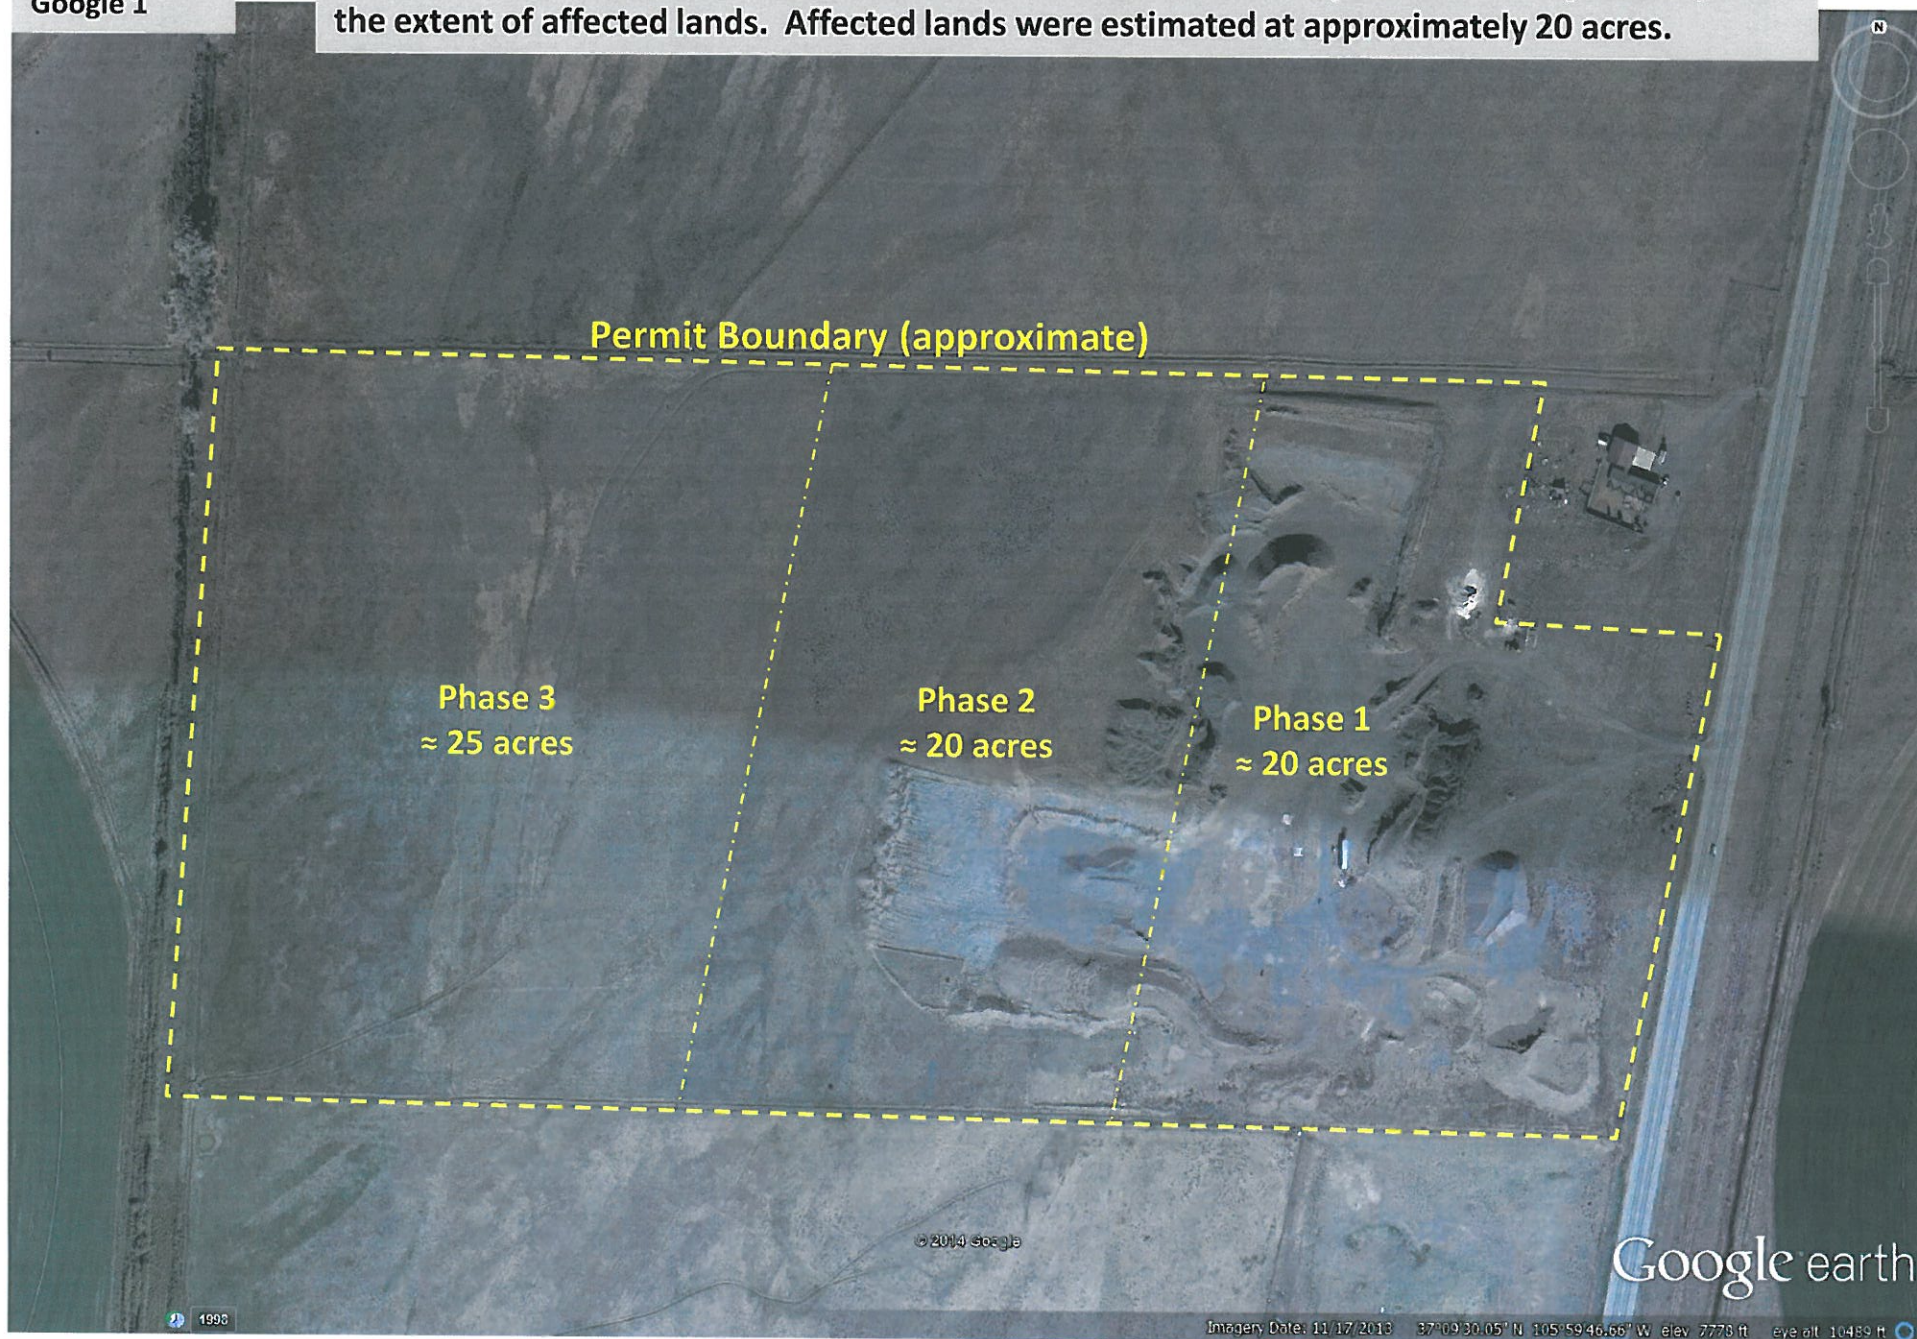
Gallegos Pit
M-1983-164
Google 1

Google Earth imagery, dated November 17, 2013 (north half of image) and September 28, 2013 (south half of image), showing the permit boundary, the various phases of the operation, and the extent of affected lands. Affected lands were estimated at approximately 20 acres.

As shown on the enclosed images from Google Earth, the affected lands were appropriately contained within the approved boundaries. The Google 1 image represents the view from approximately 2,700 feet above ground surface, resulting in a scale of approximately 1:3,678 or 1 inch = 306 feet. The Google 2 image represents the view from approximately 1,500 feet above ground surface, resulting in a scale of approximately 1:2,160 or 1 inch = 180 feet. Based upon observations made during the inspection, measurements taken from

the maps of the permit, and measurements taken from the Google Earth images, the Division estimates the current area of the affected lands at approximately 20 acres. This is in conflict with the most recent annual report, signed by the Operator on August 2, 2013, which reported the extent of affected lands at seven acres.

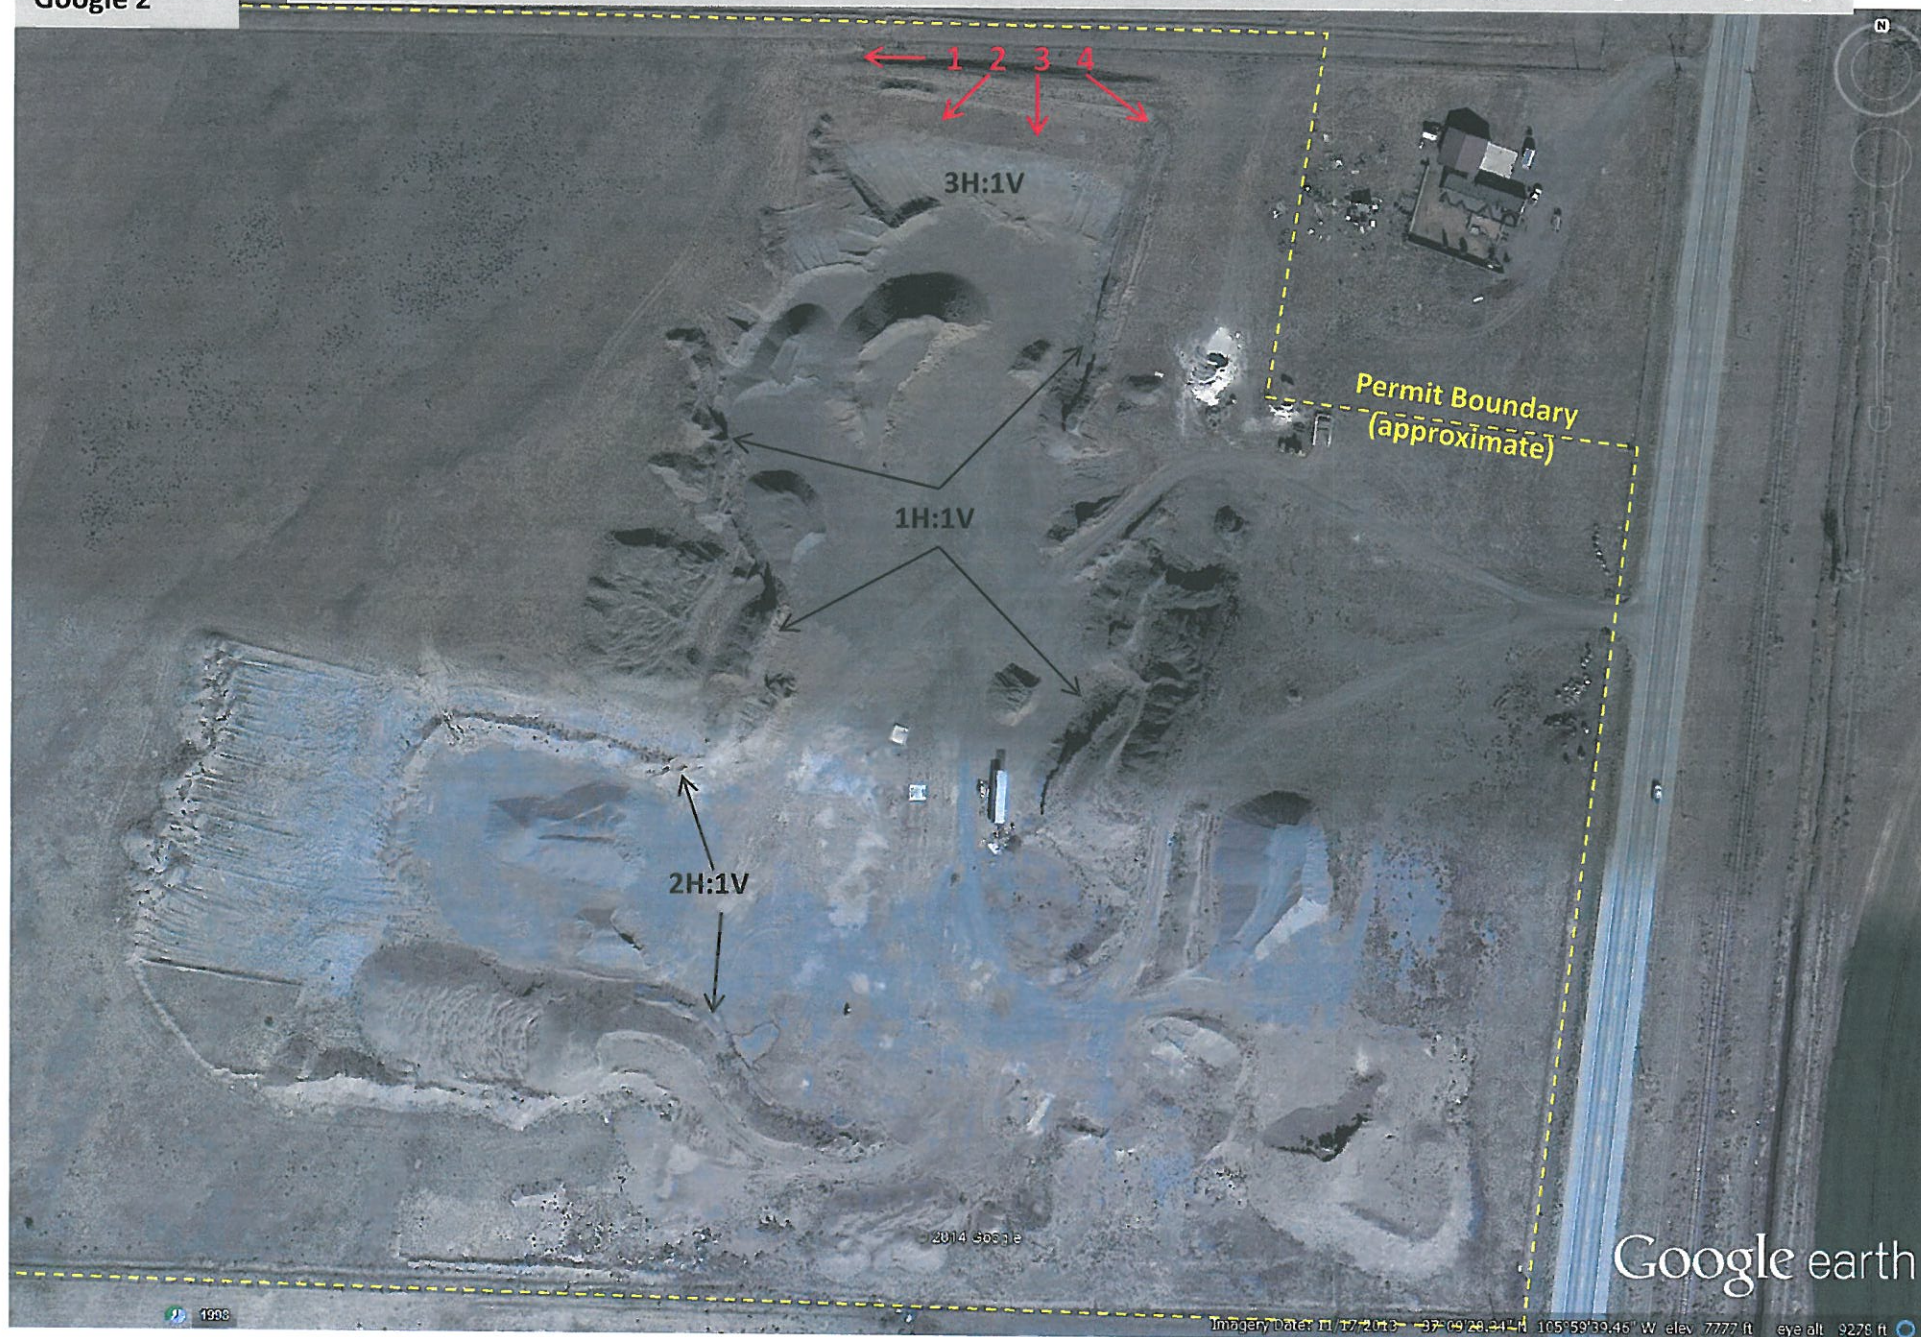
Gallegos Pit
M-1983-164
Google 2

Google Earth imagery, dated November 17, 2013 (north half of image) and September 28, 2013 (south half of image), showing the locations of four photographs taken during the inspection (**red**).

As shown on the enclosed Google Earth images and the photographs taken during the inspection, the slopes of the pit highwalls ranged from 1H:1V to 3H:1V. The 3H:1V slopes were limited to the north highwall (see Google 2 and Photo 3). The Operator indicated the 3H:1V slope represented the final configuration of the reclaimed slope. This is in conflict with the conditions of the approved reclamation plan, which indicate final slopes will be no steeper than 10H:1V. If the Operator desires final slopes at 3H:1V and not 10H:1V, the Operator must modify the conditions of the approved reclamation plan through either the Technical Revision process, described under Rules 1.1(49) and 1.9, or the Amendment process, described under Rules 1.1(6) and 1.10. In the absence of such modification the Division will require the Operator to reduce all pit slopes to no steeper than 10H:1V, as currently stated in the approved reclamation plan.

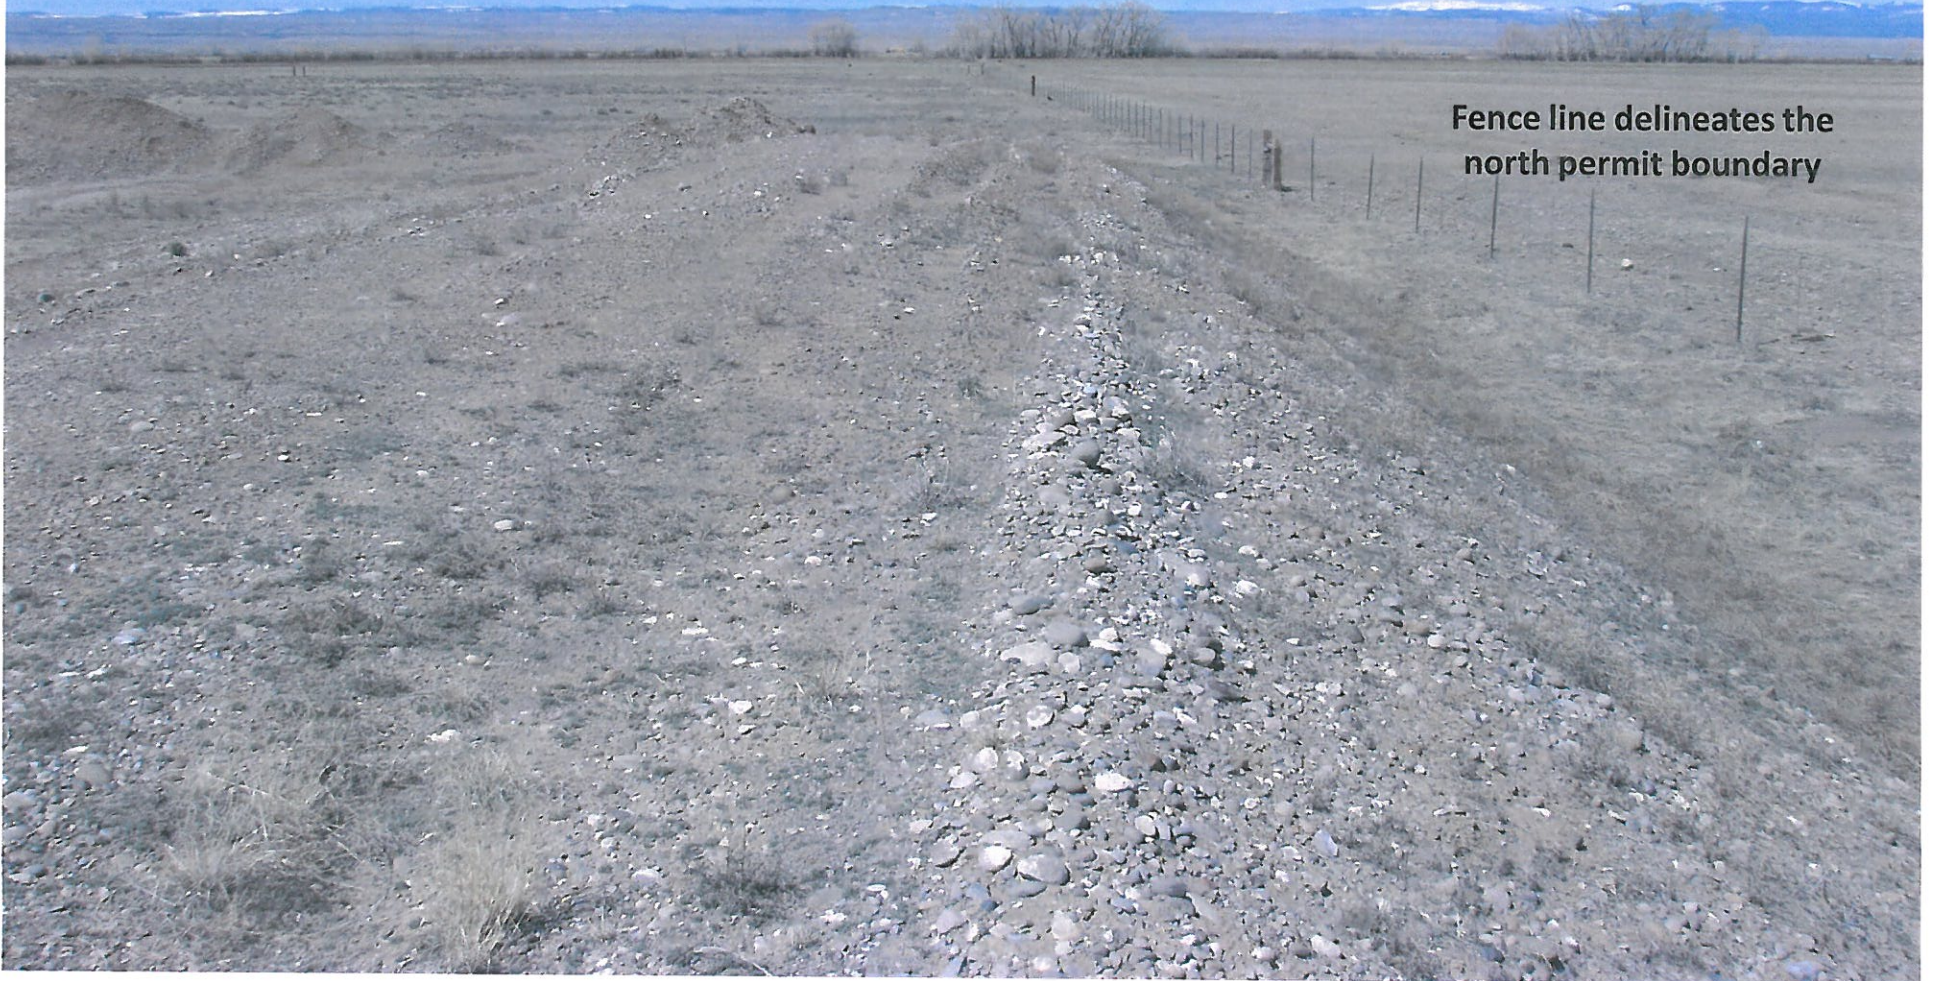
Gallegos Pit
M-1983-164
April 10, 2014
Photo 1

View west, taken from the top of a topsoil stockpile located at the north end of the Phase 1 area. Vegetative cover for the stockpiled topsoil appeared sparse and weedy, relative to the native vegetative cover, as shown in photos 1 through 4. Evidence of erosion of the stockpiled topsoil was limited to minor wind erosion.

**Fence line delineates the
north permit boundary**

PROBLEM: The approved mining and reclamation plans indicate topsoil will be salvaged and stockpiled along the north side of the pit area and maintained for reclamation purposes. Topsoil was observed stockpiled not only at the north side of the pit area, but also at unspecified locations along the east, south and west sides of the pit area. Pursuant to section 34-32.5-112(4) C.R.S., the locations and volumes of topsoil stockpiles must be identified within the permit documents. Additionally, the topsoil stockpiles did not exhibit a protective vegetative cover and are thereby susceptible to erosion and/or contamination due to infestation by noxious weeds. Pursuant to section 34-32.5-116(4)(g) C.R.S., topsoil shall be salvaged and segregated from other spoil. If such topsoil is not replaced on a backfill area within a period of time short enough to avoid deterioration of the topsoil, vegetative cover or other means shall be employed so that such topsoil is preserved from wind and water erosion, remains free of contamination, and is in a useable condition for sustaining vegetation when restored during reclamation. The Division has specified one year as the period of time whereby the Operator shall establish a protective vegetative cover for stockpiled topsoil.

CORRECTIVE ACTIONS: Within 60 days of the signature date of this inspection report, due July 15, 2014, the Operator must file with the Division a modification to the permit identifying all locations and volumes of topsoil stockpiles and addressing how topsoil stockpiles will be preserved from wind and water erosion, remains free of contamination, and is in a useable condition for sustaining vegetation when restored during reclamation. The modification shall be filed with the Division through either the Technical Revision process, described under Rules 1.1(49) and 1.9, or the Amendment process, described under Rules 1.1(6) and 1.10.

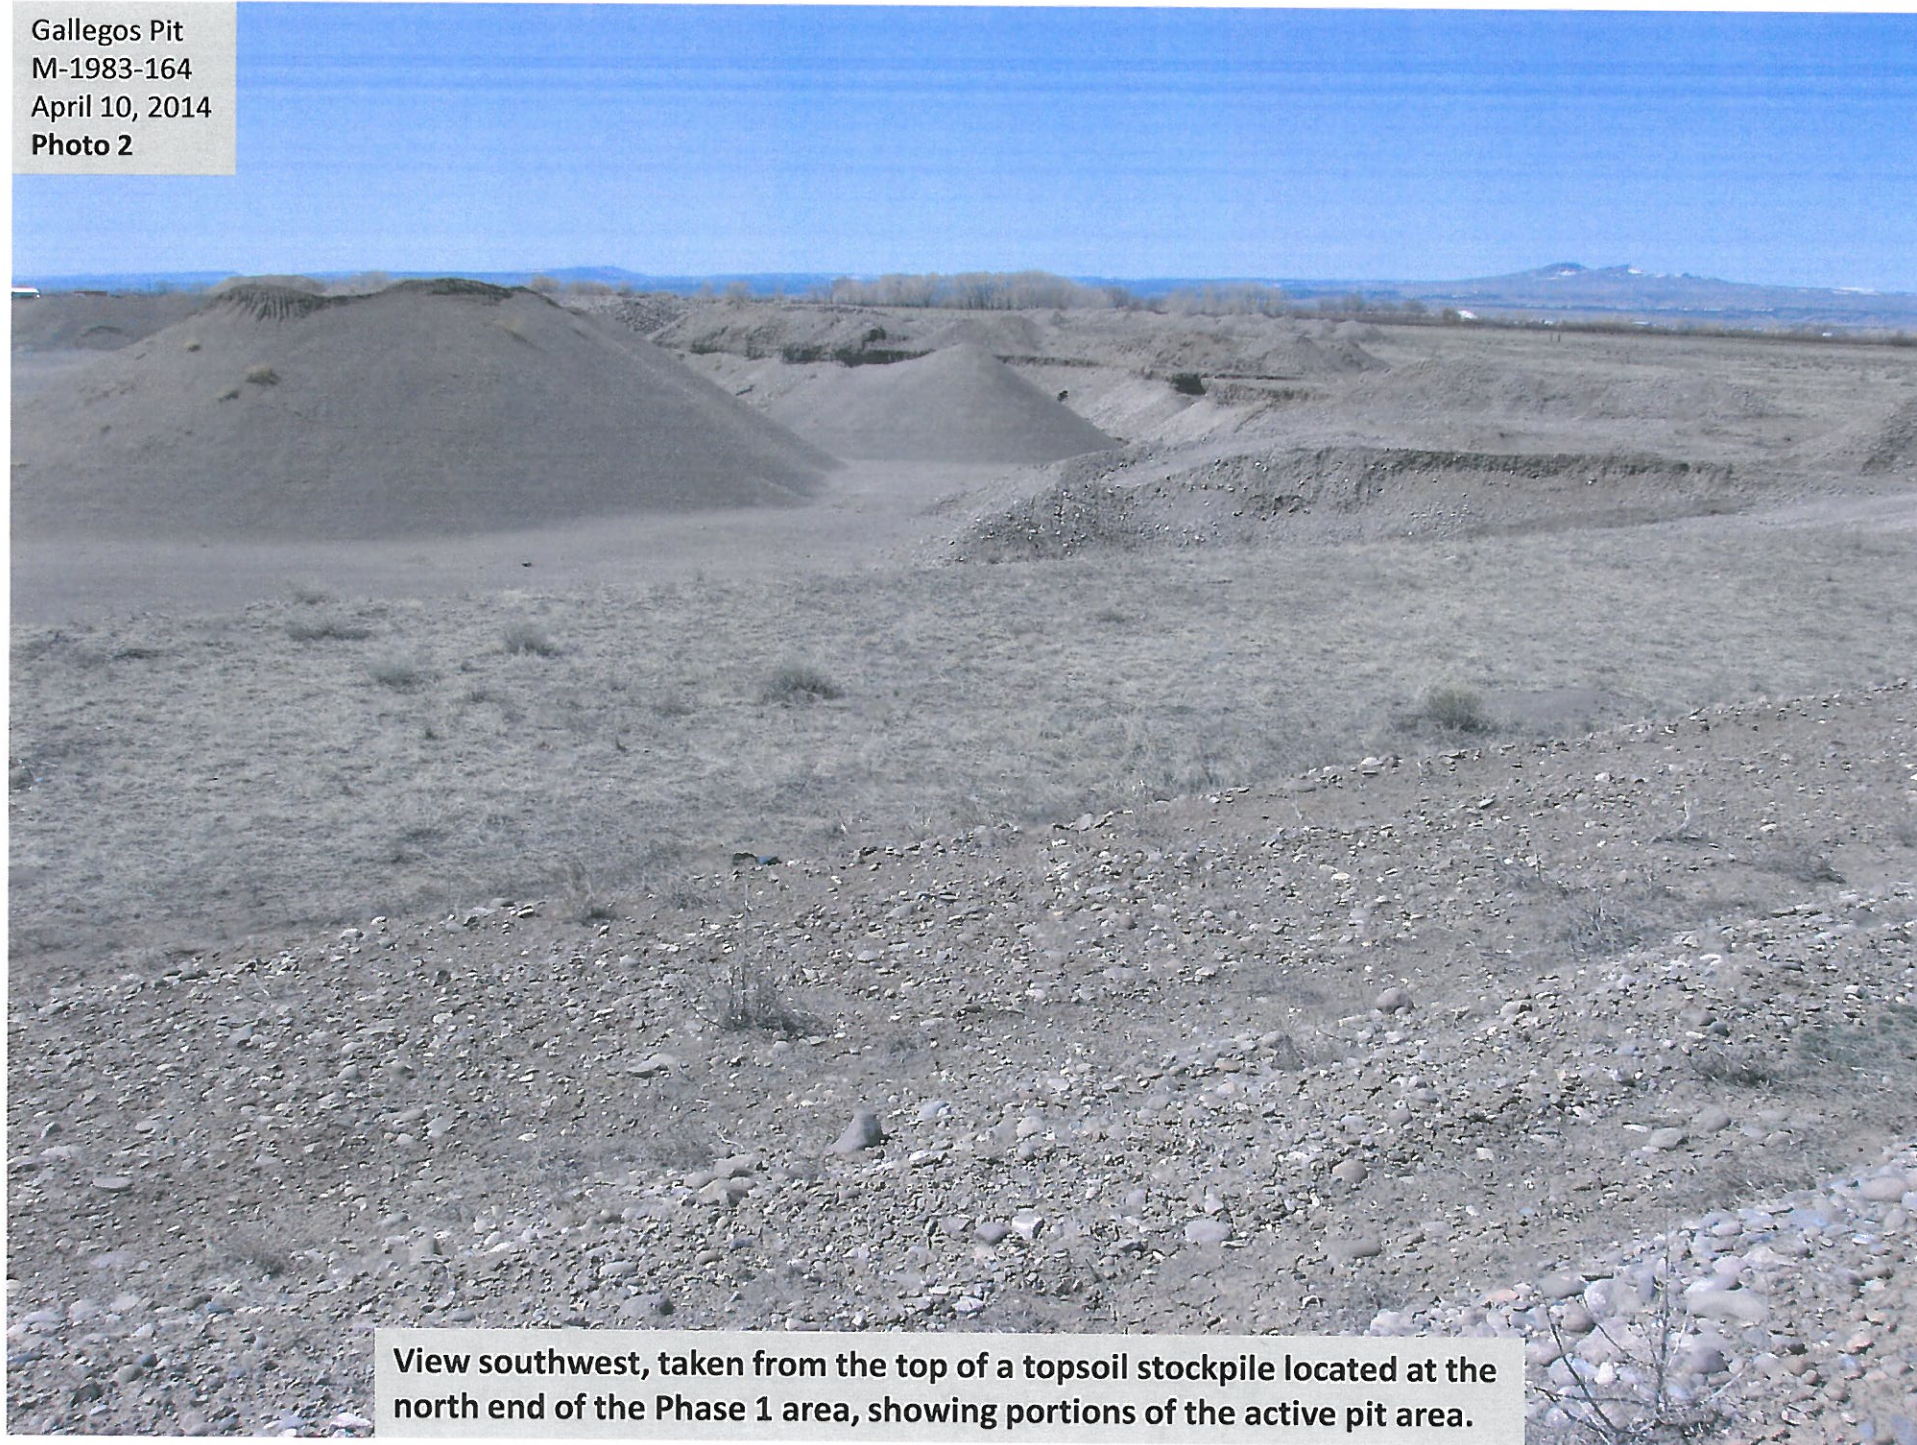
Gallegos Pit
M-1983-164
April 10, 2014
Photo 2

View southwest, taken from the top of a topsoil stockpile located at the north end of the Phase 1 area, showing portions of the active pit area.

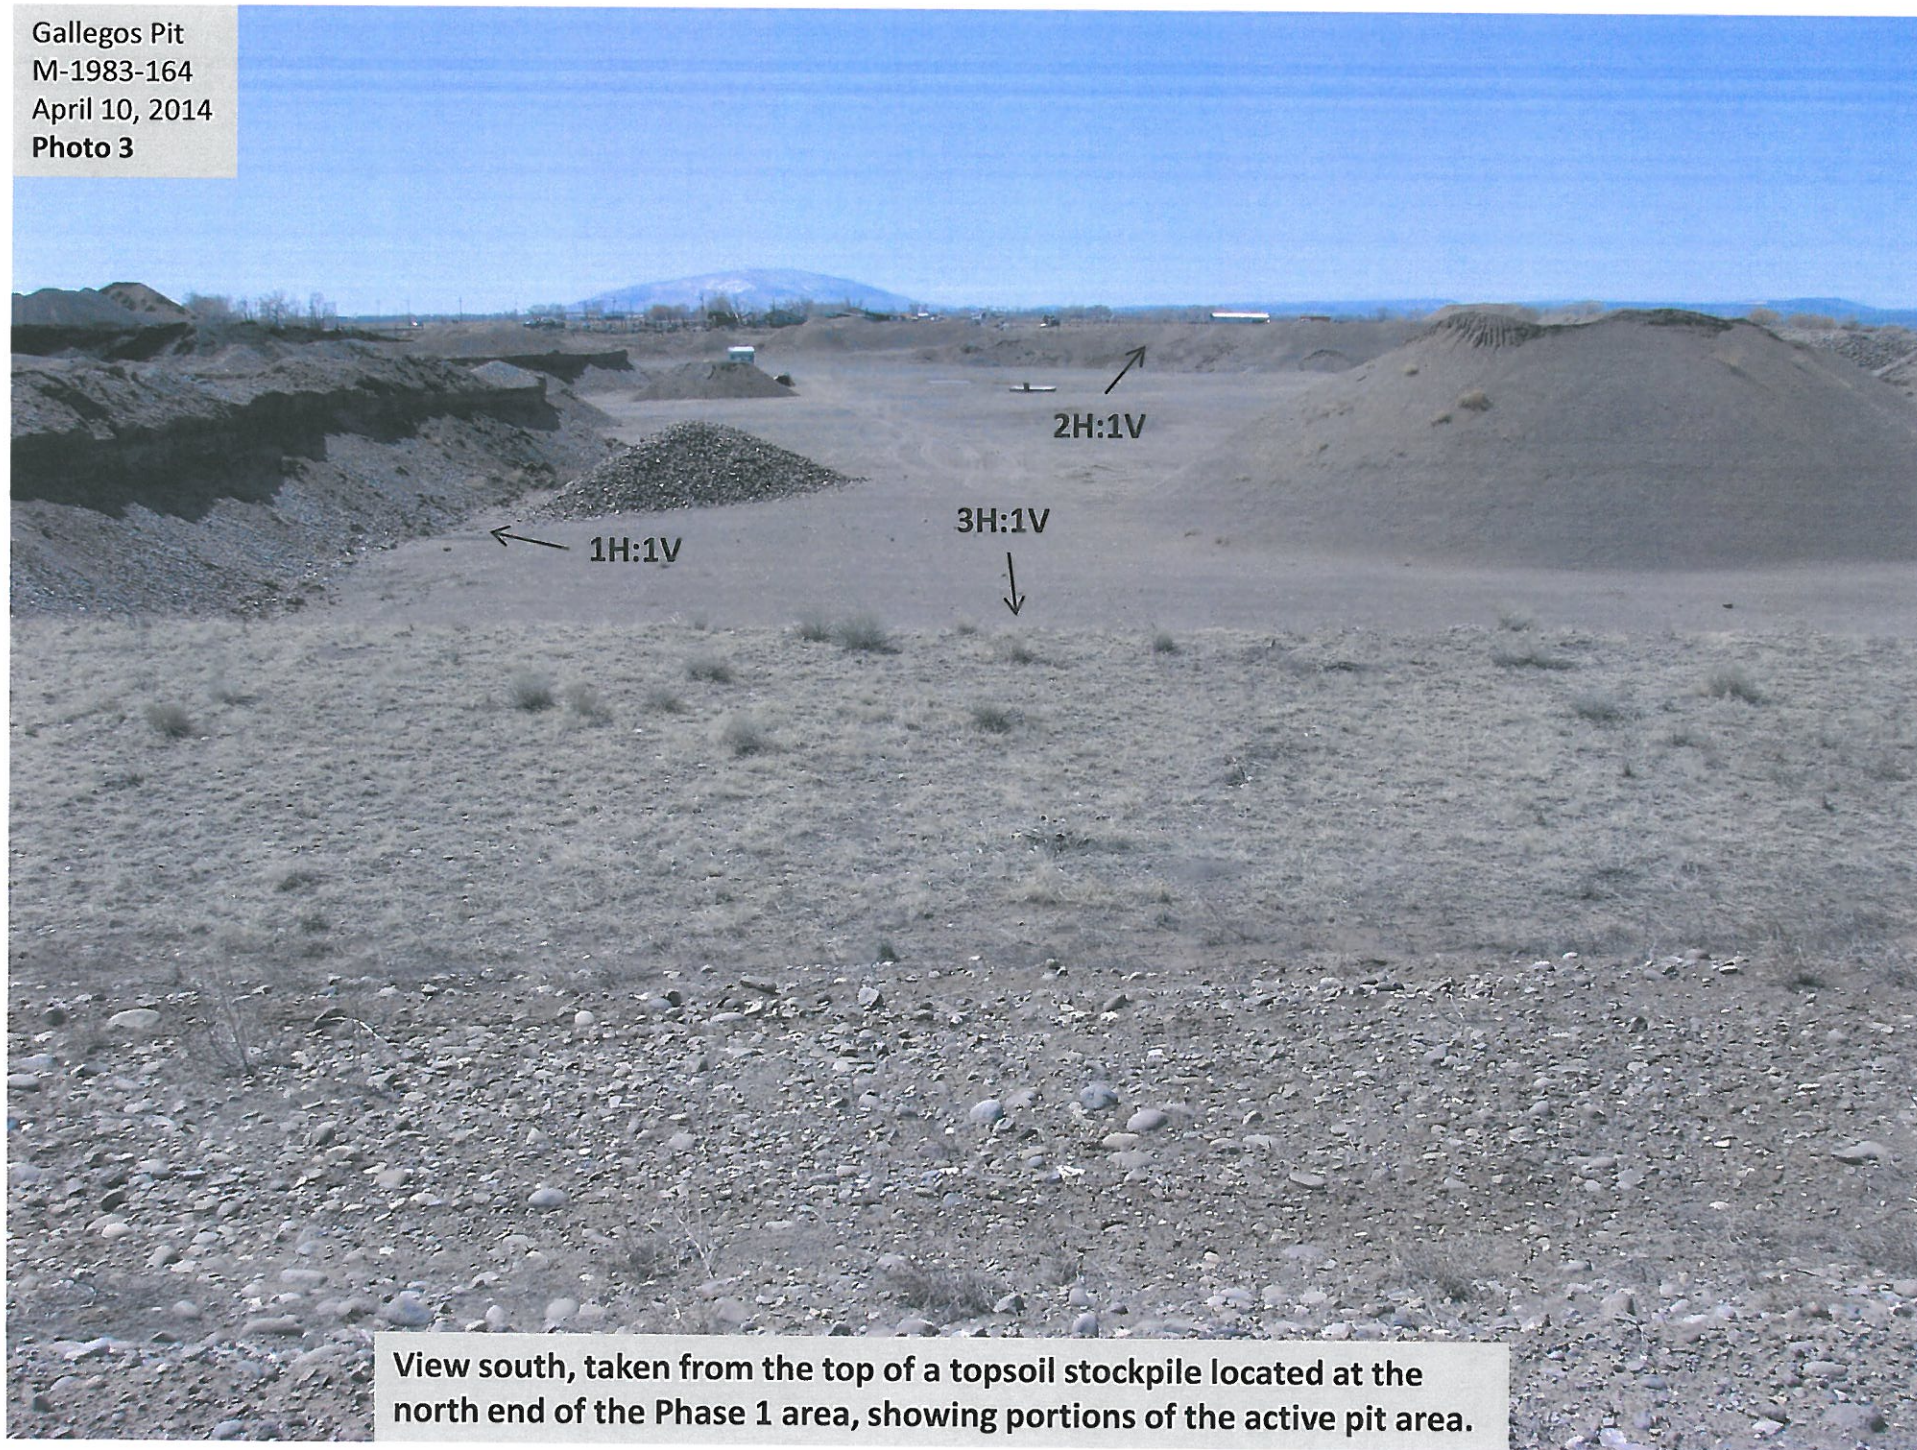
Gallegos Pit
M-1983-164
April 10, 2014
Photo 3

View south, taken from the top of a topsoil stockpile located at the north end of the Phase 1 area, showing portions of the active pit area.

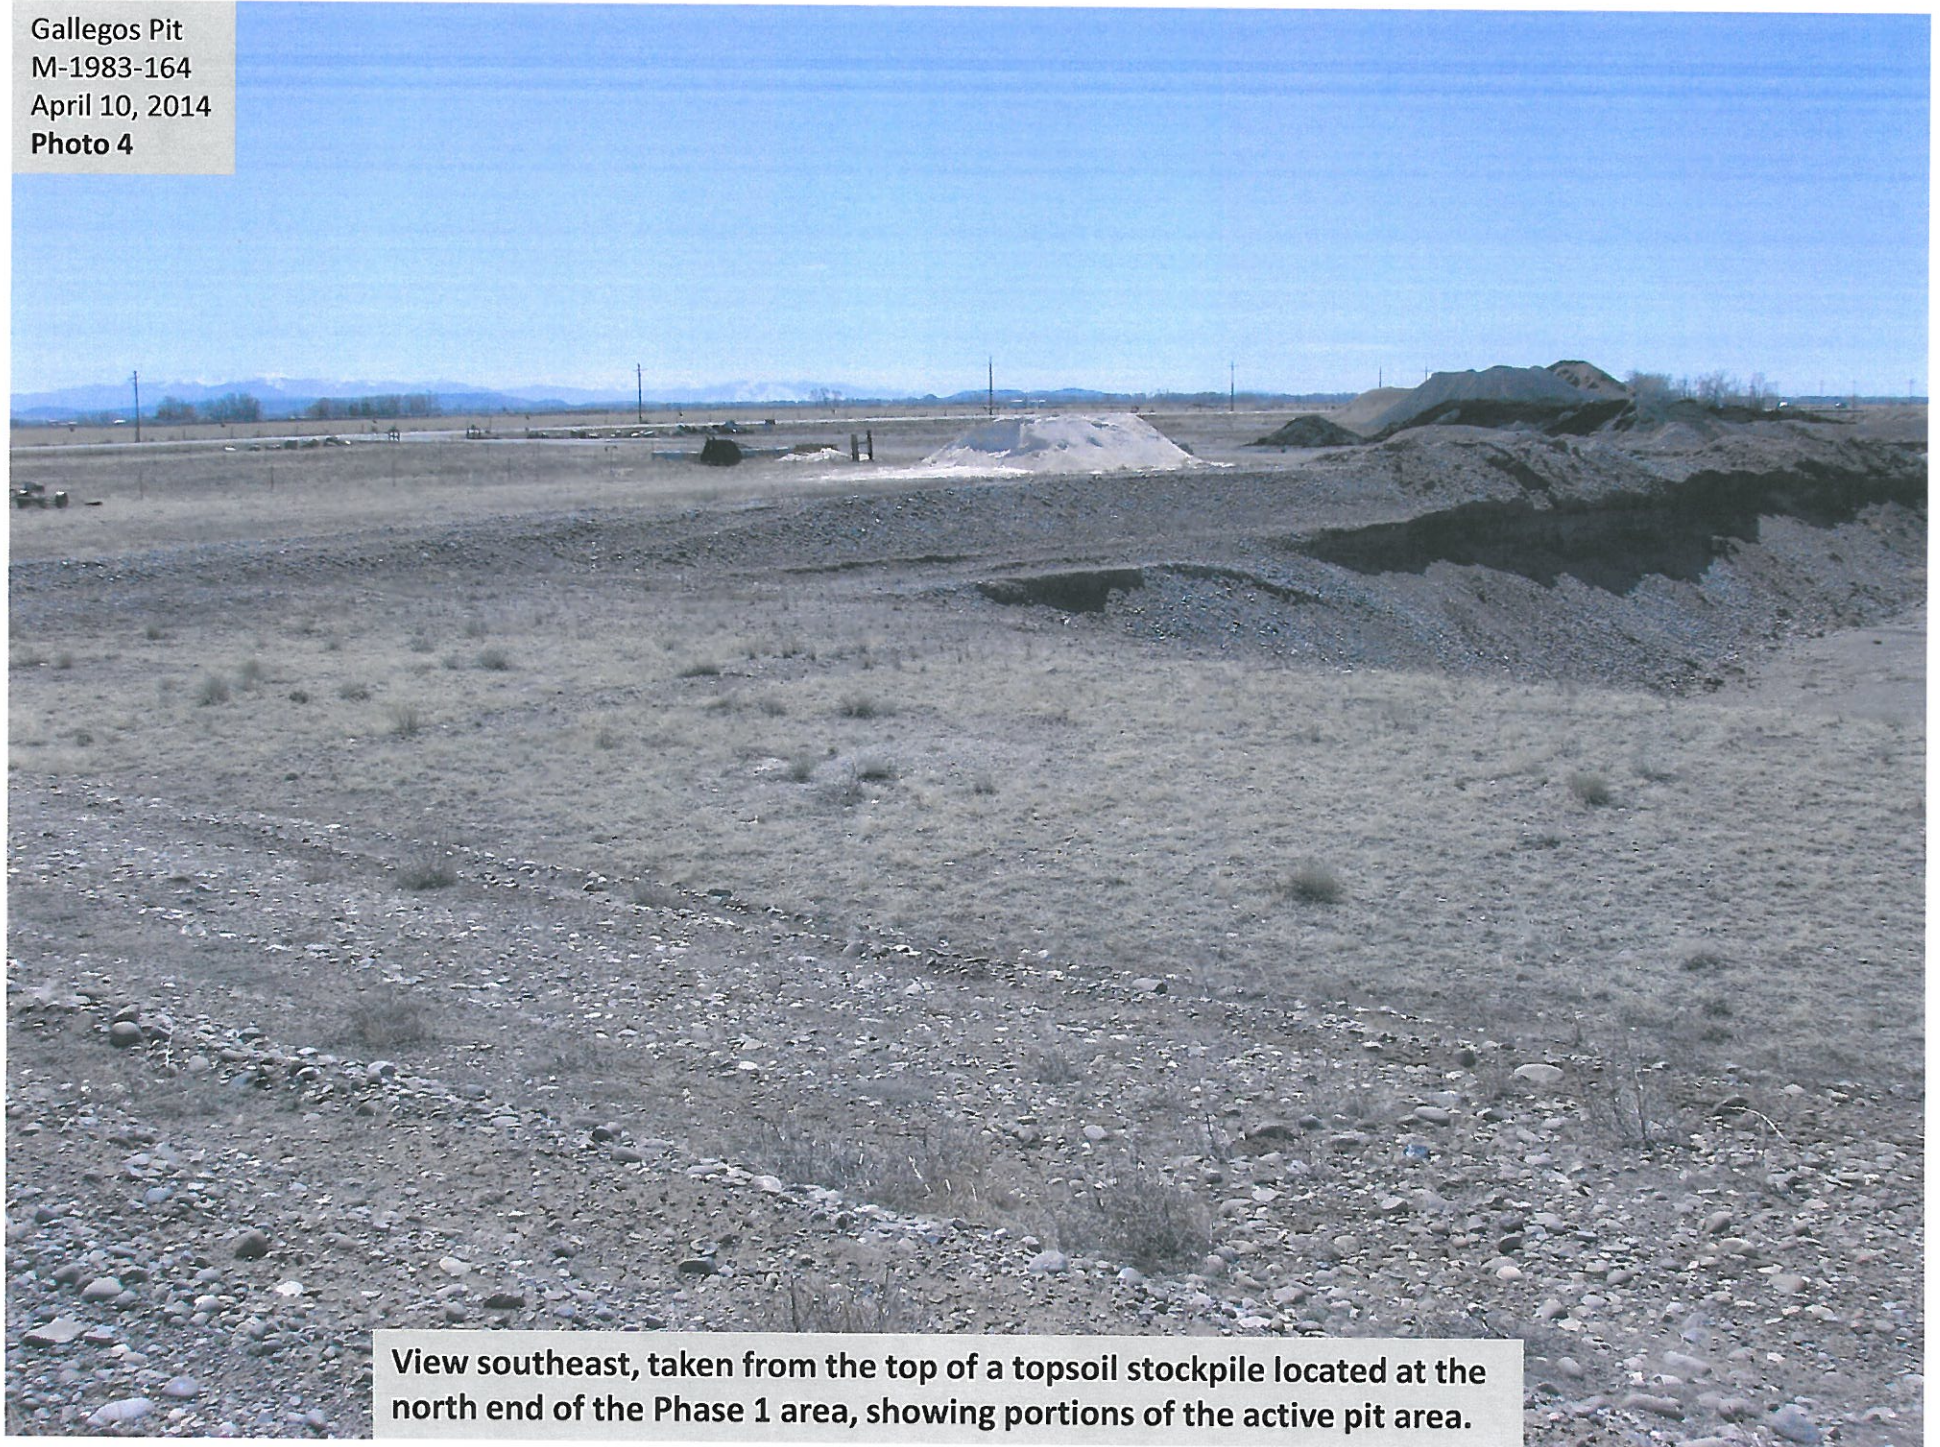
Gallegos Pit
M-1983-164
April 10, 2014
Photo 4

View southeast, taken from the top of a topsoil stockpile located at the north end of the Phase 1 area, showing portions of the active pit area.

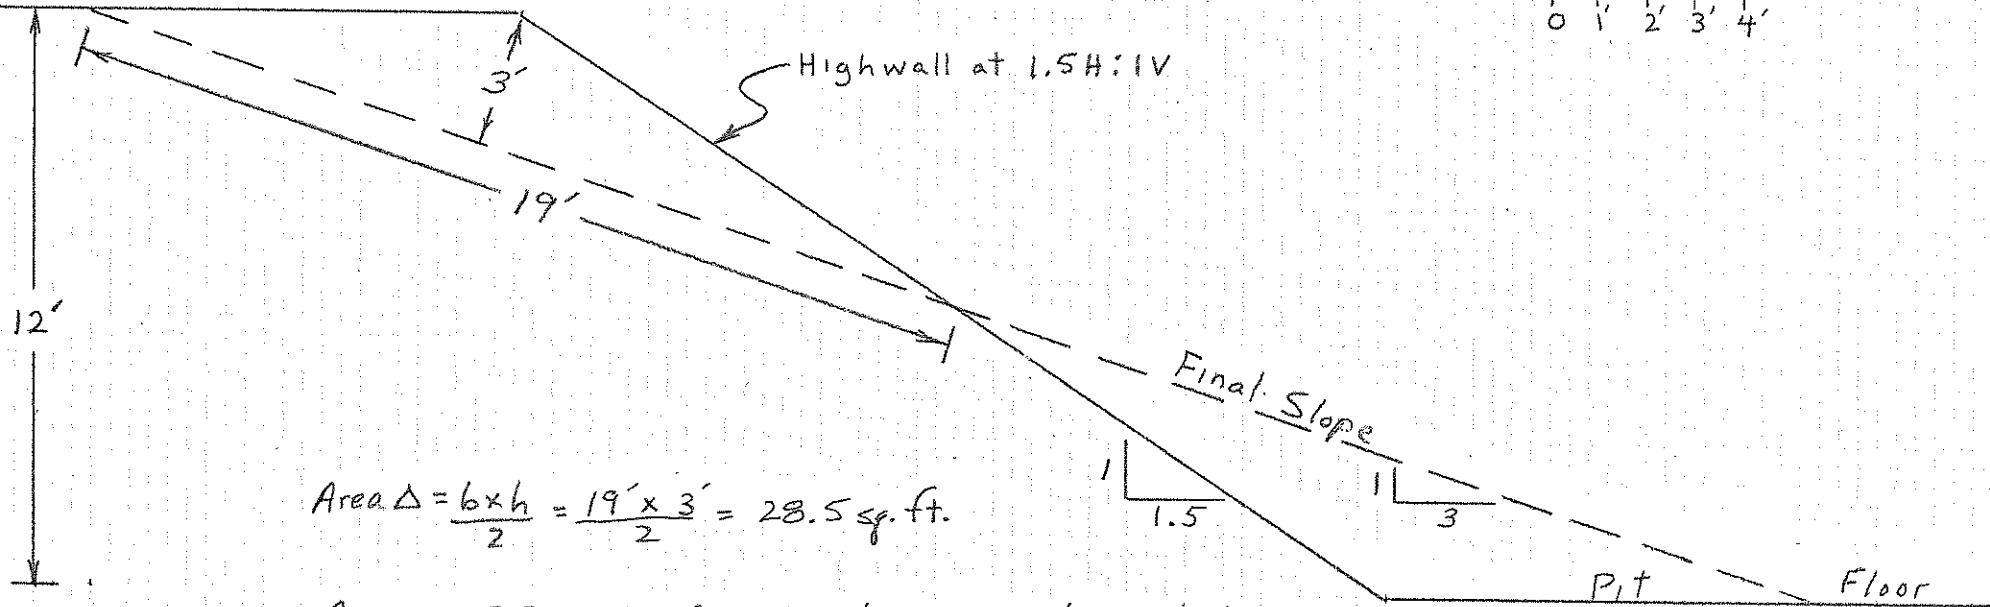
Highwall Reduction Balanced Cut and Fill

Gallegos Pit
M-1983-164
5/15/14 WHE
Scale 1" = 4'

$$\text{Area } \Delta = \frac{b \times h}{2} = \frac{19' \times 3'}{2} = 28.5 \text{ sq. ft.}$$

Assume 3,300 LF of highwall requires slope reduction

$$\begin{aligned} \text{Material Quantity} &= 3,300 \text{ LF} \times 28.5 \text{ sq. ft.} \\ &= 94,050 \text{ cu. ft} \\ &= 3,483.33 \text{ cy} \end{aligned}$$

$$\begin{aligned} \text{Area of final 3H:1V slope} &= 3,300 \text{ LF} \times 37.9 \text{ ft.} \\ &= 125,070 \text{ sq. ft} \\ &+ 9,096 \text{ sq. ft.} \\ \hline &134,166 \text{ sq. ft.} = 3.08 \text{ acres} \end{aligned}$$

Approximately 240 LF highwall
already at 3H:1V
 $240 \text{ LF} \times 37.9 \text{ ft}$
 $= 9,096 \text{ sq. ft.}$

Total unit Cost/Hour: \$264.49Total Fleet Cost/Hour: \$264.49MATERIAL QUANTITIESInitial Volume: 3,483Swell factor: 1.124Loose volume: 3,914 LCYSource of estimated volume: See attached drawing, "Highwall Reduction"Source of estimated swell factor: Cat HandbookHOURLY PRODUCTIONAverage push distance: 50 feetUnadjusted hourly production: 2,222.9 LCY/hrMaterials consistency description: Compacted fill or embankment 0.9Average push gradient: -15 %Average site altitude: 7,700 feetMaterial weight: 2,900 lbs/LCYWeight description: Sand and gravel - DryJob Condition Correction Factor
