**COLORADO DIVISION OF RECLAMATION, MINING AND SAFETY**  
**MINERALS PROGRAM INSPECTION REPORT**  
**PHONE: (303) 866-3567**

| <b>MINE NAME:</b><br>Leone Gravel Pit | <b>MINE/PROSPECTING ID#:</b><br>M-2004-026 | <b>MINERAL:</b><br>Sand and gravel | <b>COUNTY:</b><br>Las Animas |
| <b>INSPECTION TYPE:</b><br>Monitoring | <b>INSPECTOR(S):</b><br>Amy Eschberger | <b>INSP. DATE:</b><br>April 25, 2014 | <b>INSP. TIME:</b><br>08:00 |

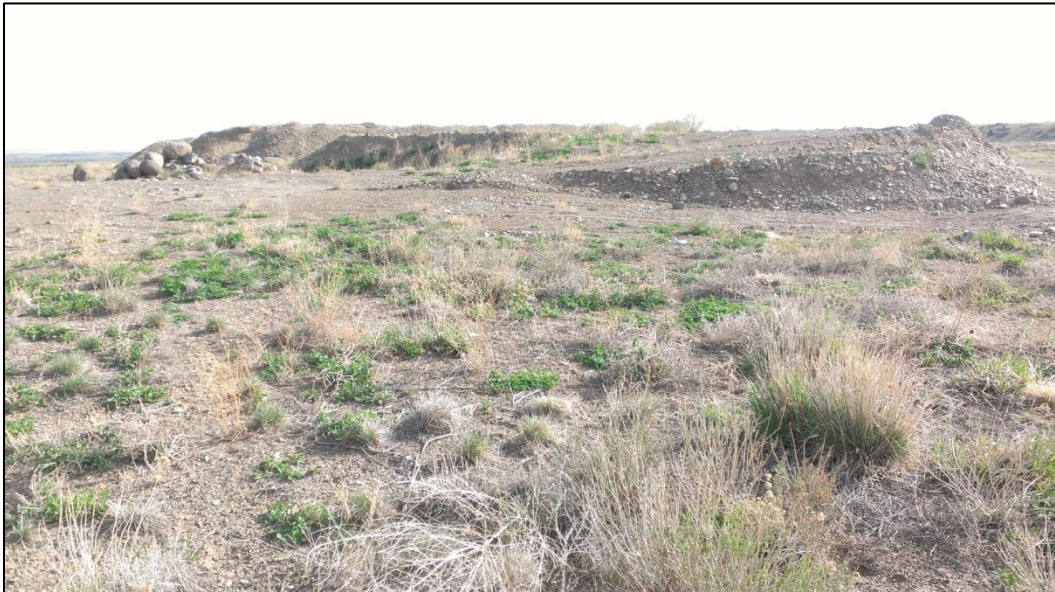
**Photo 1.** View from upper level looking north/northeast, showing small mined material and rock stockpiles.

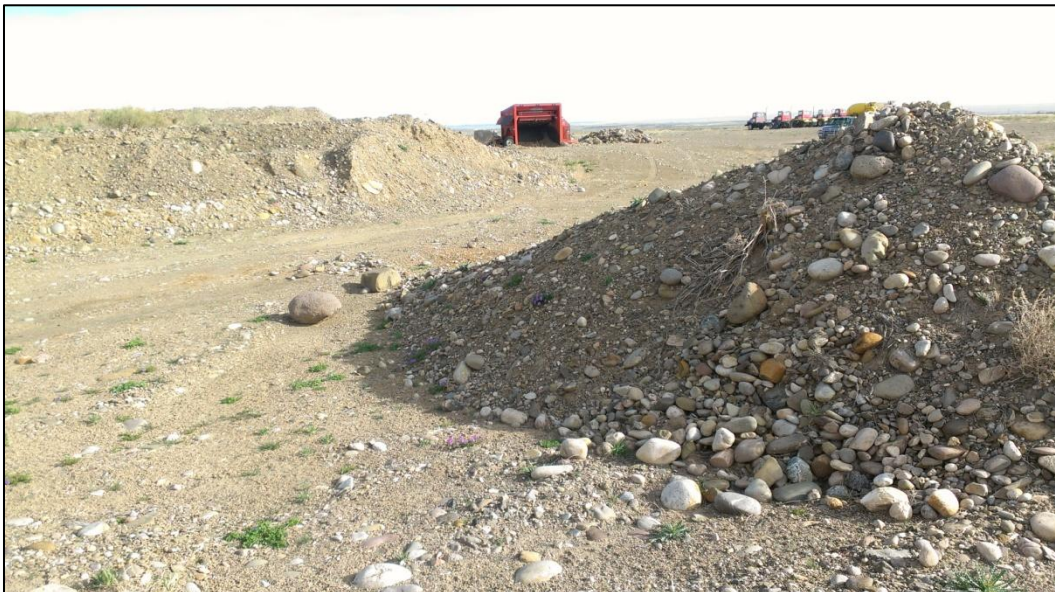
**Photo 2.** View from upper level looking northeast, showing small mined material and rock stockpiles. Portable screener and trucks shown in background.

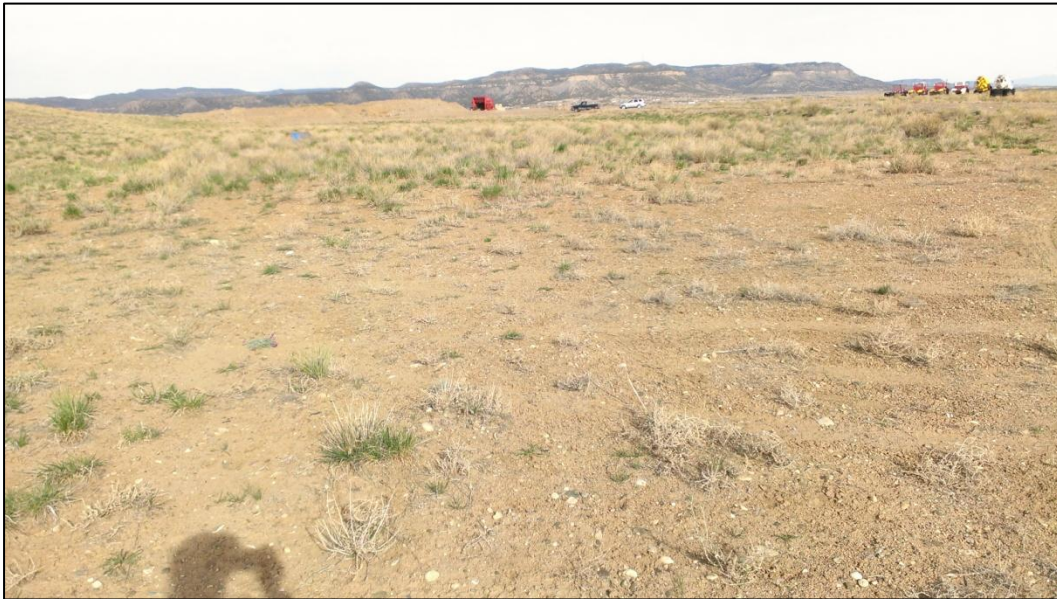
**Photo 3.** View from upper level looking northwest, with stored equipment and trucks shown in background.

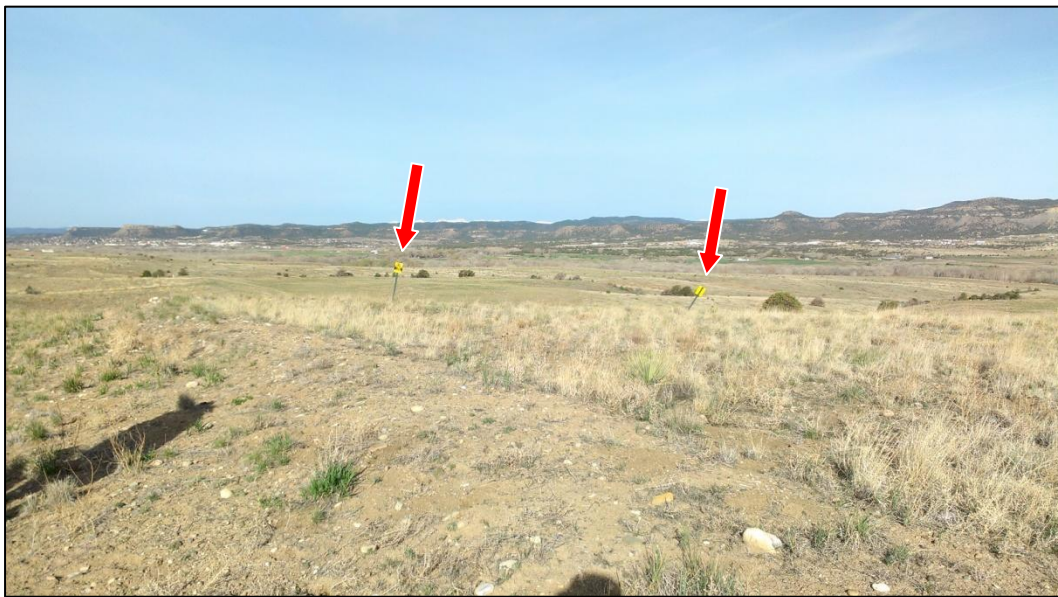
**Photo 4.** View from lower level looking northwest, showing marked gaslines running southwest-northeast through center of permit area (arrows point to two of the markers).

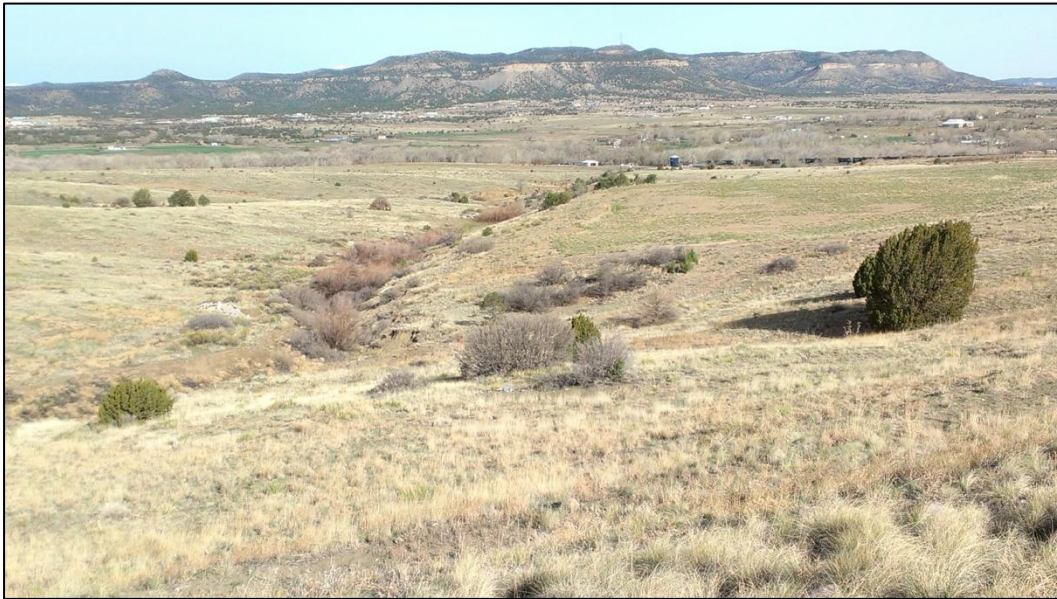
This is a 112c operation permitted for 56.00 acres. A pre-existing reclaimed gravel pit (terminated permit M-1979-217, Latuda Gravel Pit) is located in the southeastern portion of the site. Part of this reclaimed pit comprises the upper (relatively flat) level of the permitted site, where a few small mined material and rock stockpiles (Photos 1 and 2), stored equipment and trucks (Photos 2 and 3) are present. This upper level area is approximately 6 acres in size. The rest of the site is at a lower level, approximately 50 acres in size. Two gas pipelines owned by Colorado Interstate Gasline (CIG) run southwest-northeast across the center of the permit area (Photo 4). The Operator appears to be maintaining the proper setbacks from the lines. The site was mined in four phases, with Phases 1 and 2 south of the gas lines, and Phases 3 and 4 north of the gas lines. A gully with an intermittent stream runs southeast-northwest across the middle of the site (Photo 5), with Phases 1 and 4 to the east, and Phases 2 and 3 to the west.

During the most recent inspection, the entire area north of the gas lines (approximately 28 acres in size), comprised of Phases 3 and 4, had well-established vegetation, and appeared to have been successfully reclaimed in accordance with the post-mining land use of rangeland (Photos 5-7). The Division recommends that the Operator submit an Acreage Reduction (Partial Release) request (see enclosed form) for this portion of the permit area located north of the gas lines. The portion of the permit area that runs south of the gas lines down to the base of the hill that rises to the upper level (approximately 22 acres in size) had some bare patches in vegetative cover (Photos 8 and 9) that will require reseeding before it can be released from the permit. However, as discussed with the Operator during inspection, pursuant to Rule 4.14.1, the Operator may submit a Surety Reduction request by letter to ask that the bond be reduced to account for reseeding only of this portion of the permit area.

**Photo 5.** View from lower level looking northwest across permit area north of gaslines, showing gulley running southeast-northwest across middle of site.

- 1) The Division recommends that the Operator submit an Acreage Reduction (Partial Release) request (form enclosed) for the reclaimed acreage north of the gas lines (approximately 28 acres, according to Division calculations) by **July 24, 2014** (90 days from this inspection).

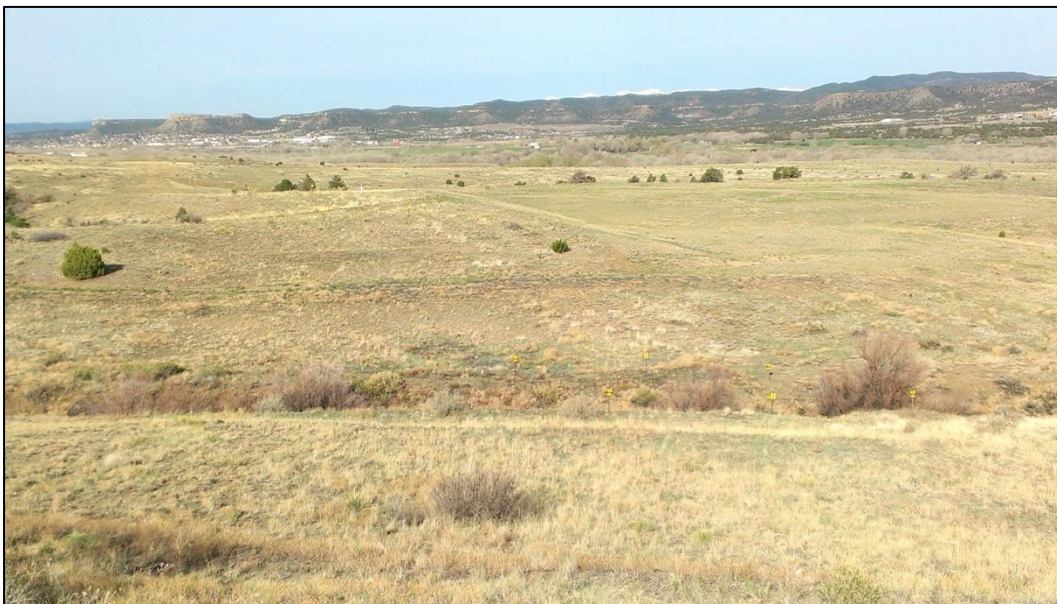
**Photo 6.** View from lower level looking west across permit area, showing reclaimed portion north of gaslines.

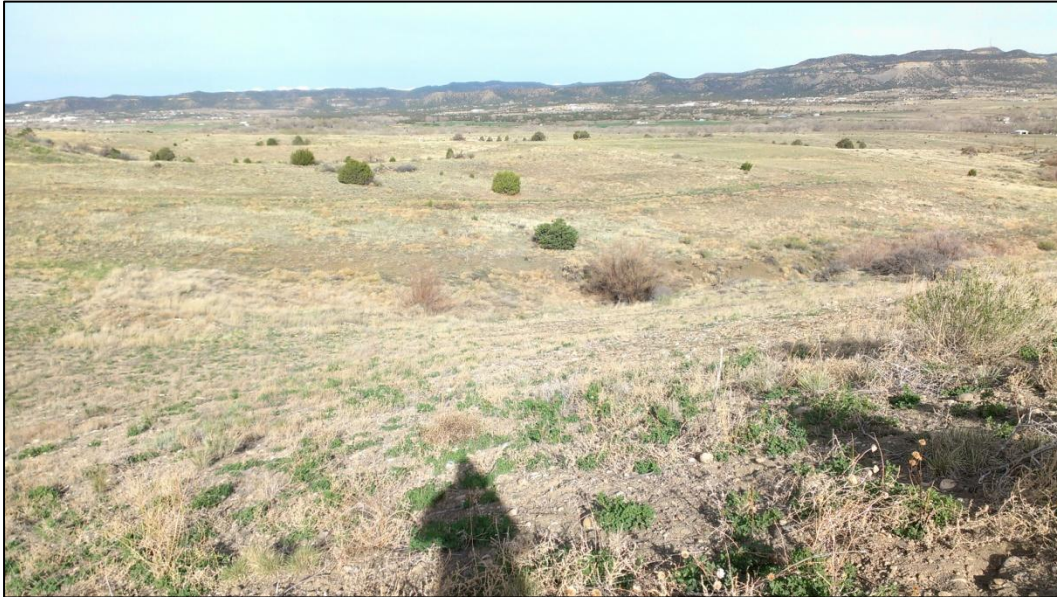
**Photo 7.** View from lower level looking west across permit area, showing reclaimed portion north of gaslines. Photo taken from farther south than in Photo 6.

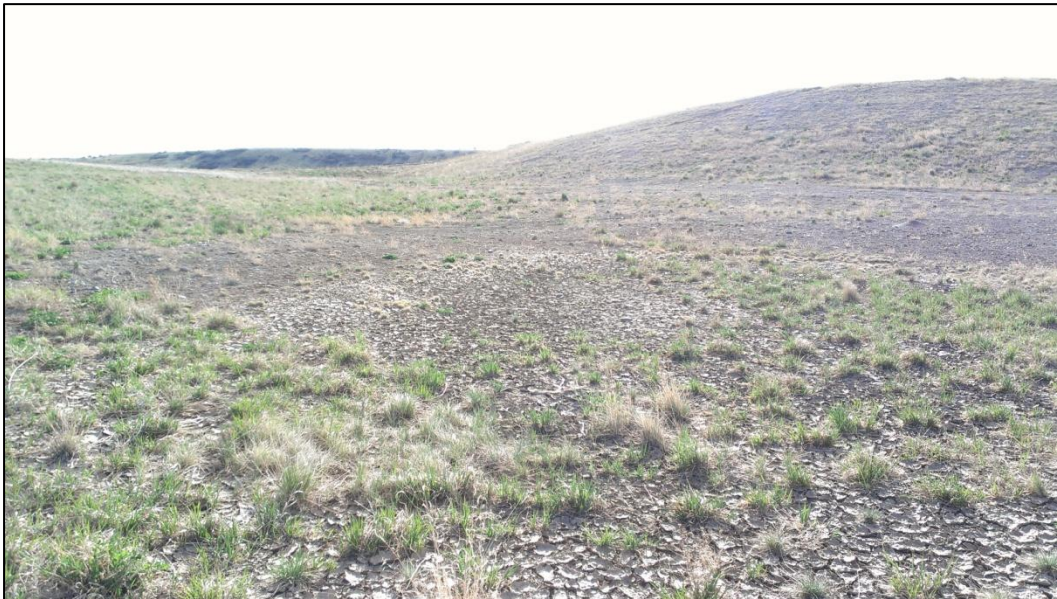
**Photo 8.** View from lower level looking east/southeast across portion of permit area showing some bare patches in vegetative cover.

- 2) The Operator may wish to submit a Surety Reduction request by letter to ask that the bond be reduced to account for re-seeding only of the section of land south of the gas lines down to the base of the hill that rises to the upper level in the permit area (approximately 10 of the 22 acres will need re-seeding, according to Division calculations). The Division recommends that this request be submitted by **July 24, 2014** (90 days from this inspection)

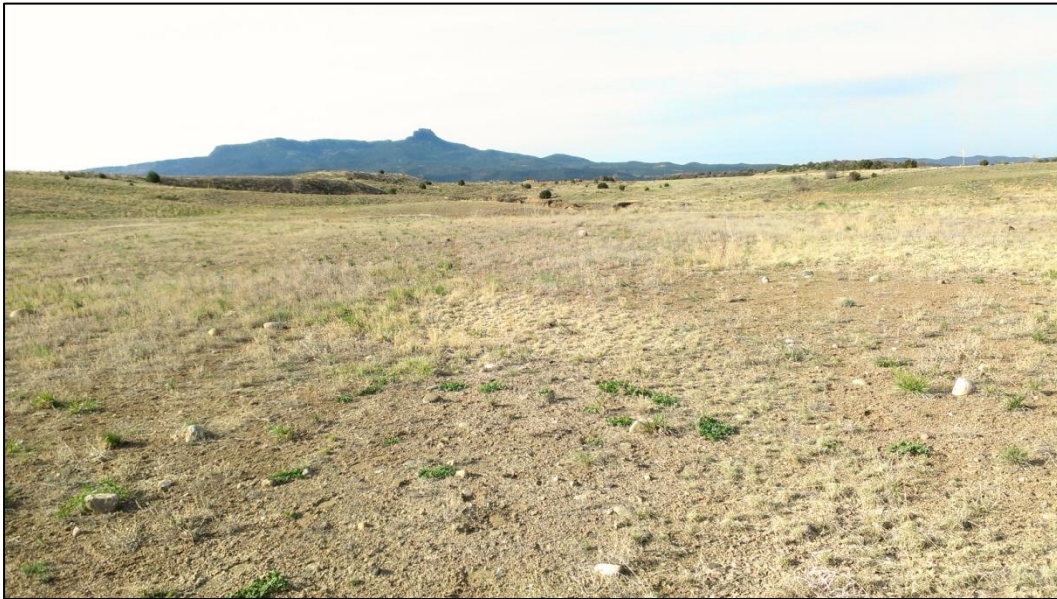
**Photo 9.** View from lower level looking west across portion of permit area showing some bare patches in vegetative cover.

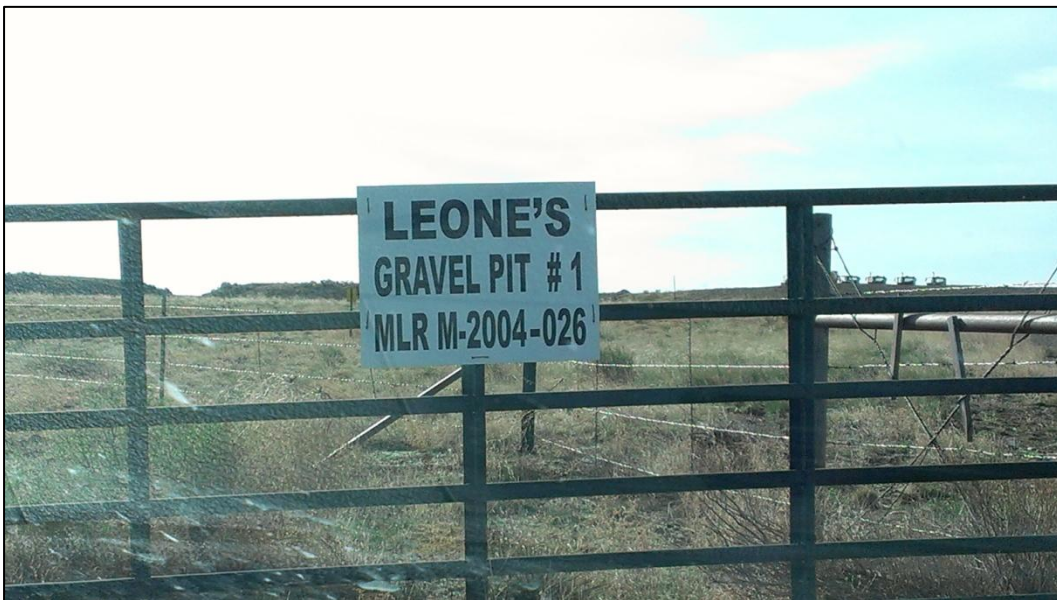
During inspection, the permit sign was posted at the gated entrance (Photo 10), and the boundary markers were in place. However, after comparing recent aerial images of the site with the approved permit boundary, the Division has found the eastern marked boundary, especially near the old reclaimed mine area, to be outside of the approved permit boundary. This will be cited as a Possible Problem and will require the Operator to re-survey the eastern boundary of the permit area south of the gas lines, and submit a Technical Revision (see enclosed form) including an updated Reclamation Plan Map for the site. The permit boundary shall be clearly delineated pursuant to Rule 3.1.12(2).

**Photo 10.** Permit sign posted at gated entrance to site.

- 3) A Possible Problem will be cited for failure to properly mark the boundaries of the affected area pursuant to Rule 3.1.12(2). The Operator will need to re-survey the eastern boundary of the affected area and submit a Technical Revision (form enclosed) including an updated Reclamation Plan Map. This Technical Revision should be submitted with the Acreage Reduction request, so that the "new" proposed permit area consists of the affected area south of the gas lines (approximately 28 acres total, according to Division calculations). The Division requires that the Technical Revision be submitted by **July 24, 2014** (90 days from this inspection).
