COLORADO DIVISION OF RECLAMATION, MINING AND SAFETY
MINERALS PROGRAM INSPECTION REPORT
PHONE: (303) 866-3567

MINE NAME: Proctor Pit	MINE/PROSPECTING ID#: M-2009-054	MINERAL: Gravel and sand	COUNTY: Otero
INSPECTION TYPE: Monitoring	INSPECTOR(S): Amy Eschberger	INSP. DATE: May 8, 2014	INSP. TIME: 11:15
OPERATOR: ALL-RITE PAVING & REDI-MIX, INC.	OPERATOR REPRESENTATIVE: Herb Pearson	TYPE OF OPERATION: 112c - Construction Regular Operation

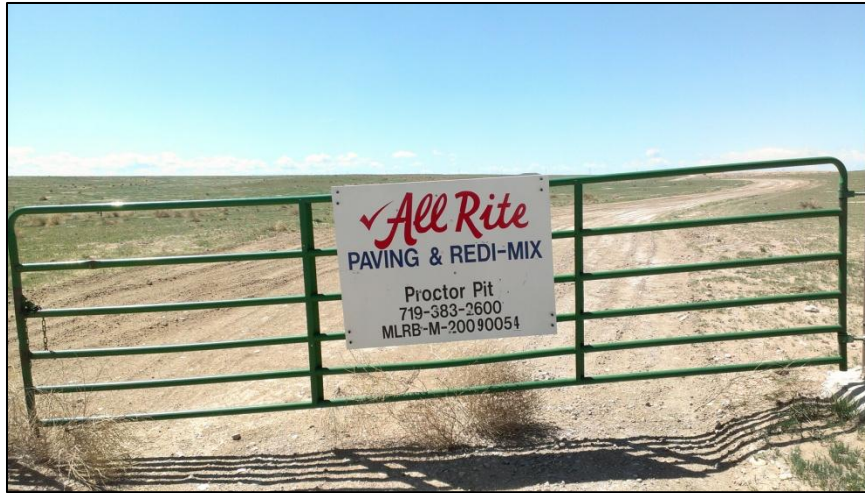
Photo 1. View of permit sign posted at gated entrance off Co Rd Ee.

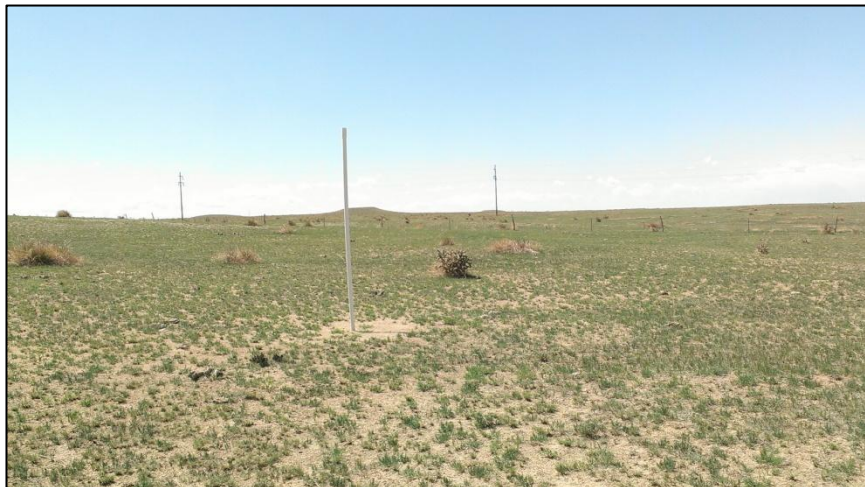
Photo 2. View looking south, showing PVC pipe marking southern boundary of permit area.

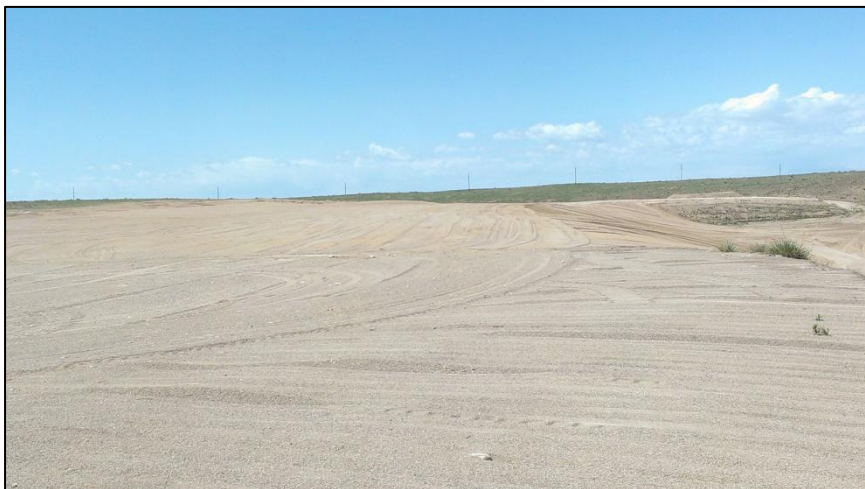
Photo 3. View looking south from northwestern corner of affected area, showing western part of site that has been graded.

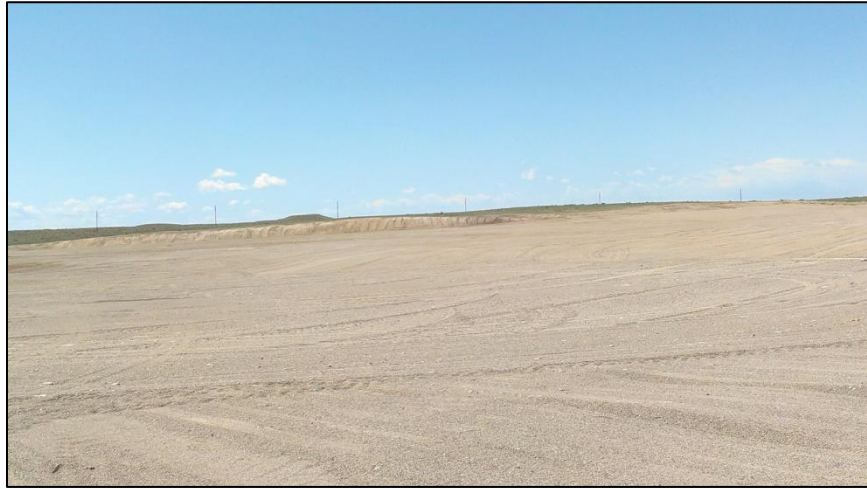
Photo 4. View looking southeast from northwestern corner of permit area across central part of site that has been graded.

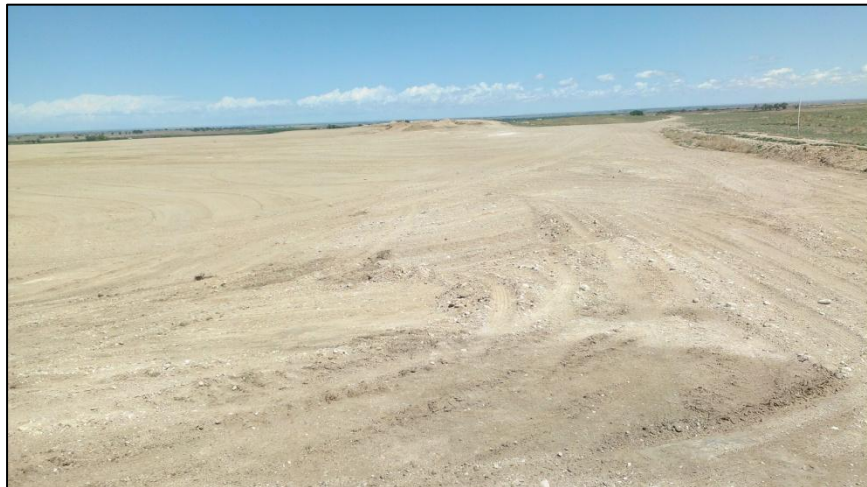
Photo 5. View looking north from southeastern corner of permit area, showing eastern part of site that has been graded.

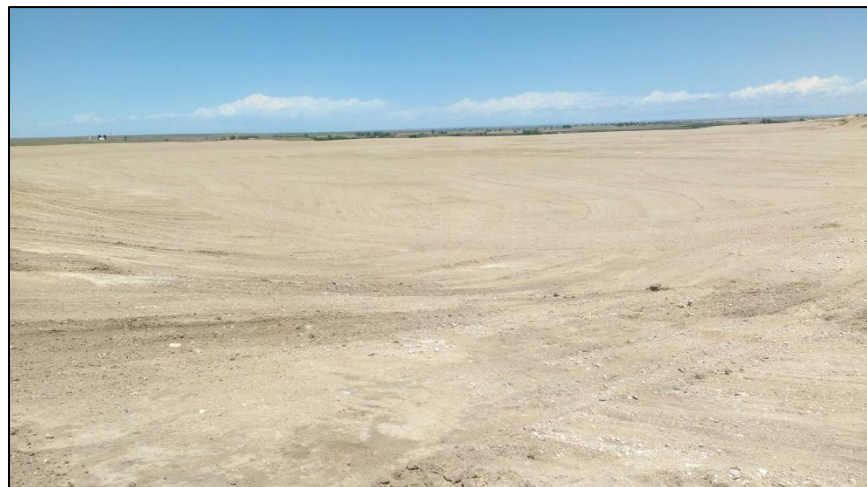
Photo 6. View looking northwest from southeastern corner of permit area, across central part of site that has been graded.

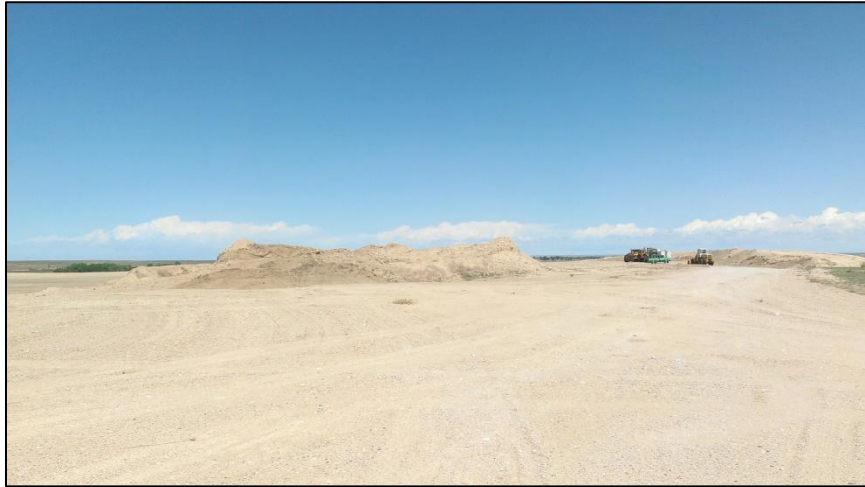
Photo 7. View looking west from eastern portion of permit area, showing overburden stockpile. Note trucks stored north of stockpile (on right).

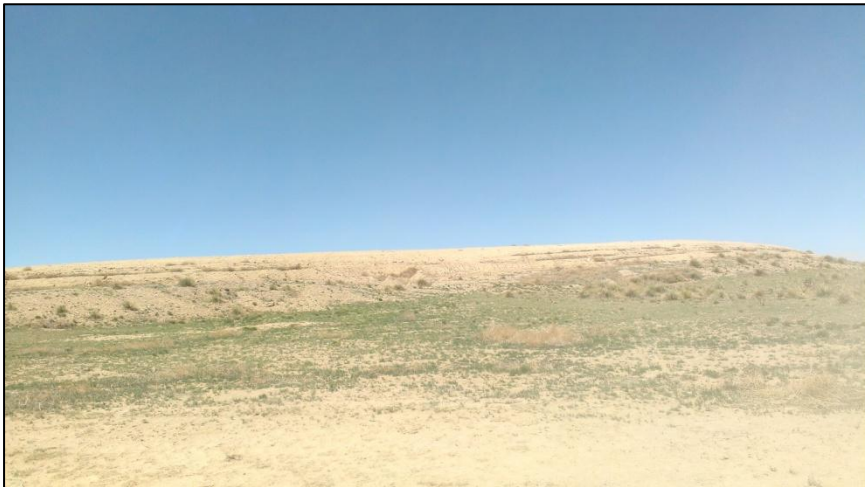
Photo 8. View looking south at berm constructed along northern edge of site to contain stormwater basin.

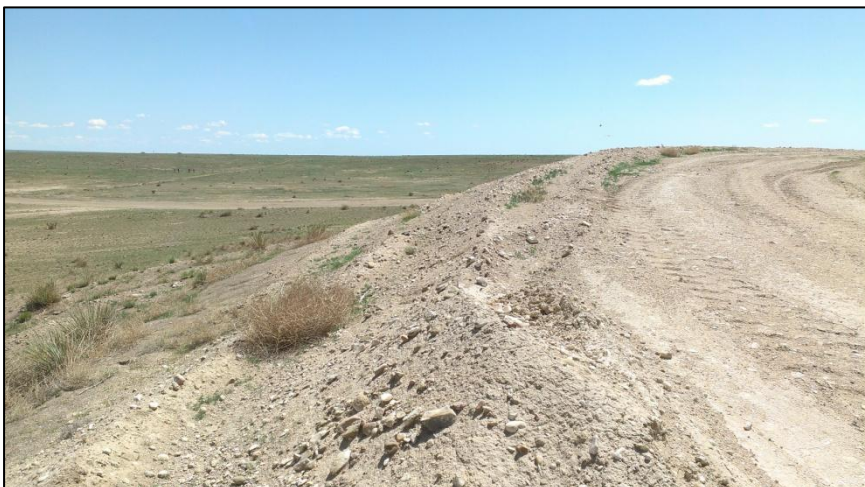
Photo 9. View looking east across northern slope of berm constructed along northern edge of site to contain stormwater basin.

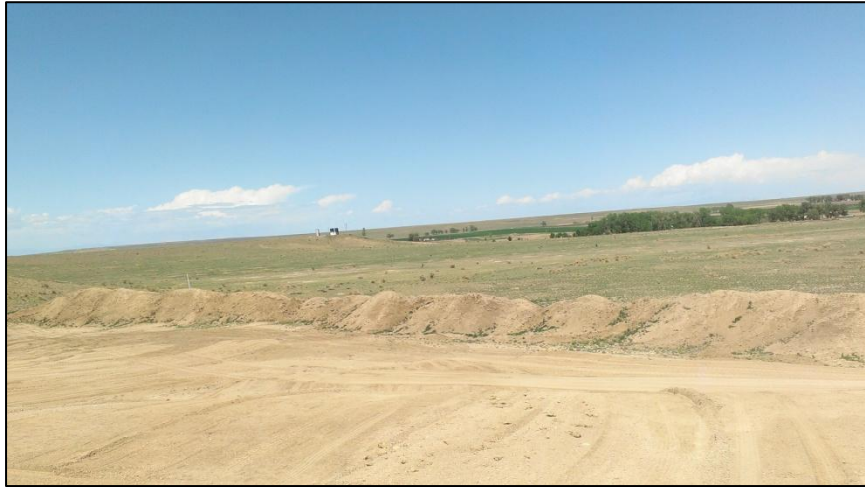
Photo 10. View looking west at small berm present along western boundary of site.

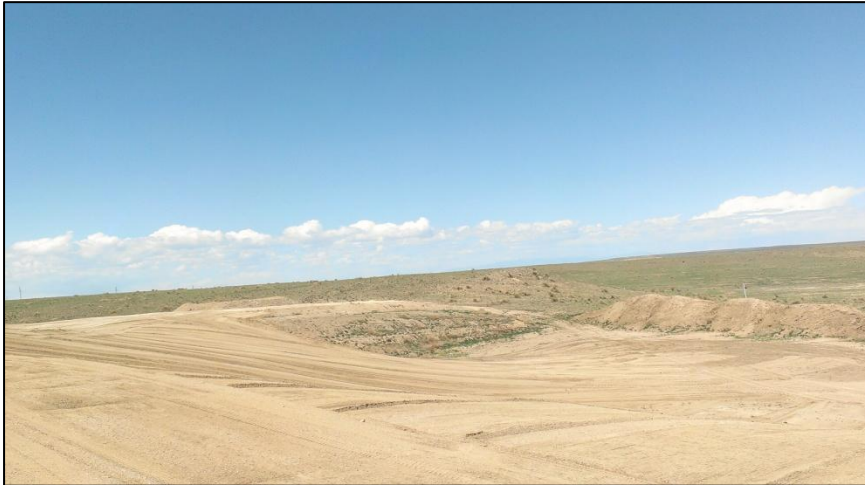
Photo 11. View looking southwest at small berms present along southwestern boundary of site.

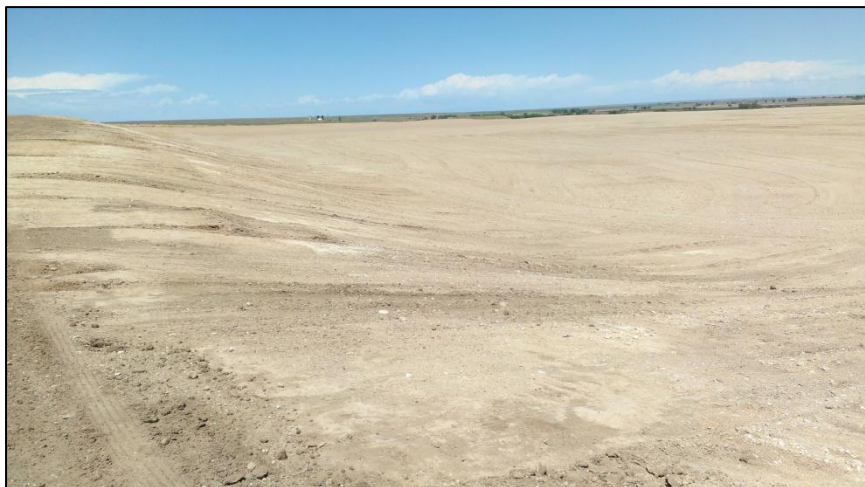
Photo 12. View looking west from southeastern corner of permit area, showing previous north-facing highwall graded to 4H:1V slope.
