COLORADO DIVISION OF RECLAMATION, MINING AND SAFETY
MINERALS PROGRAM INSPECTION REPORT
PHONE: (303) 866-3567

MINE NAME: Ekberg Pit	MINE/PROSPECTING ID#: M-1981-256	MINERAL: Sand and gravel	COUNTY: Yuma
INSPECTION TYPE: Monitoring	INSPECTOR(S): Elliott R. Russell	INSP. DATE: June 10, 2014	INSP. TIME: 08:00
OPERATOR: Yuma County	OPERATOR REPRESENTATIVE: Howard McGinnis	TYPE OF OPERATION: 112c - Construction Regular Operation

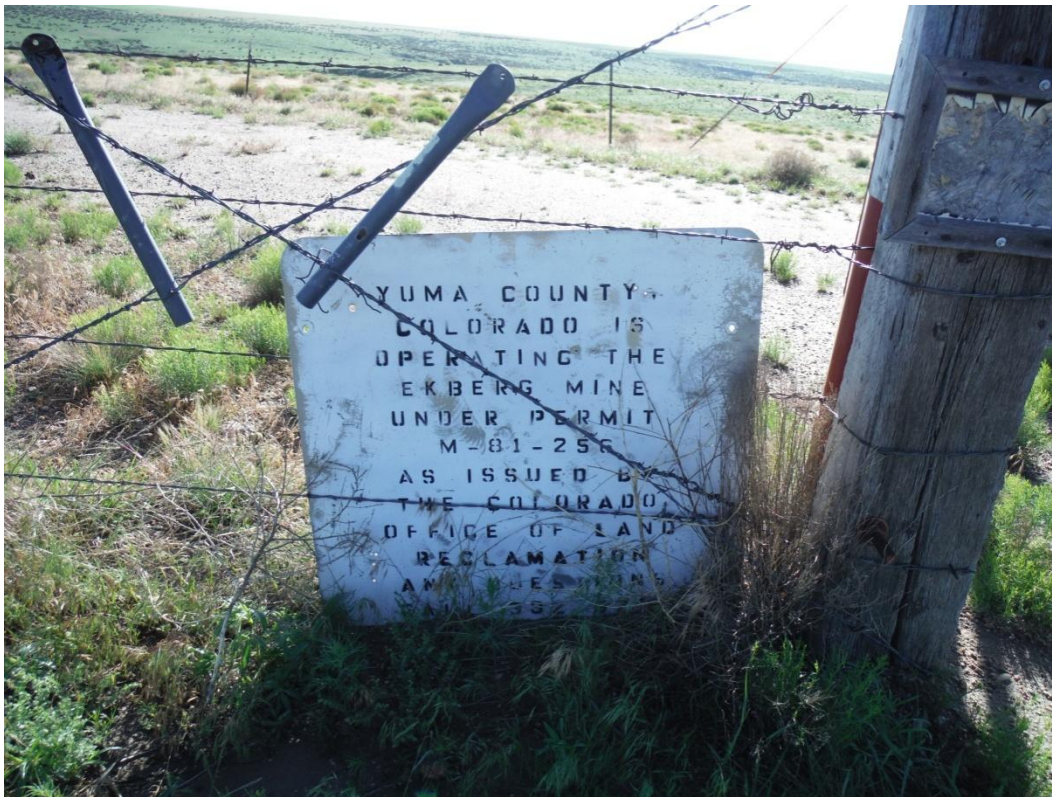
At 08:00, the Division and Mr. McGinnis arrived at the mine site along County Road MM. At the time of the inspection it was clear and warm, and the ground was wet from a recent rain. The permit identification sign was posted at the entrance to the site and met the requirements of Rule 3.1.12(1). The permit boundary of the mine was delineated by a fence lines or single t-posts. No mining activities were occurring during the time of the inspection, and no equipment was present on site. There was no evidence of recent mining activities observed.

Mine site identification sign; looking east.

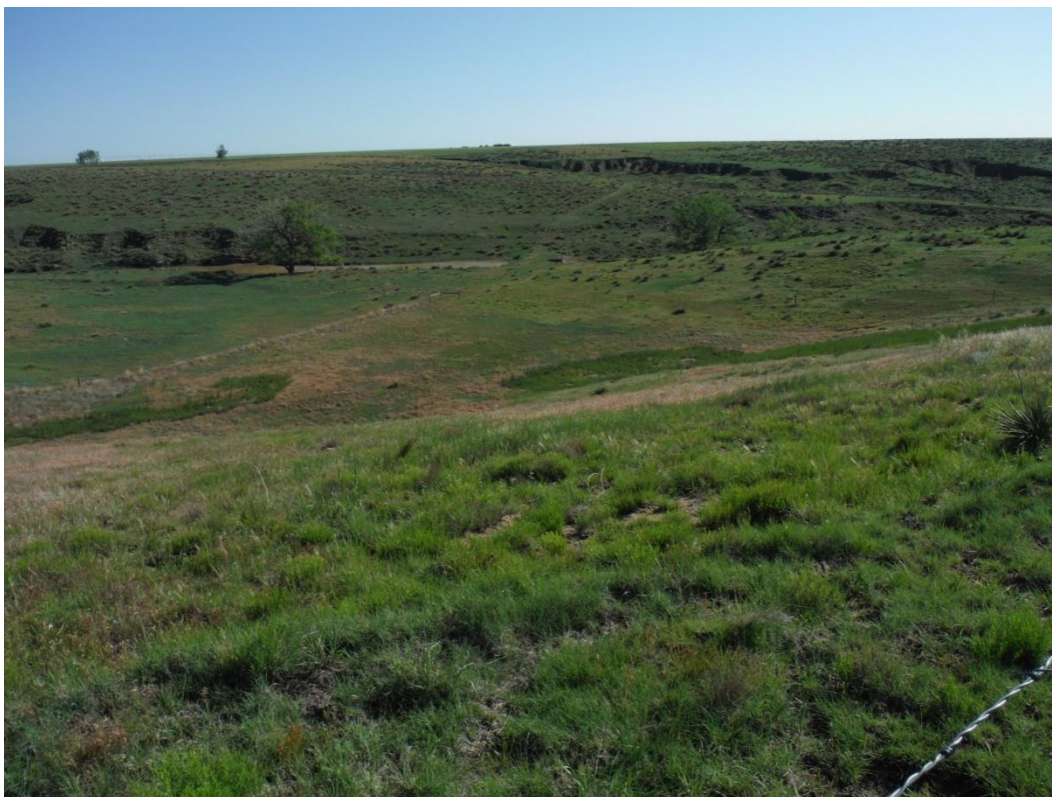
The site consisted of three separate areas along the eastern bank of a small intermittent creek. The two southern most areas were individually fenced and have been re-sloped and seeded for reclamation; the northern most area was the active mine area which consisted of the dig face along the eastern slope and a stockpile in the middle. This pile had approximately 2,000 C.Y. of material.

Southern most area, fenced off for reclamation; looking northeast.

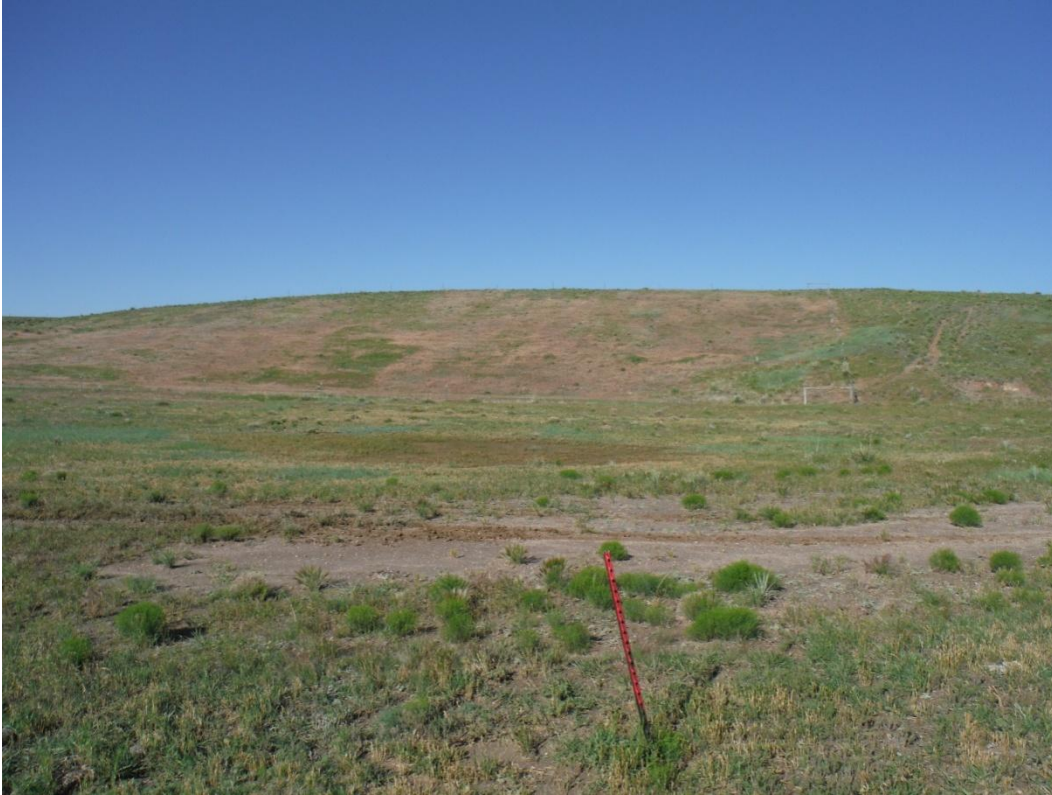
Middle area, fenced off for reclamation; looking west (eastern boundary line marker in foreground).

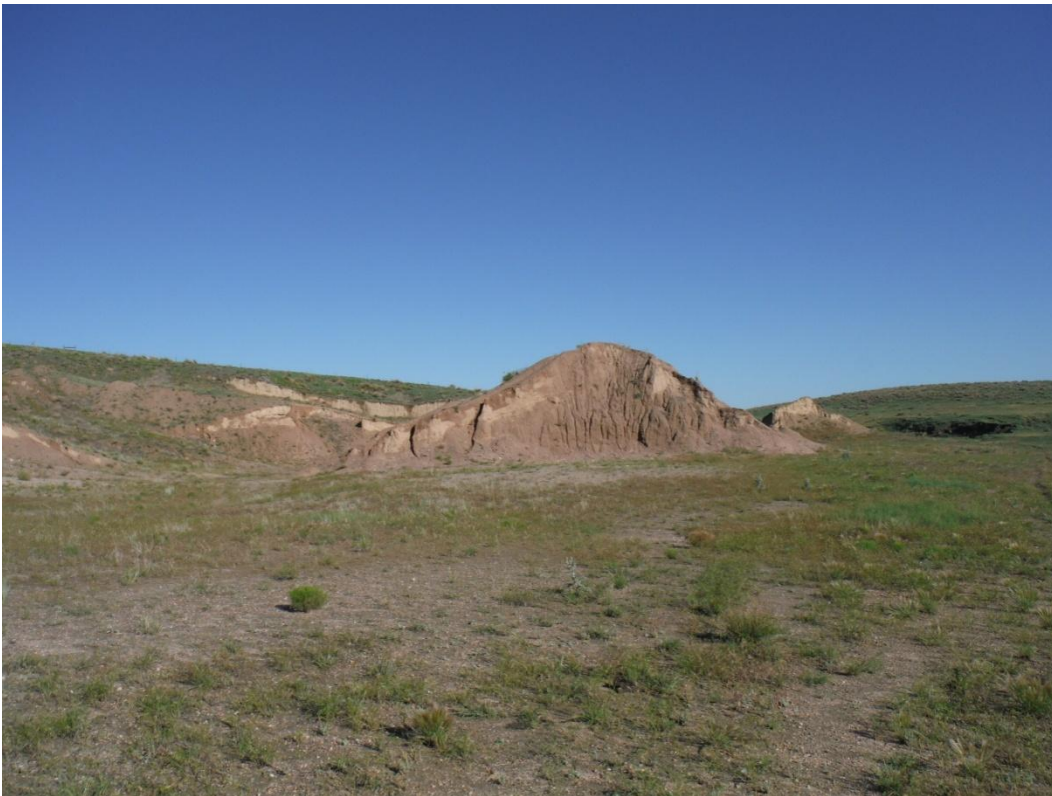
Material stockpile in northern area; looking north.

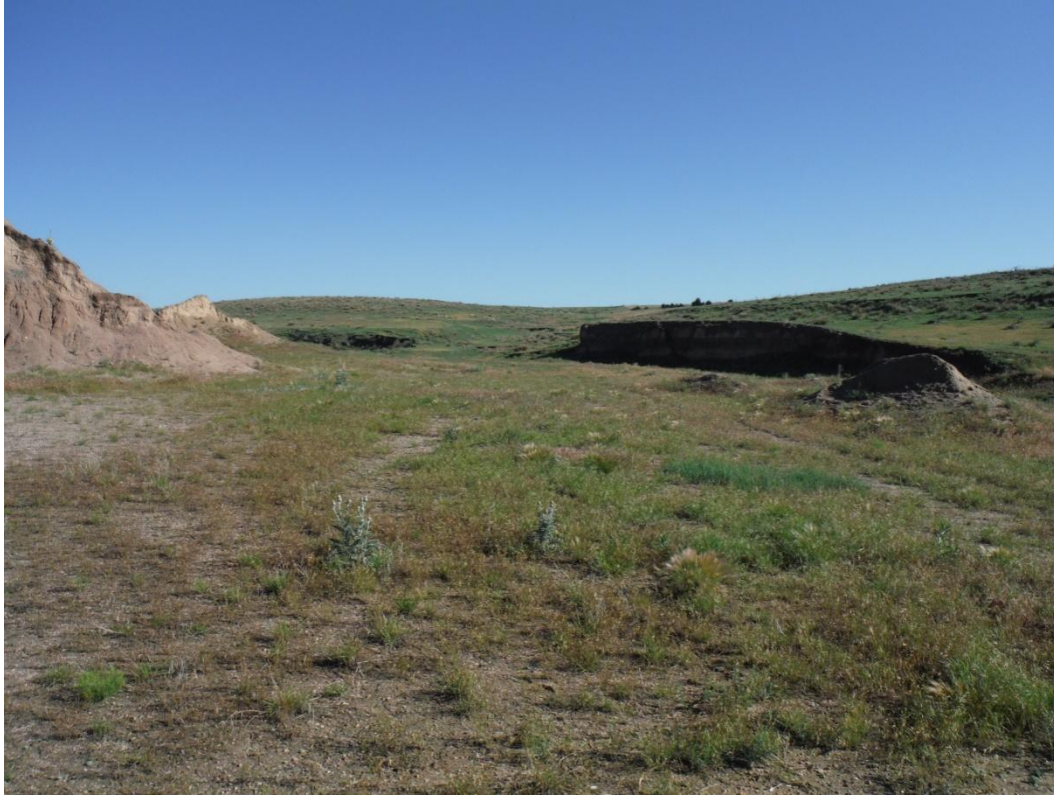
PROBLEM/POSSIBLE VIOLATION: Problem: There is cheat grass, a state-listed noxious weed, present on site. This is a problem for failure to employ weed control methods for state listed noxious weed species within the permitted area, and to reduce the spread of weeds to nearby areas as required by Section 3.1.10 (6) of the Rule.

During the inspection, the Division observed a Downy Brome (*Bromus tectorum*) infestation on the mine site. Also known as cheat grass, this is a state listed noxious weed and will need to be treated. This will be cited as a problem in the inspection report, and will require corrective action. The species was present throughout the mine site, including the two reclaimed fenced off areas in the southern portion of the permit.

Natural cut-bank of creek near the eastern boundary line of the permit, heavy cheat grass infestation within mine site; looking north.

CORRECTIVE ACTIONS: Implement approved weed control plan and provide proof to the Division that this has been done. If a weed control plan is not already in place, the operator shall develop a weed control and management plan in accordance with Section 3.1.10 (6) of the Rule. This plan should be developed in consultation with the county extension agency, or weed control district office and should include specific control measures to be applied, a schedule for when control measures will be applied and a post-treatment monitoring plan. This weed control plan shall be submitted to the Division as a Technical Revision to the approved plan with the appropriate Technical Revision fee of \$216.00 by the corrective action date.

CORRECTIVE ACTION DUE DATE: 9/05/14

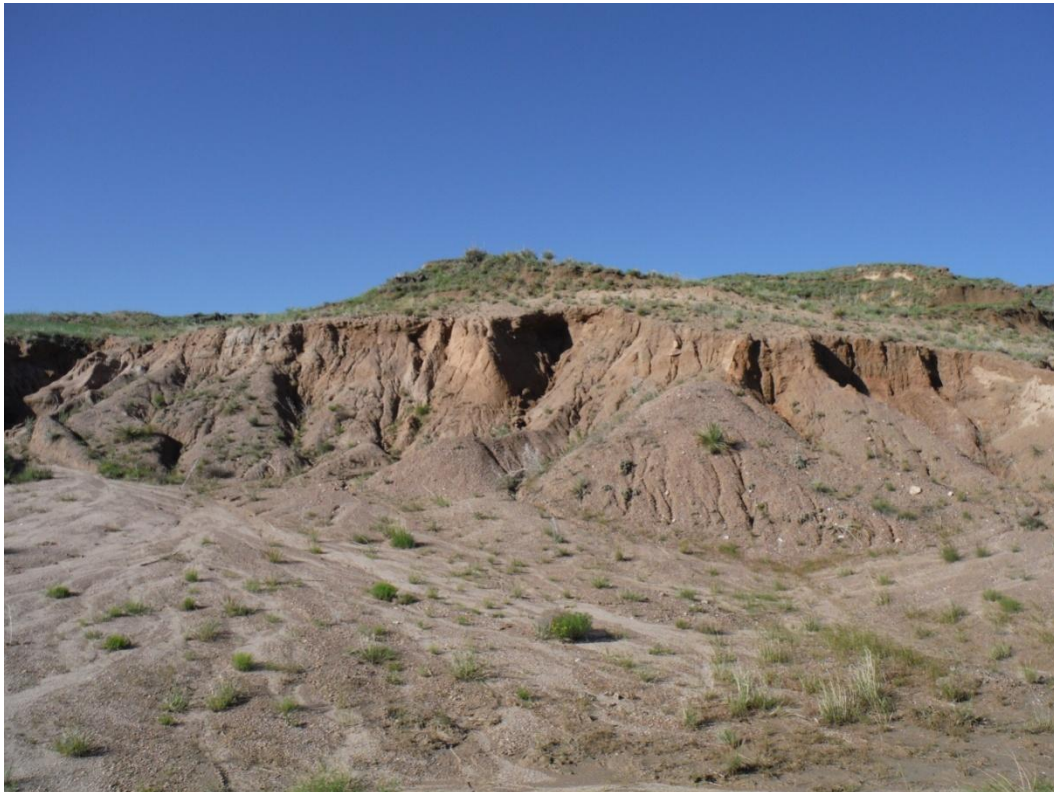
Highwall/dig face of northern area; looking west.
