COLORADO DIVISION OF RECLAMATION, MINING AND SAFETY
MINERALS PROGRAM INSPECTION REPORT
PHONE: (303) 866-3567

MINE NAME: Twin Crk Campground	MINE/PROSPECTING ID#: M-1989-044	MINERAL: Sand and gravel	COUNTY: Teller
INSPECTION TYPE: Monitoring	INSPECTOR(S): Timothy A. Cazier	INSP. DATE: January 28, 2014	INSP. TIME: 11:55
OPERATOR: The Clare Corporation	OPERATOR REPRESENTATIVES: Harold & Justin Clare	TYPE OF OPERATION: 110c - Construction Limited Impact

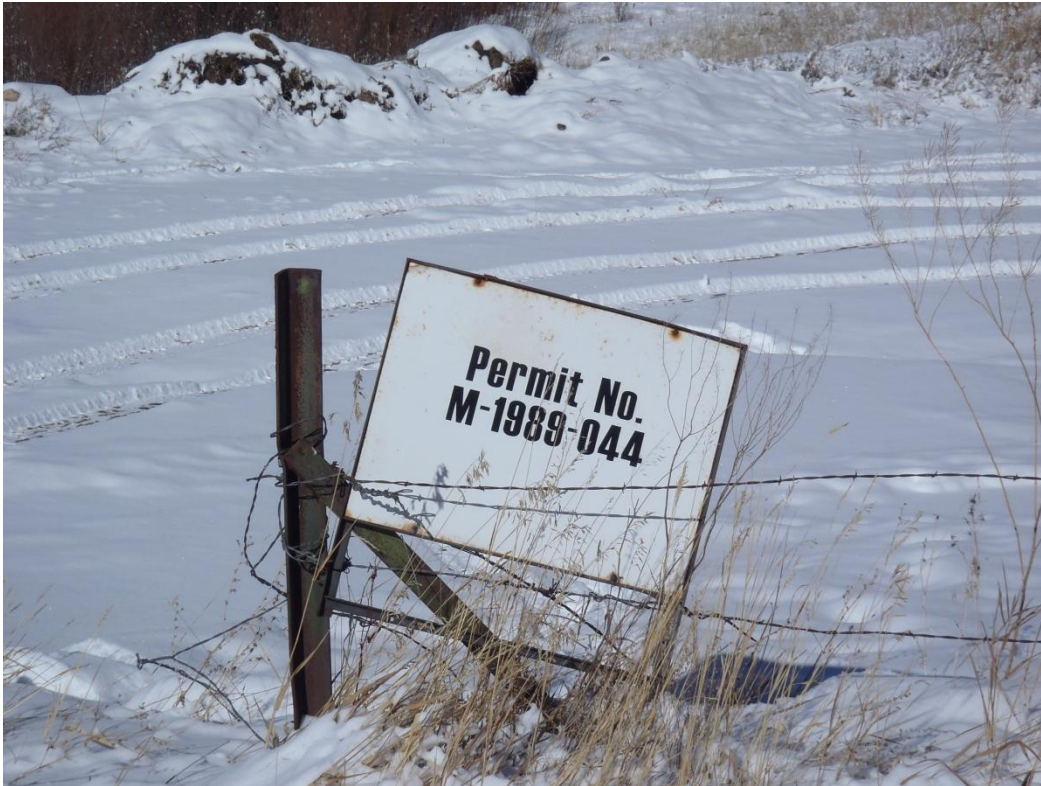
The site was covered with 3 to 4 inches of snow and not operating at the time of the inspection. A permit sign was displayed at the site entrance (see **Photo 1**), and the site is bounded by fence on the south and west boundaries. The creek establishes the northern boundary (see **Photo 2**). There is a short access road along the south side of the site (**Photo 3**). Mine equipment observed on site included a screen, backhoe, and loader (**Photo 4**).

Photo 1. Permit sign (at entrance).

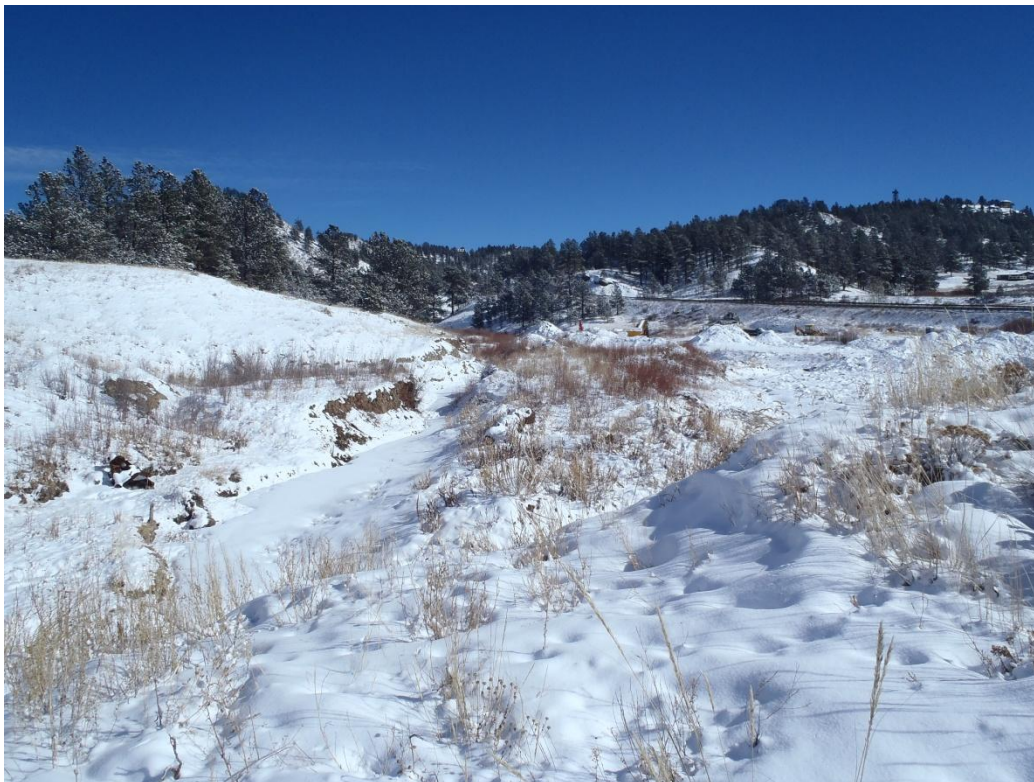
Photo 2. Creek on the northern boundary (looking east).

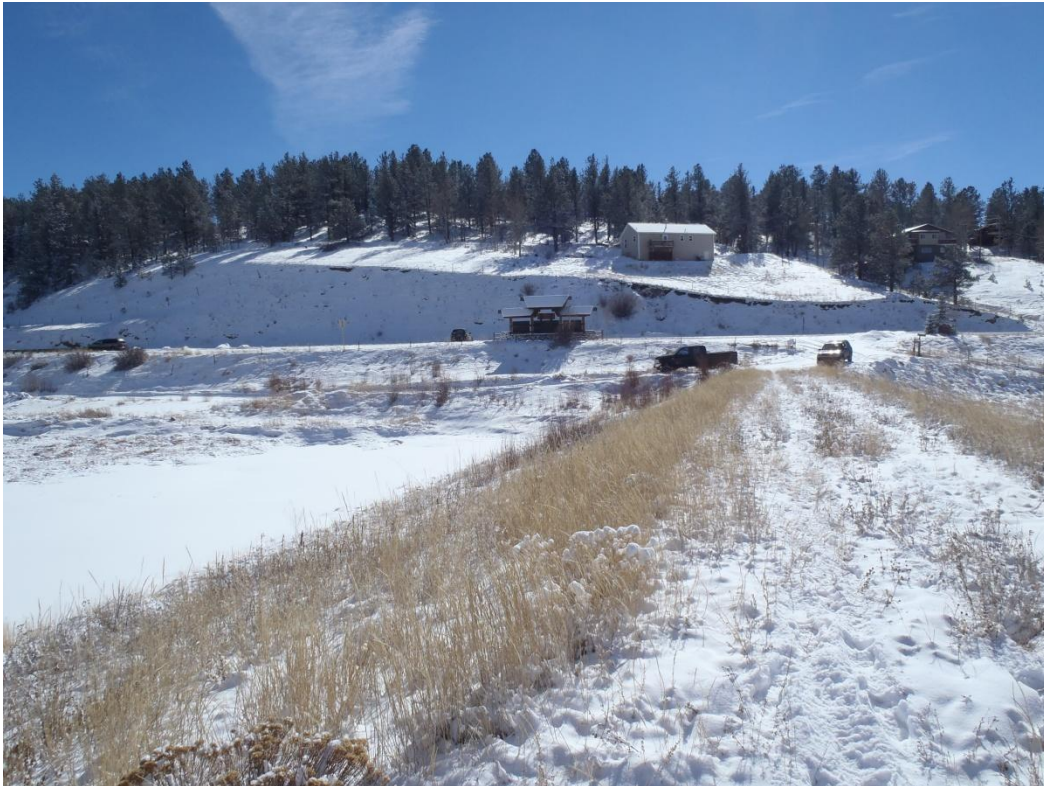
Mr. Harold Clare indicated an interest in lowering the dam height and modifying the course of the stream. He said the dam was constructed in the 1960s as a Soil Conservation Service project. This inspector told Mr. Clare a technical revision would be needed to revise the permit for those changes.

Photo 3. Short access road (east-west in background) & dam (looking south).

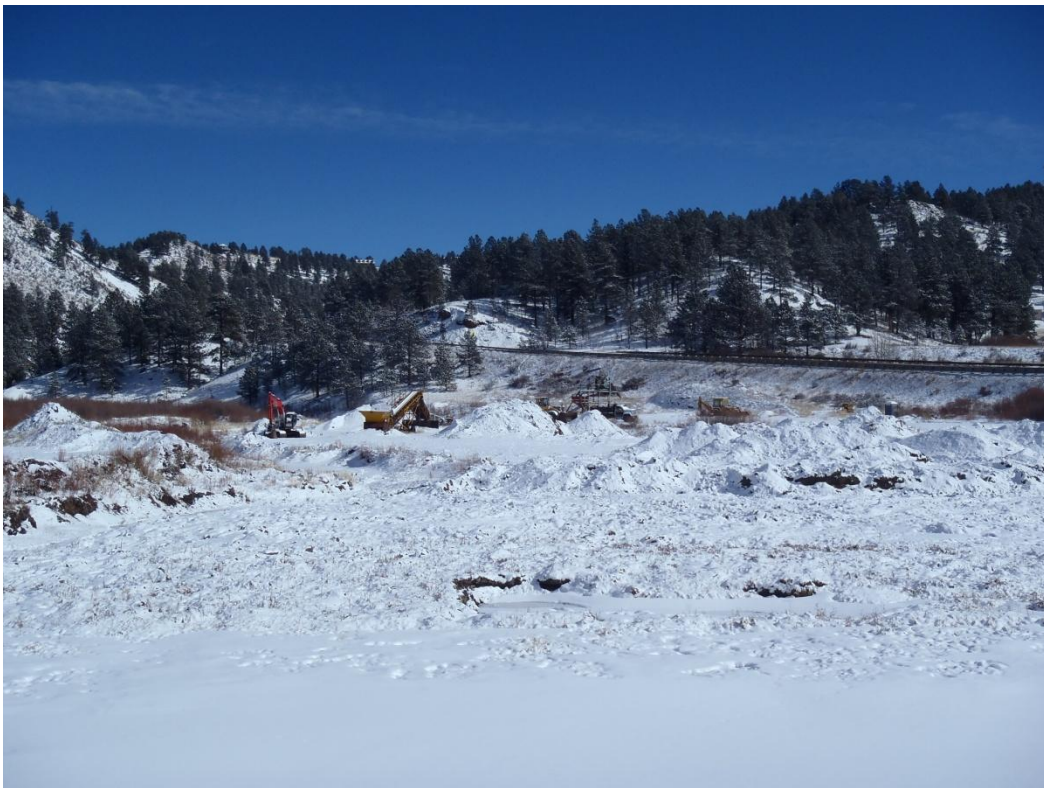
The DRMS estimates approximately 4 acres have been disturbed as part of the operation. Most of the western portion of the site has vegetation established as grasses were seen protruding through the snow cover (**Photo 4**). Topsoil stockpiles (**Photo 5**) were observed for reclamation. The only grading needed is minor contouring for the proposed campground and spreading the topsoil. Mr. Clare said he hoped to have the campground completed by the end of 2015.

Photo 4. Mine equipment observed on site included a screen, backhoe, and loader (looking SE).

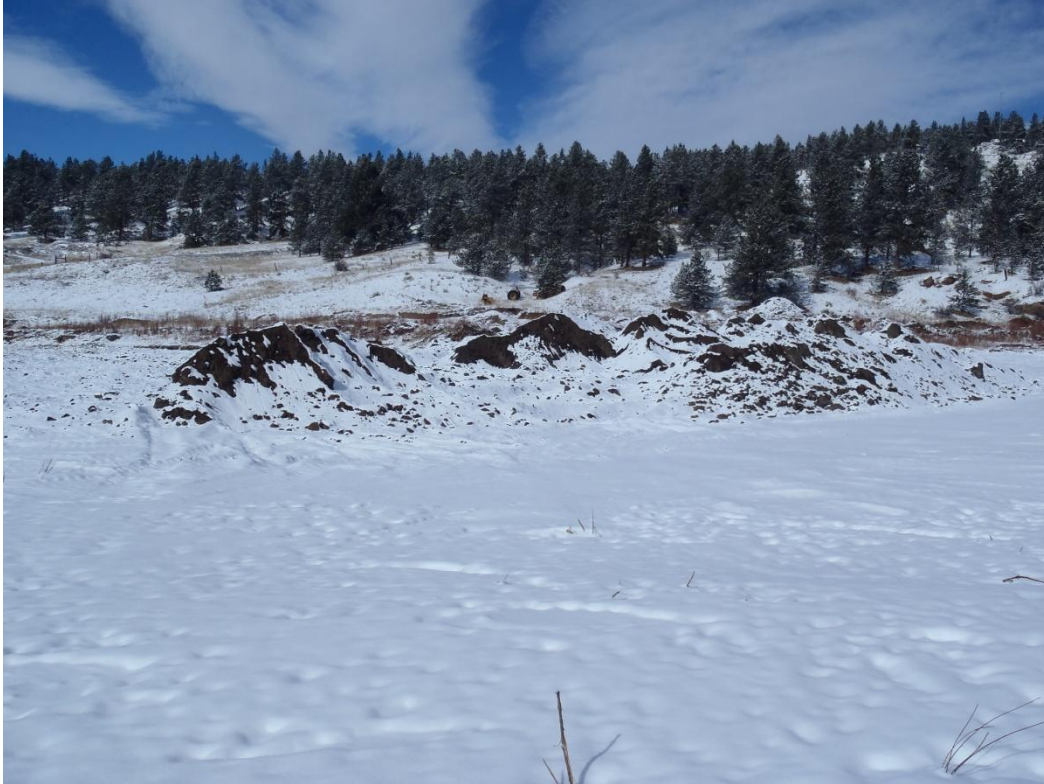
Photo 5. Topsoil stockpiles (looking NW).
