COLORADO DIVISION OF RECLAMATION, MINING AND SAFETY
MINERALS PROGRAM INSPECTION REPORT
PHONE: (303) 866-3567

MINE NAME: Lamar Park Grav Pit	MINE/PROSPECTING ID#: M-1987-078	MINERAL: Sand and gravel	COUNTY: Prowers
INSPECTION TYPE: Monitoring	INSPECTOR(S): Amy Eschberger	INSP. DATE: August 14, 2014	INSP. TIME: 08:30
OPERATOR: City of Lamar	OPERATOR REPRESENTATIVE: John Sutherland and Patrick Mason	TYPE OF OPERATION: 110c - Construction Limited Impact

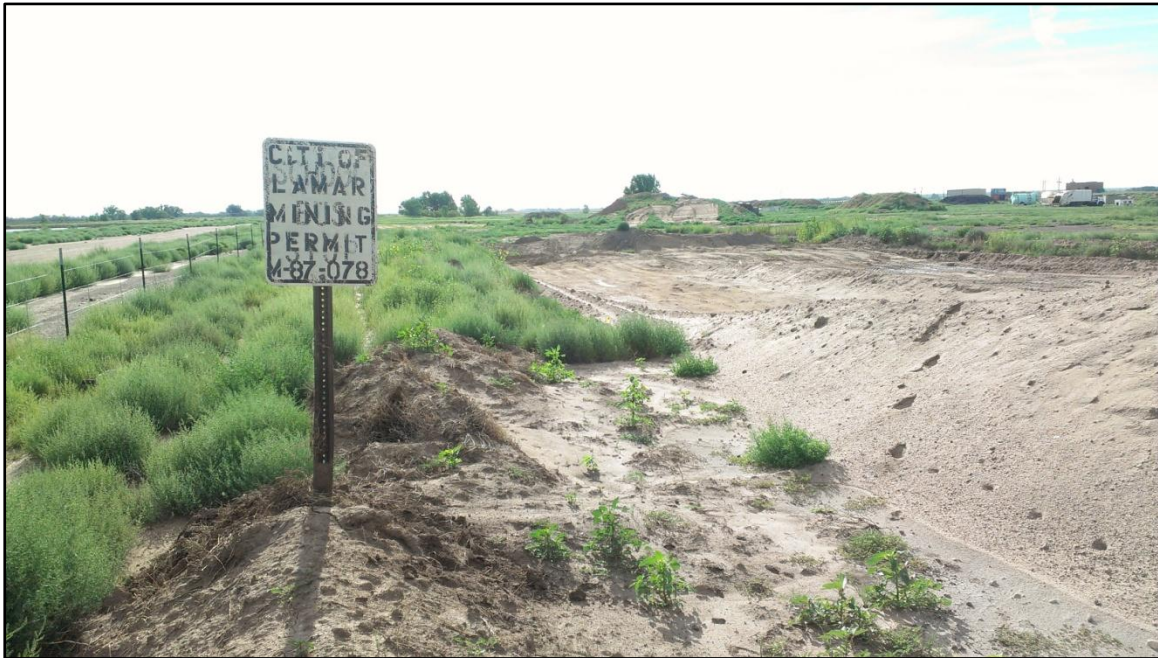
At the time of the inspection, the weather was warm and breezy, and the ground was slightly moist from a previous rain event. A permit sign was posted at the northern permit boundary near the main access road (Photo 1). The northern permit boundary was delineated by a fenceline, and the western boundary was delineated by the main access road. The eastern and southern boundaries were marked by metal posts (Photo 2). No mining activity was occurring during the inspection. Mr. Mason indicated that mined material is hauled off site every year. A small track loader was present in the western portion of the site. Some equipment and old vehicles were stored near the southern permit boundary (Photos 3 and 4). The current post-mining land use of wildlife habitat would not allow for storing this equipment on site. However, the post-mining land use can be changed through the submittal of a permit Amendment. If instead, the Operator wishes to add an additional post-mining land use, this can be done through the submittal of a Technical Revision. Otherwise, any unapproved equipment, vehicles, or refuse should be removed from the permit area.

Photo 1. View of permit sign posted at northern permit boundary near site entrance. Note small excavation area at right.

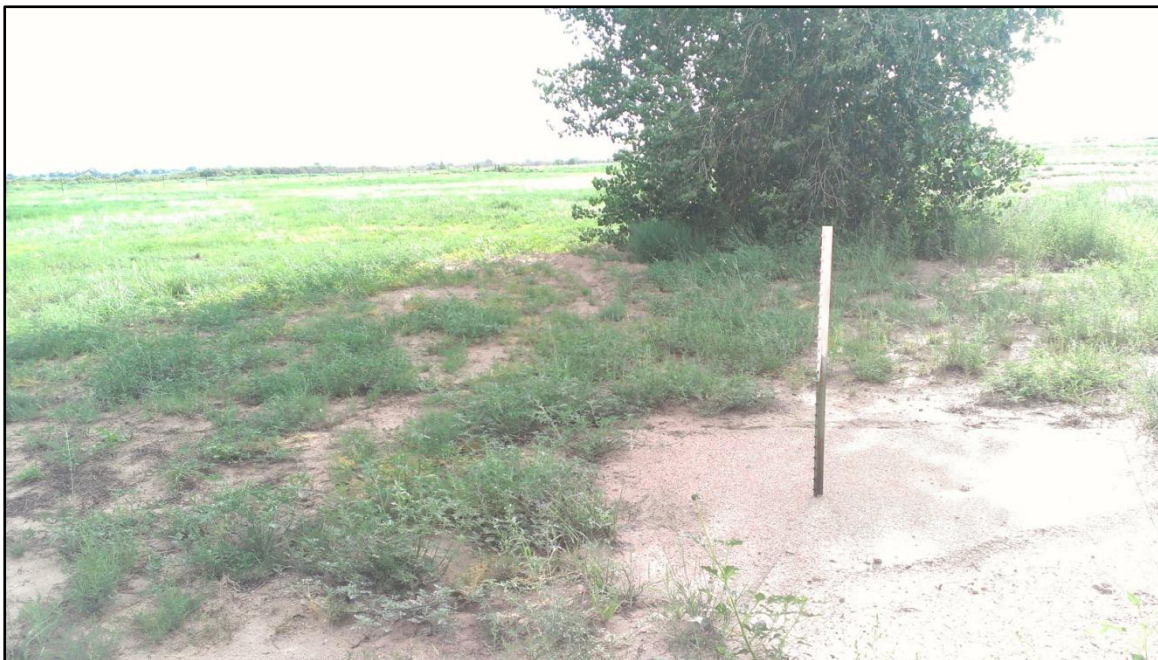
Photo 2. View looking east, showing metal post marking southern permit boundary.

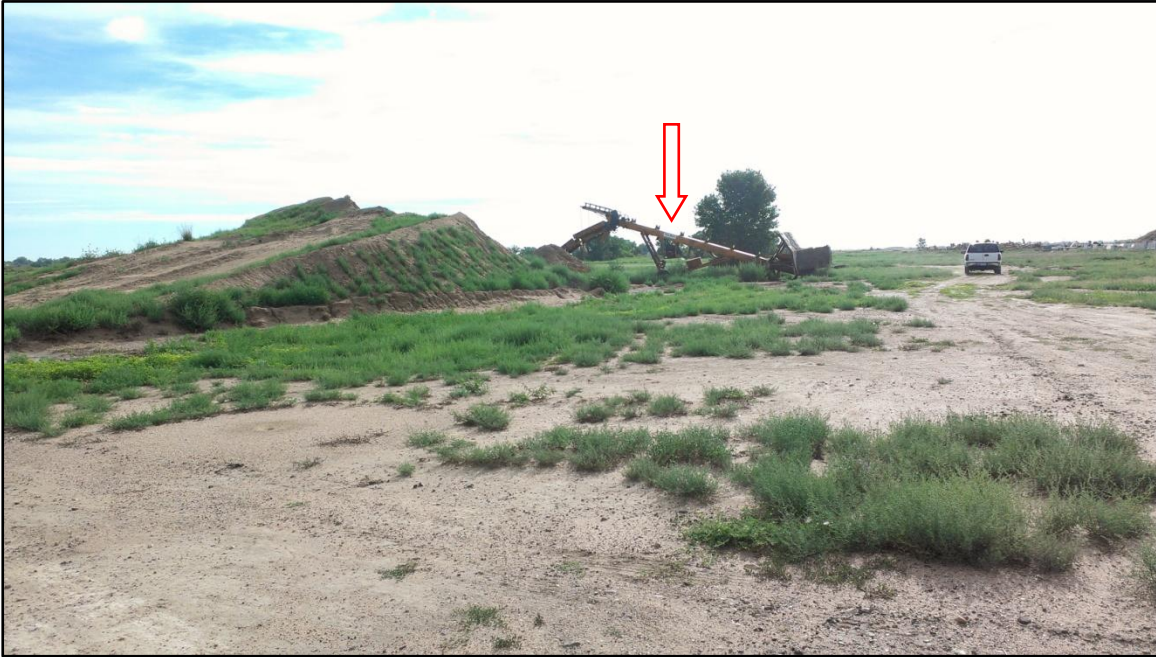
Photo 3. View looking east from southern permit boundary, showing equipment stored on site (marked). Note topsoil stockpile (at left).

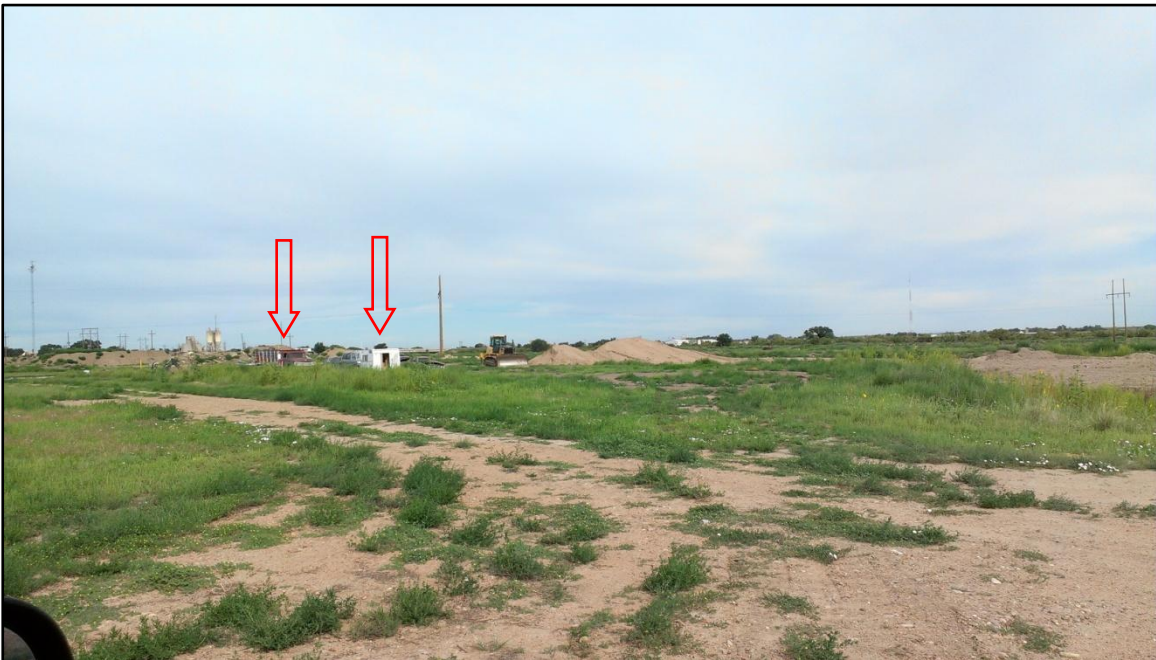
Photo 4. View looking west from dirt road located south of permit area, showing non-mining related equipment and vehicles stored on site (marked).

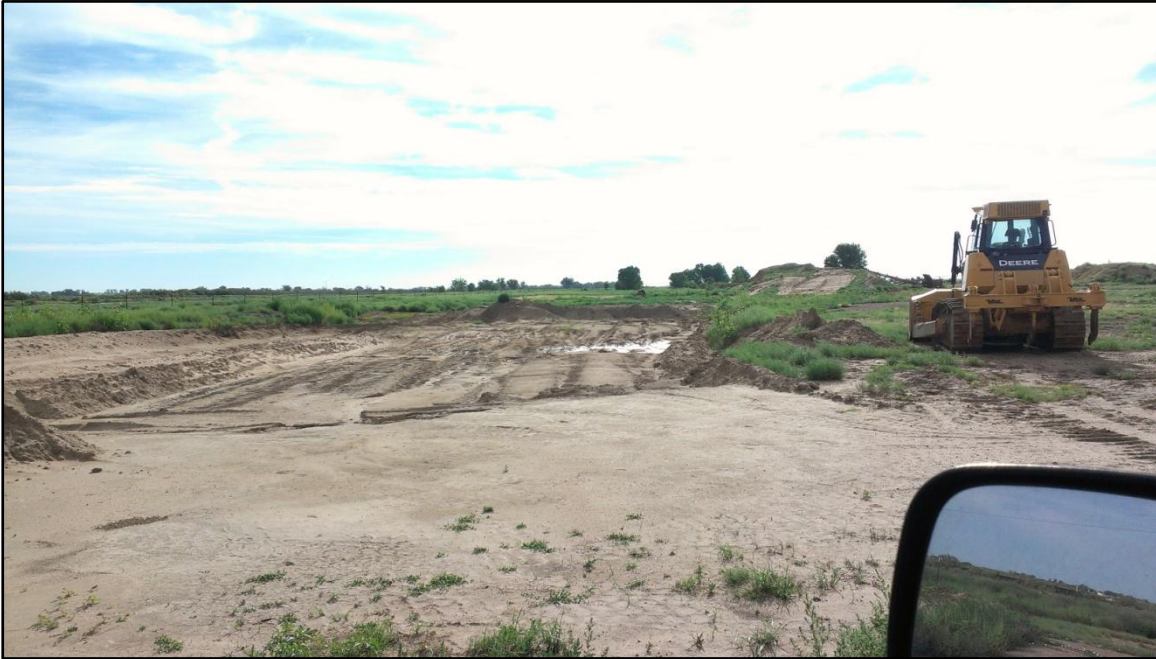
The current excavation area is located near the center of the site (Photo 5). Topsoil and overburden have been removed from this small area and stored adjacent to the excavation. Several small stockpiles of mined material are present west of the current excavation area, near the main access road (Photo 6). A topsoil stockpile is stored near the southern permit boundary (Photo 7). This stockpile appears to be stable with some volunteer vegetative cover (consisting mainly of annual weeds). A few material stockpiles are stored near the center of the site, and appear to be stable with volunteer vegetative cover (also consisting mainly of annual weeds).

Photo 5. View of small excavation area located near center of permit area. Note small track loader (at right).

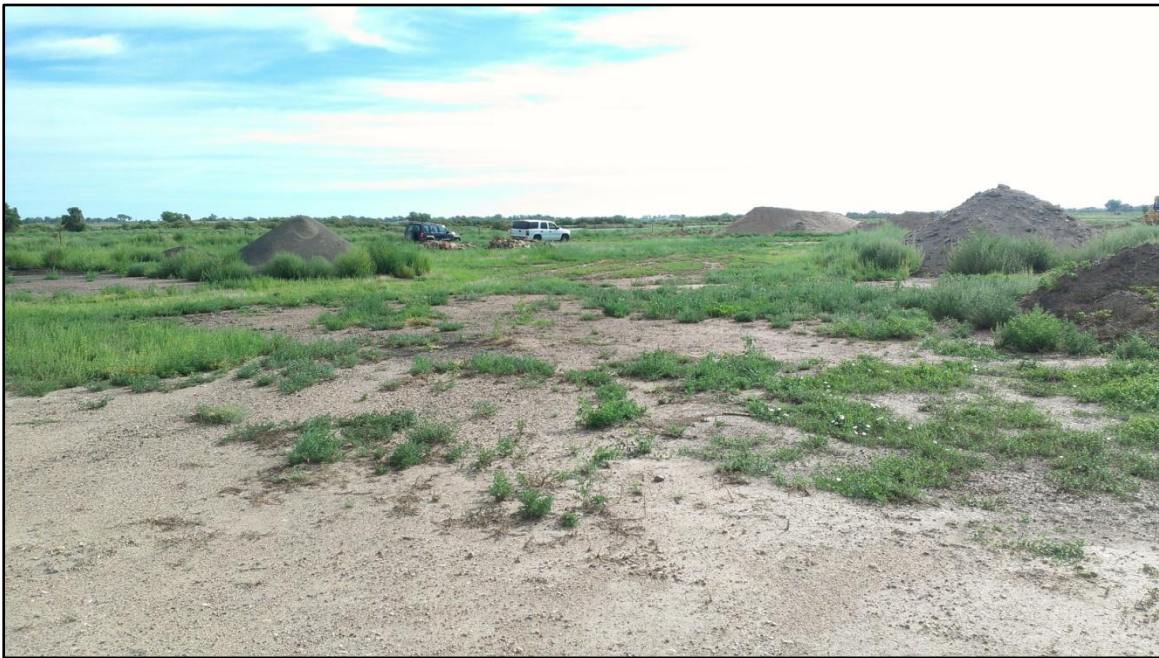
Photo 6. View looking northeast from western permit boundary, showing several small material stockpiles stored in western portion of permit area.

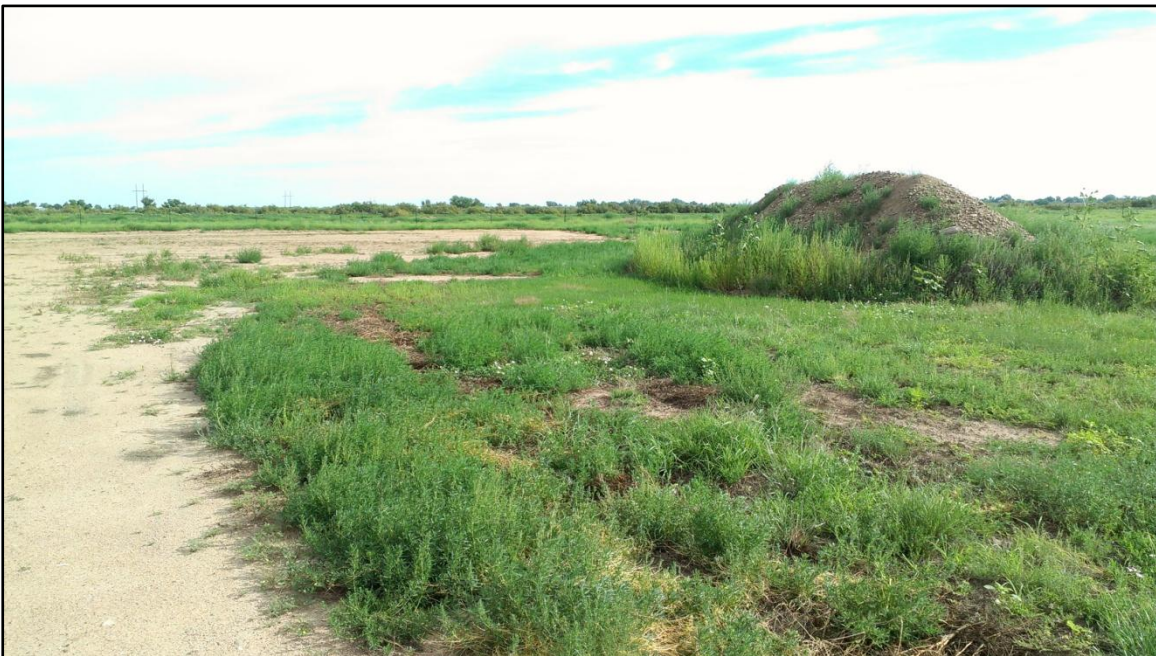
Photo 8. View looking north from southern permit boundary, showing small gravel stockpile that will need to be removed before this area can be released. Also note bare, graded area (at left) that will need to be revegetated.

As discussed with Mr. Sutherland and Mr. Mason during the inspection, this area will not be releasable until the small gravel stockpile located on the western edge (Photo 10) is removed and the area beneath it is revegetated. In addition, the bare, graded area just north of the small gravel stockpile (see Photo 10) will also need to be revegetated. Any land released from this permit will need to be consistent with the post-mining land use of wildlife habitat (see above for information on changing/adding to the post-mining land use). The portion of land located east of the small gravel stockpile and the graded area appears to be releasable. The Division estimates this area to be approximately 2.0 acres in size. If the Operator wishes to release this area at this time, an Acreage Reduction request will need to be submitted within 60 days of this inspection report (for no additional inspection required). An Acreage Reduction request form is enclosed with this report.
