COLORADO DIVISION OF RECLAMATION, MINING AND SAFETY
MINERALS PROGRAM INSPECTION REPORT
PHONE: (303) 866-3567

MINE NAME: San Luis Project	MINE/PROSPECTING ID#: M-1988-112	MINERAL: Au, Ag	COUNTY: Costilla
INSPECTION TYPE: Monitoring	INSPECTOR(S): Wallace H. Erickson	INSP. DATE: October 2, 2014	INSP. TIME: 15:00
OPERATOR: Battle Mountain Resources, Inc.	OPERATOR REPRESENTATIVE: Julio Madrid, Melissa Chalona	TYPE OF OPERATION: 112d-3 - Designated Mining Operation	
REASON FOR INSPECTION: Normal I&E Program	BOND CALCULATION TYPE: Partial Bond	BOND AMOUNT: \$7,400,000.00	
DATE OF COMPLAINT: NA	POST INSP. CONTACTS: County	JOINT INSP. AGENCY: None	
WEATHER: Clear	INSPECTOR'S SIGNATURE:

Observations Specific to the Lands Addressed Under AR-02

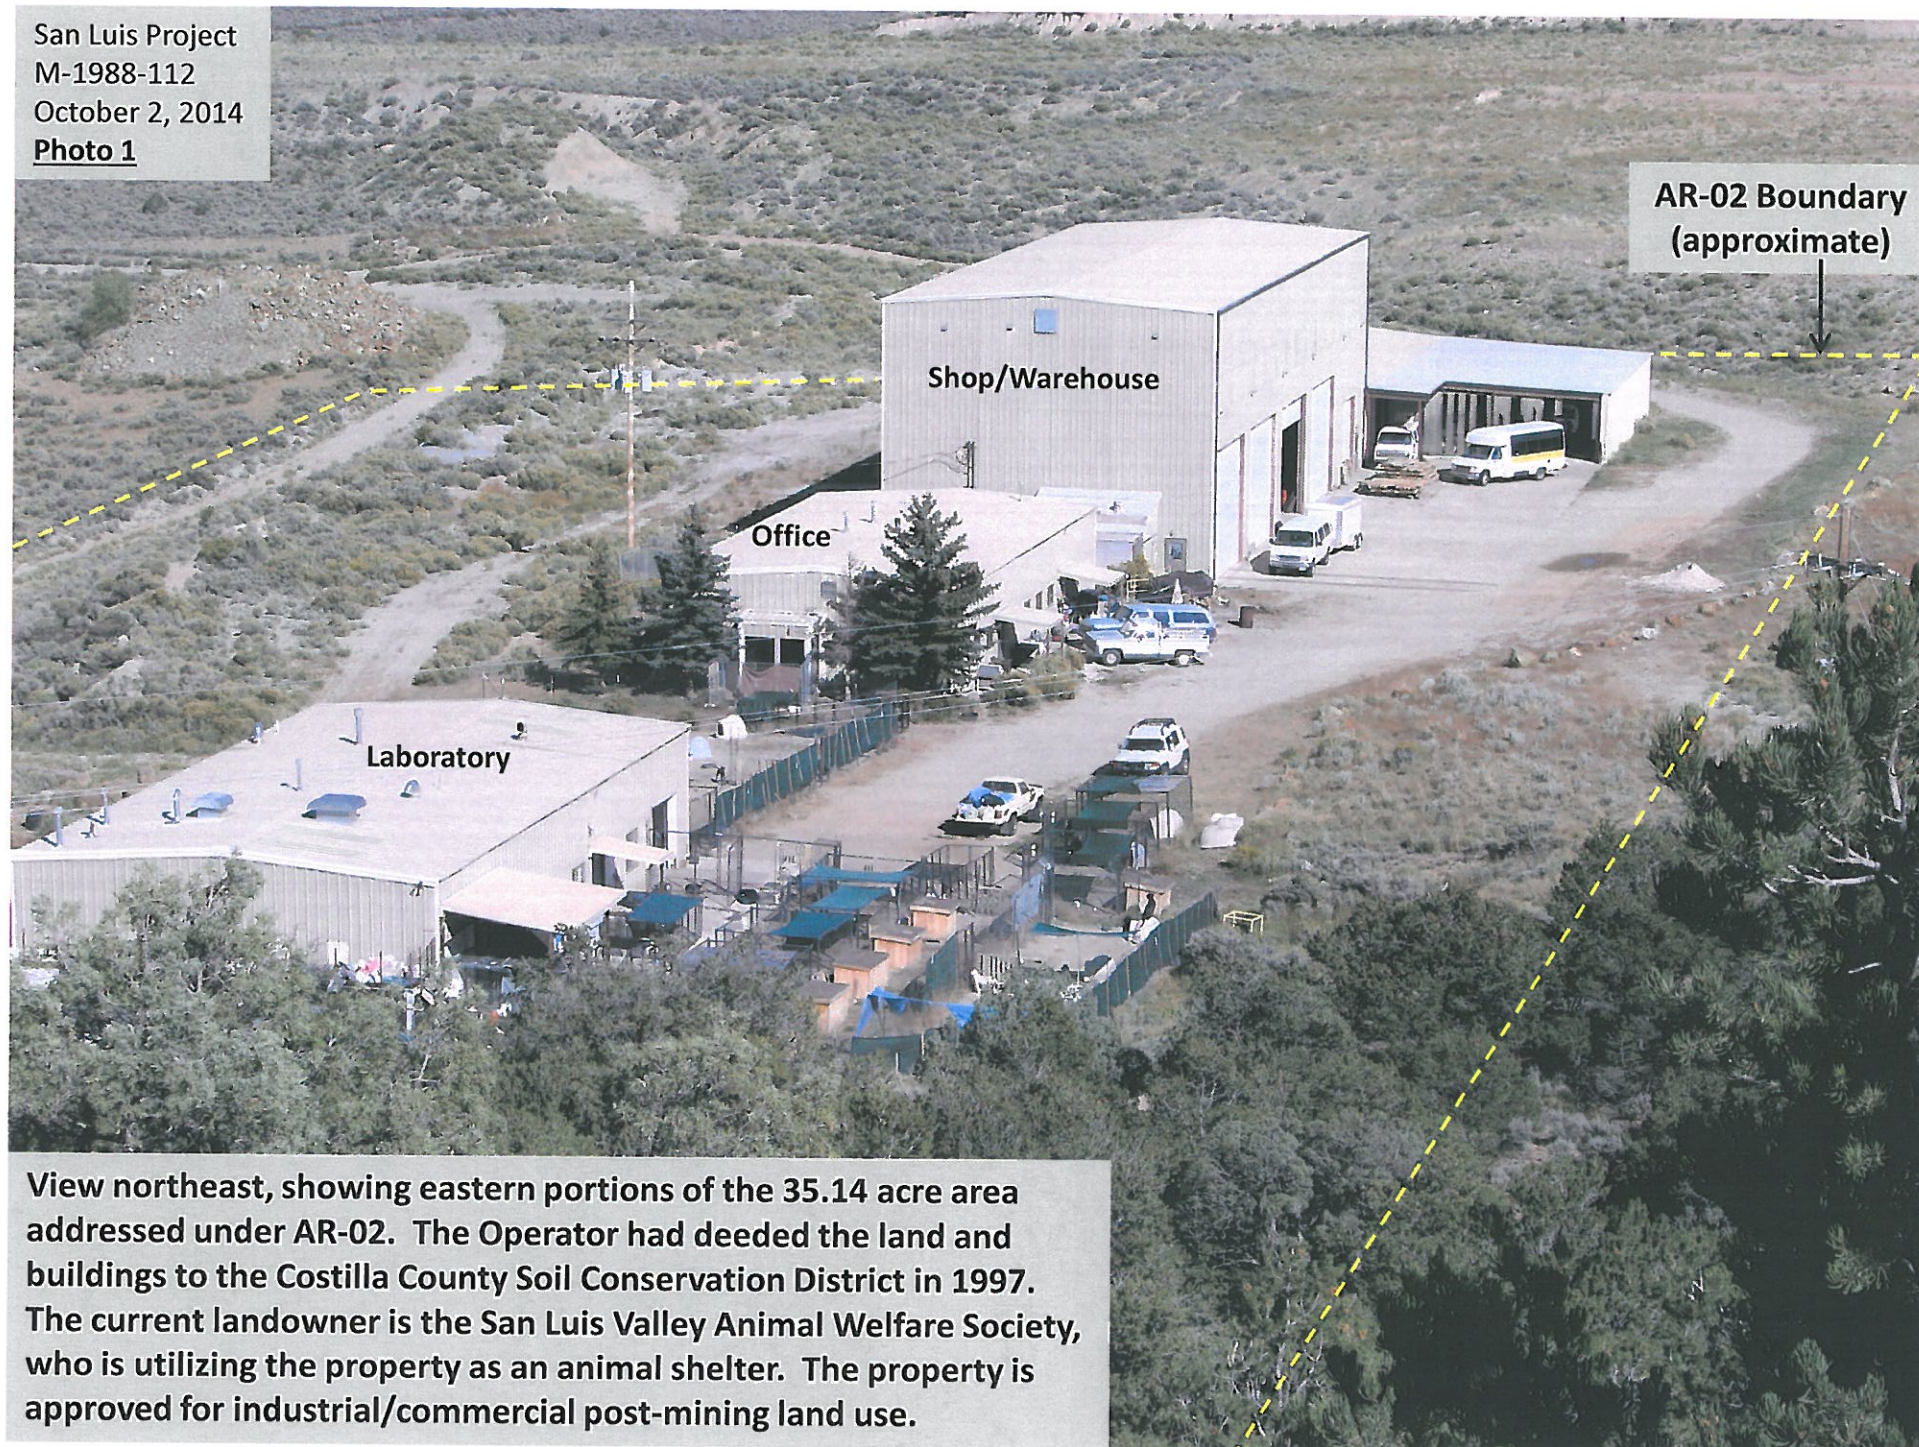
San Luis Project
M-1988-112
October 2, 2014
Photo 1

View northeast, showing eastern portions of the 35.14 acre area addressed under AR-02. The Operator had deeded the land and buildings to the Costilla County Soil Conservation District in 1997. The current landowner is the San Luis Valley Animal Welfare Society, who is utilizing the property as an animal shelter. The property is approved for industrial/commercial post-mining land use.

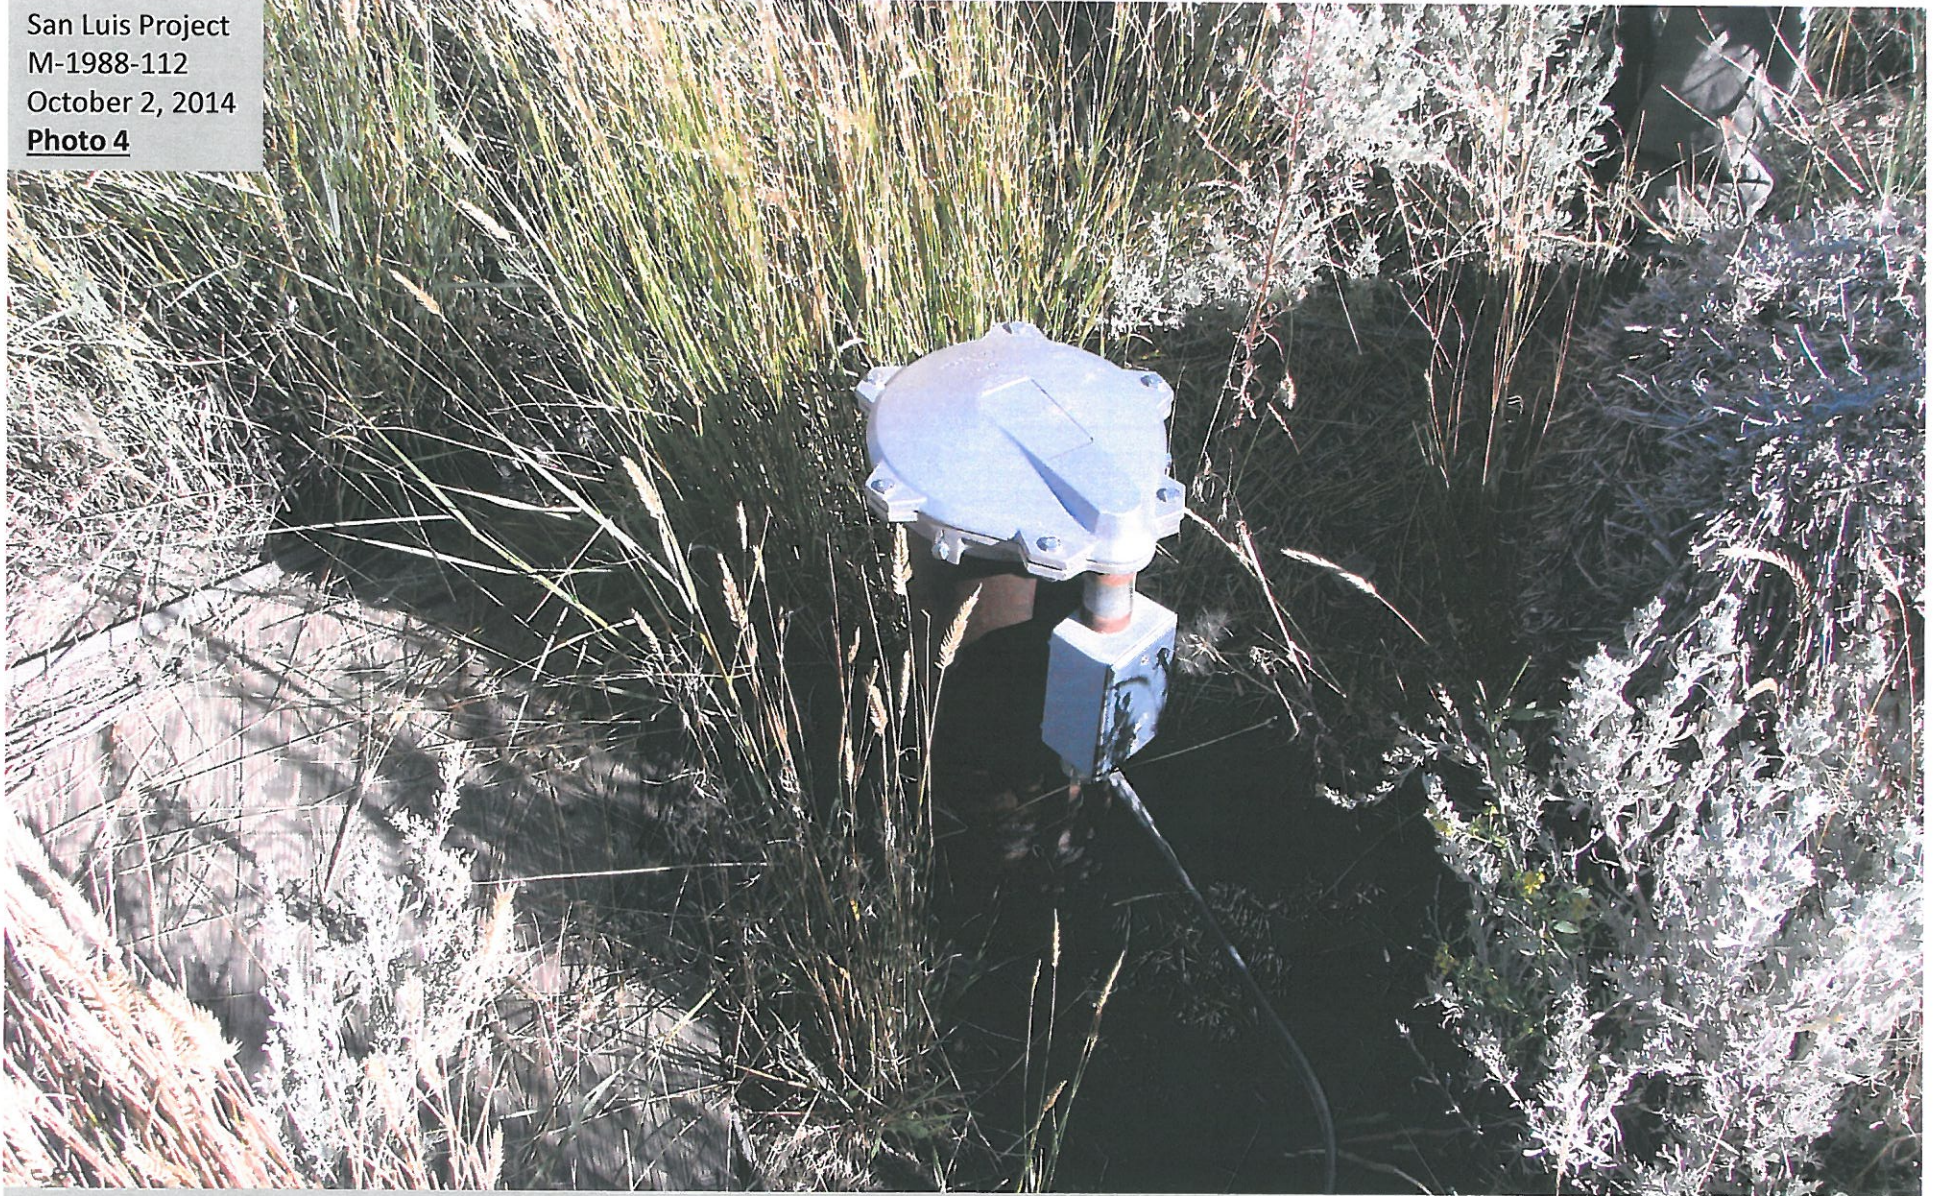
San Luis Project
M-1988-112
October 2, 2014
Photo 4

Ground water monitoring well, M-4R, was located within the AR-02 boundary. The monitoring well had been reclassified to a production well for commercial use, initially under Division of Water Resources Permit No. 221167 and currently under Permit No. 251799, both owned by Costilla County Soil Conservation District. Pursuant to the conditions of Technical Revision No. 32, monitoring well M-4R has been removed from the approved hydrologic monitoring plan and the well has been reclaimed to a beneficial use in accordance with the commercial/industrial post-mining land use.

- On November 10, 1999, the Costilla County Soil Conservation District acquired Permit No. 221167 from the Division of Water Resources, effectively reclassifying the ground water monitoring well M-4R as a production well for commercial use. Permit No. 221167 expired November 12, 2001, and was later replaced by Permit No. 251799, issued July 18, 2003.
- On October 20, 2003, the Division approved TR-32, identifying monitoring well M-4R as a permanent structure and appropriate to support the industrial/commercial post-mining land use.
- Ownership of the lands addressed under AR-02 has transferred from Costilla County SCD to the San Luis Valley Animal Welfare Society, who is currently utilizing the property as an animal shelter. As such, the property has attained its industrial/commercial post-mining land use.

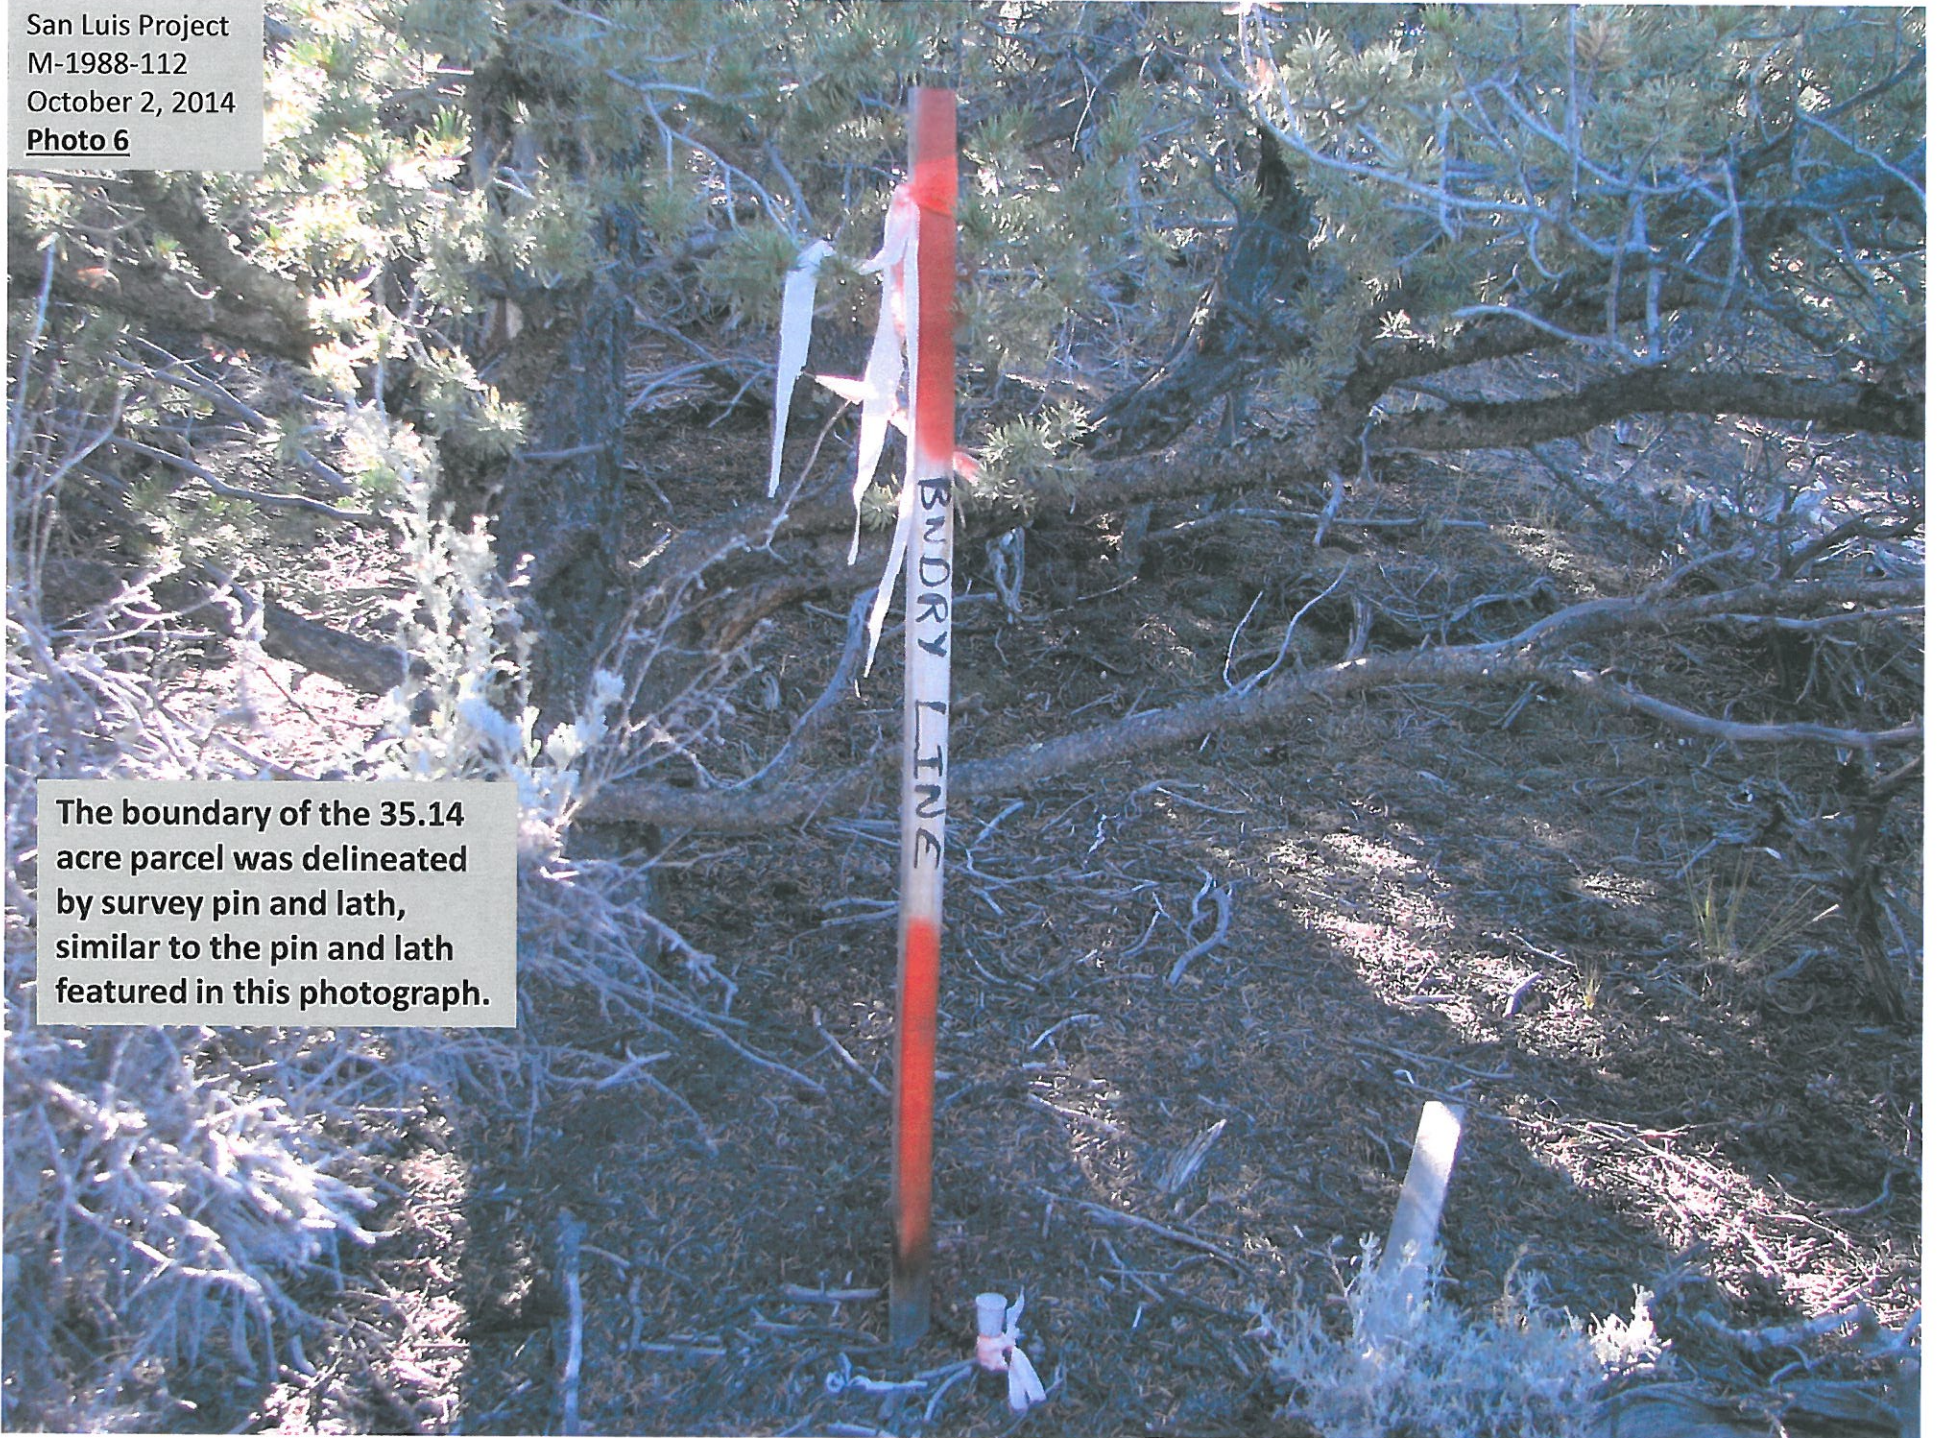
San Luis Project
M-1988-112
October 2, 2014
Photo 6

The boundary of the 35.14 acre parcel was delineated by survey pin and lath, similar to the pin and lath featured in this photograph.
