COLORADO DIVISION OF RECLAMATION, MINING AND SAFETY
MINERALS PROGRAM INSPECTION REPORT
PHONE: (303) 866-3567

MINE NAME: Clifton Water Gravel Pit	MINE/PROSPECTING ID#: M-1997-053	MINERAL: Sand and gravel	COUNTY: Mesa
INSPECTION TYPE: Monitoring	INSPECTOR(S): Travis H. Marshall	INSP. DATE: March 26, 2015	INSP. TIME: 08:30
OPERATOR: Grand Junction Pipe & Supply Co.	OPERATOR REPRESENTATIVE: Gayle Lyman	TYPE OF OPERATION: 112c - Construction Regular Operation	
REASON FOR INSPECTION: Normal I&E Program	BOND CALCULATION TYPE: None	BOND AMOUNT: \$20,725.00	
DATE OF COMPLAINT: NA	POST INSP. CONTACTS: None	JOINT INSP. AGENCY: None	
WEATHER: Clear	INSPECTOR'S SIGNATURE:

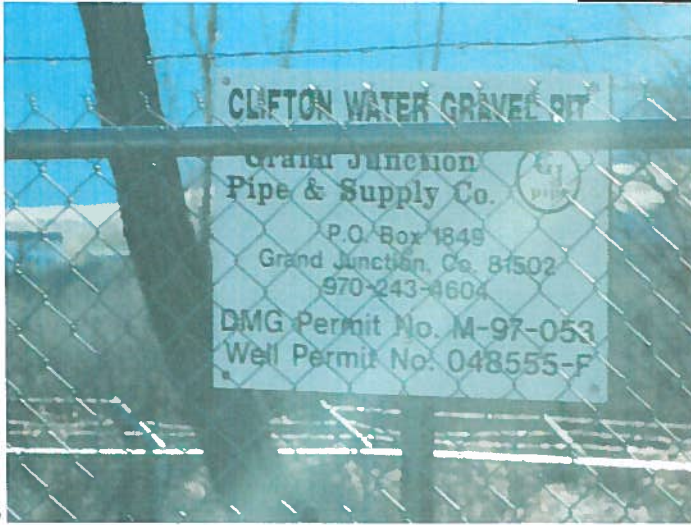
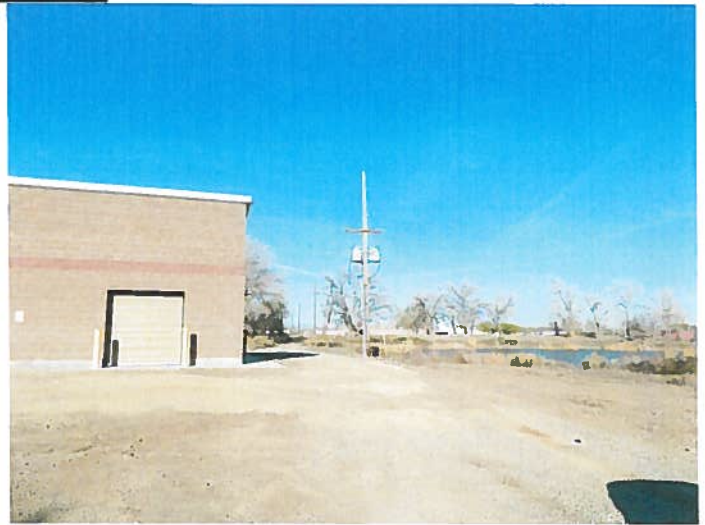
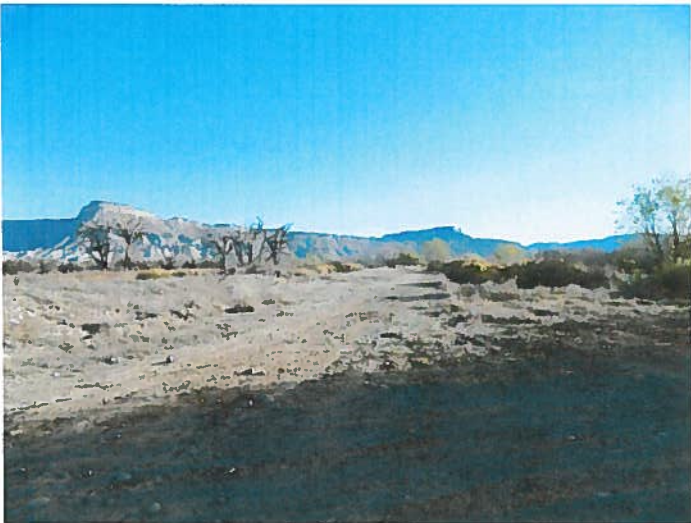
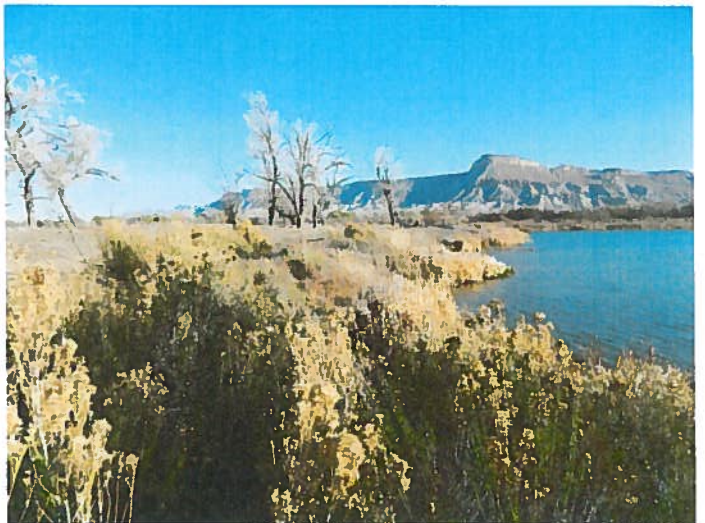
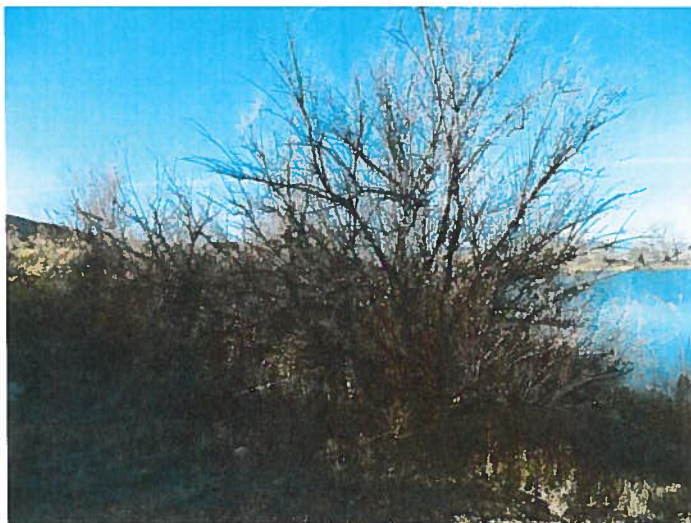
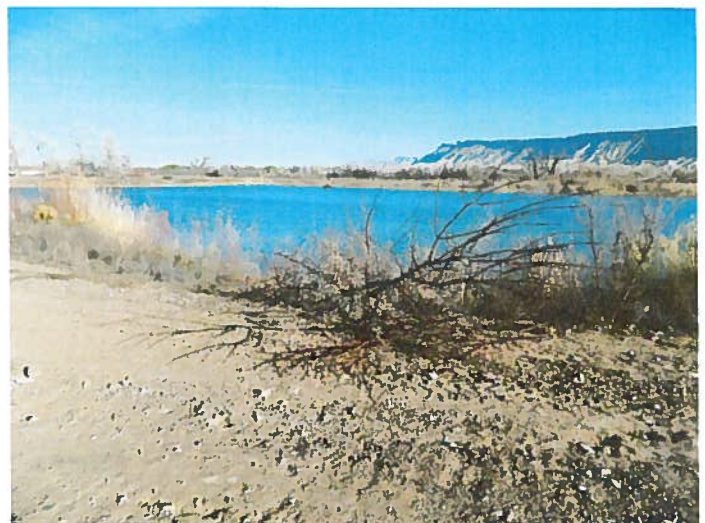
PHOTOGRAPHS

The mine was inactive at the time of the inspection. All final grading and earthwork is completed. All slopes appear to be no steeper than the required 3H:1V.

The majority of the required vegetation has been established and is predominately perennial grasses and a variety of shrubs. Some annual weeds are mixed with the desired vegetation but it appears that eventually the desired vegetation will out compete the annual weeds.

A few bare patches were observed along the west and northern slopes of the pond. Some additional topsoil and re-seeding of these areas may accelerate re-vegetative success.

Tamarisk and Russian olive were observed within the permit area. As of January 19, 2005 Tamarisk and Russian olive are considered noxious weeds but due to the site being in final reclamation since 2002, when final grading and seeding was completed, the site is not required to completely eliminate the noxious species. The DRMS Tamarisk and Russian olive policy states that if a mining site was in final reclamation prior to January 19, 2005 the pre January 19, 2005 weed control policy is the "grandfathered" guideline the operator must comply with. Even though the operator is not required to eliminate Tamarisk and Russian olive evidence of mechanical control of the noxious species was observed during the inspection.
