COLORADO DIVISION OF RECLAMATION, MINING AND SAFETY
MINERALS PROGRAM INSPECTION REPORT
PHONE: (303) 866-3567

MINE NAME: Gravel Pit No 7	MINE/PROSPECTING ID#: M-1977-484	MINERAL: Sand and gravel	COUNTY: Baca
INSPECTION TYPE: Monitoring	INSPECTOR(S): Amy Eschberger	INSP. DATE: November 19, 2014	INSP. TIME: 13:00
OPERATOR: Robins Redi Mix, LLC	OPERATOR REPRESENTATIVE: James Adams and Kurt Eskew	TYPE OF OPERATION: 112c - Construction Regular Operation

OBSERVATIONS

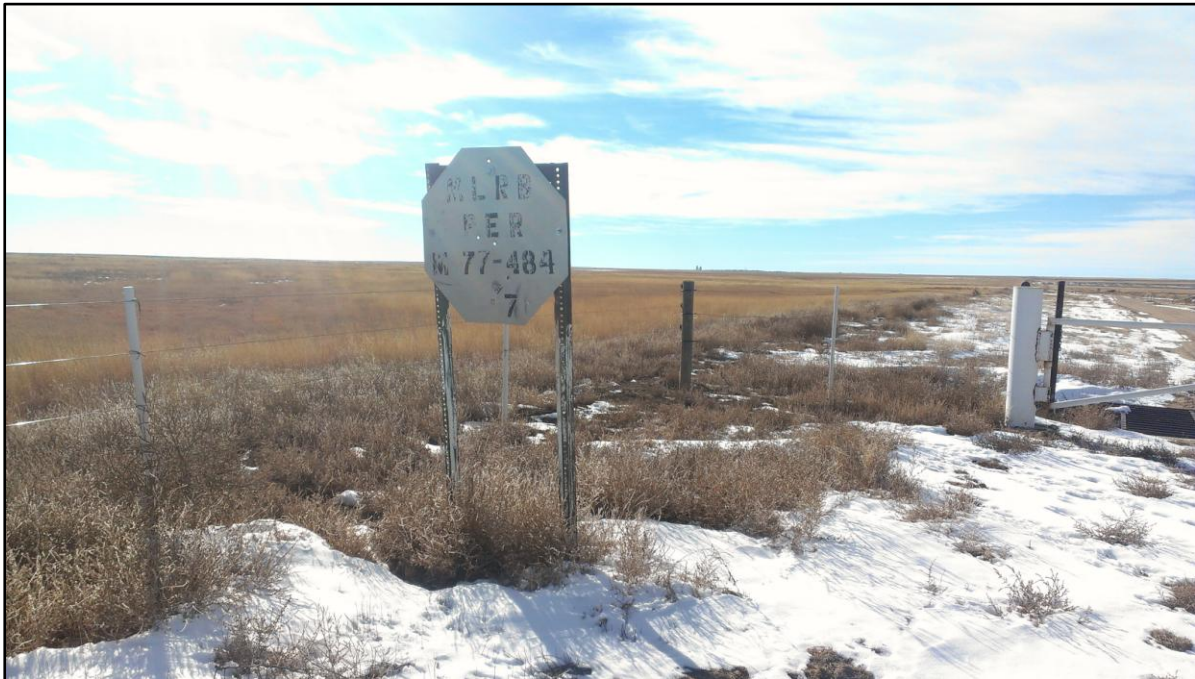
At the time of the inspection, the weather was clear and some portions of the ground were still covered in snow. A permit sign was posted at the main entrance to the site off of Co Rd 18 (Photo 1). The permit boundary was delineated by property fencelines. However, only some boundary markers were in place to delineate the maximum allowed disturbed area. Pursuant to Rule 3.1.12(2), the boundaries of the affected area shall be marked by monuments or other markers that are clearly visible and adequate to delineate such boundaries. For 112c operations such as this one, the affected area is the area proposed to be disturbed by mining operations for which a Financial Warranty has been posted. Therefore, the operator will need to make sure that the maximum allowed disturbed area of 20 acres is adequately delineated. This will also help mine staff to keep disturbance under the approved maximum acreage as the operation continues. As discussed with the County representatives during the inspection, the maximum allowed disturbed acreage can be changed at any time by submitting a Technical Revision (see enclosed form).

Photo 1. View of permit sign posted at main entrance to site off of Co Rd 18.

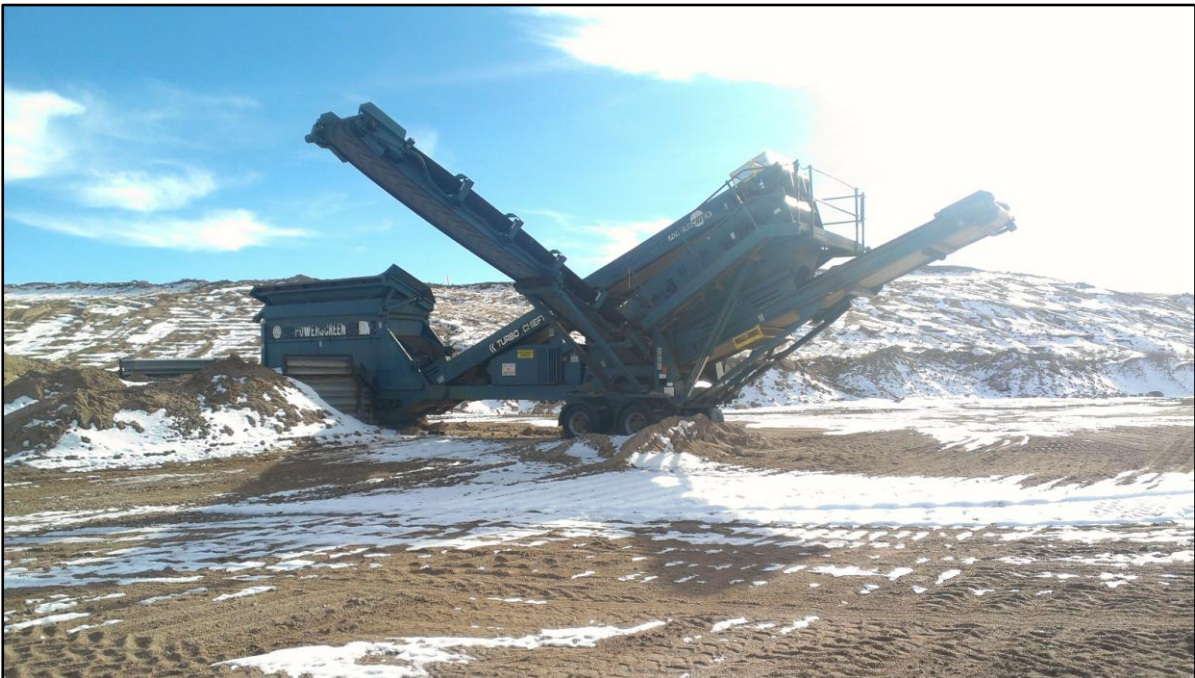
Photo 2. View of processing equipment present on pit floor.

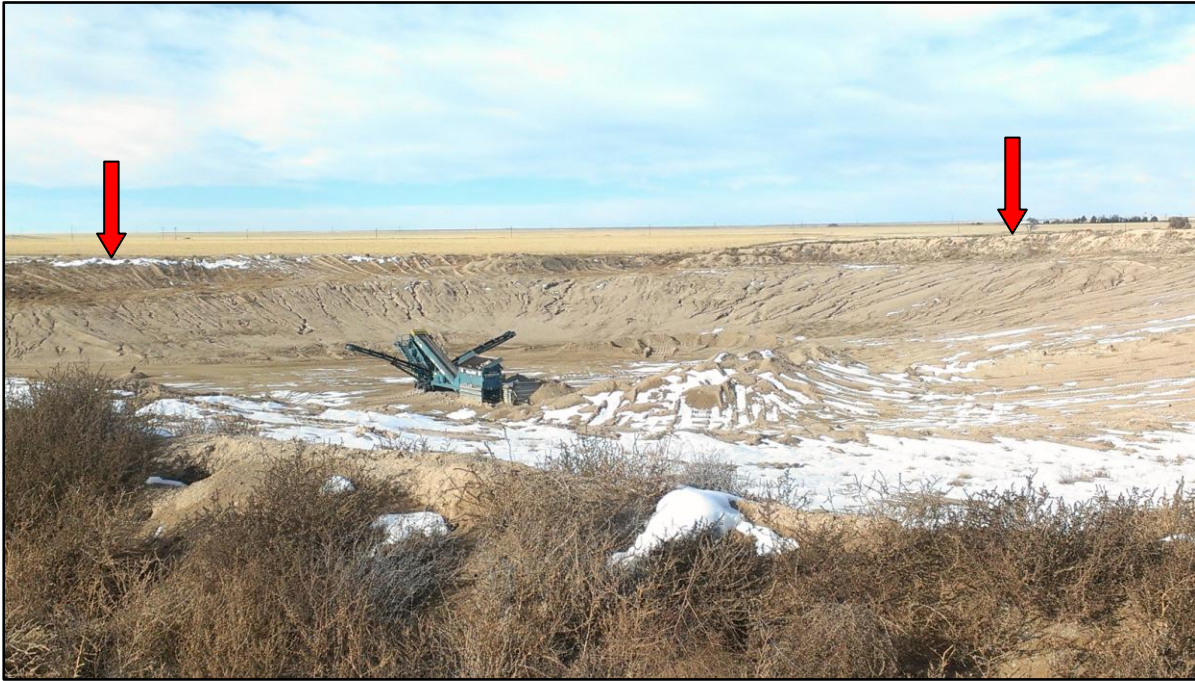
The site was inactive during the inspection. However, material processing equipment (Photo 2) and a few trucks were present on the pit floor. The operator has excavated a pit approximately 30-35 feet deep (Photos 3). The mined slopes are pushed to a gradient of 3H:1V (Photo 4; also see Photo 3). The slopes appeared stable; however, some rilling was observed mainly along the northern pit wall (Photo 5; also see Photo 3). The operator should work to monitor and repair erosional damage as needed pursuant to C.R.S. 34-32.5-116(4)(j), which requires that all surface areas of the affected land be stabilized and protected so as to effectively control erosion.

Photo 3. View looking north into mined pit from top of southern pit wall. Note mined slopes kept at 3H:1V gradient or flatter, and topsoil stockpiled in berms around edges of pit (indicated).

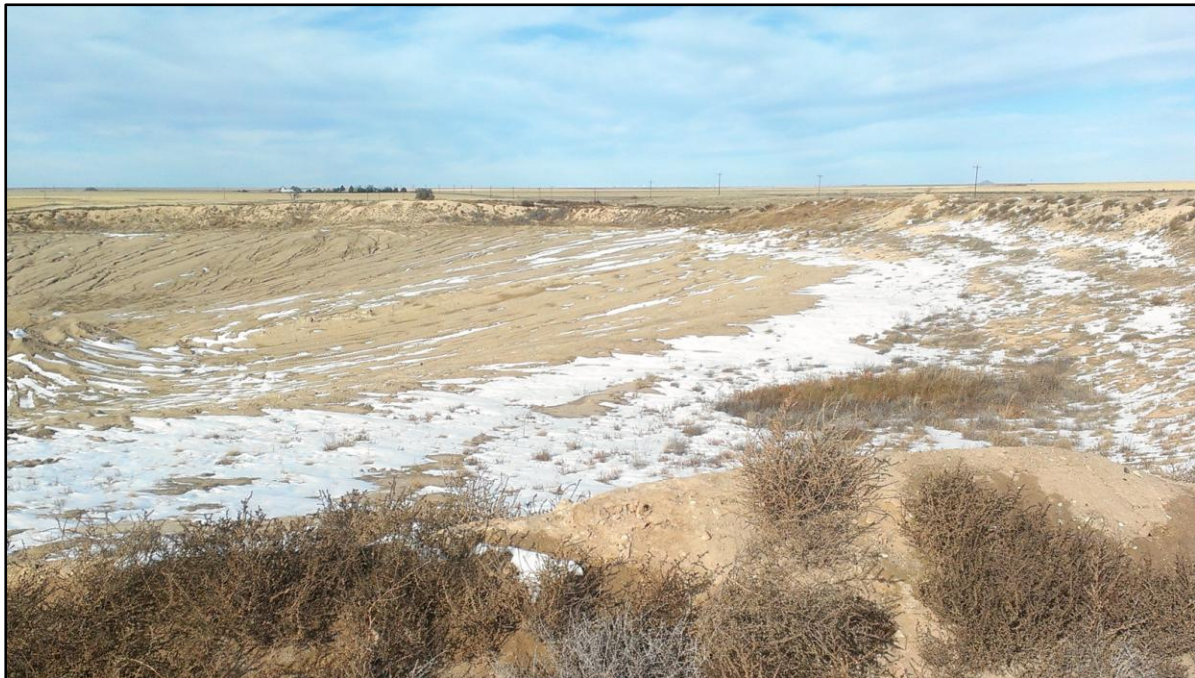
Photo 4. View looking northeast from top of southern pit wall, showing mined slopes kept at 3H:1V gradient or flatter. Note topsoil stockpiled in berms around edges of pit.

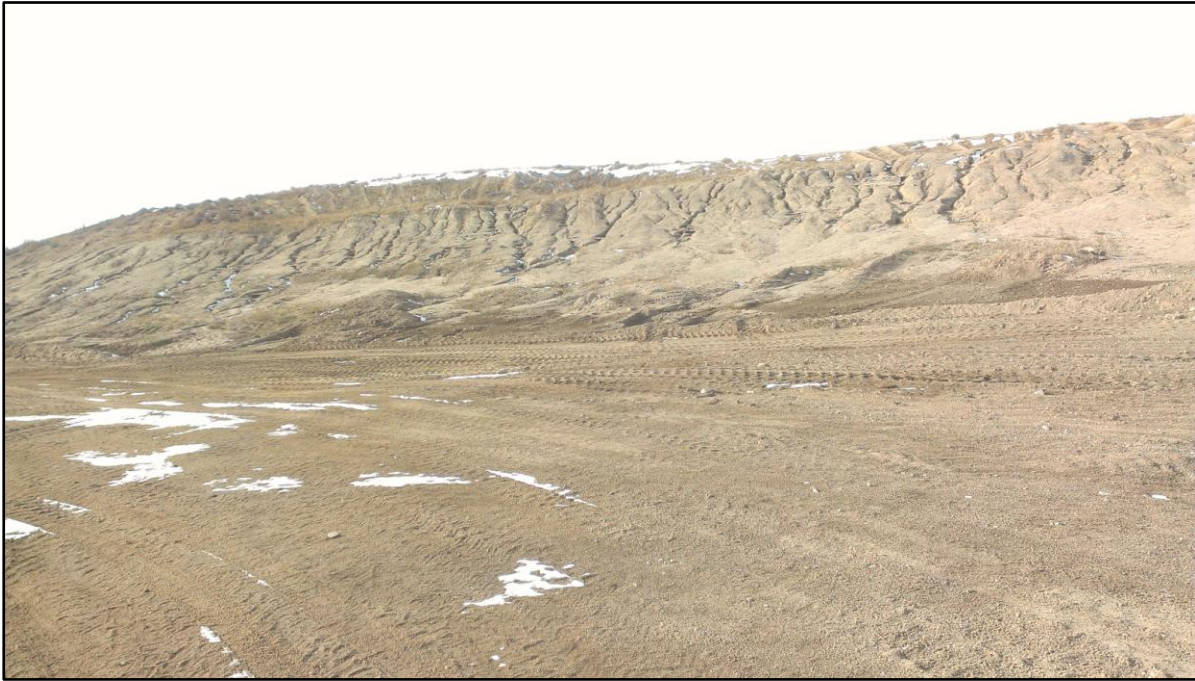
Photo 5. View looking northwest from pit floor, showing some rilling that has developed along the northwestern mined wall.

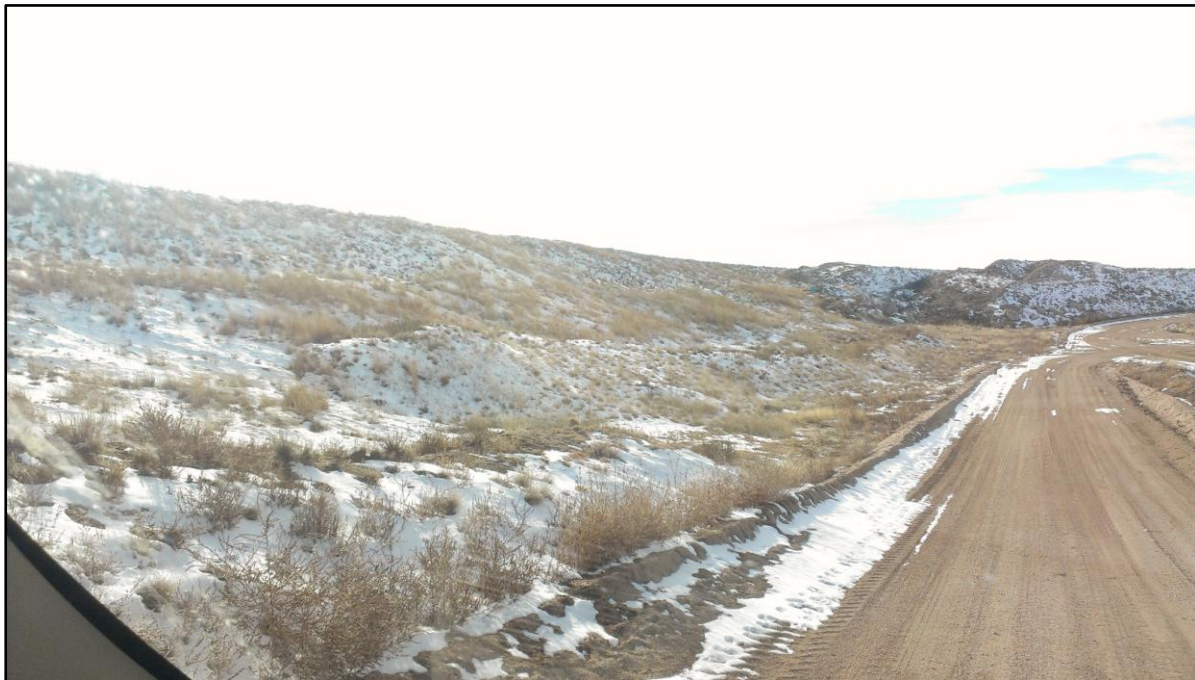
A portion of the southwestern pit wall, approximately 450 feet in length, was graded to slopes of 2H:1V (Photo 6; also see enclosed Google Earth image). The financial warranty currently held for this site includes costs for grading this slope to the approved 3H:1V gradient. Mined material is stockpiled on the pit floor (Photo 7). Salvaged topsoil is stockpiled in berms around the top edges of the pit and they appear to be stable (see Photos 3 and 4). A waste rock stockpile containing up to boulder sized rocks is present in the southwestern portion of the site, adjacent to the pit haul road (Photo 8). This stockpile appears to be stable; however, before the site can be released, this material will need to either be used for backfilling the pit or be graded to slopes of 3H:1V or flatter and revegetated.

Photo 6. View looking west from haul road, showing portion of southwestern pit wall graded to approximately 2H:1V. This wall will need to be graded to 3H:1V or flatter before final release.

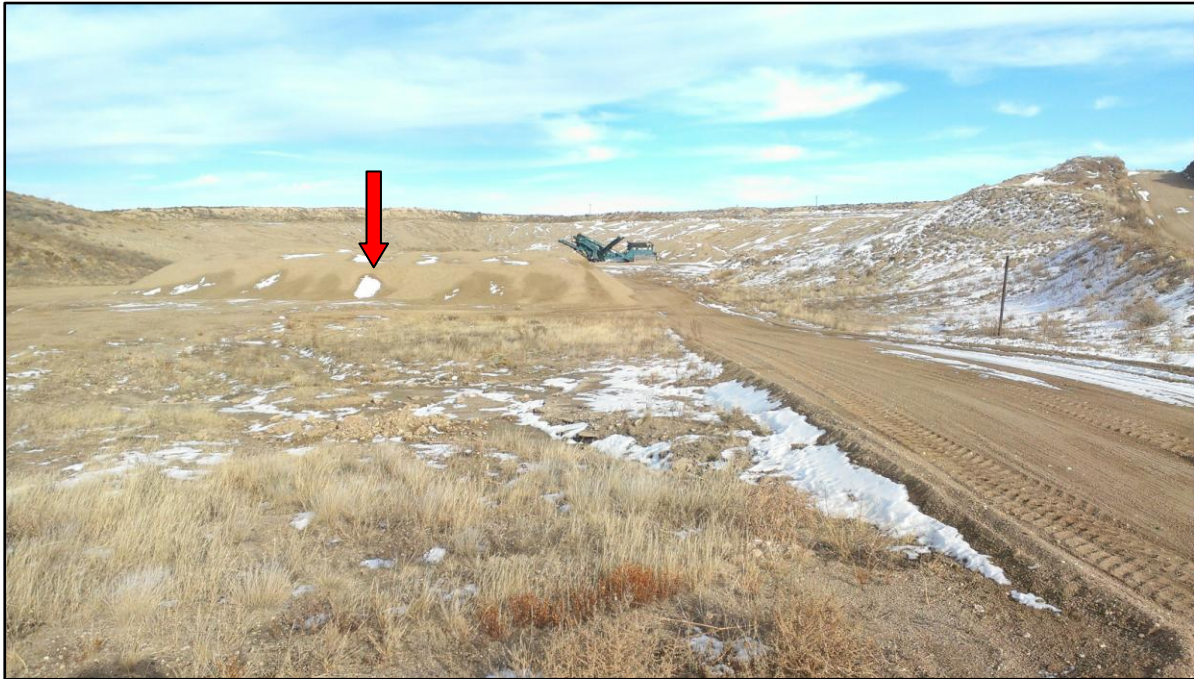
Photo 7. View looking east into pit from haul road, showing one of material stockpiles stored on pit floor (indicated).

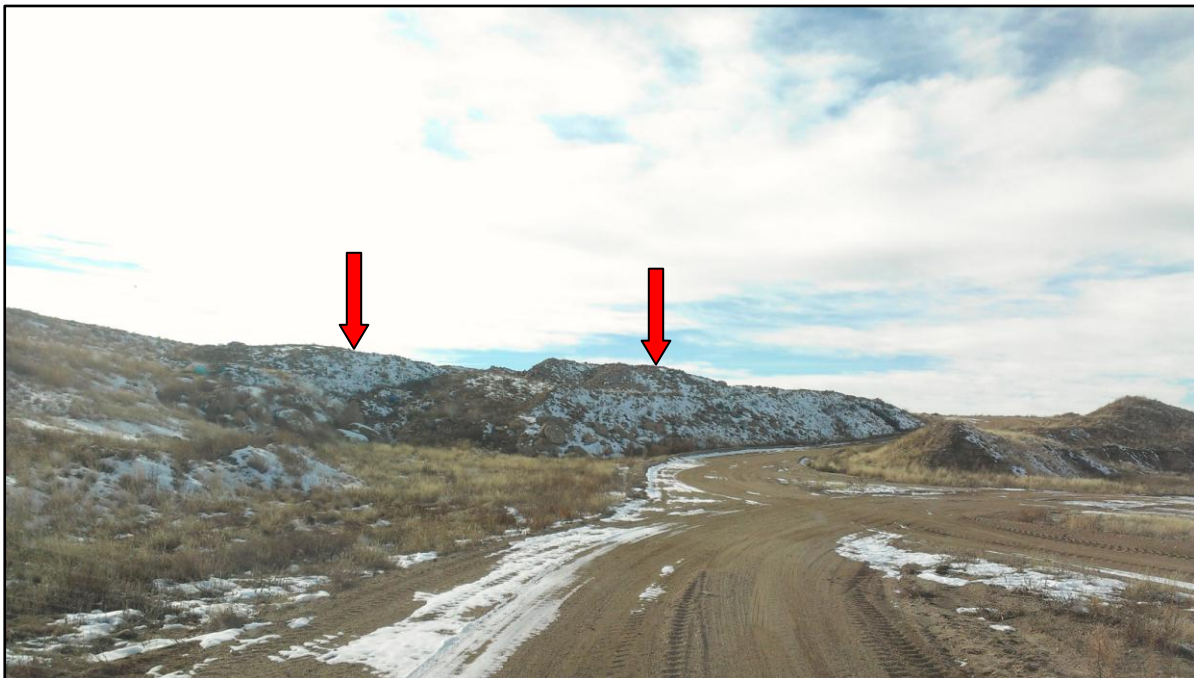
Photo 8. View looking west from haul road, showing portion of waste rock stockpile (indicated) that will need to be used for final reclamation or graded to 3H:1V or flatter before final release.

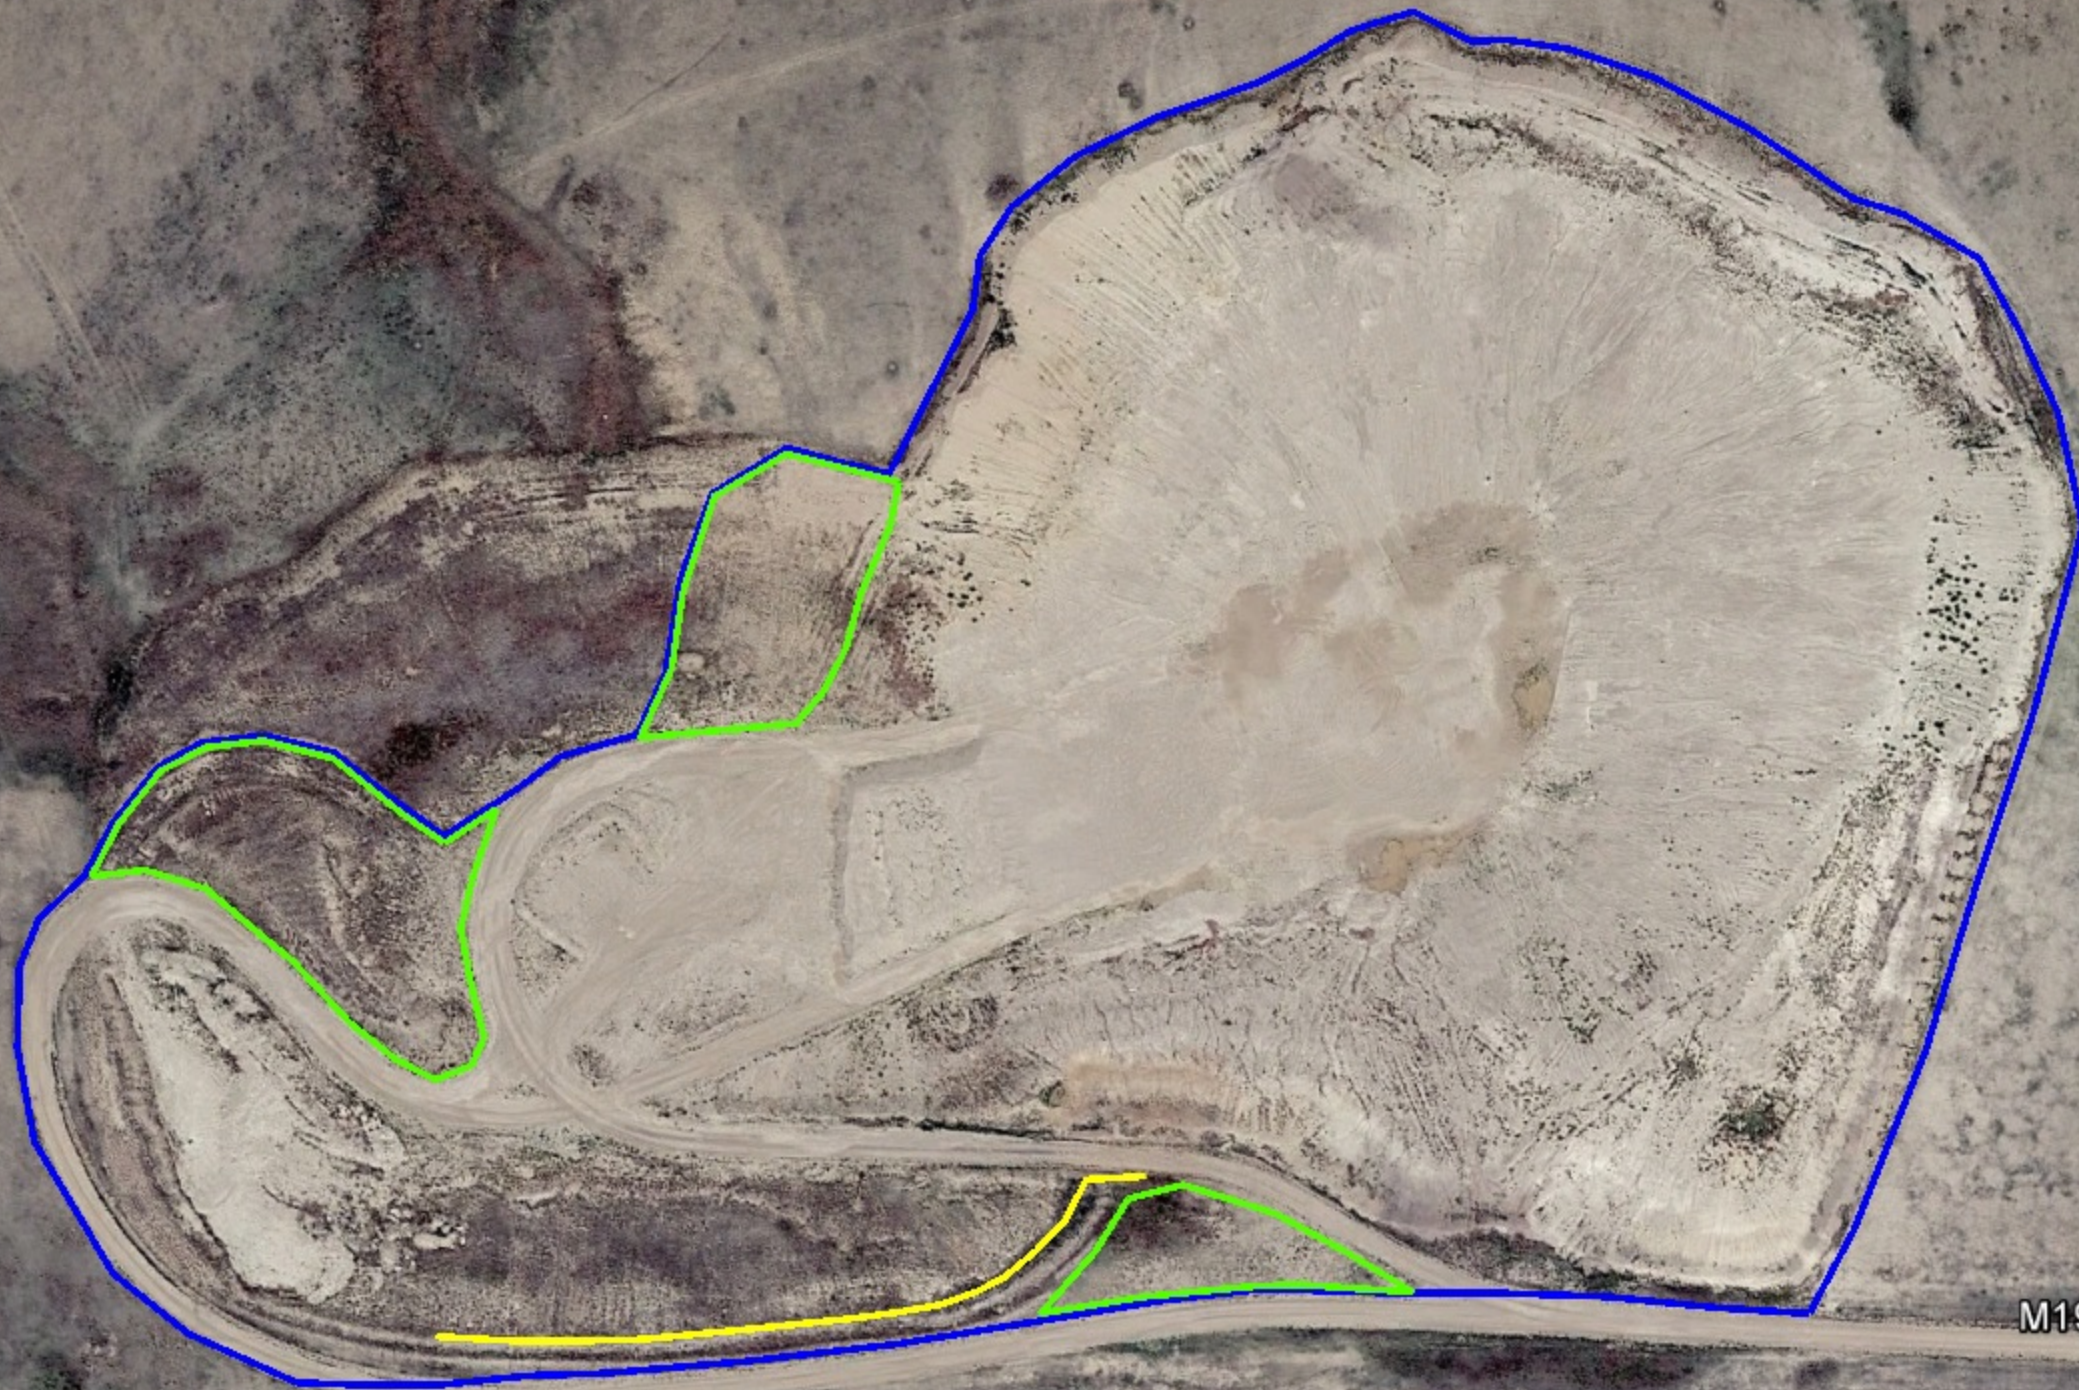
M1977-484 / Gravel Pit No 7 / Robins Redi Mix, LLC

Red Line = 160 acres = approved permit area

Blue Line = 14.5 acres = disturbed area (as of 11/19/14 inspection)

Green Line = 1.10 acres (total) = areas in reclamation

Yellow Line = 450 feet L = 2H:1V slope gradient

The Division estimates current disturbance at this site to be approximately 14.5 acres, which is in compliance with the approved maximum allowed disturbance. Of the 14.5 acres, approximately 1.10 acres are in reclamation. The financial warranty for this permit was last updated in late 2011 when the permit was transferred to the current permittee. The Division has determined that the currently held financial warranty of \$24,570.70 is adequate for reclamation of the site. However, if additional land is disturbed without the concurrent reclamation of previously disturbed areas, additional financial warranty may be required.
