Please find attached; The CC&V response on ponding of barren solution on the Phase 5 Road as a corrective action follow-up of the June 17, 2015 DRMS inspection.

## Cripple Creek & Victor Gold Mining

Re: Permit No. M-1980-244; Cripple Creek & Victor Gold Mining Company ("CC&V");  
Cresson Project; – Response on ponding of barren solution on Phase 5 road as a corrective  
action follow up on the 17 June 2015 DRMS inspection

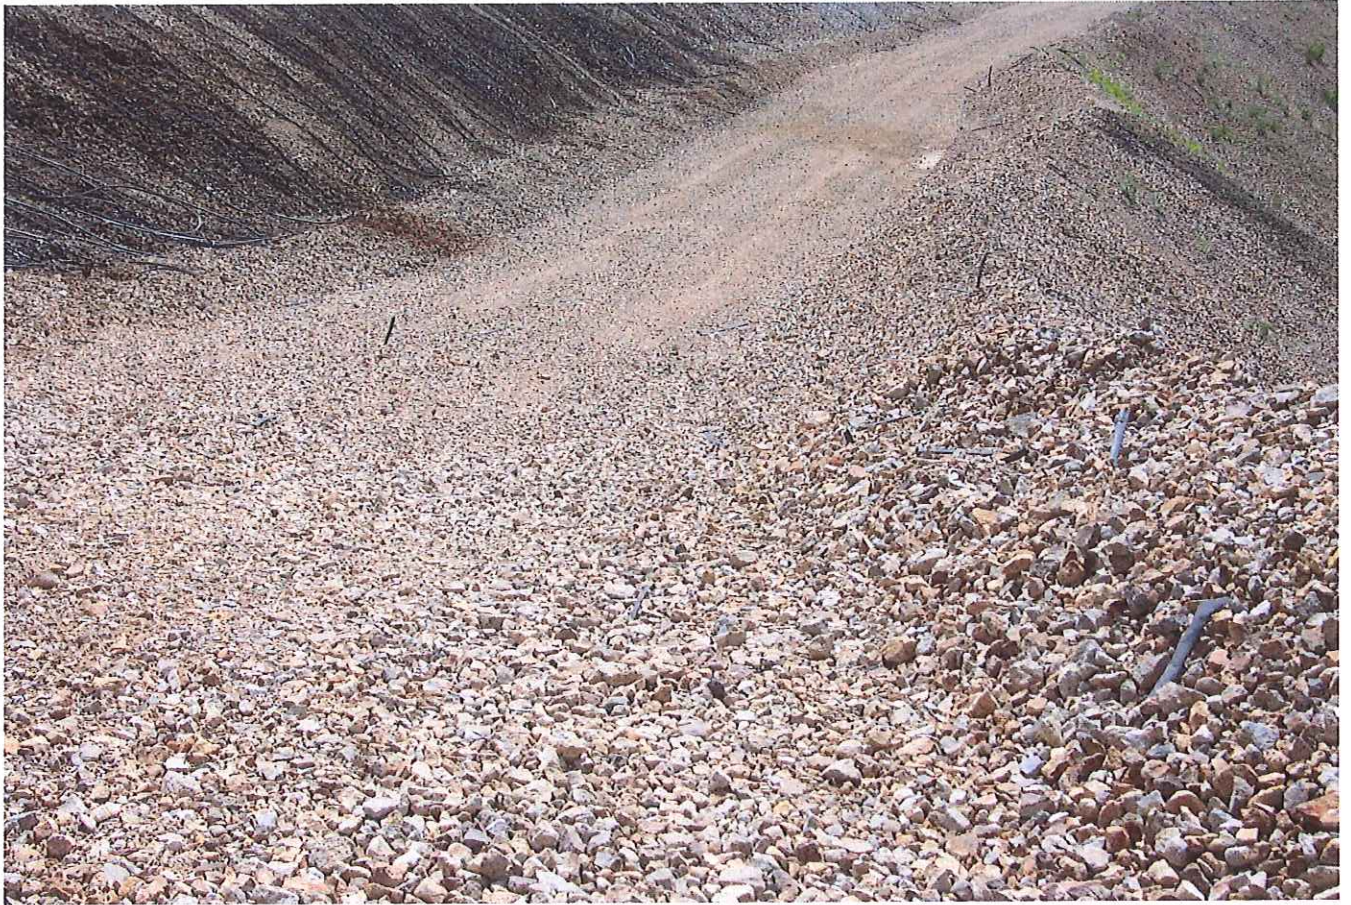
Photograph 1 – A berm was grade against the toe in this location to prevent ponding on the road.

No solution went off liner. To remedy ponding along the Phase 5 pump road, which is on liner, the following steps have been taken: the lines have been shortened so that the solution has an opportunity to be absorbed into the slope of the leach pad above the road. This will retard pooling on the more compacted road. The level of the road was raised and graded to promote drainage off the road. And staff repaired lines with broken ends which forces the solution to weep from the lines further up slope. Please find attached photographs taken by CC&V as the Phase 5 road appeared after mitigation (photograph 1, 2 and 3).

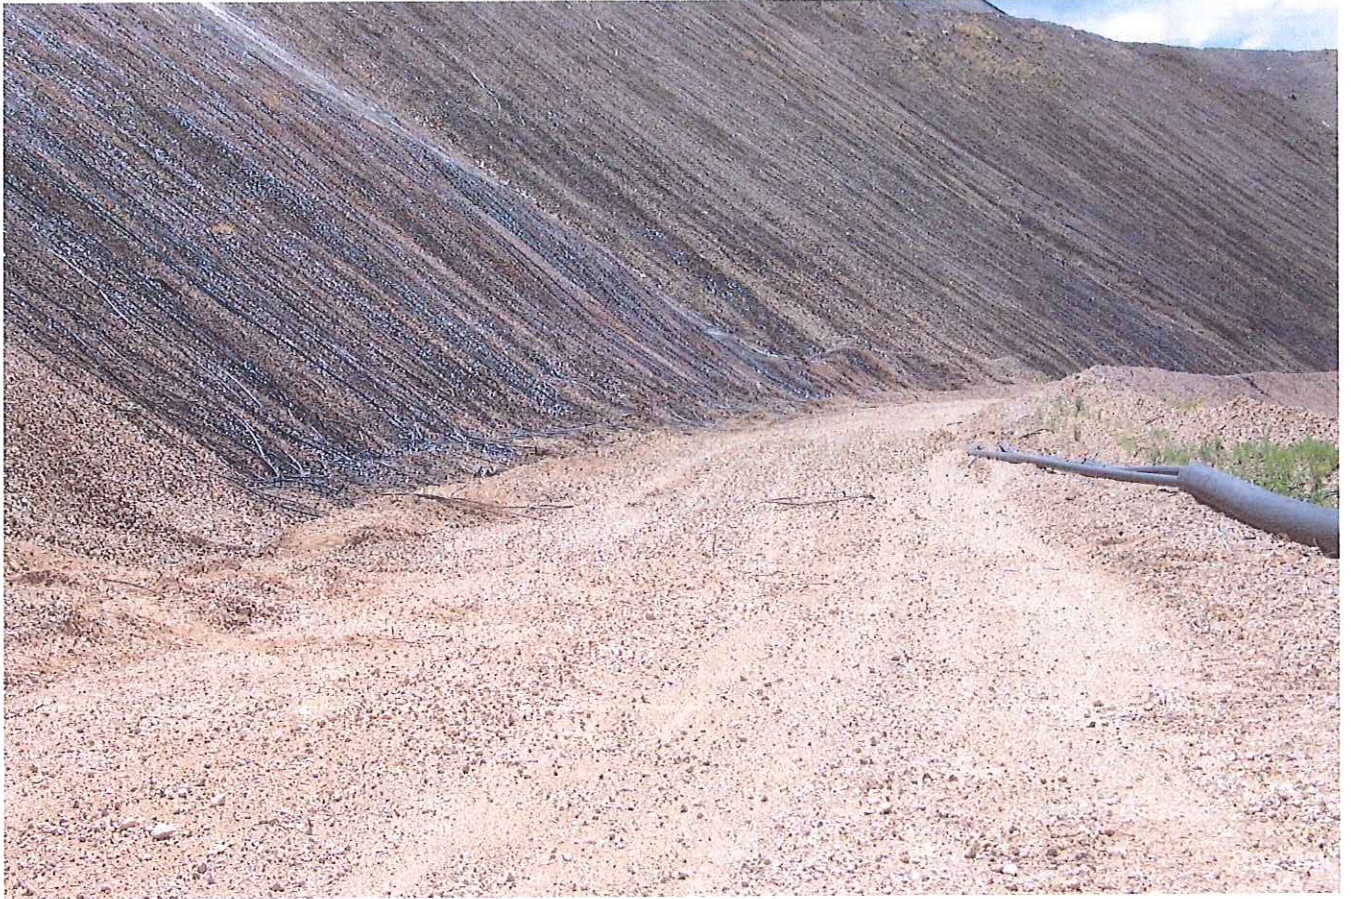
Photograph 2 – Driplines were shortened.

Upon examination, the root causes were determined to be drip lines that were too long and came to the edge of the road. The knotted end of several drip pipes had broken so that solution could simply flow out the end. Finally, the road was a compact surface that had settled which facilitated ponding.

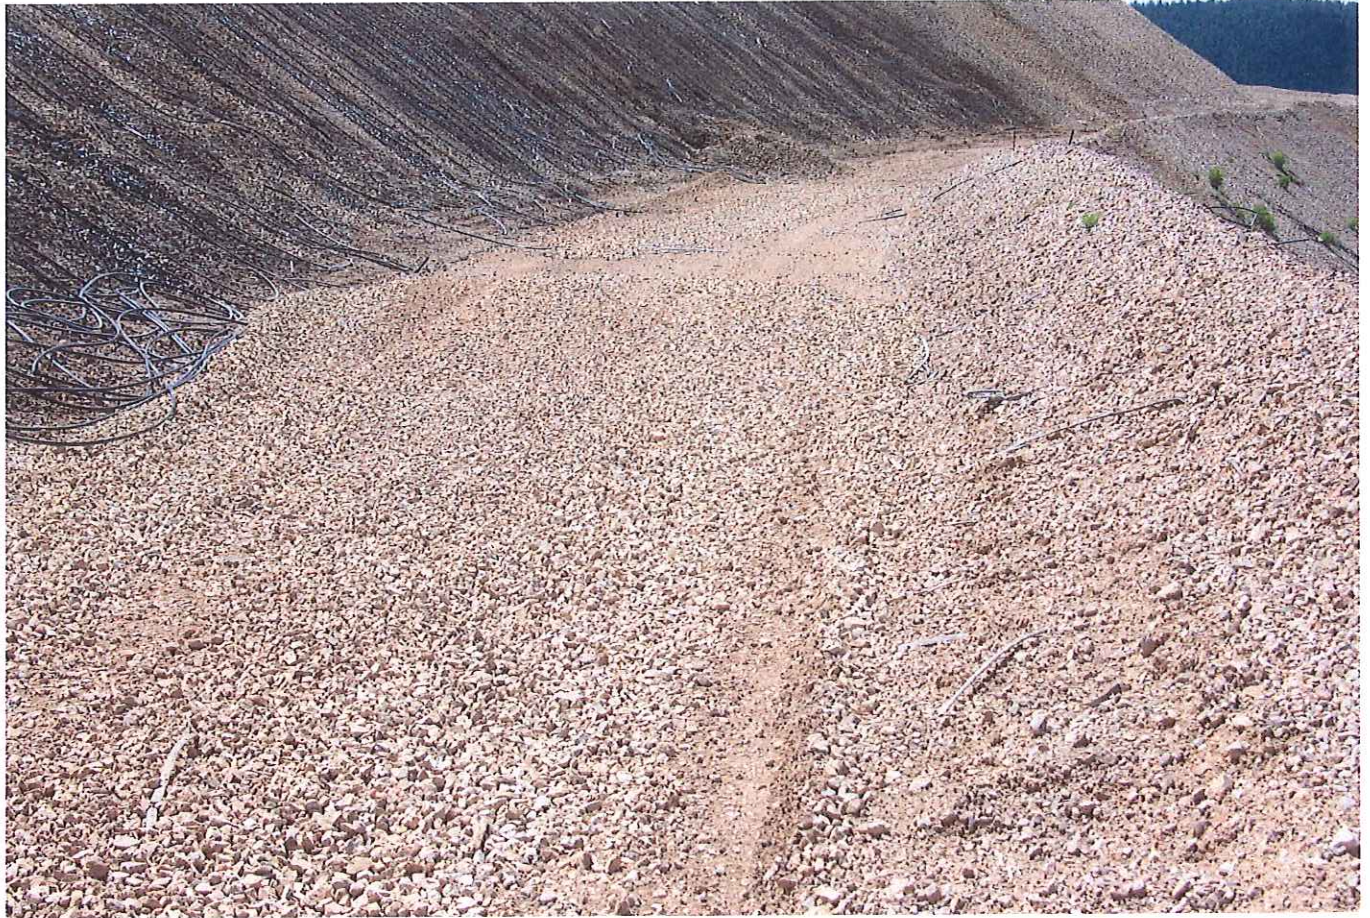
Photograph 3 – Elevated grade and a new stormwater sump used as part of the solution to ponding on the road.
