YANKEE GULCH SODIUM MINERALS PROJECT

**July 13, 2014 through July 12, 2015
ANNUAL RECLAMATION AND MINING
REPORT**

**Hard Rock Mining Operation
Permit No. M-99-002
U.S. Sodium Lease
Nos. C-0118328 and C-0118329**

**American Soda L. L. P., a wholly owned
subsidiary of Solvay Chemicals
PARACHUTE, COLORADO
July 9, 2015**

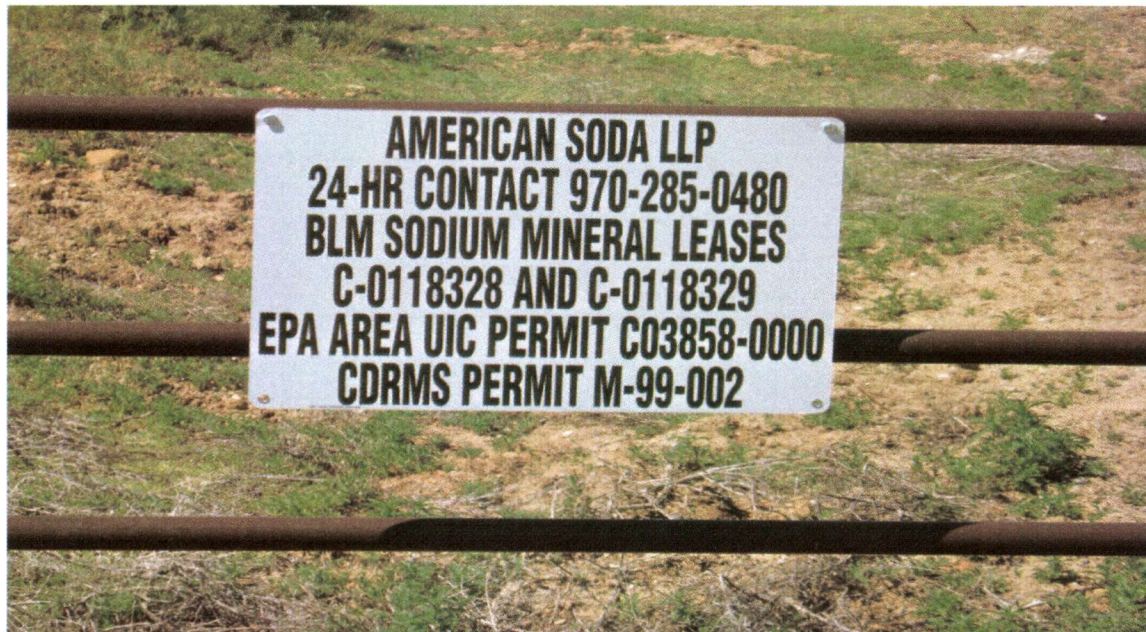
Sign posted on main gate to American Soda Solution Mining Well Field

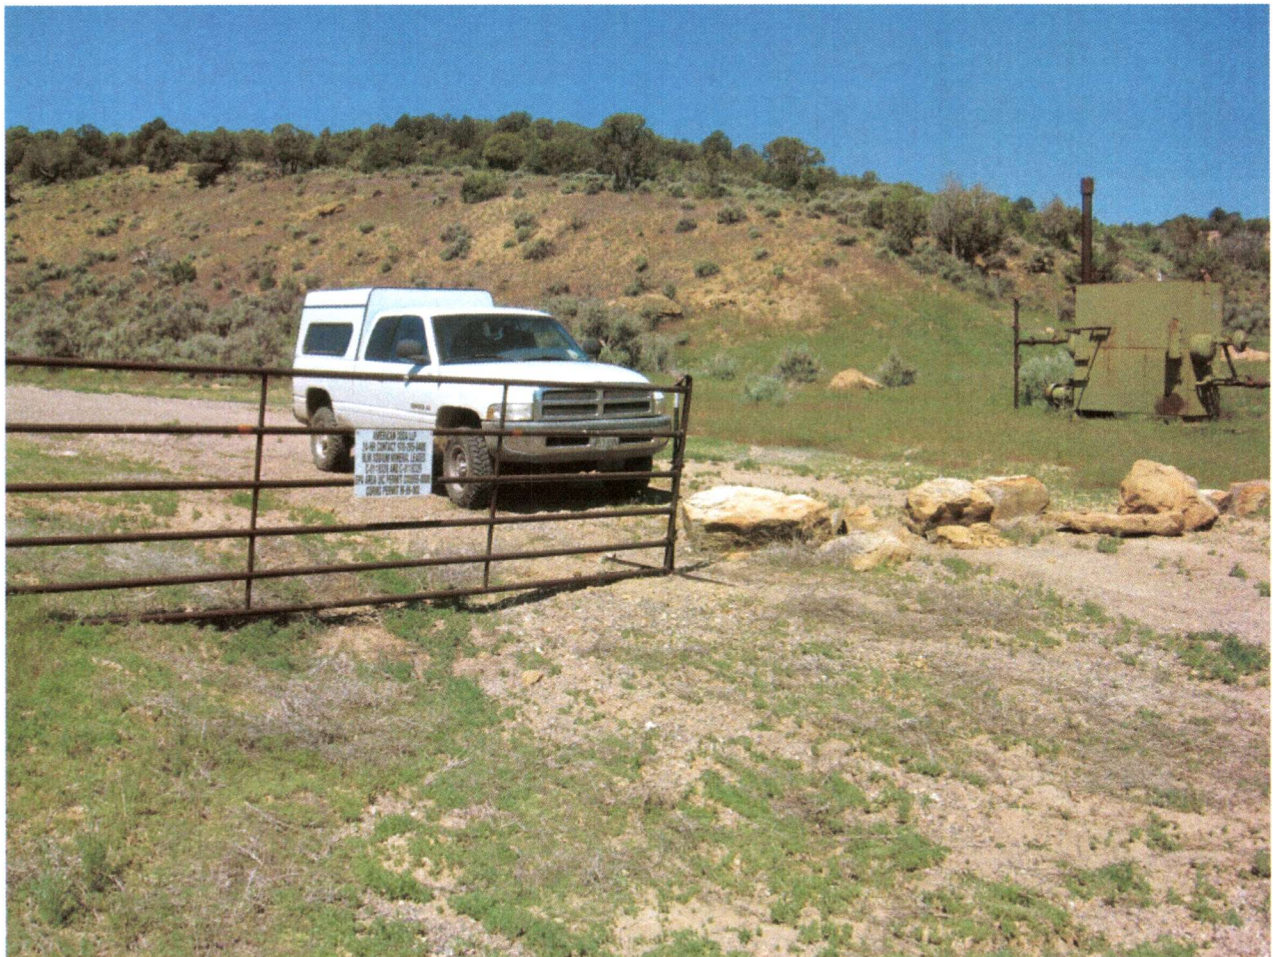
Permit sign on gate below pilot test mine pad - marking second boundary.

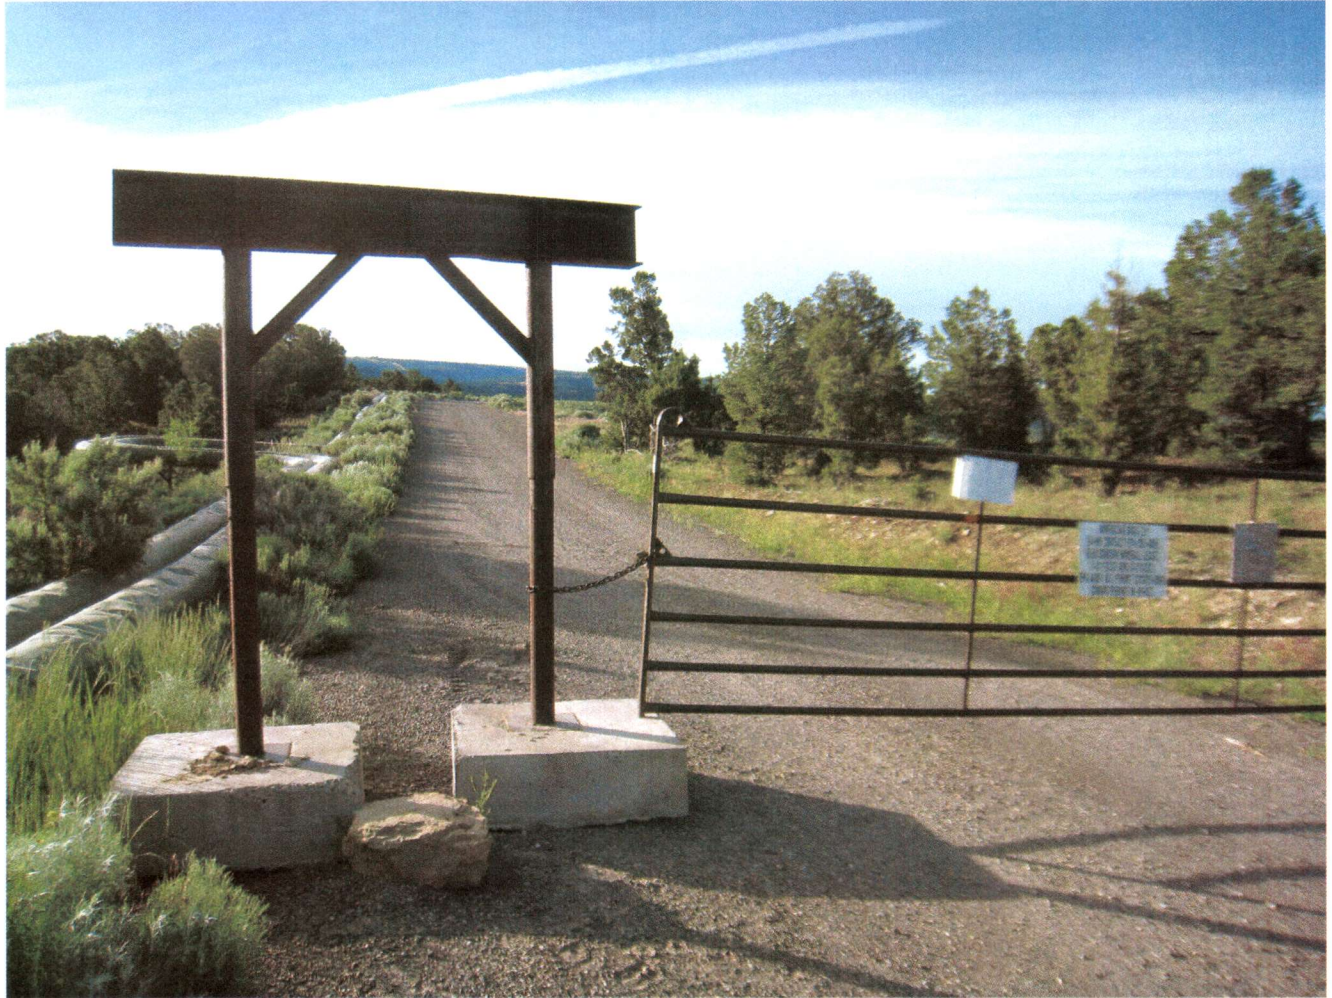
Access gate from main road to the well field. Added reinforced gate post support – installed June 2014.

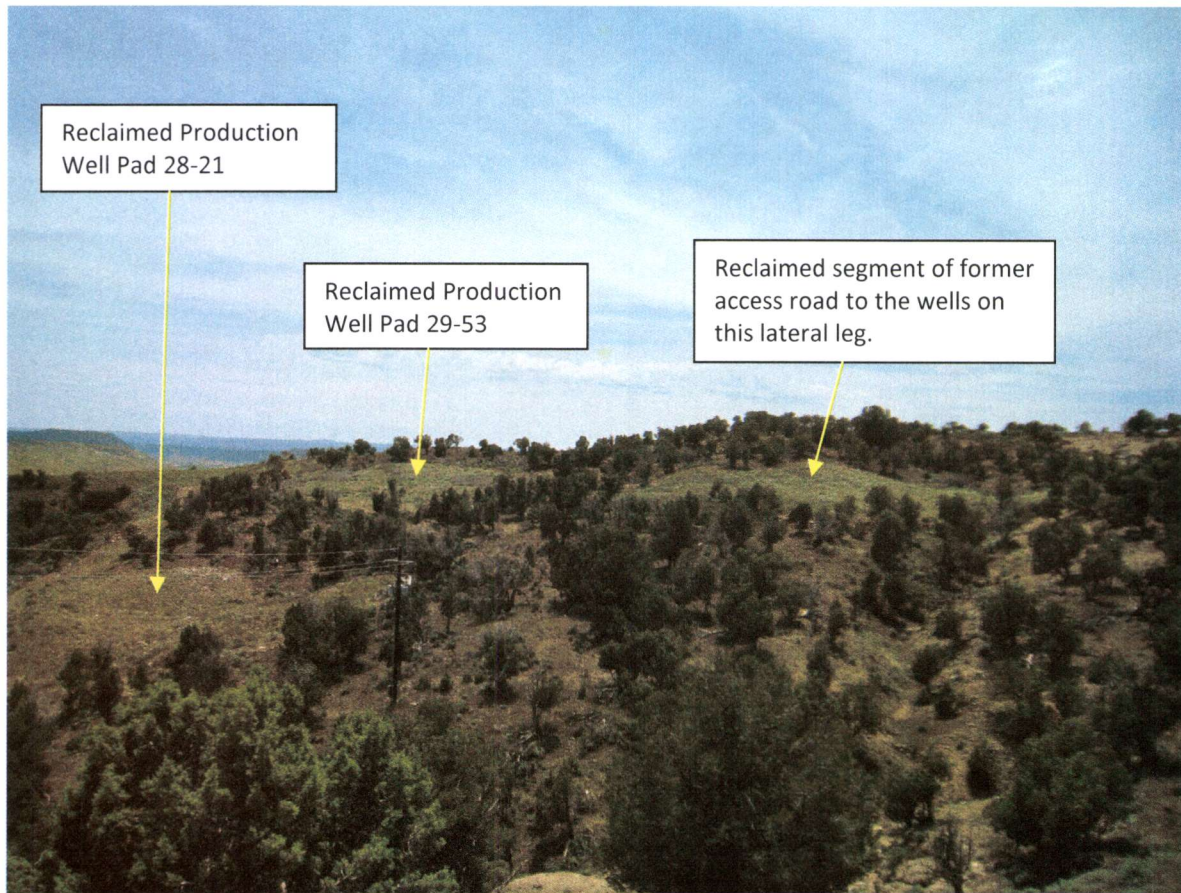
Photo 1 – Landscape view of three areas initially reclaimed in 2013 (photo taken in late June 2015). Good establishment of dense and diverse vegetation providing excellent cover after two full growing seasons with above average precipitation. All previously reclaimed areas are periodically inspected and photographed to monitor reclamation success.

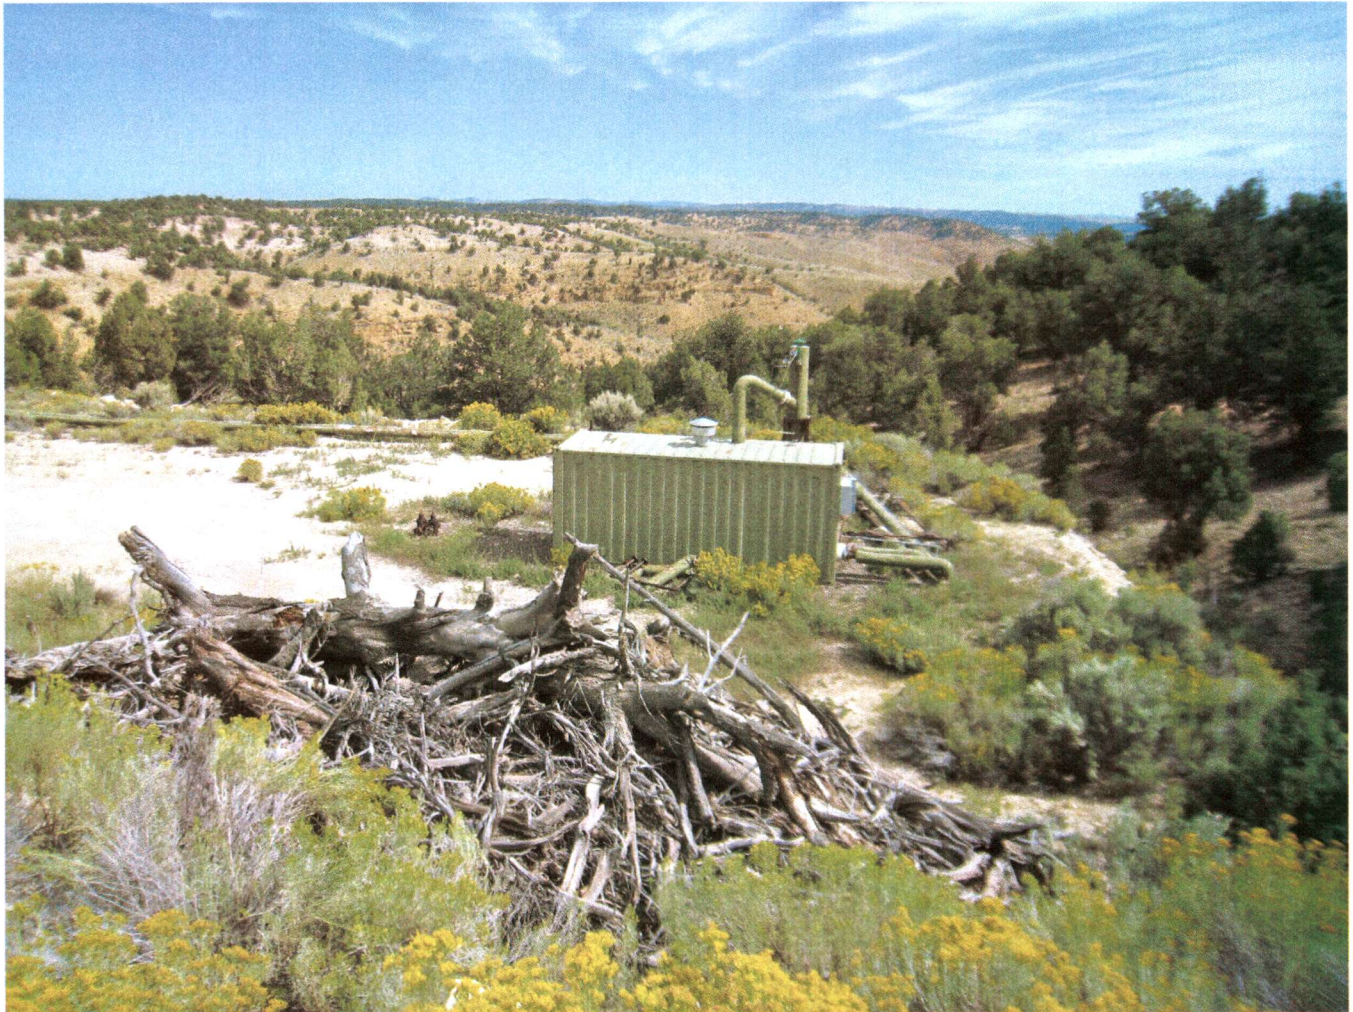
Photo 3 – Production well 29-26 location prior to plugging and abandonment. The short string on production well 29-26 failed to hold pressure and was plugged and abandoned using tremie- line cement placement through shallow coil tubing in September 2014. The long string was also plugged to close out the location. The well skid was removed from the pad, the piping was all cut and removed and the location was restored to the original contours. The top soil pile was distributed over the newly contoured pad and the pad was drill seeded. All of the cut trees you see that were originally harvested from the location and stockpiled when it was created in 2000 are now spread out over the pad to provide habitat and to restrict vehicle access.

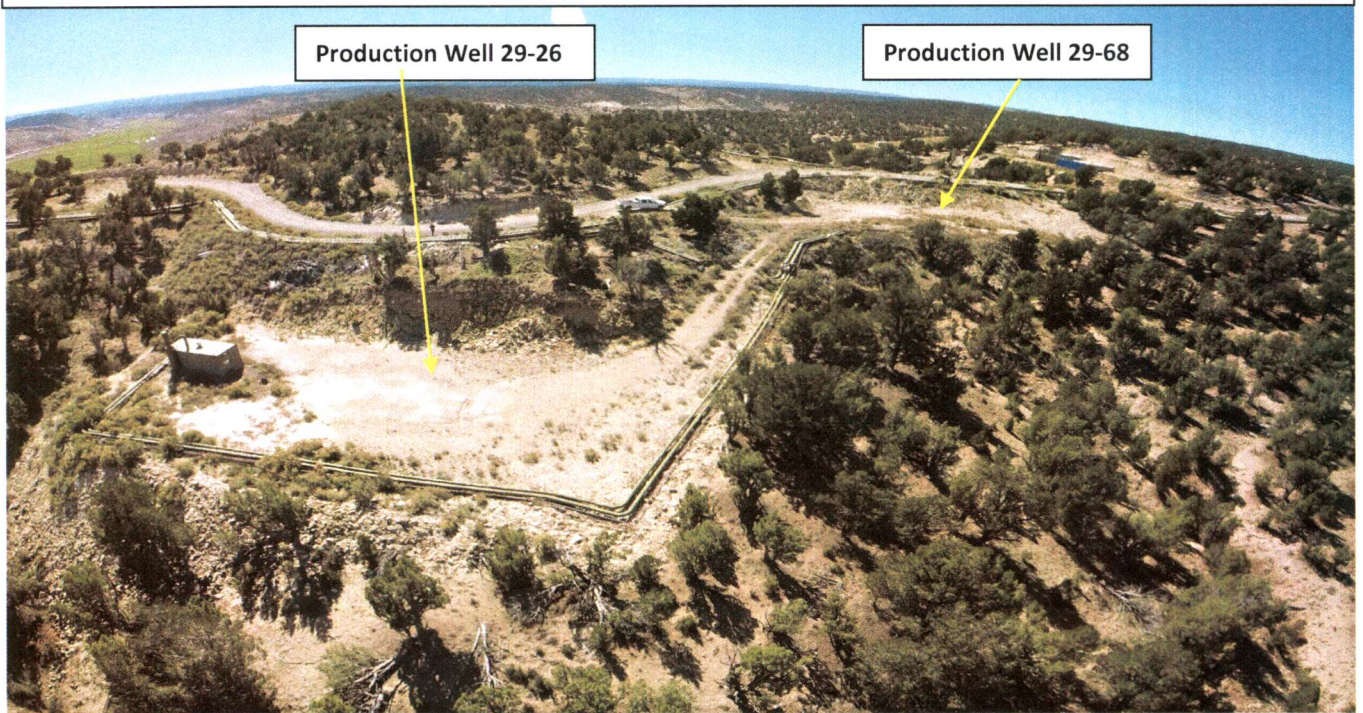
Photo 4 - Production well pad 29-26 and production well pad 29-68 before plugging and abandonment. Reclamation work completed in fall 2014 included demolition of the well skid and piping, reclamation re-contouring and drill seeding.

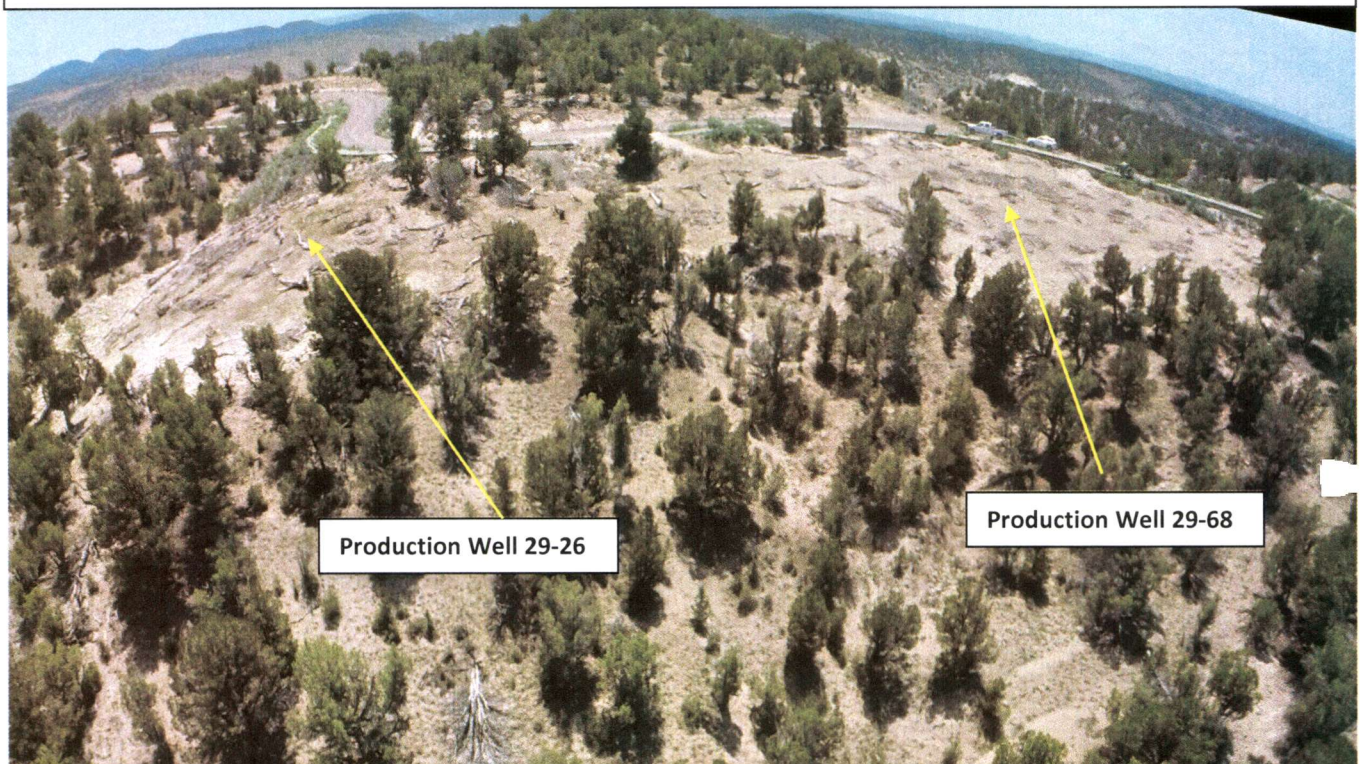
Photo 5 - Production well pad 29-26 and production well pad 29-68 after plugging and abandonment, demolition of well skid and piping, reclamation re-contouring and drill seeding. Photo taken June 2015.

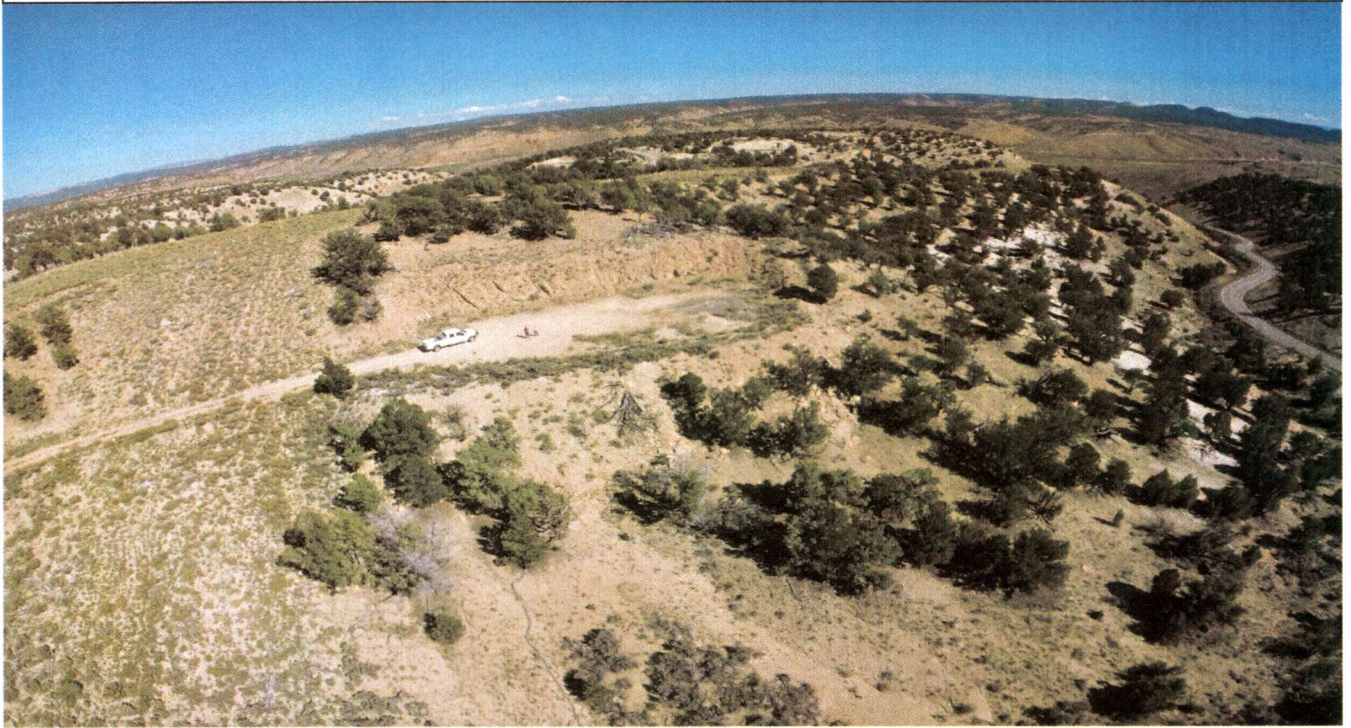
Photo 6 – Production well pad 20-35 was plugged and abandoned in September 2004. In the fall of 2014 the piping and well skid were removed and the well pad re-contoured and reclaimed. A reclaimed natural gas pipeline corridor can be seen on the left side of this photo taken in fall 2014.

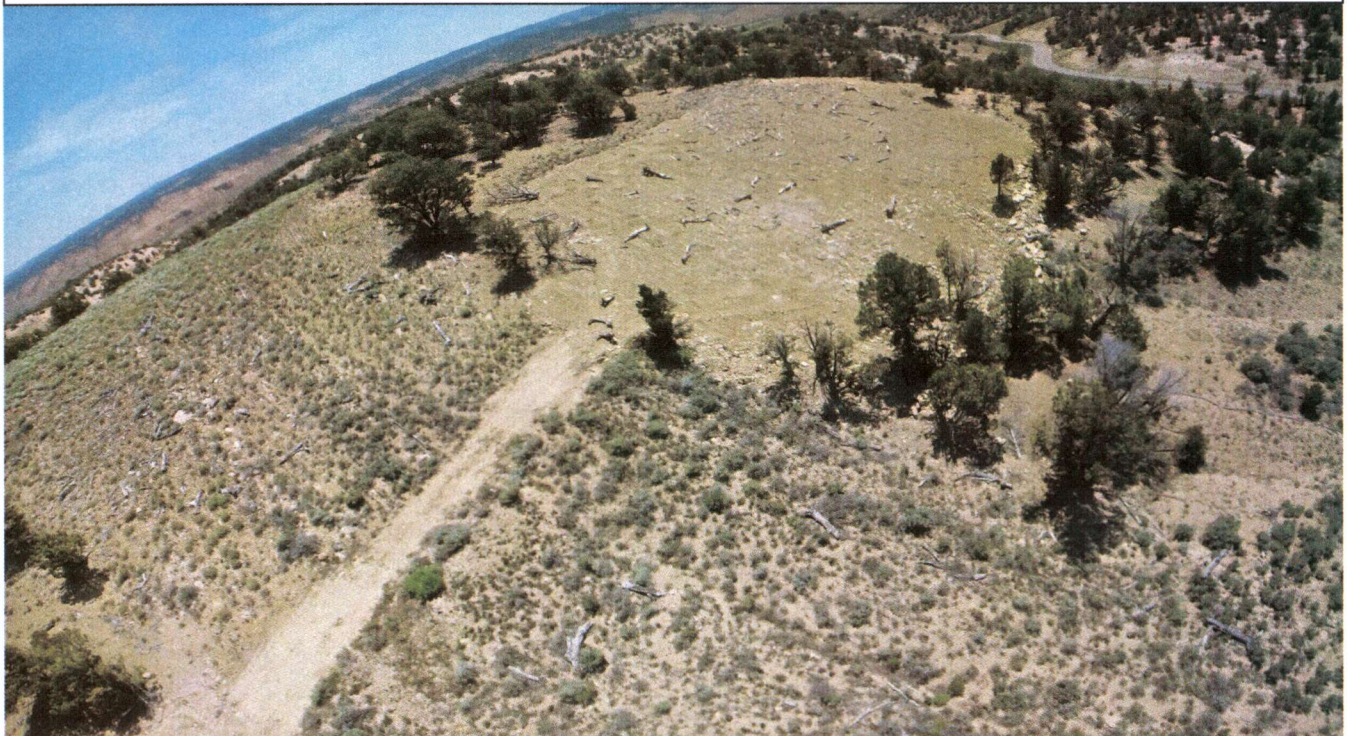
Photo 7 – Production well pad 20-35 after the pad was re-contoured, top soil distributed across the disturbance area and drill seeded. Trees removed during the construction of the pad which were stock piled then are now spread out across the reclamation area to provide habitat and to restrict access for motor vehicles. Photo taken June 2015.

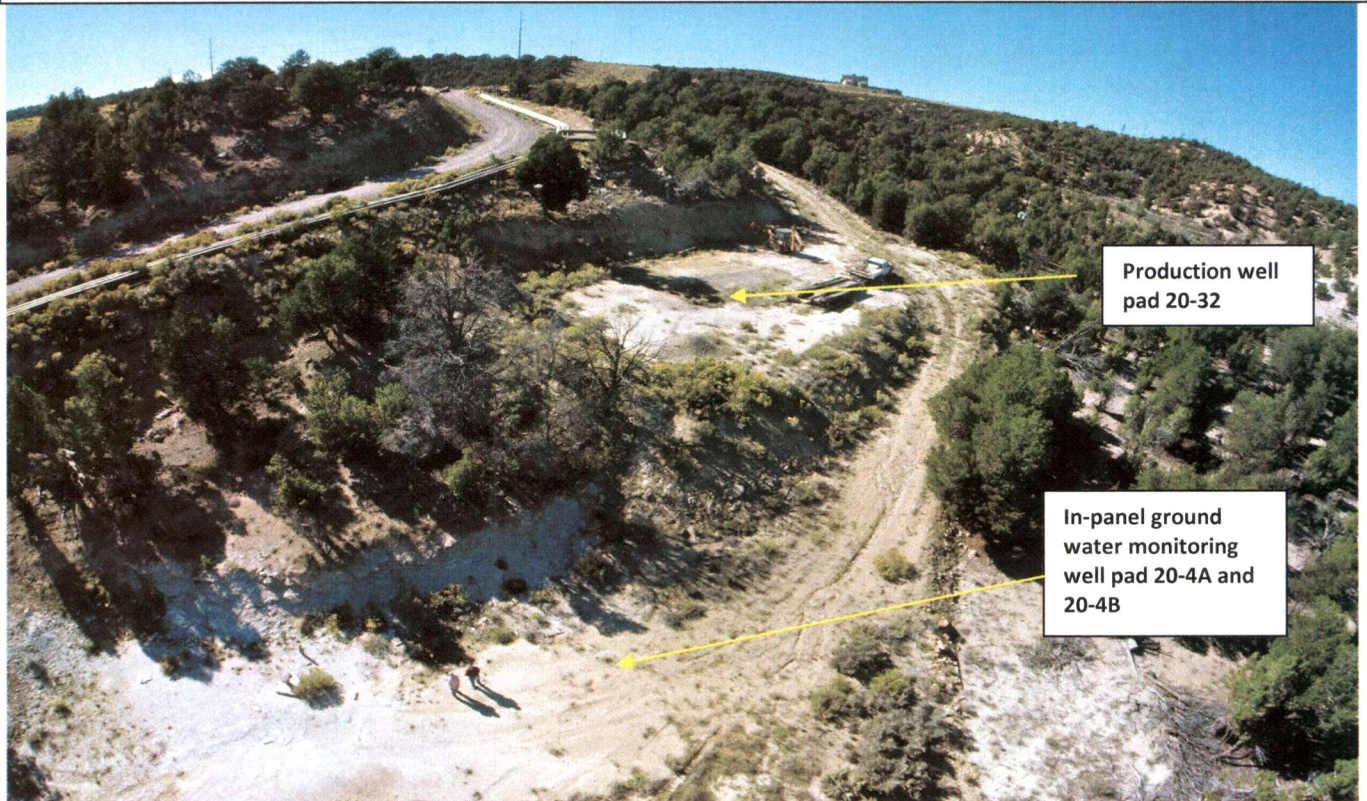
Photo 8 - Production well 20-32 and pad for ground water monitoring wells 20-4A and 20-4B. Photo taken fall 2014 as piping was being removed from the 20-32 pad. A truck and trailer loaded with pipe can be seen exiting the pad..

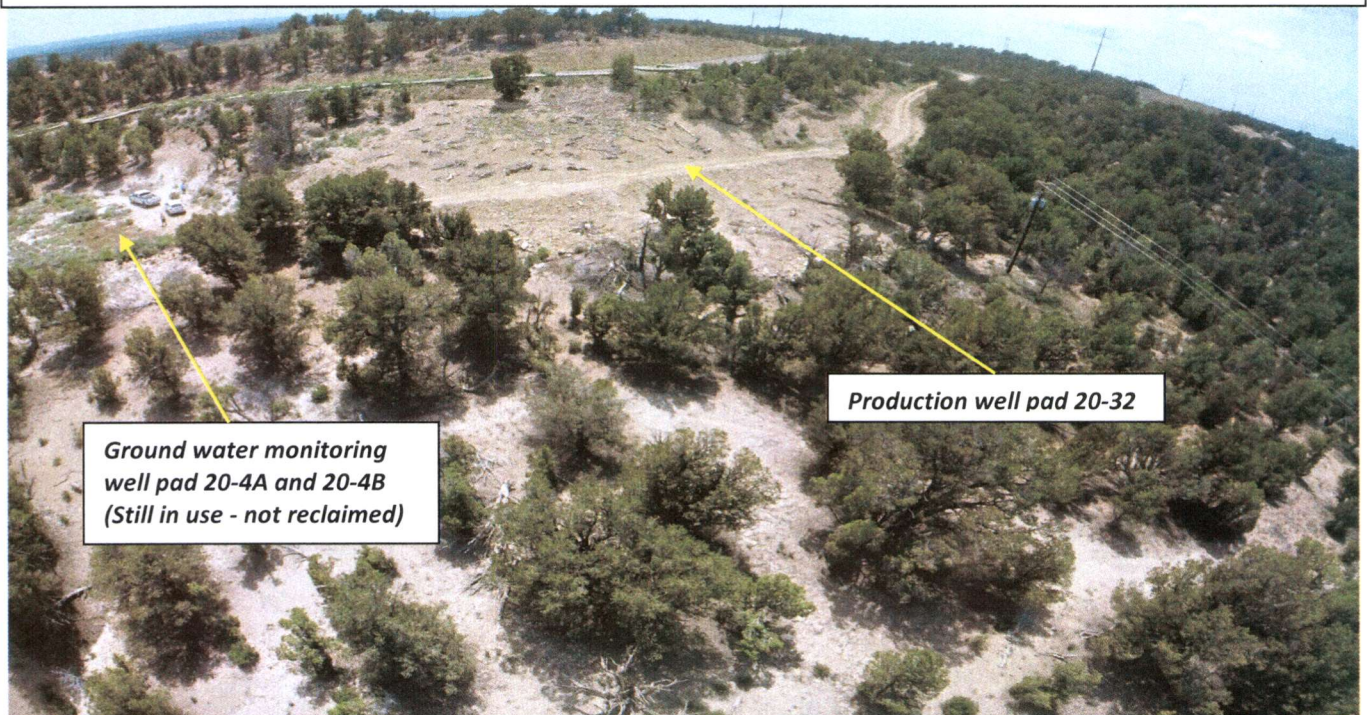
Photo 9 – Production well 20-32 after re-contouring and drill seeding. The reclamation area is temporarily bisected by the narrow road to allow access to the ground water monitoring well 20-4A and B. Photo taken June 2015.

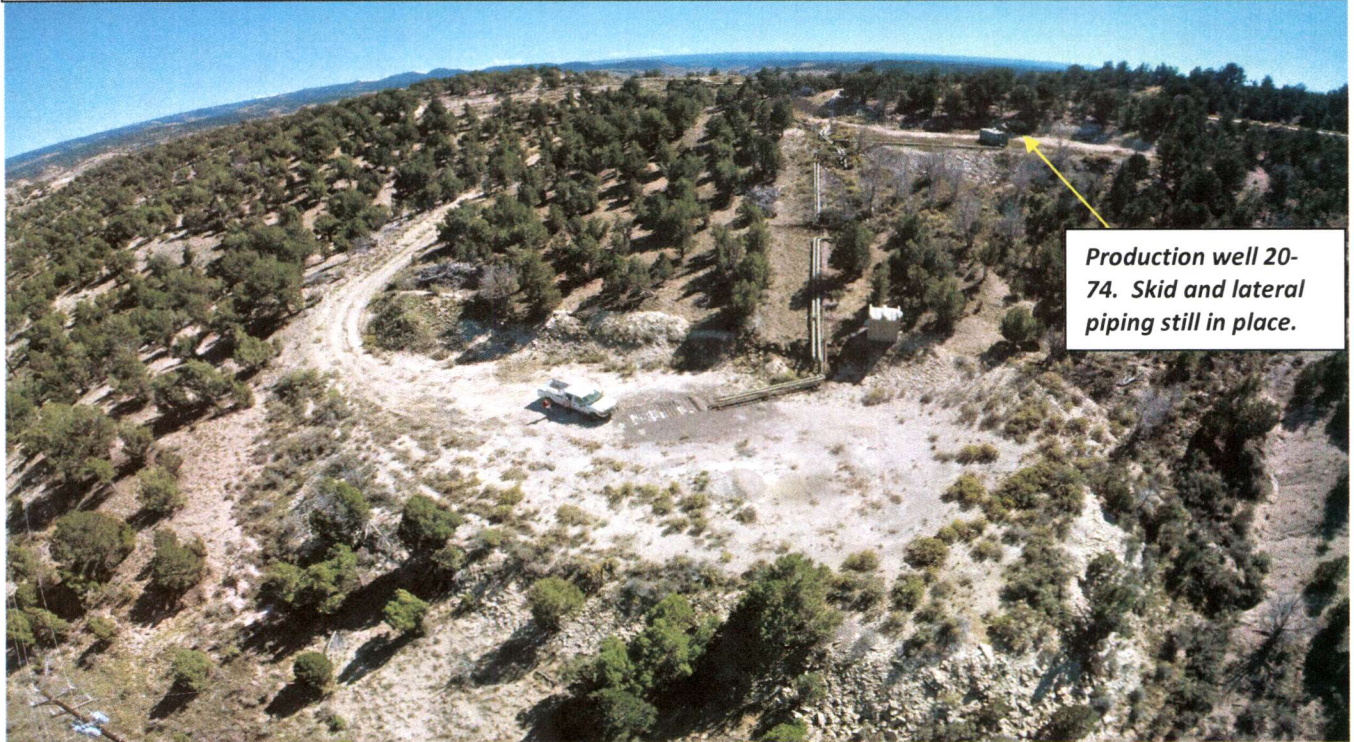
Photo 10 – A white truck is parked on production well pad 20-31. Lateral piping dropping down the slope from production well pad 20-74 and the skid are still in place on this location. Photo taken September 2014.

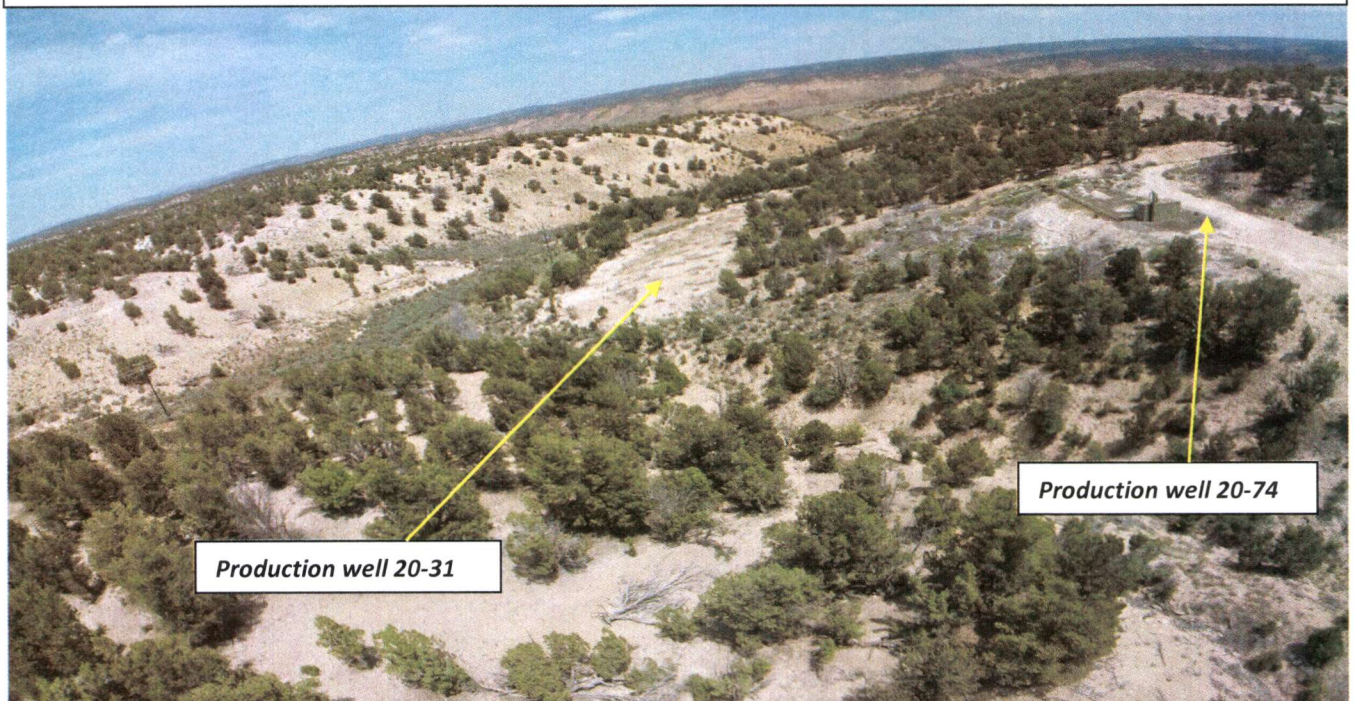
Photo 11 – Production well pad 20-31 after reclamation re-contouring and reseeding. In this view you can also see production well pad 20-74. The well skid is still in place with the lateral piping extending out to the skid. The piping to well 20-31 was removed prior to reclamation. Several dead trees in a small area just below the pad for 20-74 were cut down. Some of these trees will be scattered on the 20-74 pad after it is re-contoured and drill seeded.

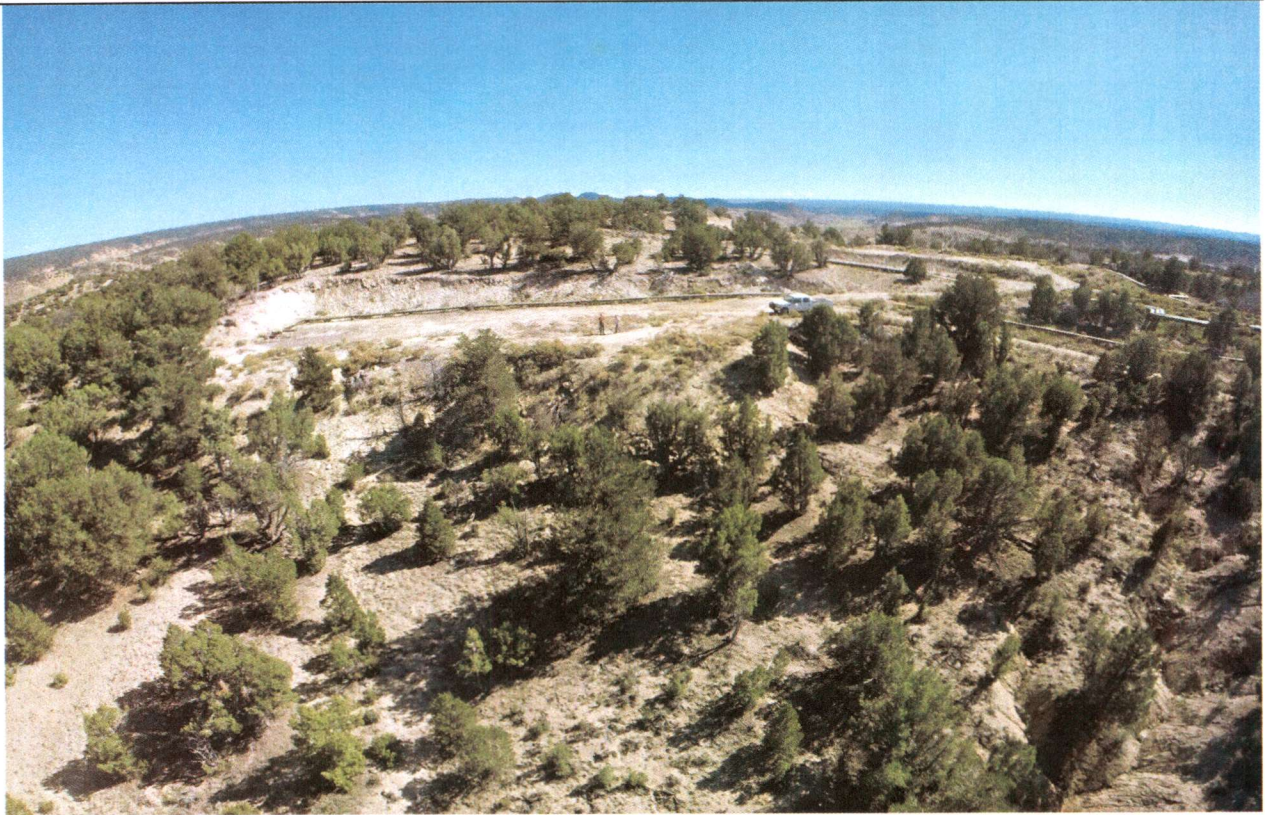
Photo 12 – Production well pad 20-30 in fall 2014. Lateral well piping is still in place lengthwise across the base of the cut slope of the pad but in this photo the well skid is removed from the location.

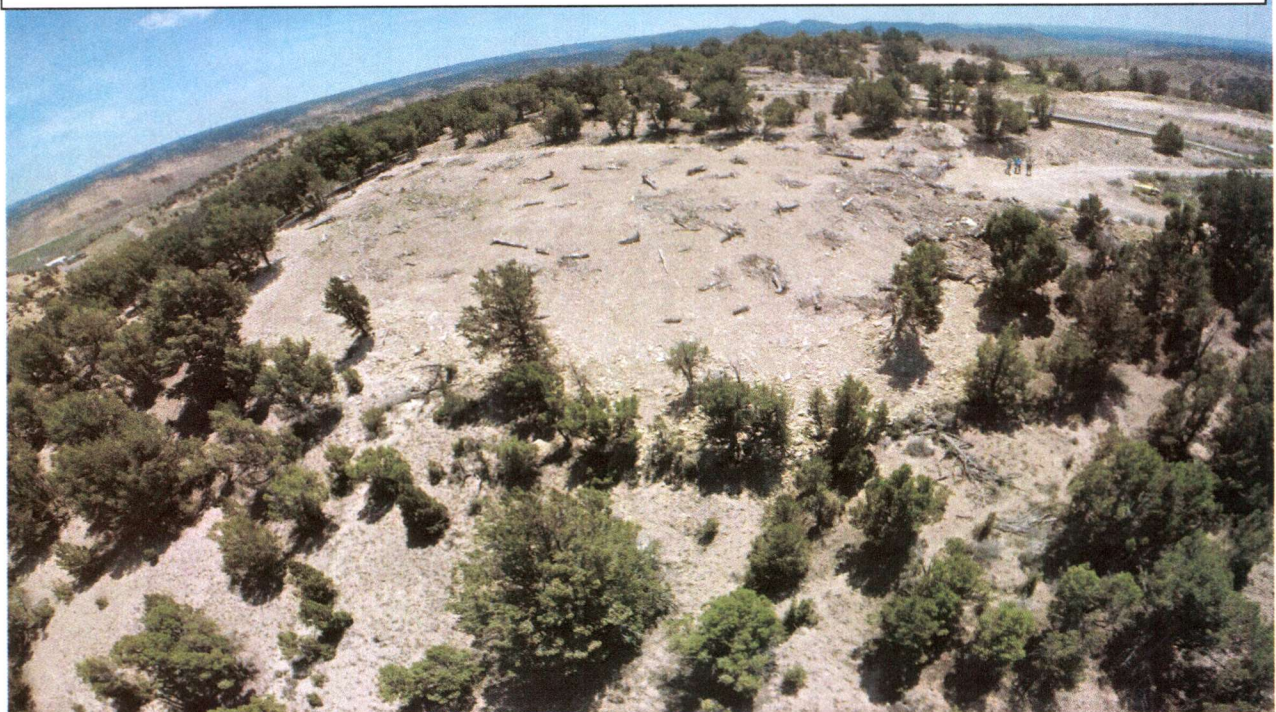
Photo 13 – Production well pad 20-30 after re-contouring and drill seeding. Photo taken June 2015. Reclamation work is completed in late fall to allow for overwinter seeding which enhances germination.

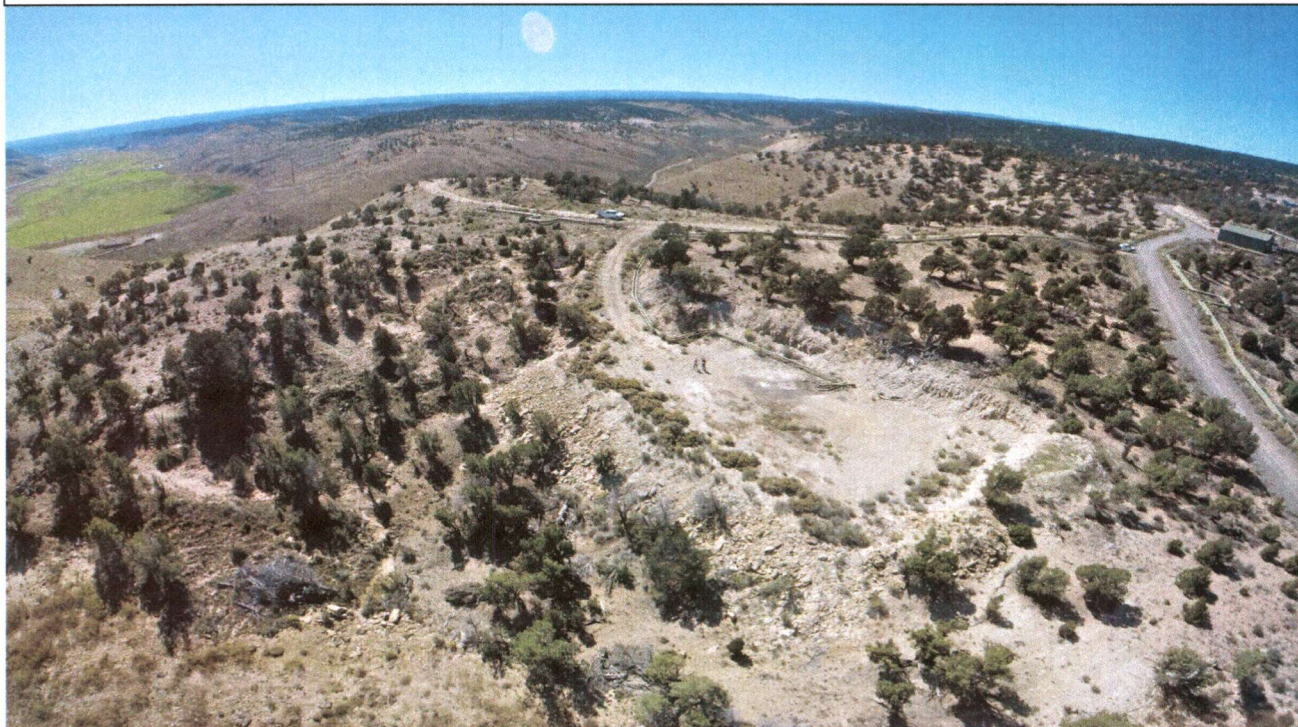
Photo 14 – Production well pad 29-23 in fall 2014. Lateral piping is still in place on the pad but the well skid is absent. The road where the white truck is parked provides access to production well pad 29-27 on the far side of the ridge out of view in this photograph.

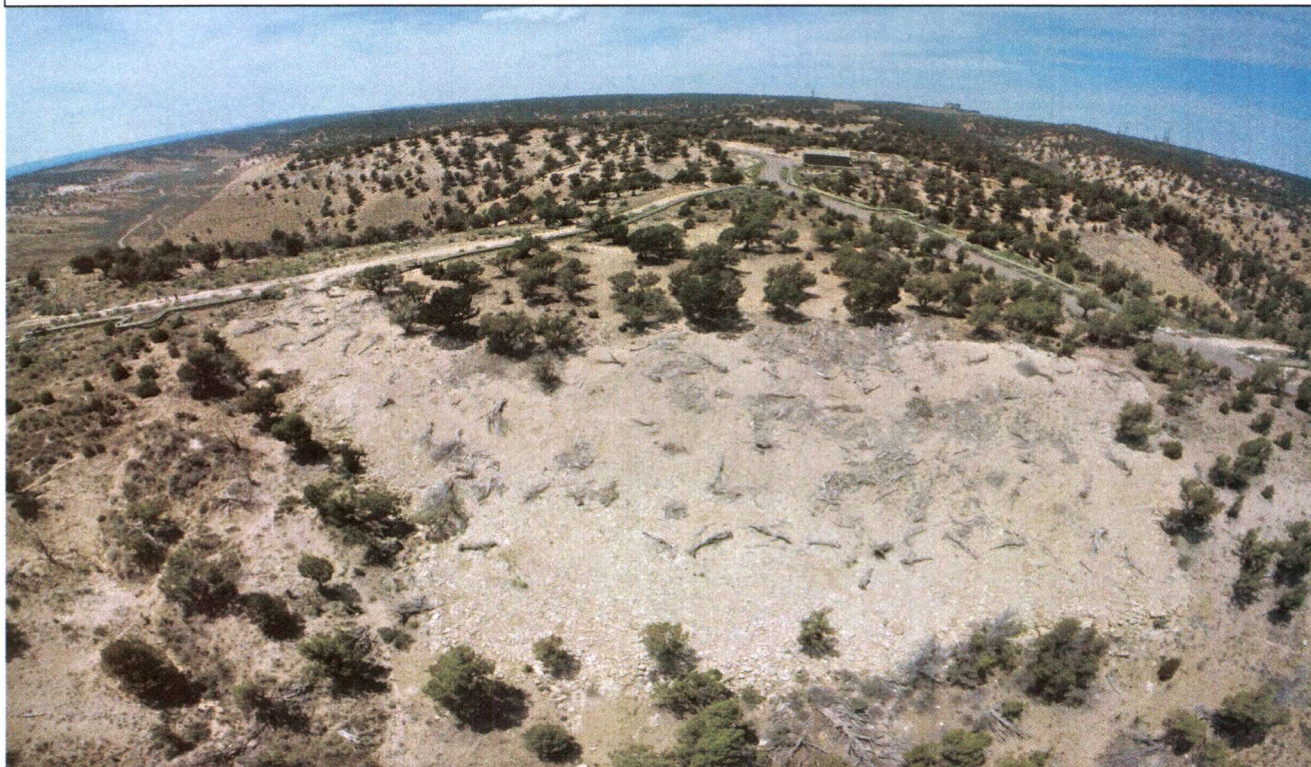
Photo 15- Production well pad 29-23 after reclamation is completed and trees are scattered. Photo from June 2015.

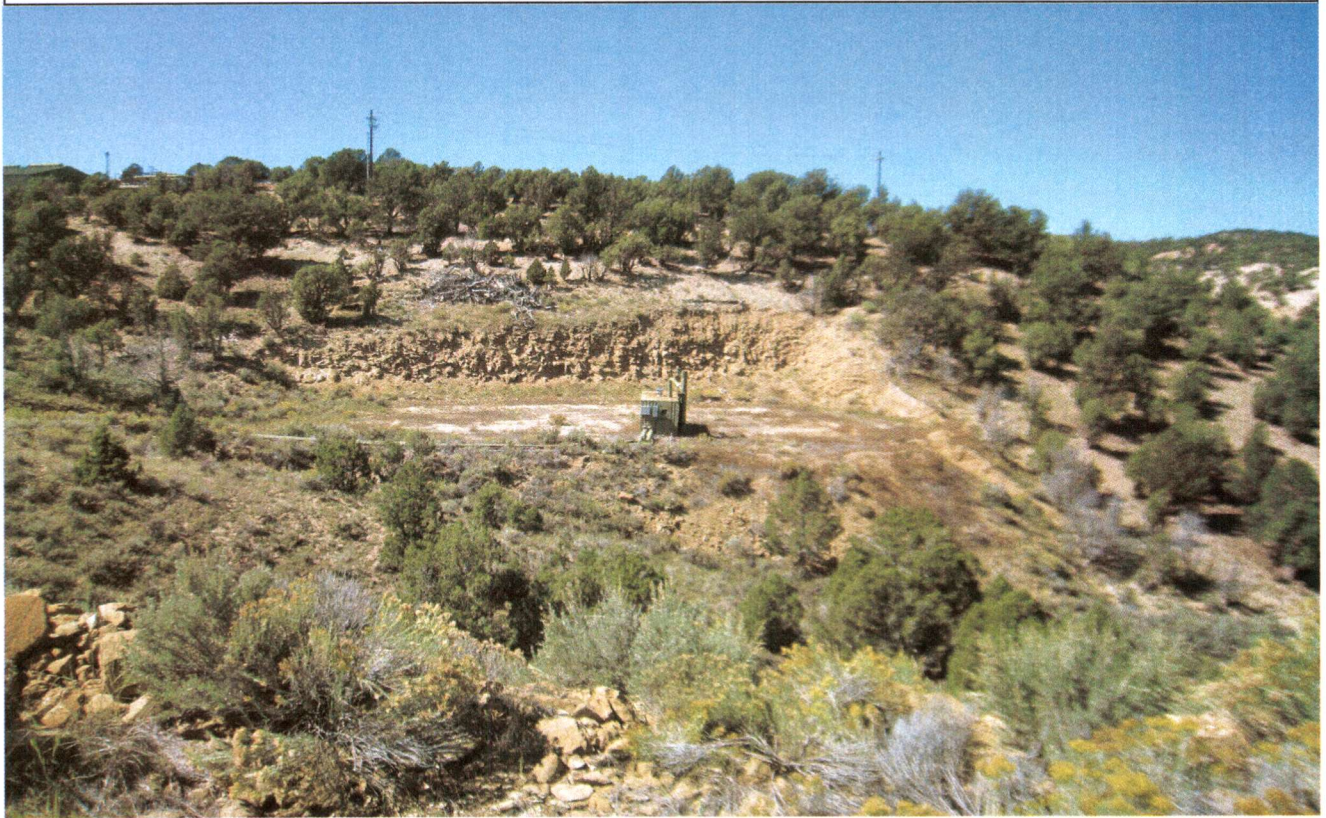
Photo 16- Production well pad 29-24 in fall 2014. Well skid and piping are still in place. This location has an extensive cut slope and the lateral access road into it intersects a complex two leg drainage into Yankee Gulch.

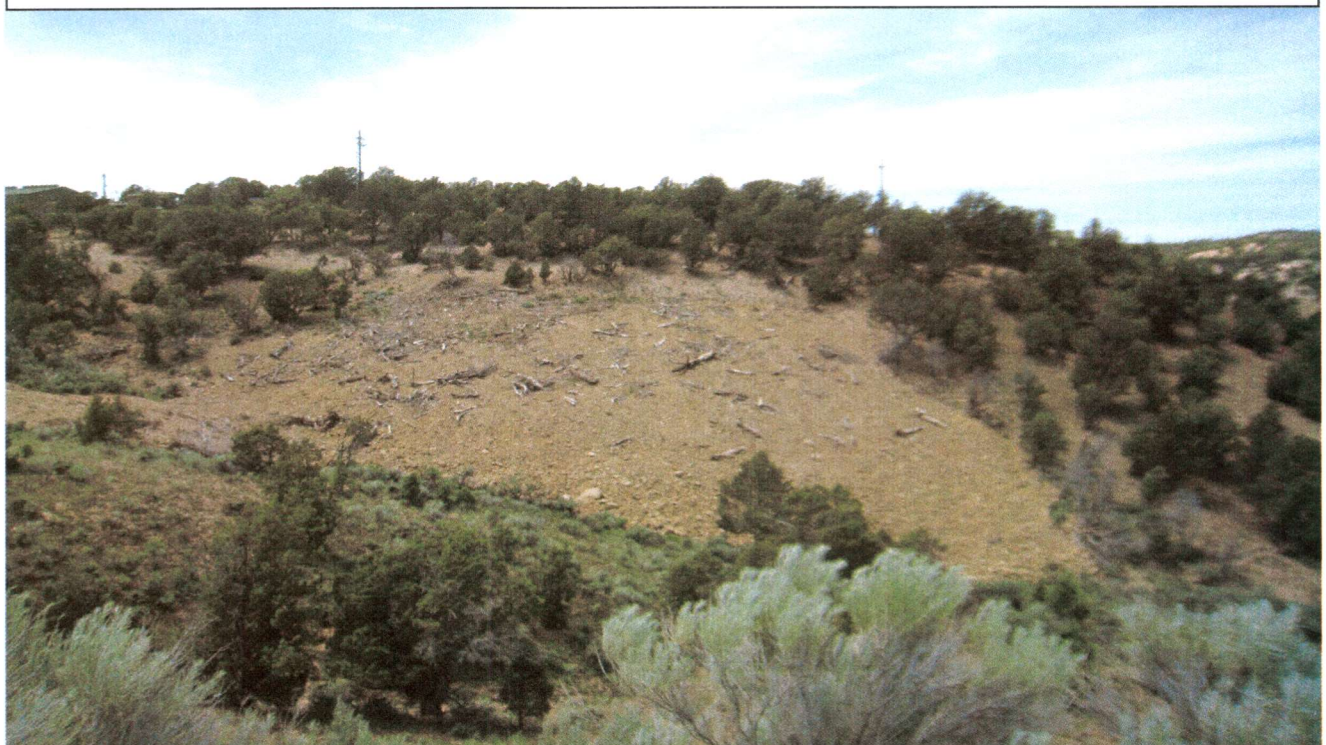
Photo 17 – Production well pad 29-24 after re-contouring and drill seeding is complete. Photo taken June 2015.

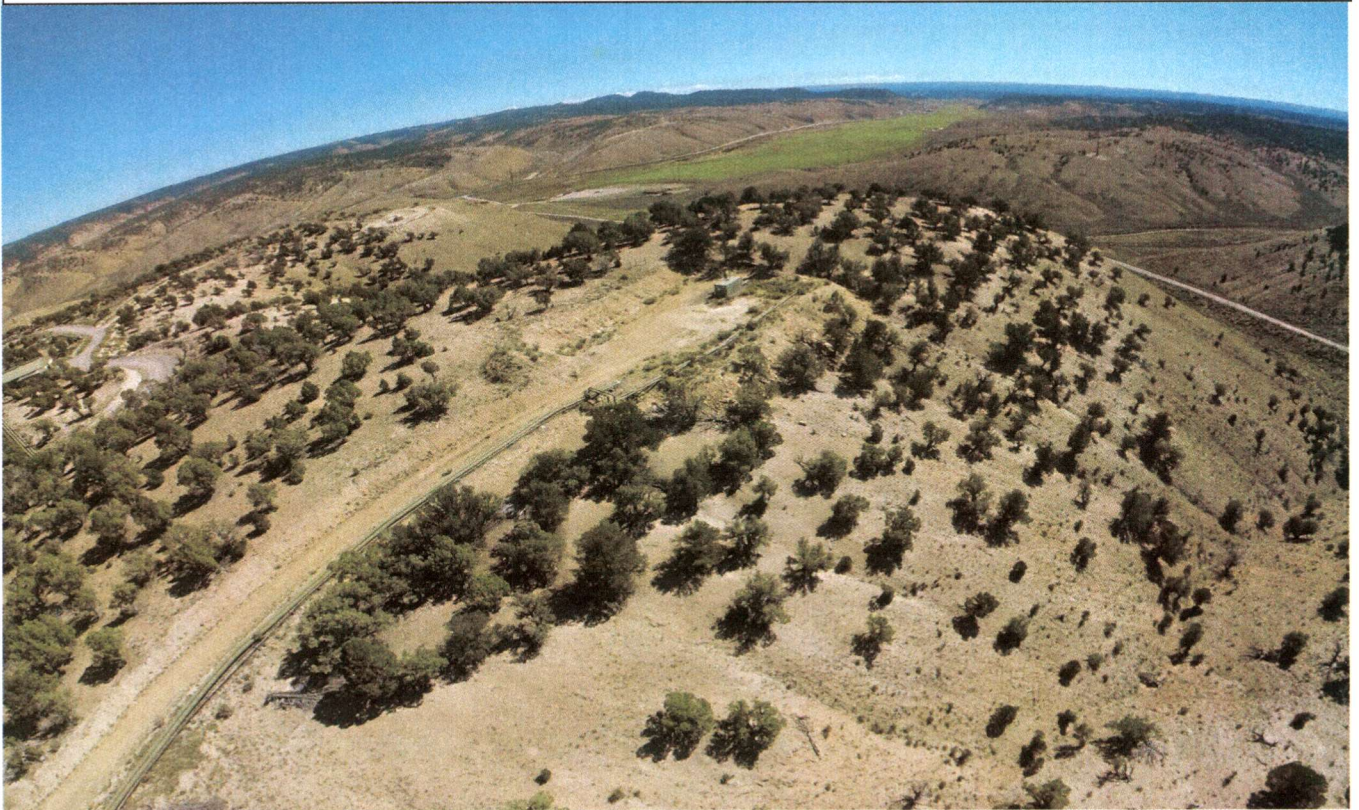
Photo 18 – Production well pad 29-28 in fall 2014 before the well skid and lateral piping were removed.

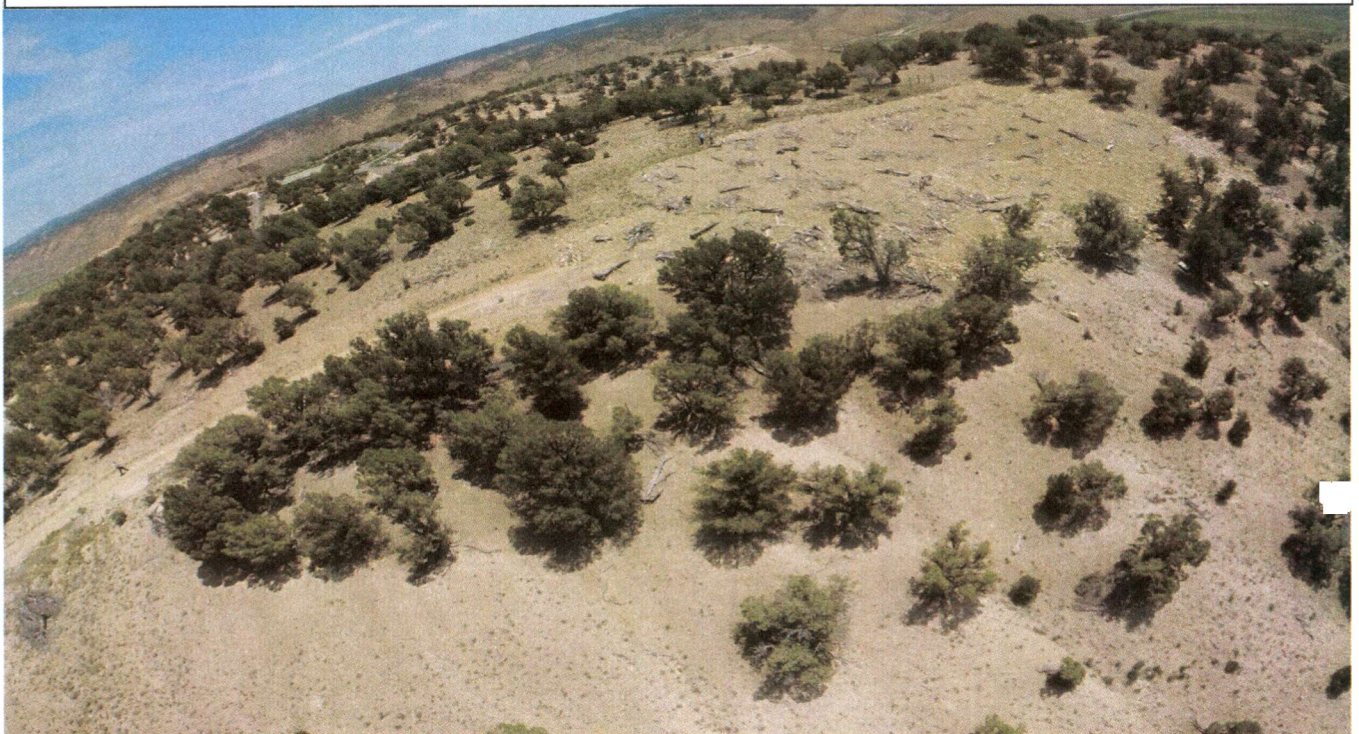
Photo 19 – Production well pad 29-28 after re-contouring and drill seeding were complete. The remainder of the lateral access road to this location is scheduled for reclamation in the fall of 2015. Photo taken June 2015.
