YANKEE GULCH SODIUM MINERALS PROJECT

**July 13, 2014 through July 12, 2015
ANNUAL RECLAMATION AND MINING
REPORT**

**Hard Rock Mining Operation
Permit No. M-99-002
U.S. Sodium Lease
Nos. C-0118328 and C-0118329**

**American Soda L. L. P., a wholly owned
subsidiary of Solvay Chemicals
PARACHUTE, COLORADO
July 9, 2015**

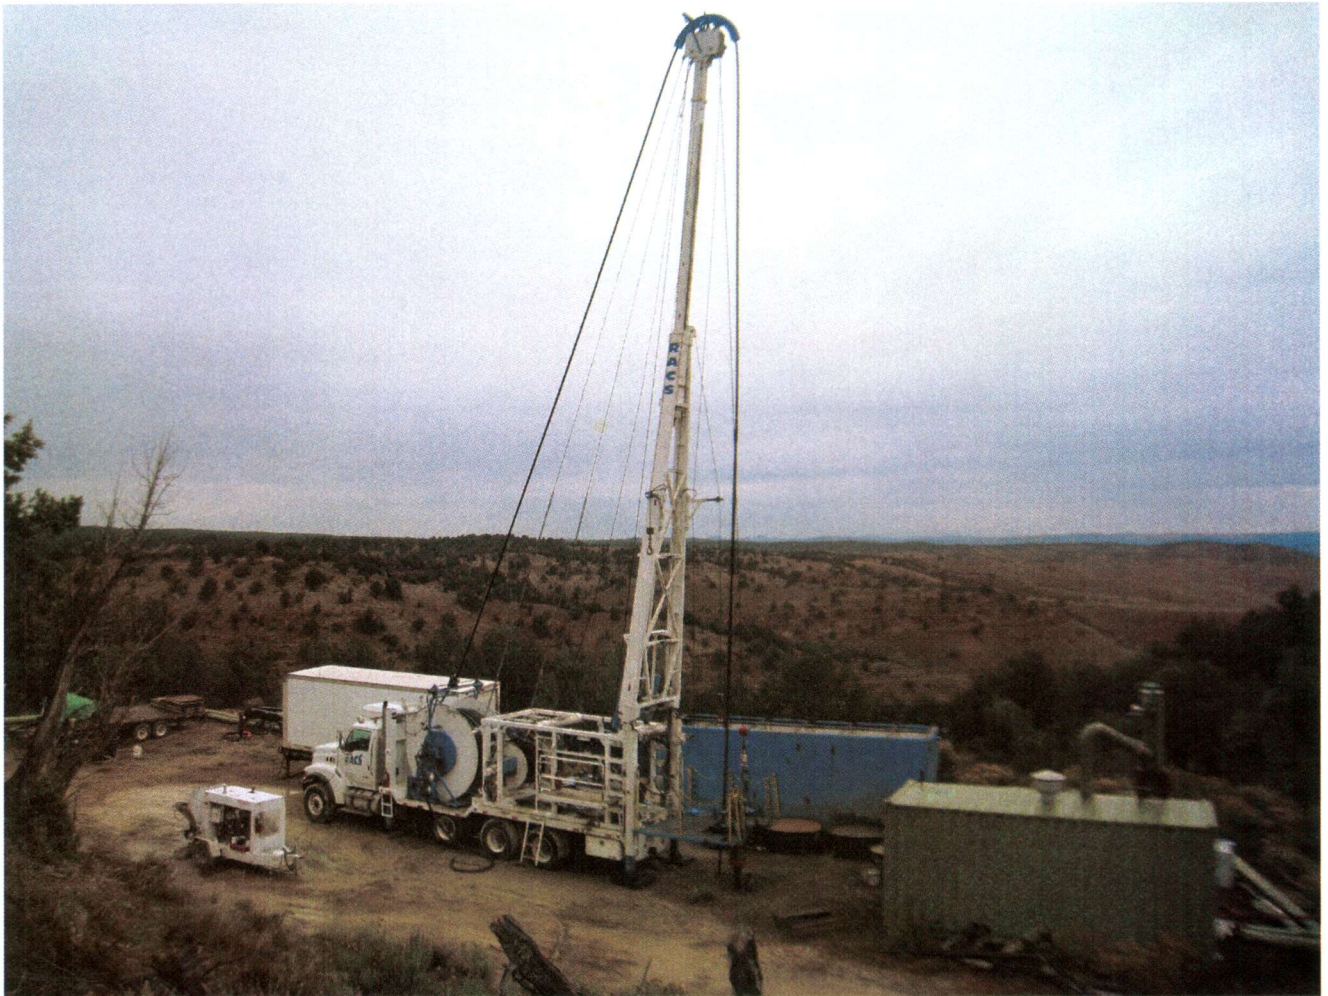
Photo 20 – A drill rig using shallow coil for tremie-line placement of cement from cast iron bridge plug set at 1840 feet to the top of the well on production well 29-78 in October 2014. Lateral piping still extends to this location which is planned for re-contouring and drill seeding in 2015.

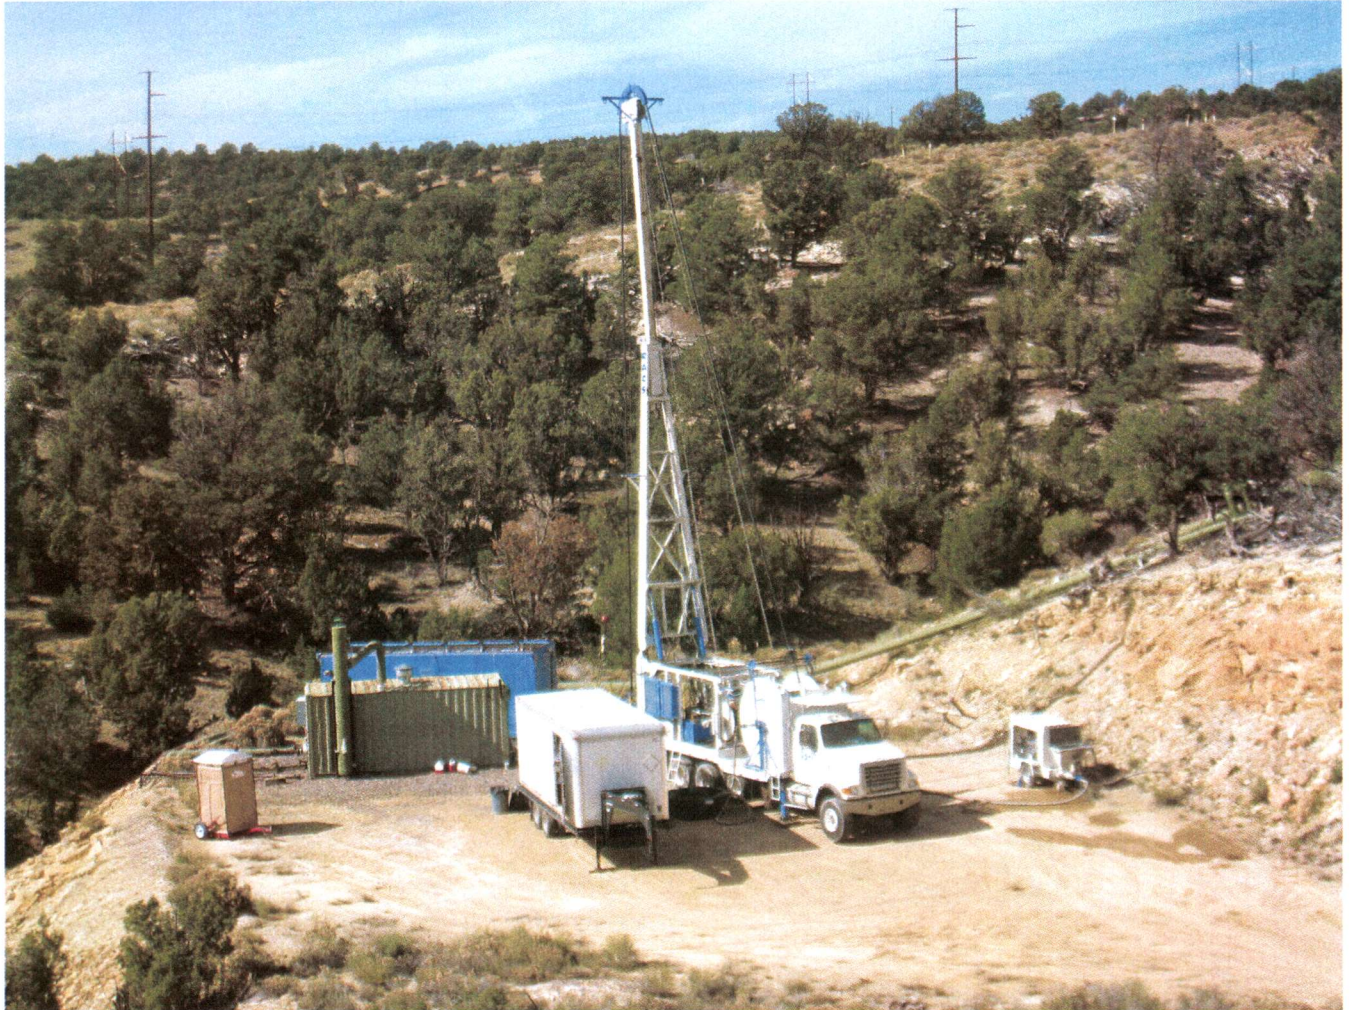
Photo 21 – Rigging up to plug and abandon production well 29-34 in October 2014. The smaller drill rig and shallow coil are ideal for the work needed on these small footprint well pads. The lateral pipe extending to this well comes in from the top across the undisturbed ground rather than parallel to the access road for this well. This was a shorter distance to lay the pipe. Care will be observed in removing this run of pipe from the well field so that the established vegetation is not disturbed.

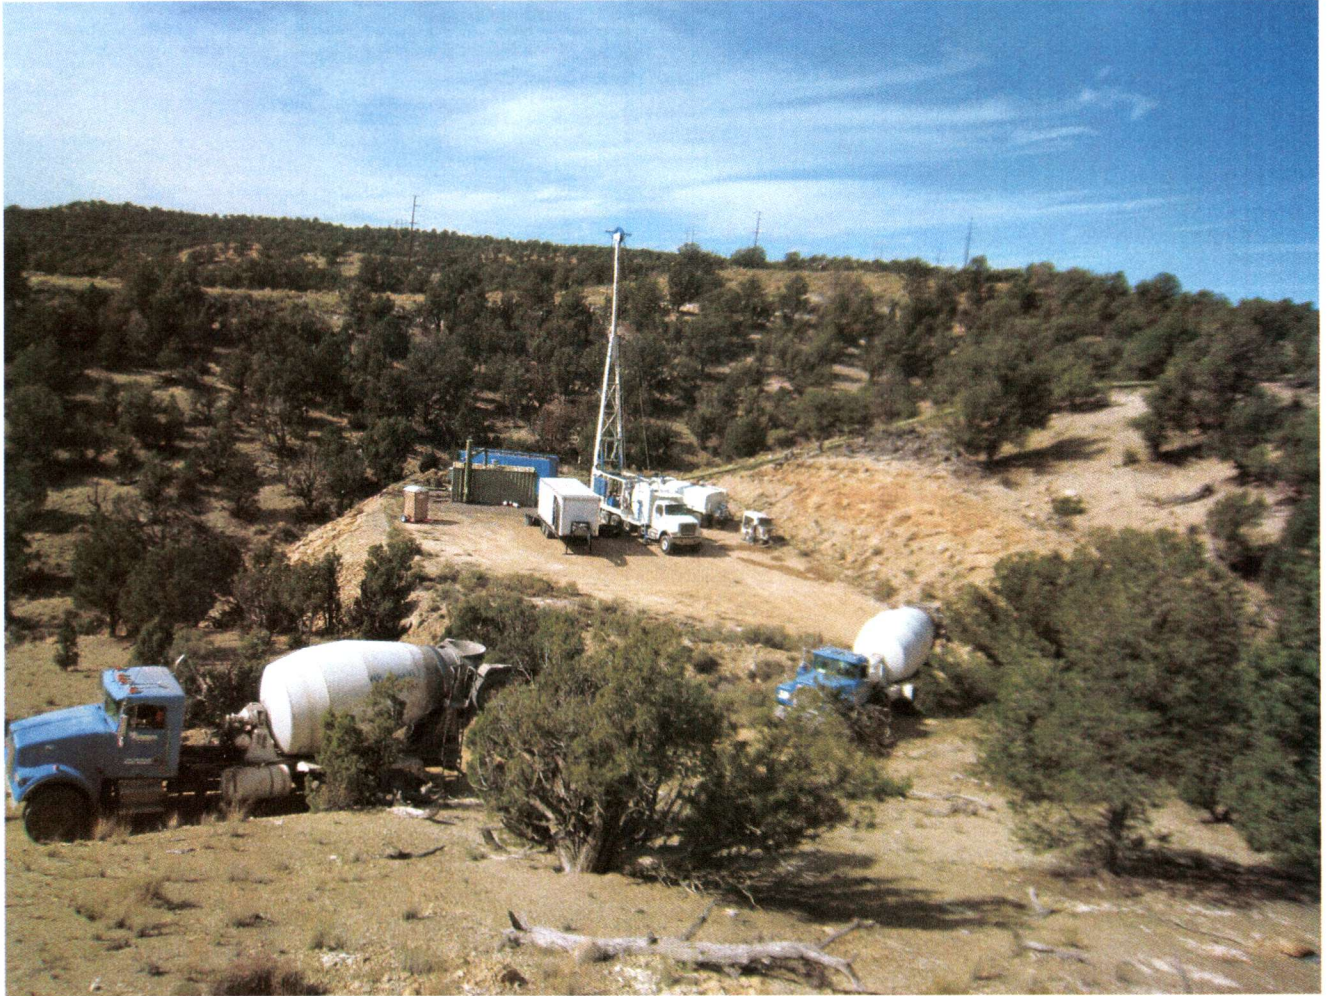
Photo 22 – Loaded cement trucks backing onto location at production well pad 29-34. A small portable cement batch plant set up by the contractor on location at production well pad 20-33, easy access from the main well field road, enhanced the efficiency of plugging the wells. Photo taken October 2014.

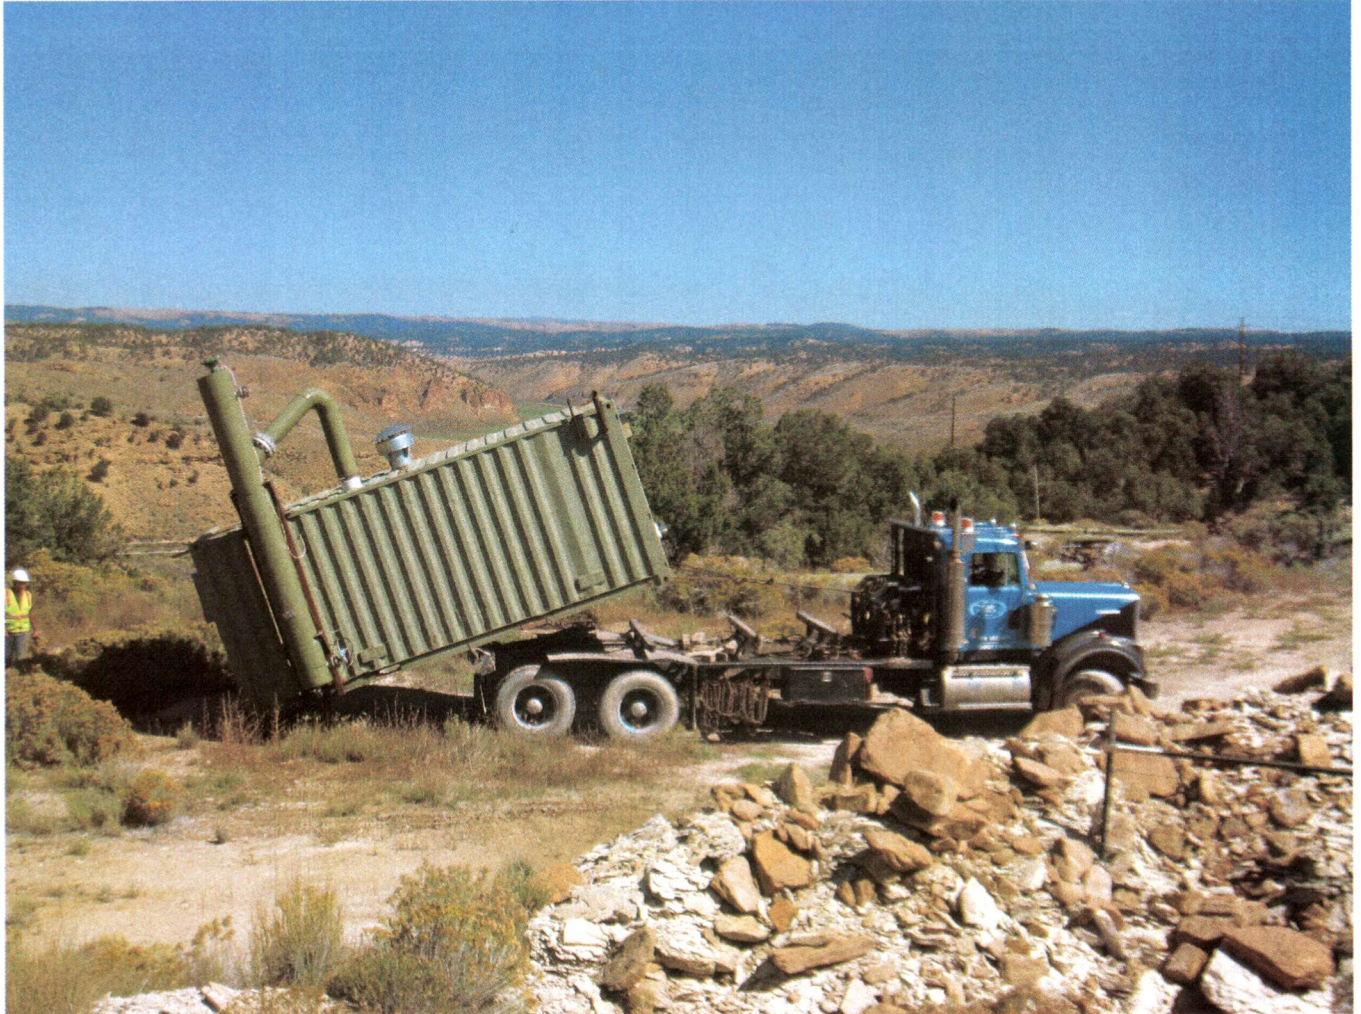
Photo 23 – After a production well is plugged and abandoned the well head is cut down and capped and a marker is welded in place to identify the well. Next the well skid and pipe are removed so the site is ready for re-contouring. In the photo above a well skid is being loaded on a truck for short transport to the test mine pad. The well skids are being temporarily staged on this location until they are all ready to be hauled out. Five well skids still remain on location connected to piping in the well field. Before transport on public roads each well skid must have the gas separator (14 foot tall pressure vessel mounted on the side) removed from the side and piping removed from the top to meet height and width road restrictions. Inside of some of the containers large valves not connected laying on the floor must be strapped down with chains to keep them from going through the end of the container as they are tilted onto a wench truck for transport. All of the pipe openings in the well skids are also covered to prevent loose materials from blowing or vibrating out during transport. This well skid is being removed from production well pad 29-68 in the fall of 2014.

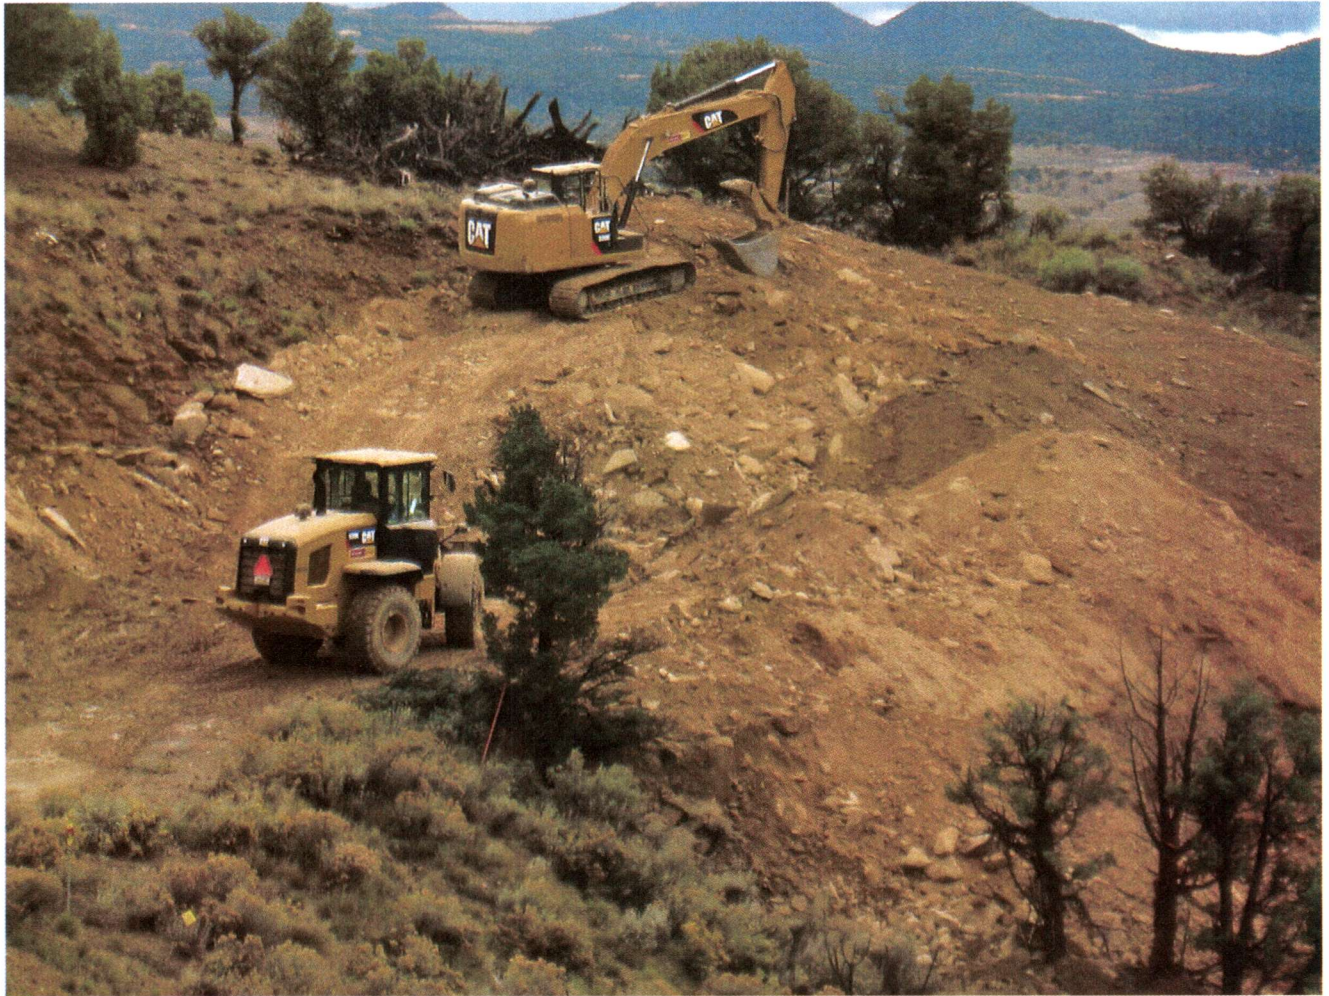
Photo 24 – Construction equipment moving dirt to re-contour production well pad 20-35 in September 2014. Smaller sized equipment that can move in a tighter radius is used for this work so that the maximum amount of mature pinion juniper trees along the margins of the pads can be preserved as cast over slopes are restored. The loader easily works around the pinion juniper tree on the edge of this pad so it can remain undisturbed.

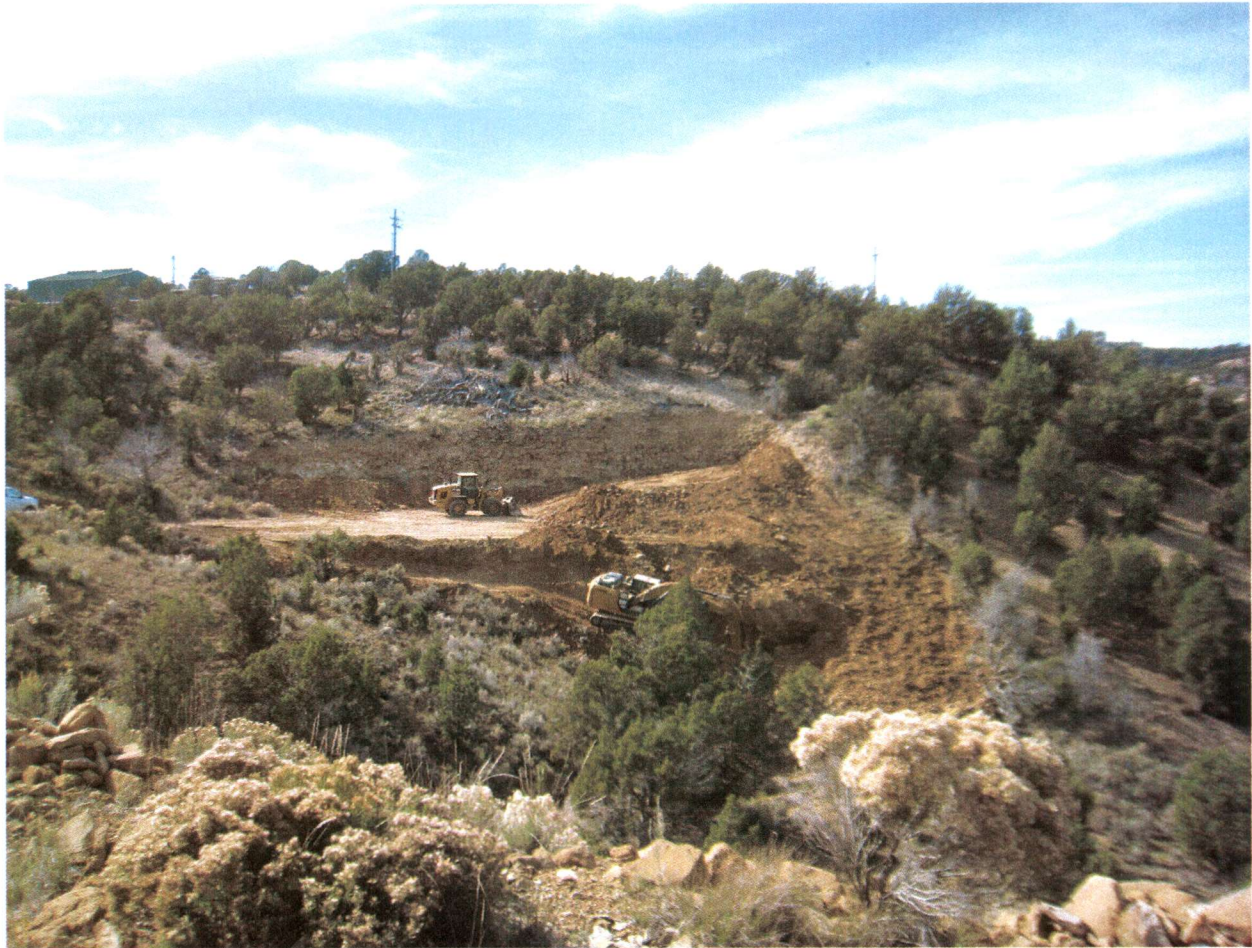
Photo 25 – Re-contouring and drill seeding of production well pad 29-24 has been the most time consuming location to reclaim so far. The cut slope on this location is substantial and the cast over slope and lateral road incorporated a more complex storm drainage system that had to be self- sustaining and stable once the culverts were removed. The reclaimed slope was drill seeded by pulling the seeder across the slope with a skid steer. Some areas of this location were hand seeded.

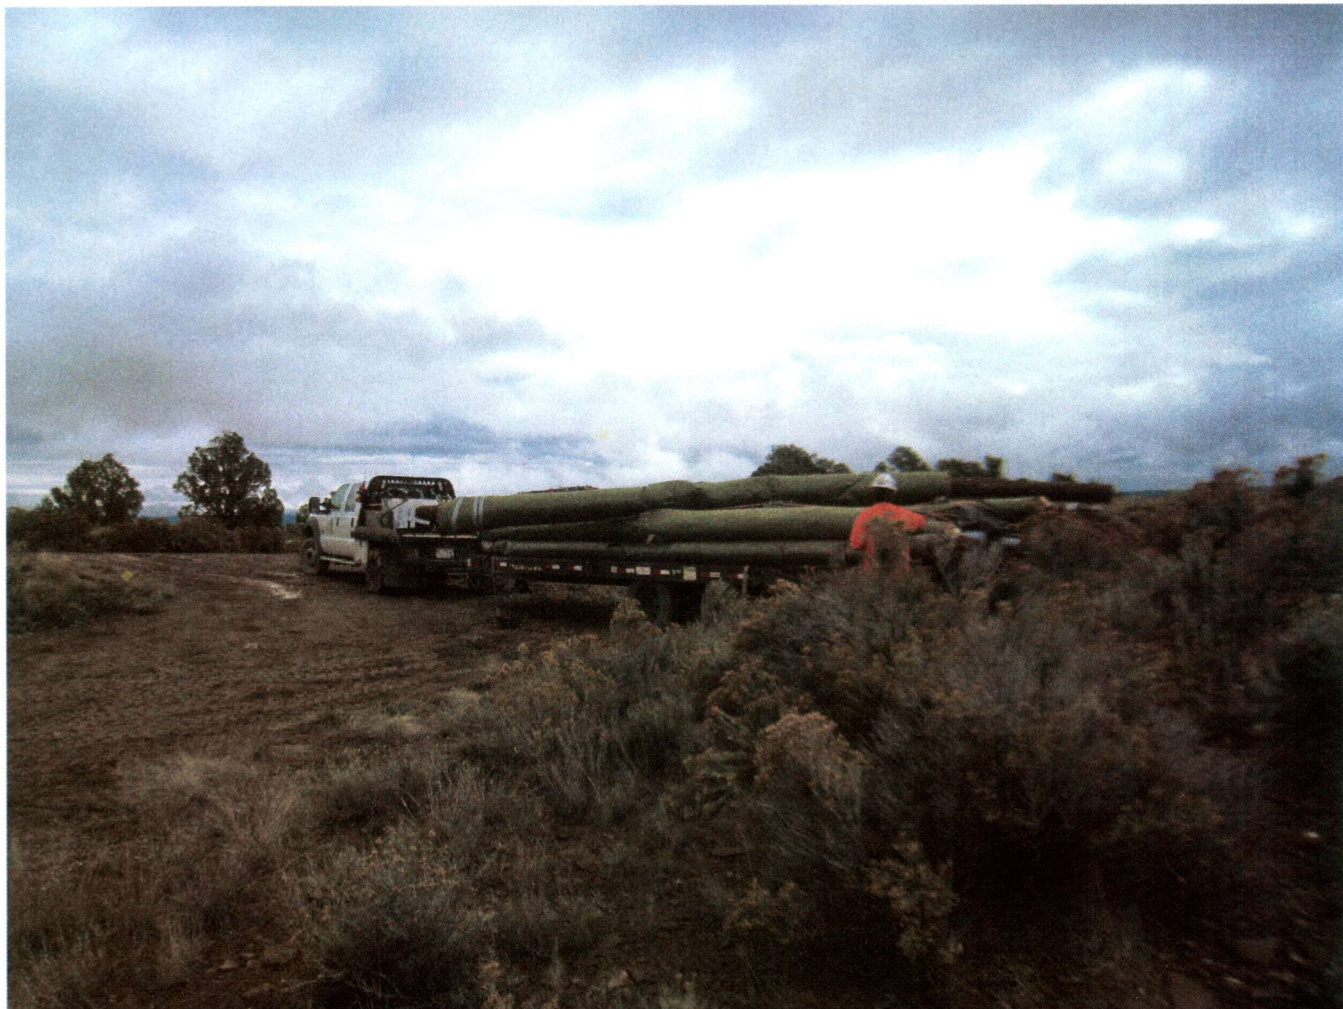
Photo 26 – An estimated 44,000 feet of carbon steel pipe twists and runs through the well field extending down the lateral lines and along the main well field road. Nearly all runs of pipe are in pairs and in some sections there are three runs of pipe side-by-side. Along each run of pipe is a series of 4 to 12 cables which also have to be removed. Both the pipe and the cable bundles are cut into 27 foot sections and loaded for transport to the Parachute site. Before the loaded pipe trailer leaves the well field the ends of each section of pipe are capped to prevent debris from blowing out as the pipe is transported. Insulation that is removed from one foot sections of the pipe where it is cut is gathered up and put into a large covered dumpster at the test mine pad. A fire watch and water truck is on location during all work activity at the Picenace site. Once the pipe is transported to the Parachute site the remaining pipe insulation is removed on an asphalt pad that is easily cleaned.

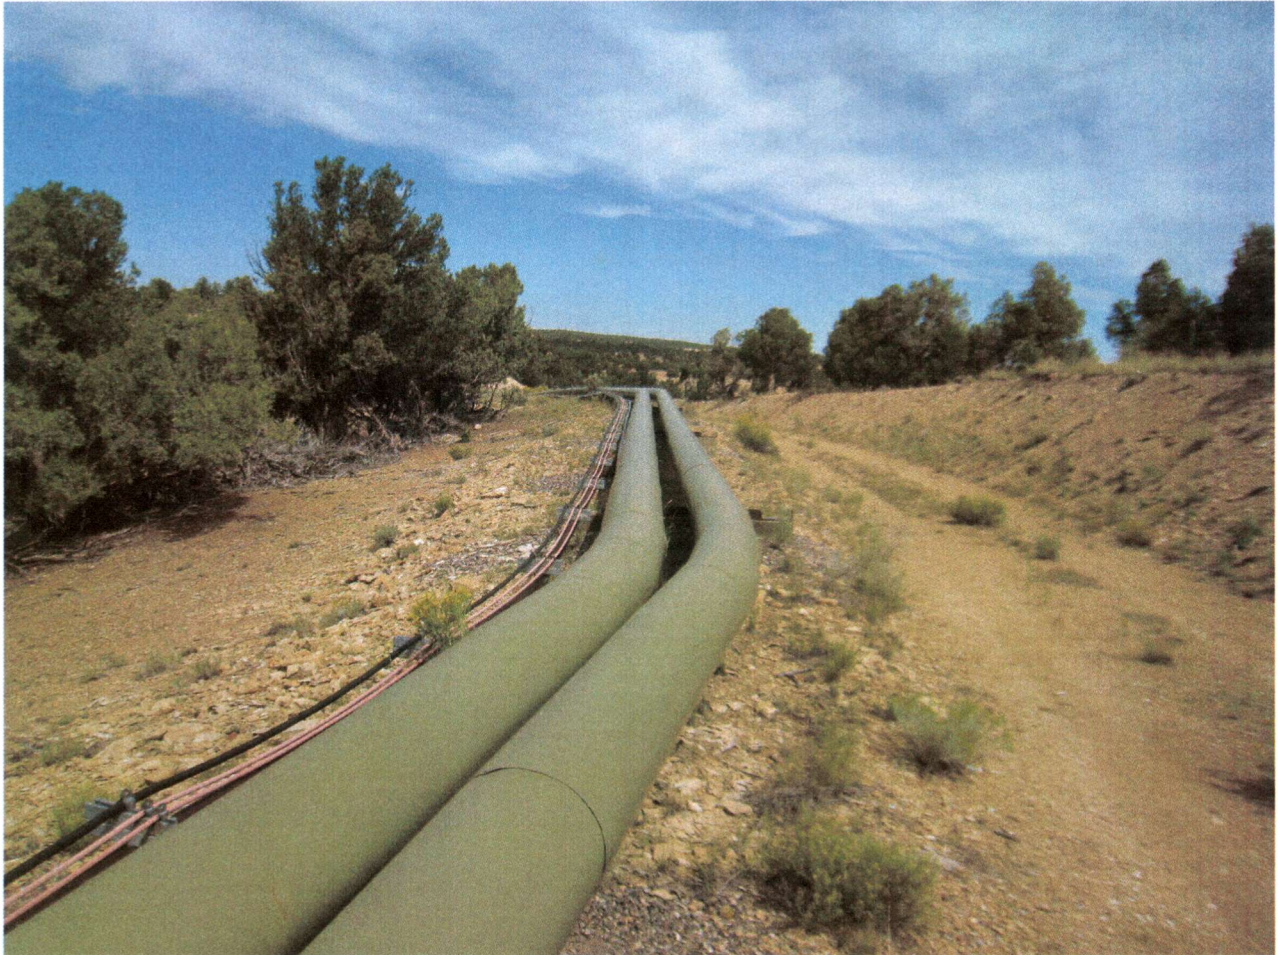
Photo 27 – Dual lateral piping and accompanying four lines of cable extending along the access road to production well 29-28. All of the piping and cables extending to production well 29-28 were removed and transported to the Parachute site in October 2014. Not all pipe lines run adjacent to the lateral roads. Pipe lines extending from the main well field road across country in a more direct route for a shorter distance to wells which are more remotely located are carefully removed to preserve the established vegetation.

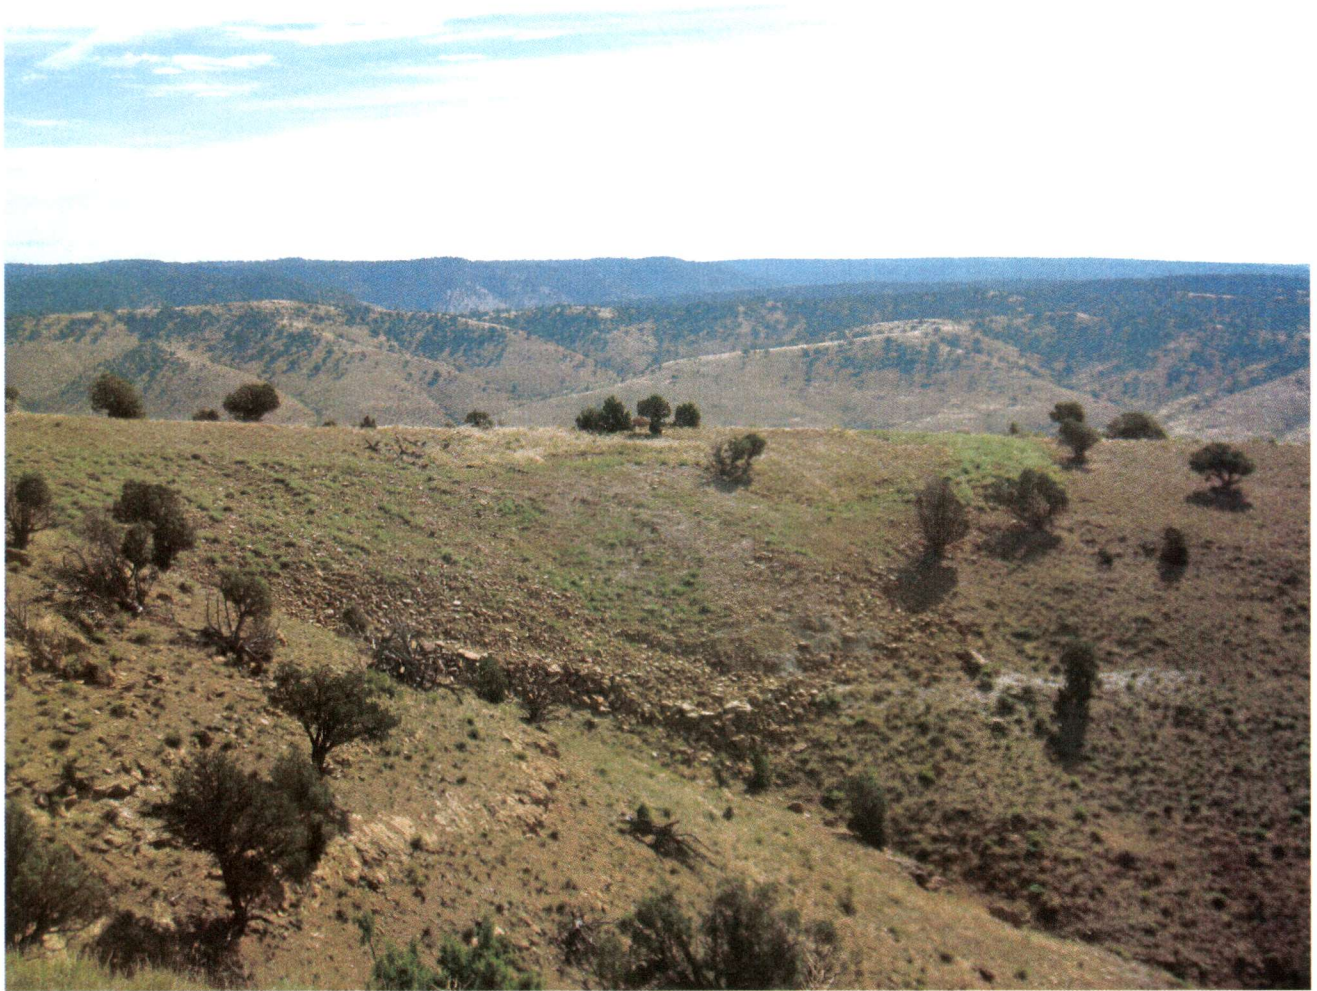
Photo 28 – A side view of reclaimed production well pad 29-22 taken in June 2015. This pad and the road to it were re-contoured and drill seeded in the fall of 2013. The drill seeding was done in multiple directions to break up the appearance of orderly rows. The vegetation density is very good all across this reclamation area and all the trees near the original disturbance were preserved during the work. It nearly impossible to identify where the location of former production well 29-22 was.

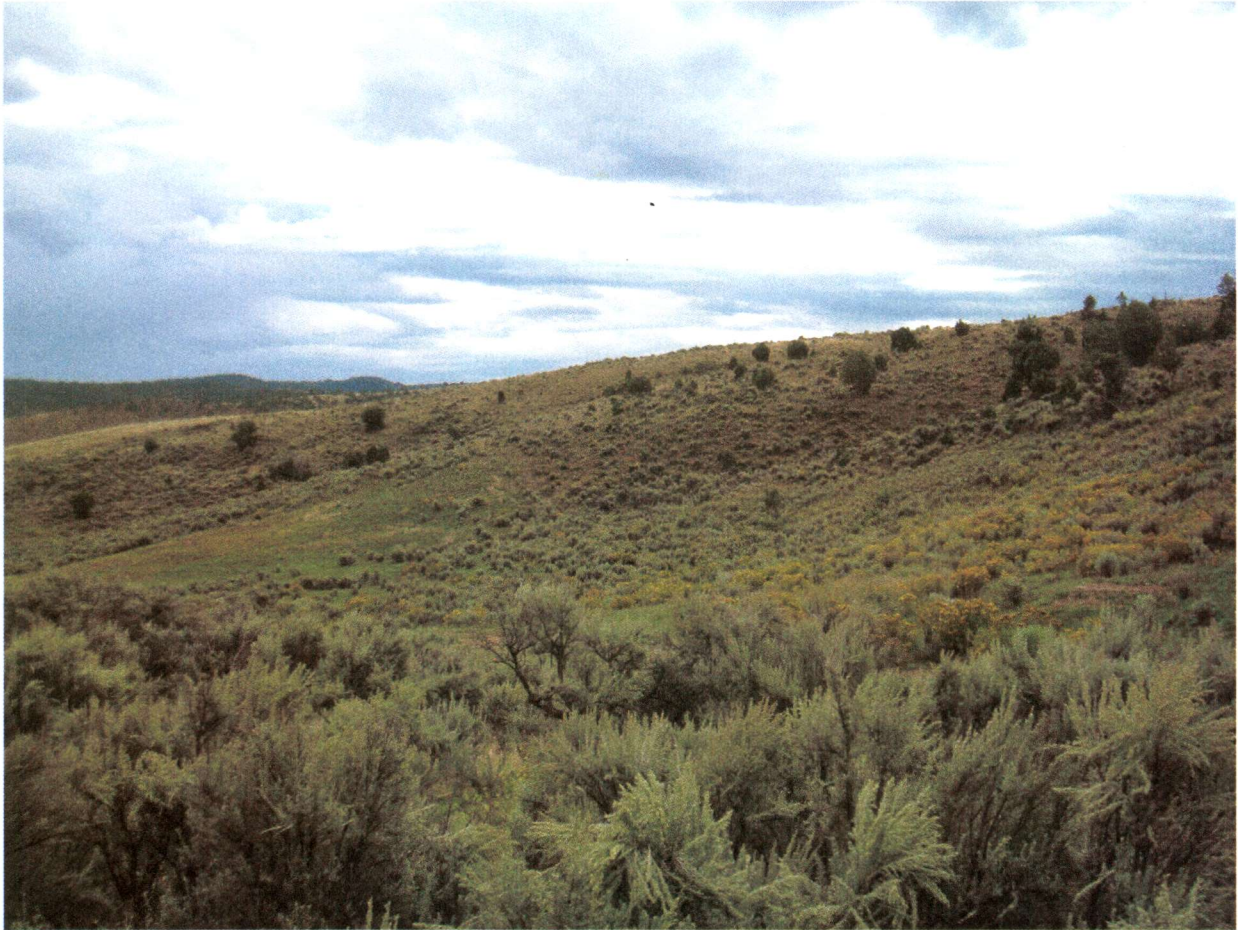
PHOTO 29 - Looking down Yankee Gulch from the draw just north of the test mine pad in October 2014. This reclamation area was once the location of the two ponds constructed for the test mine operation. Vegetation in the formerly disturbed area is similar in density, diversity, and cover to the vegetation of the valley where no disturbance has occurred.
