**COLORADO DIVISION OF RECLAMATION, MINING AND SAFETY**  
**MINERALS PROGRAM INSPECTION REPORT**  
**PHONE: (303) 866-3567**

<b>MINE NAME:</b> Lamar Pit	<b>MINE/PROSPECTING ID#:</b> M-1987-079	<b>MINERAL:</b> Sand and gravel	<b>COUNTY:</b> Prowers
<b>INSPECTION TYPE:</b> Monitoring	<b>INSPECTOR(S):</b> Amy Eschberger	<b>INSP. DATE:</b> January 22, 2015	<b>INSP. TIME:</b> 09:00
<b>OPERATOR:</b> ALL-RITE PAVING & REDI-MIX, INC.	<b>OPERATOR REPRESENTATIVE:</b> Jeff Flynn	<b>TYPE OF OPERATION:</b> 112c - Construction Regular Operation

# M1987-079 / Lamar Pit / All-Rite Paving & Redi-Mix, Inc.

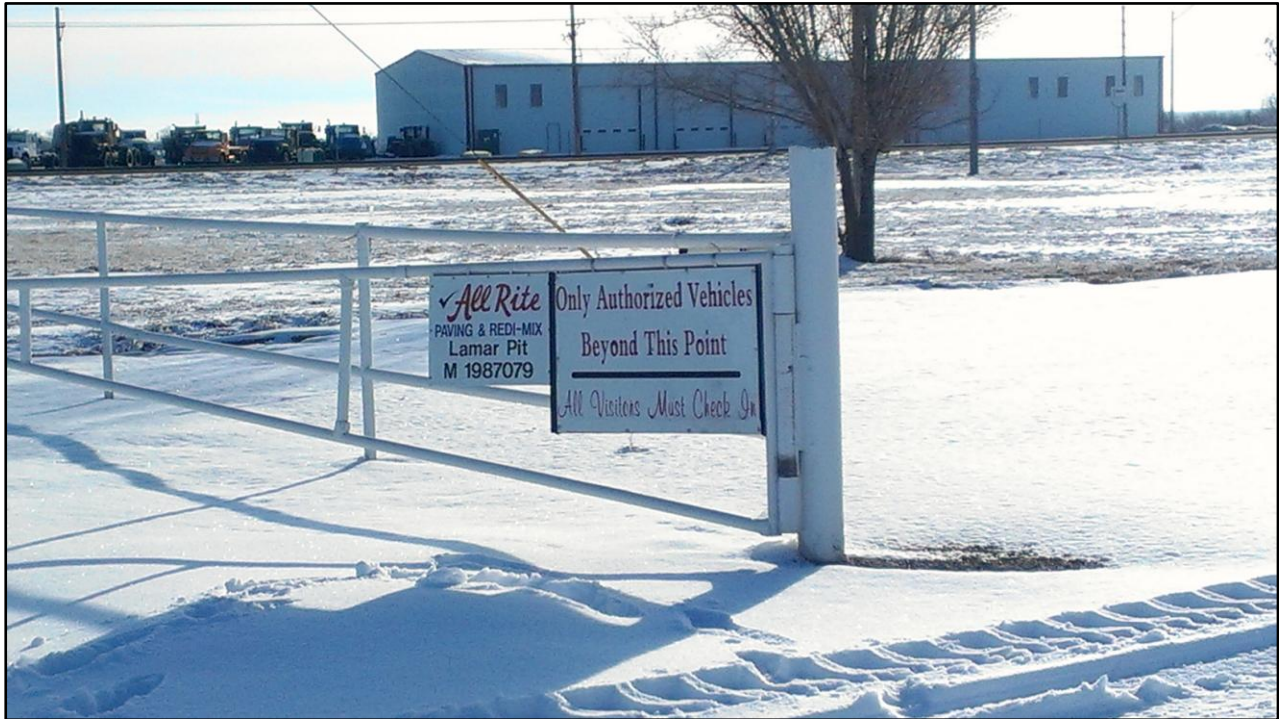
**Photo 1.** View of permit sign posted at main site entrance off of Speculator Ave.

At the time of the inspection, the weather was clear and cold, and the ground was covered by snow. A permit sign was posted at the main site entrance off of Speculator Avenue (**Photo 1**). The permit boundary was properly delineated by metal posts (**Photo 2**). Only the industrial yard was active during the inspection (**Photos 3-6**). Several material stockpiles of various sizes and shapes are stored in this area; however, none of this material came from this operation. It appears that this site has not been actively mined in many years. Phase I was mined first, leaving a pond with a surface area of approximately 3.71 acres (**Photos 7-10**). Phase II has not yet been mined (**Photos 11 and 12**). This area is vegetated with native grasses and trees, and a dirt road traverses the site. It appears that topsoil is stockpiled southeast and north of the pond. The snow cover made it difficult to estimate topsoil volumes. The operator should be careful not to cover the topsoil stored south of the pond with concrete rubble.

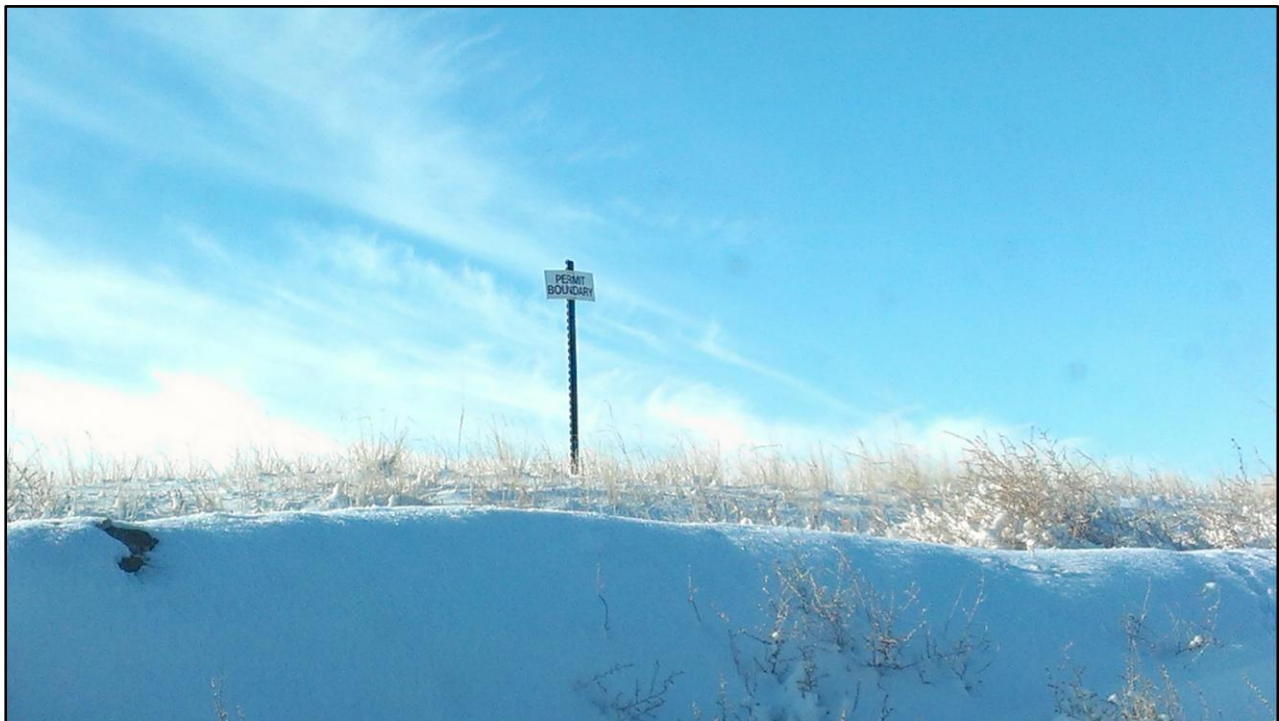
**Photo 2.** View of metal post marking southern permit boundary.

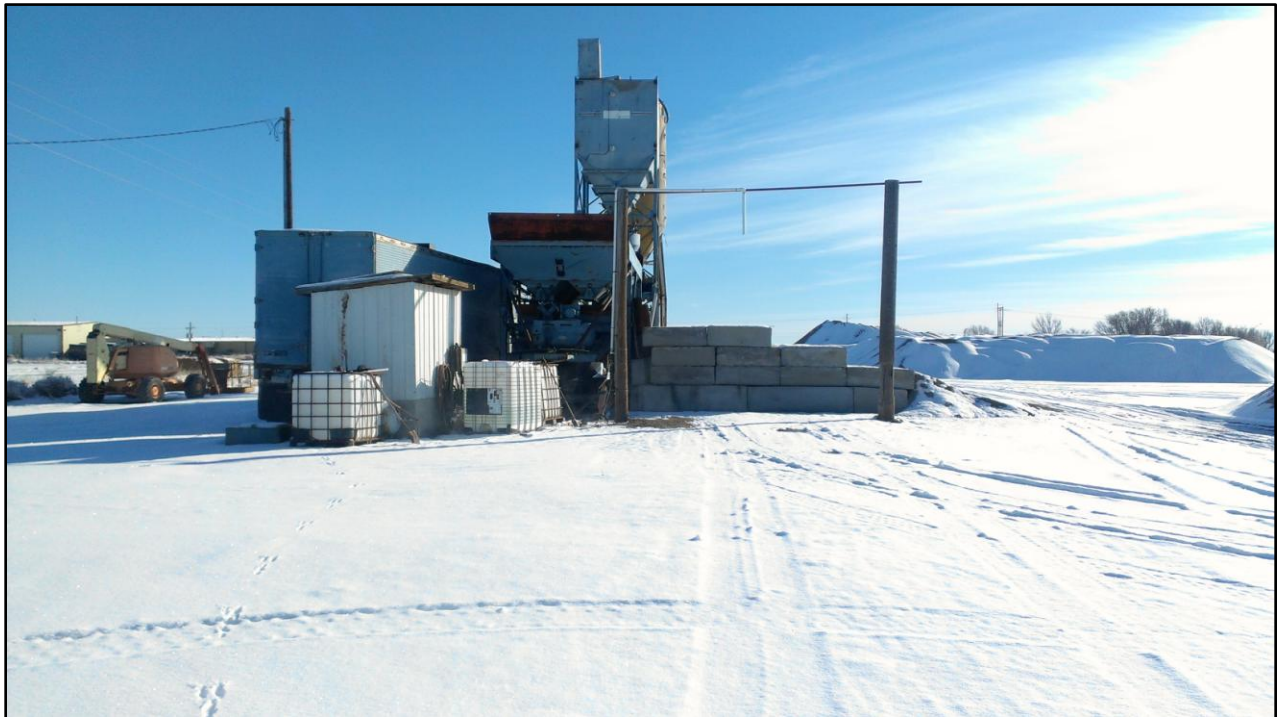
**Photo 3.** View of equipment stored in northwestern portion of industrial yard.

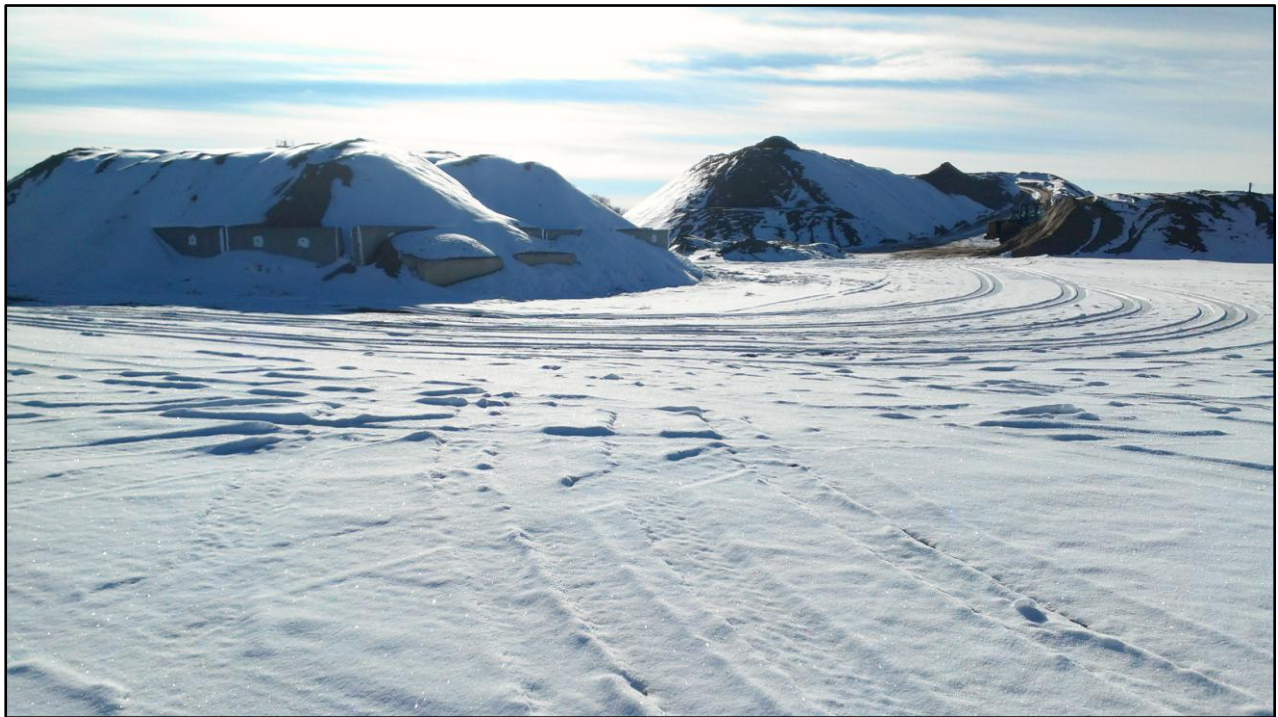
**Photo 4.** View looking south across central portion of industrial yard, showing various material stockpiles not associated with mining of this site.

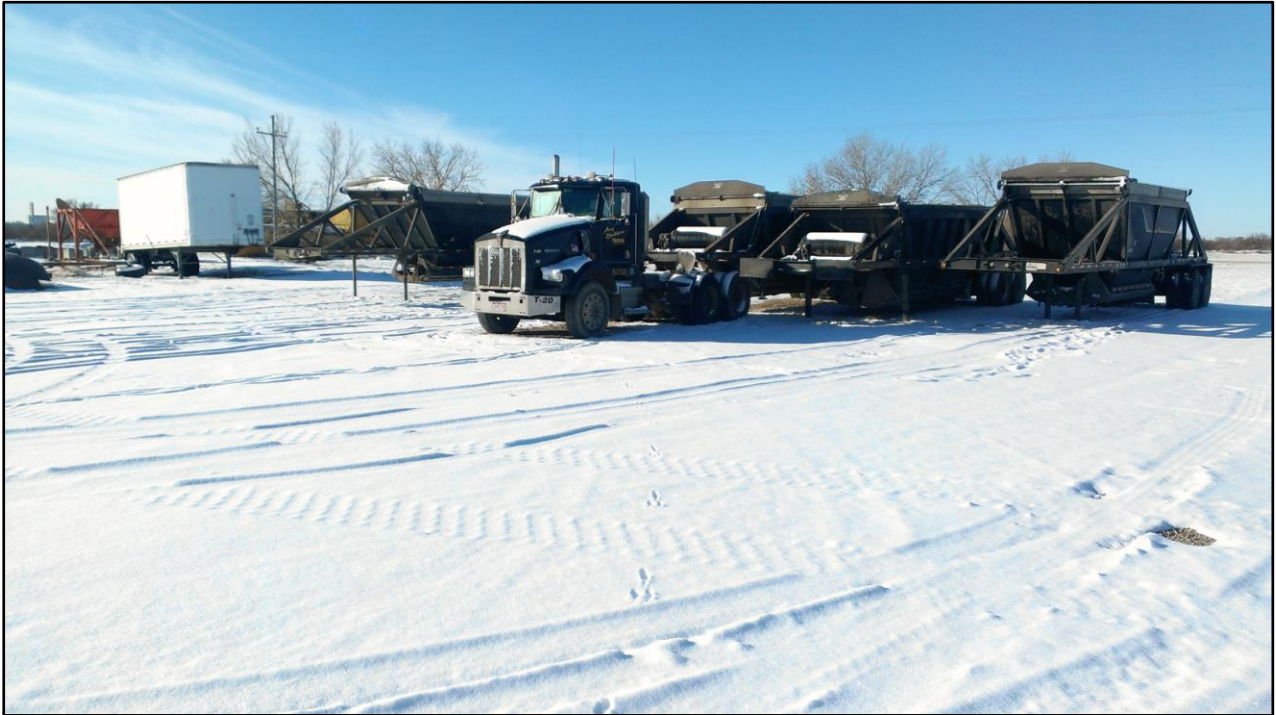
**Photo 5.** View of trucks and equipment stored in western portion of industrial yard, not associated with mining of this site.

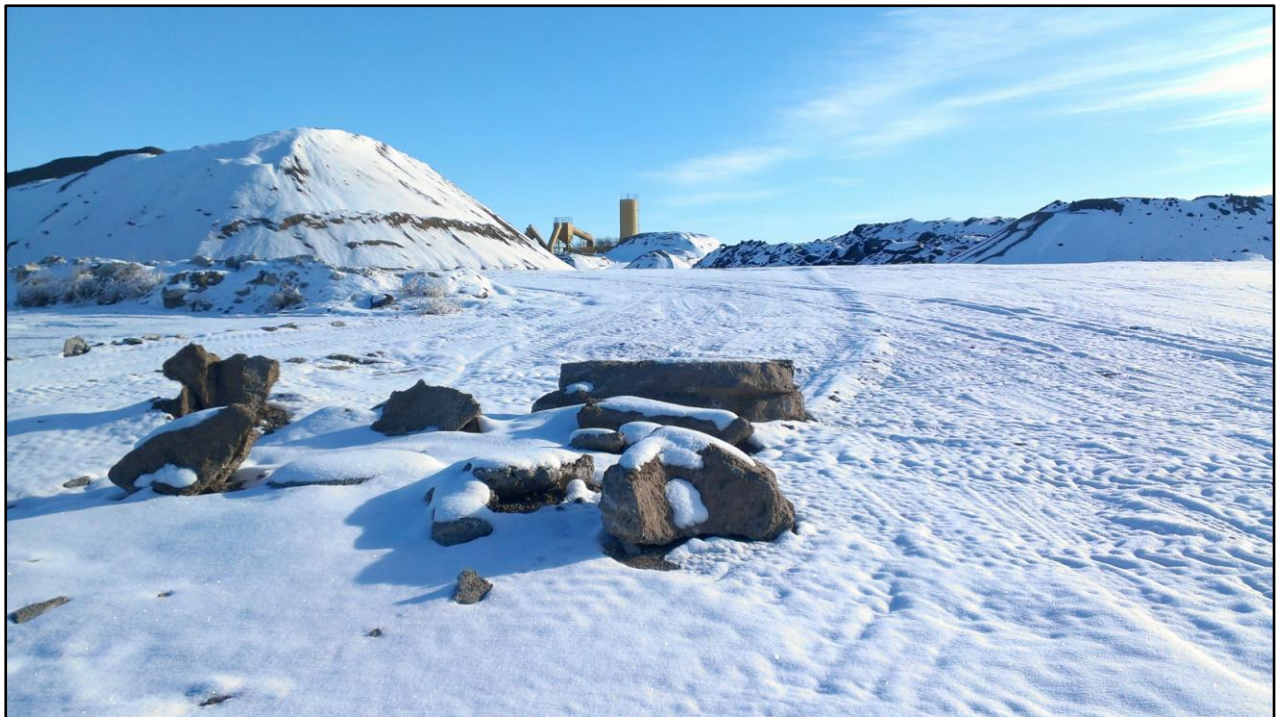
**Photo 6.** View looking east across southwestern portion of industrial yard, showing various material stockpiles not associated with mining of this site. The asphalt batch plant is barely shown in the background.

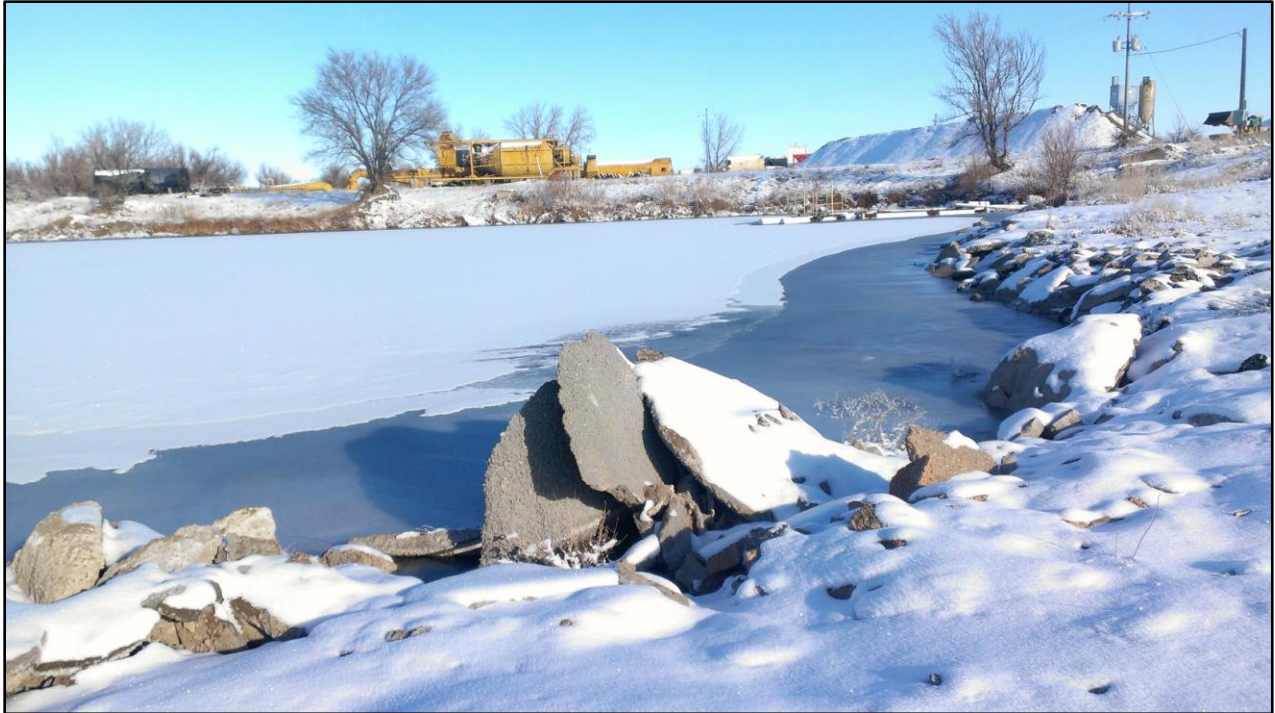
amount of exposed groundwater at this time. Currently, the pond banks have slope gradients of approximately 2H:1V to 2.5H:1V. The southern, eastern, and western pond banks are lined with concrete rubble produced from the industrial yard, as allowed in the approved mining and reclamation plans (see **Photos 7-10**). These banks appeared to be stable at the time of the inspection. Water is pumped from the pond for use in the gravel wash plant (located in the industrial yard) and then recycled back to the pond. This technique eliminates a discharge from the pond.

**Photo 7.** View looking across eastern portion of pond created by the operation many years ago. Note concrete rubble being used to backfill pond slopes, as allowed by approved plans.

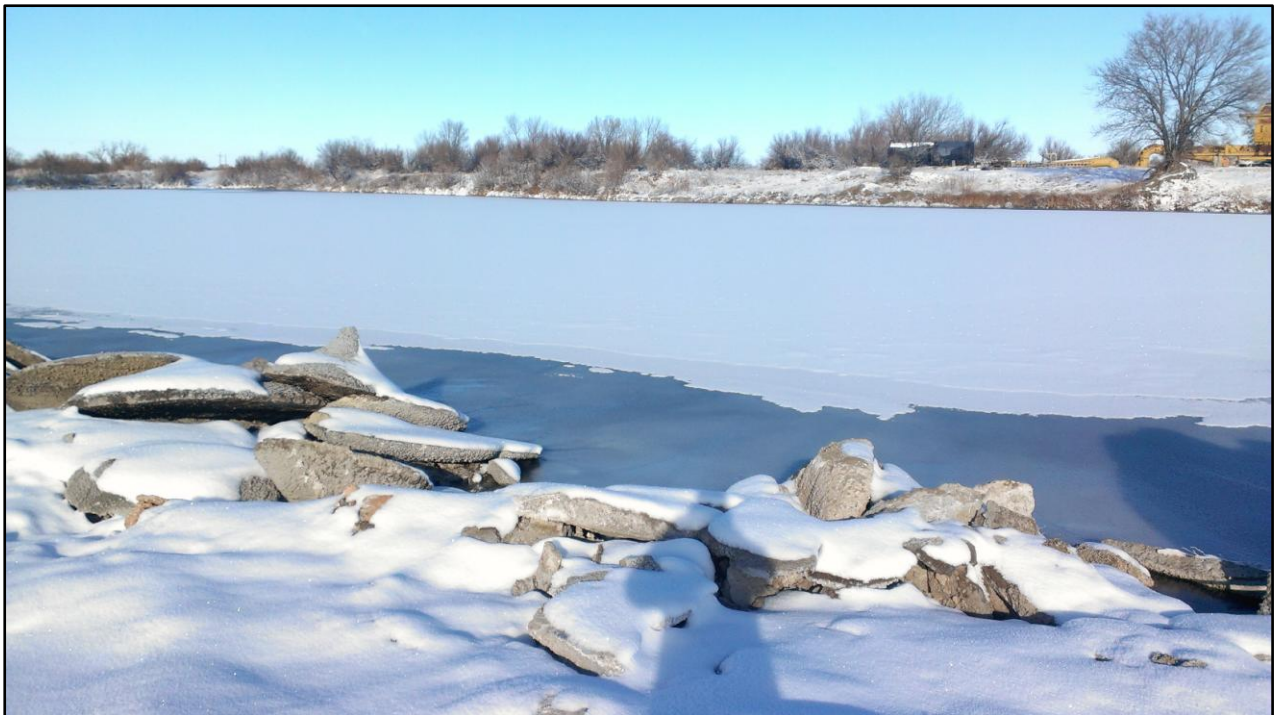
**Photo 8.** View looking across central portion of pond created by the operation many years ago. Note concrete rubble being used to backfill pond slopes, as allowed by approved plans.

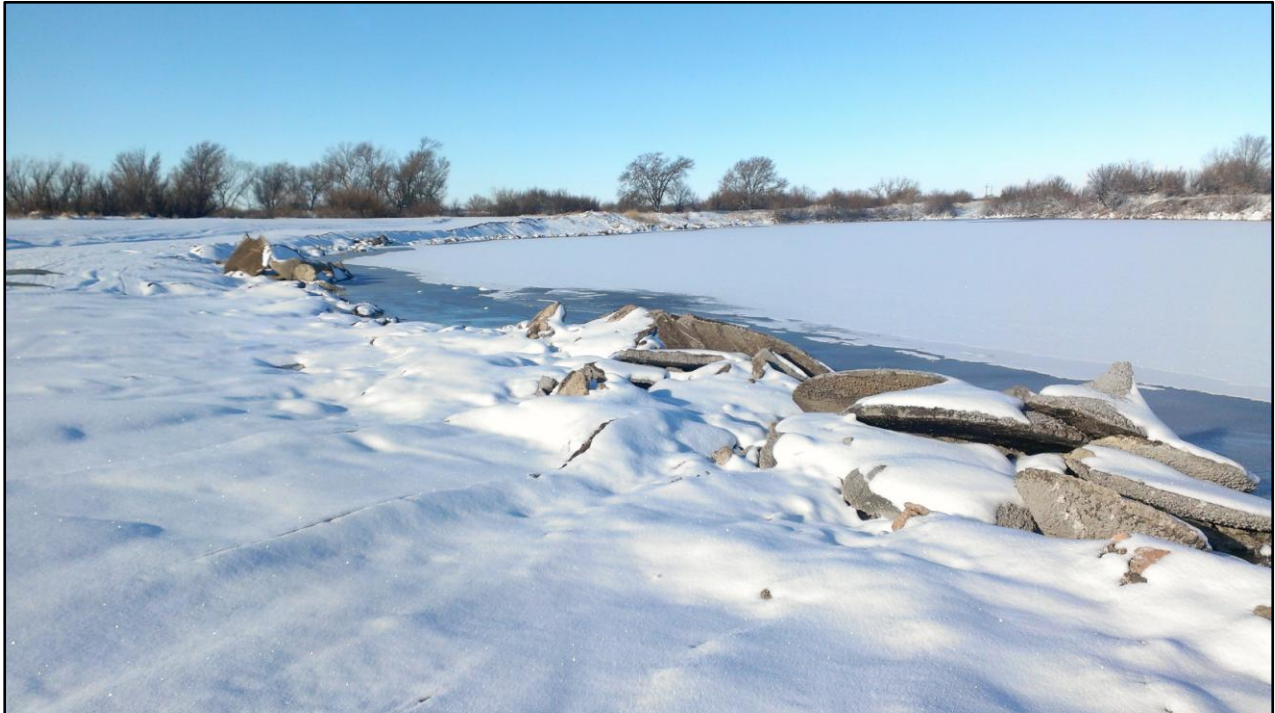
**Photo 9.** View looking across western portion of pond created by the operation many years ago. Note concrete rubble being used to backfill pond slopes, as allowed by approved plans.

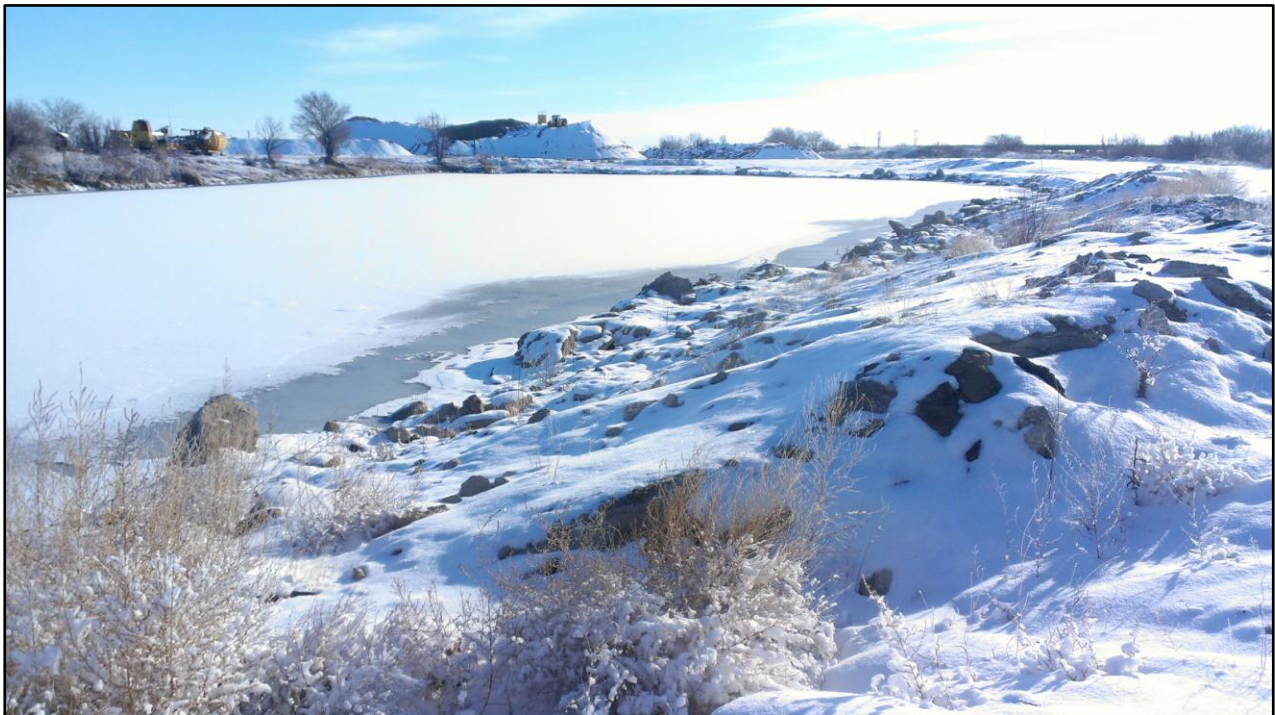
**Photo 10.** View looking northeast from southwestern edge of pond, showing concrete rubble lined bank with approximate 2.5H:1V slope gradients.

The approved reclamation plan calls for leaving a 13.8 acre industrial/commercial area in the eastern portion of the site. In the western portion of the site that was mined, the pond banks will be graded to 3H:1V slopes, and disturbed land adjacent to the pond will be retopsoiled at a minimum depth of 6 inches, and revegetated to rangeland. At this time, reclamation of the site would include grading the pond banks to 3H:1V, and retopsoiling and revegetating approximately 7.5 acres (25 acres disturbed – 13.8 acres industrial – 3.71 acres pond) of disturbed land. The Division has determined that the current bond amount of \$48,050.00 is adequate to reclaim the site in accordance with the approved reclamation plan.

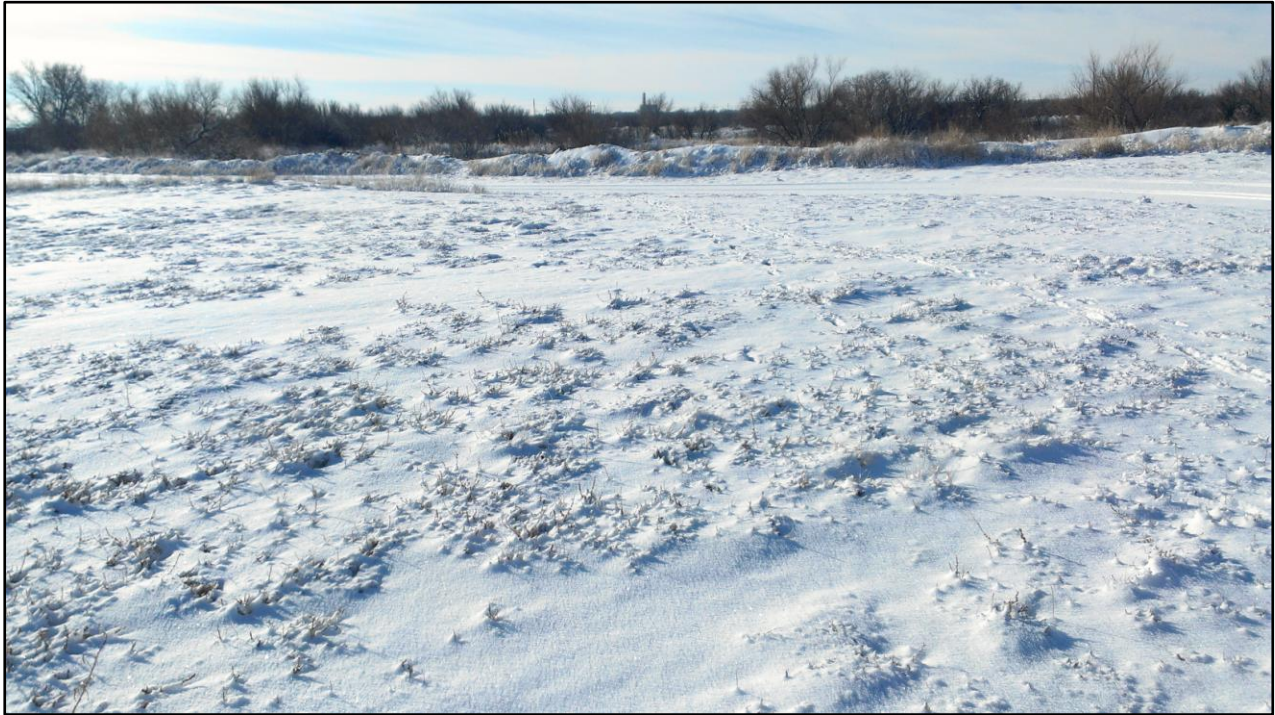
**Photo 11.** View looking south across northwestern portion of permit area (Phase II) not yet mined by this operation.

During the inspection, Mr. Flynn indicated the operator is uncertain whether they will ever mine Phase II. The Division informed Mr. Flynn that if mining activities (e.g., extracting, processing, and/or hauling off of material) associated with this site do not occur every year as required by its intermittent status, then the operator will need to either begin final reclamation of the site or file for Temporary Cessation (TC; form enclosed). If mining is expected to continue in the future, then filing for TC would allow for a 5-year period of inactivity. The Division recommends that this issue be followed up in the next inspection. If, by that time, the operator has not continued mining activities, filed for TC, or completed final reclamation (approved reclamation plan and map enclosed), then the Division may cite a Possible Violation for failure to complete final reclamation in a timely fashion as required by CRS 34-32.5-116(4)(q)(I).

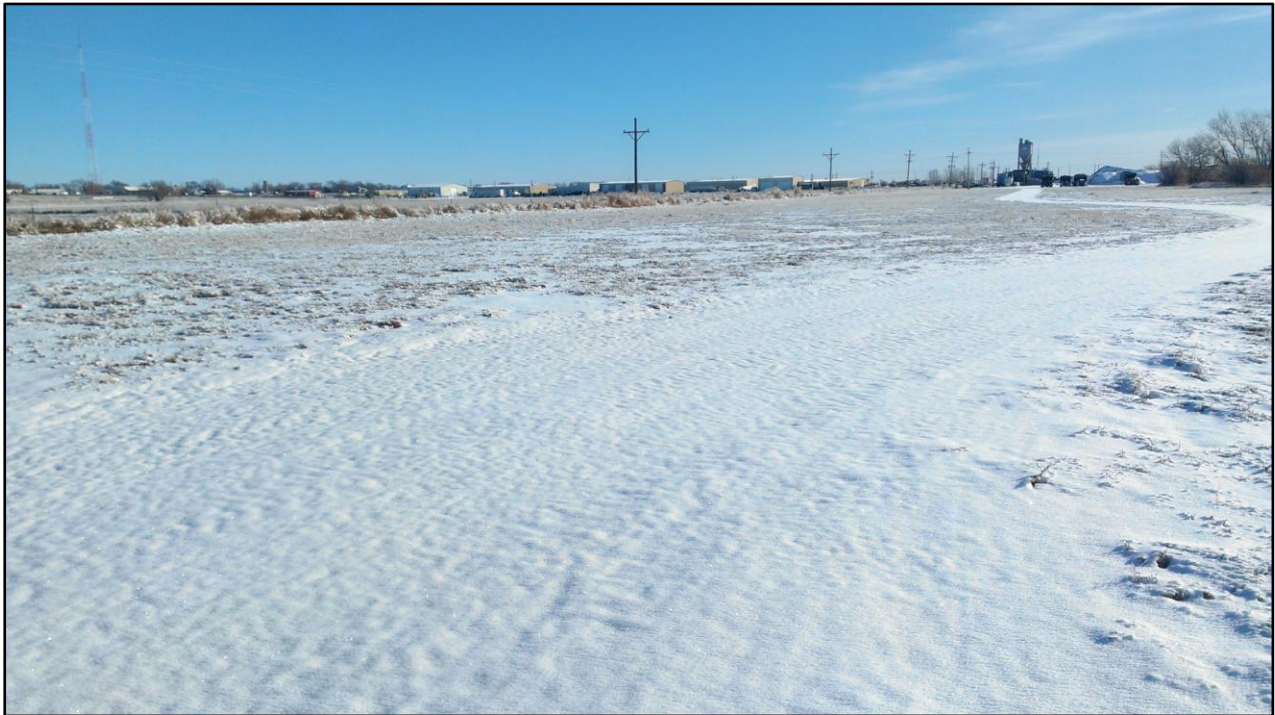
**Photo 12.** View looking northeast across northwestern portion of permit area (Phase II) not yet mined by this operation. Note dirt road traversing this area (at center).

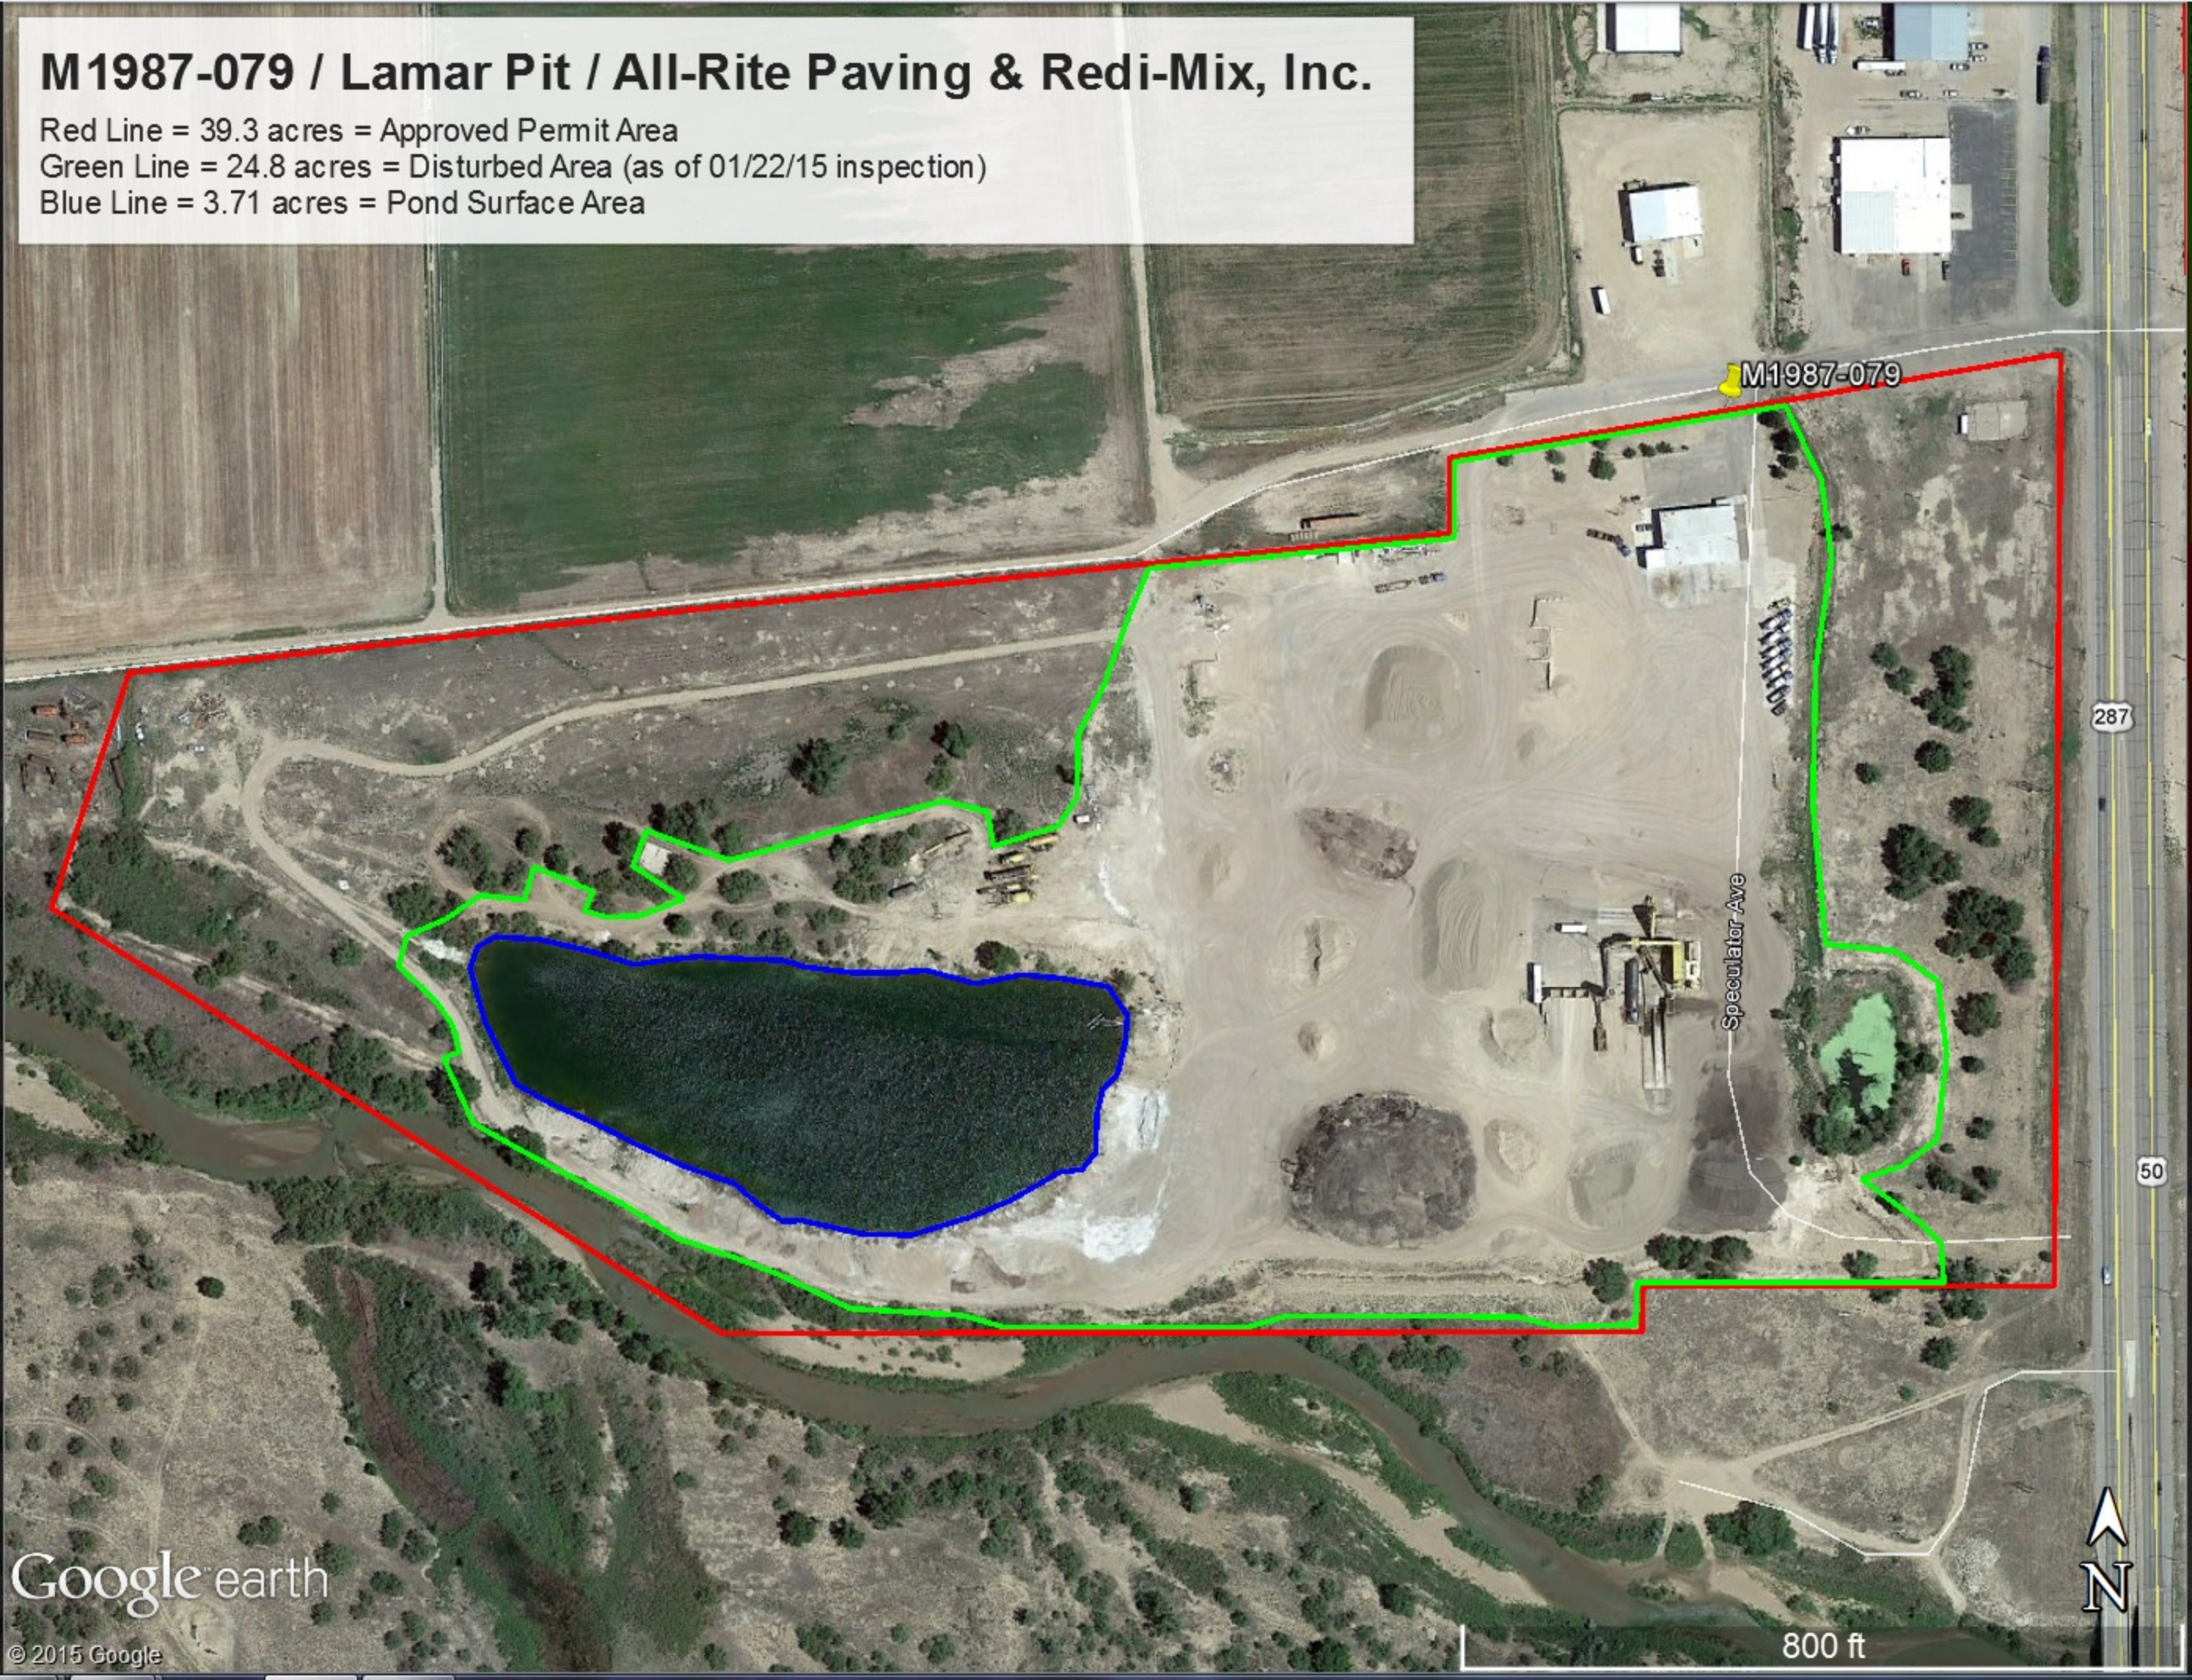
The Division estimates current disturbance to consist of approximately 25 acres (see enclosed Google Earth image of site), of which, approximately 15 acres is being used for industrial purposes and equipment storage, and approximately 3.71 acres is pond surface. According to the Colorado Division of Water Resources, this site is augmented under the Lower Arkansas Water Management Association (LAWMA) for up to 3.80 acres of exposed groundwater (see enclosed LAWMA table). Therefore, this site appears to be in compliance with the

Red Line = 39.3 acres = Approved Permit Area  
Green Line = 24.8 acres = Disturbed Area (as of 01/22/15 inspection)  
Blue Line = 3.71 acres = Pond Surface Area
