GEOTECHNICAL STABILITY STUDY

Red Canyon Quarry
Fremont County, CO

Rocky Mountain Materials & Asphalt
1910 Rand Avenue
Colorado Springs, CO 80905

Prepared by: Azurite, Inc
POBox 338
Cotopaxi, CO 81223

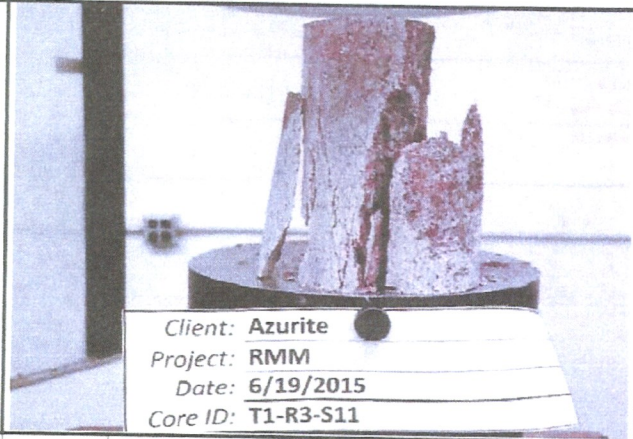
Client: **Azurite**
 Project: **RMM**
 Date: **6/19/2015**
 Core ID: **T1-R3-S11**

Client: Azurite
 Project: Rocky Mountain Minerals
 Location: CO Hwy 115
 Rock Type: Metamorphic
 Rock Name:
 Characteristics: Core axis verticle
 Core ID: T1-R3-S11
 File Name: T1-R3-S11_UCS
 Test Performed By: PK
 Date Tested: 6/19/2015
 Data Reduced By: PK
 Date Reduced: 6/19/2015

Core Length		Diameter		L/D Ratio	Failure Load	Failure Stress	UCS 2:1		Failure Mode
in	cm	in	cm		lbs	psi	psi	MPa	
3.995	10.147	1.939	4.925	2.06	29,154	9,873	9,996	68.9	Non-Structural, along foliation plane

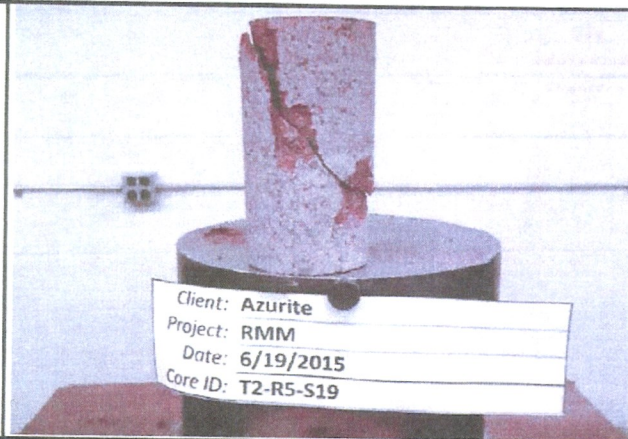
Client: Azurite
 Project: Rocky Mountain Minerals
 Location: CO Hwy 115
 Rock Type: Metamorphic
 Rock Name:
 Characteristics: Core axis verticle
 Core ID: T2-R5-S19
 File Name: T2-R5-S19_UCS
 Test Performed By: PK
 Date Tested: 6/19/2015
 Data Reduced By: PK
 Date Reduced: 6/19/2015

Core Length		Diameter		L/D Ratio	Failure Load	Failure Stress	UCS 2:1		Failure Mode		
in	cm	in	cm		lbs	psi	psi	MPa			
4.020	10.211	1.940	4.926	2.07	41,073	13,902	14,084	97.1	Structural		
P-Wave		S-Wave		Dynamic E		Dynamic v	Static E		Static v	Density	
ft/sec	m/sec	ft/sec	m/sec	ksi	GPa		ksi	GPa		lb/ft³	g/cm³
N/A	N/A	N/A	N/A	N/A	N/A	N/A	N/A	N/A	N/A	163	2.62

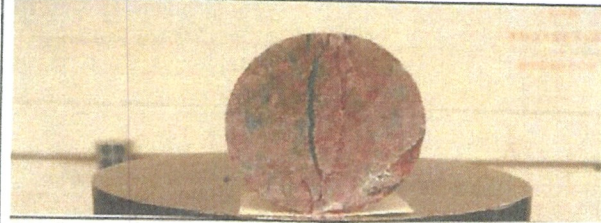
Client: Azurite
Project: Rocky Mountain Minerals
Date: 6/23/2015
Core ID: T3-R2-S9

Project Name : Rocky Mountain Minerals
Location : CO Hwy 115
Rock Type : Metamorphic
Characteristics :
Loading Direction Parallel to foliation
Test Performed by : JT
Date Tested : 6/23/2015
Data Reduced by : PK
Date Reduced : 6/24/2015
Rock Source : N/A
Core ID : T3-R2-S9
File Name : T3-R2-S9_BTS
Comments : N/A

Disc Length		Disc Diameter		L/D Ratio	Failure Load		BTS		Failure Mode
in	cm	in	cm		lbs	N	psi	MPa	
1.17	2.97	1.930	4.903	0.61	3,048	13,558	860	5.9	Non-Structural

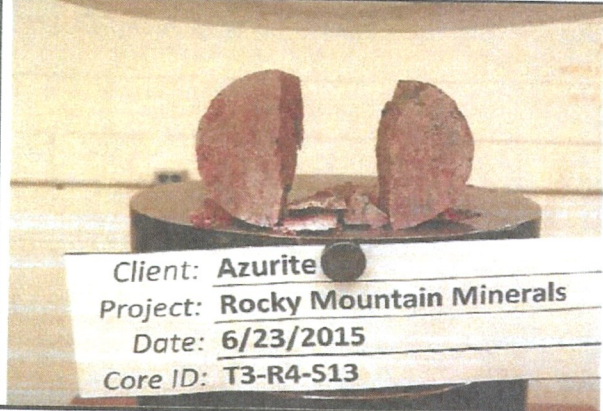
Project Name : Rocky Mountain Minerals
Location : CO Hwy 115
Rock Type : Metamorphic
Characteristics :
Loading Direction : Parallel to foliation
Test Performed by : JT
Date Tested : 6/23/2015
Data Reduced by : PK
Date Reduced : 6/24/2015
Rock Source : N/A
Core ID : T3-R4-S13
File Name : T3-R4-S13_BTS
Comments : N/A

Disc Length		Disc Diameter		L/D Ratio	Failure Load		BTS		Failure Mode
in	cm	in	cm		lbs	N	psi	MPa	
1.27	3.23	1.932	4.907	0.66	941	4,186	244	1.7	Non-Structural

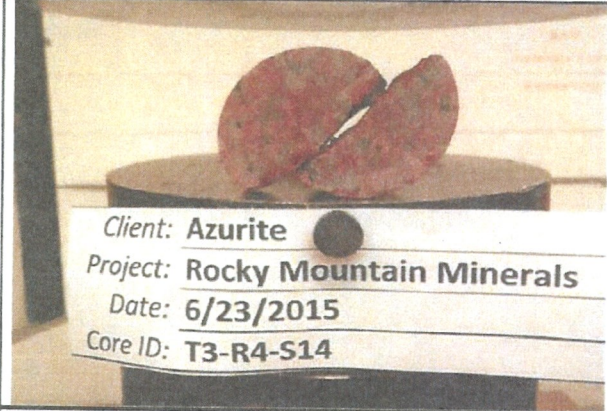
Project Name : Rocky Mountain Minerals
Location : CO Hwy 115
Rock Type : Metamorphic
Characteristics :
Loading Direction Perpendicular to foliation
Test Performed by : JT
Date Tested : 6/23/2015
Data Reduced by : PK
Date Reduced : 6/24/2015
Rock Source : N/A
Core ID : T3-R4-S14
File Name : T3-R4-S14_BTS
Comments : N/A

Disc Length		Disc Diameter		L/D Ratio	Failure Load		BTS		Failure Mode
in	cm	in	cm		lbs	N	psi	MPa	
0.92	2.33	1.932	4.907	0.47	2,162	9,617	778	5.4	Non-Structural
