COLORADO DIVISION OF RECLAMATION, MINING AND SAFETY
MINERALS PROGRAM INSPECTION REPORT
PHONE: (303) 866-3567

MINE NAME: Red Canyon Quarry	MINE/PROSPECTING ID#: M-1985-043	MINERAL: Limestone (general)	COUNTY: Fremont
INSPECTION TYPE: Monitoring	INSPECTOR(S): Timothy A. Cazier	INSP. DATE: August 18, 2015	INSP. TIME: 11:00
OPERATOR: Rocky Mountain Materials and Asphalt, Inc.	OPERATOR REPRESENTATIVE: Tom Smith, Rob Mangone	TYPE OF OPERATION: 112c - Construction Regular Operation

REASON FOR INSPECTION: Citizen Complaint	BOND CALCULATION TYPE: None	BOND AMOUNT: \$334,000.00
DATE OF COMPLAINT: NA	POST INSP. CONTACTS: U.S.BLM	JOINT INSP. AGENCY: None
WEATHER: Clear	INSPECTOR'S SIGNATURE:

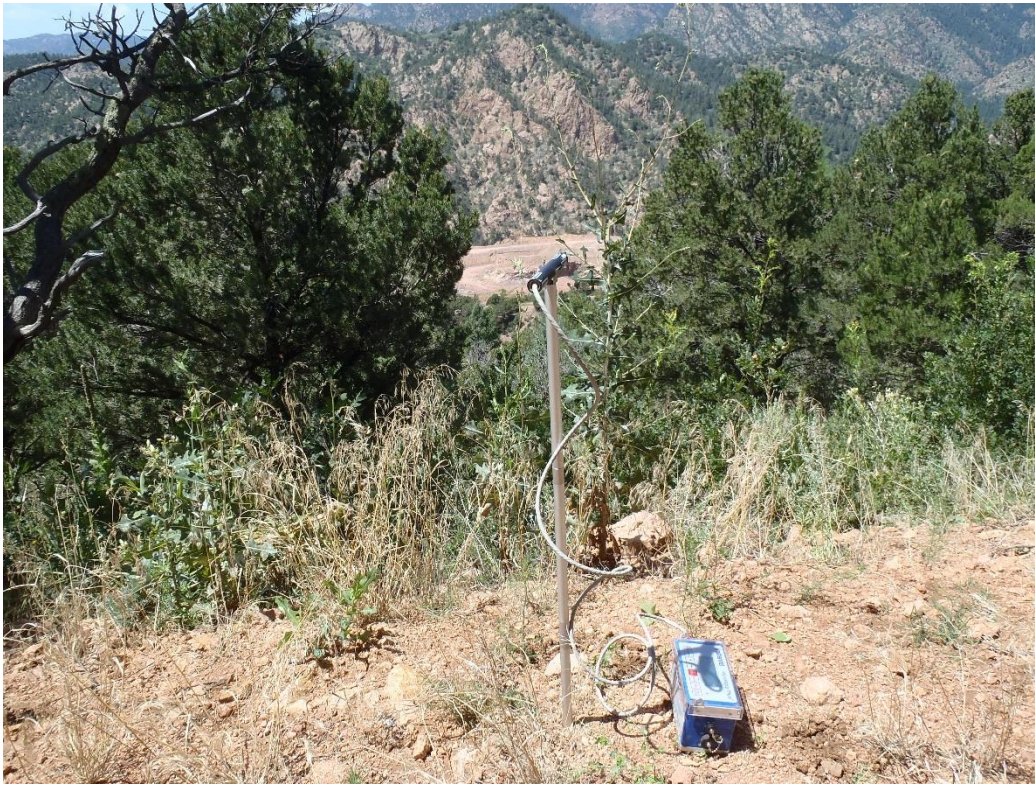
Buckley Powder set up a seismograph at the point where they initiated the blast. RMMA set up a second seismograph (see **Photo 1**) on the west side of the Complainant's residence, with a clear view of, and facing the blast area (see **Photo 2**). Based on the blast area coordinates included in Buckley's blast report (attached), the RMMA seismograph was set up approximately 1,250 feet southeast (and upgradient) of the blast site (see **Figure 1**).

Photo 1. Seismograph setup adjacent to Complainant residence (looking NW).

It should be noted the DRMS observed RMMA's seismograph calibration had expired on July 21, 2015, approximately a month before this blast. RMMA committed to recalibrating their seismograph before the next blast.

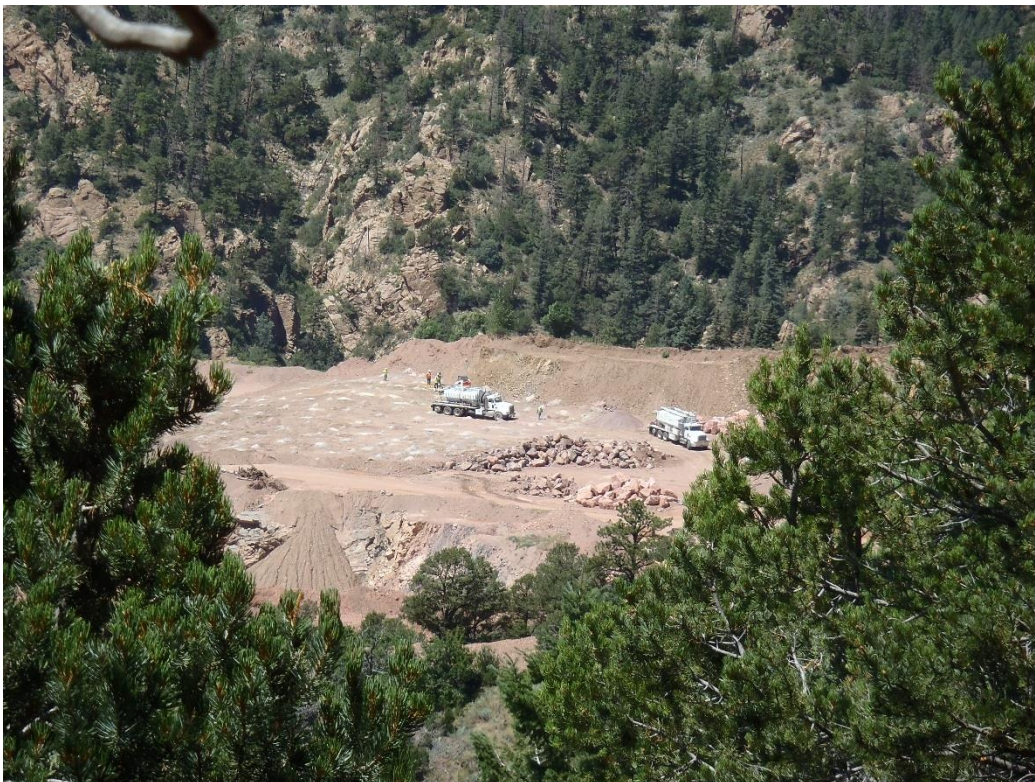
Photo 2. Telephoto view of blast area (looking NW).

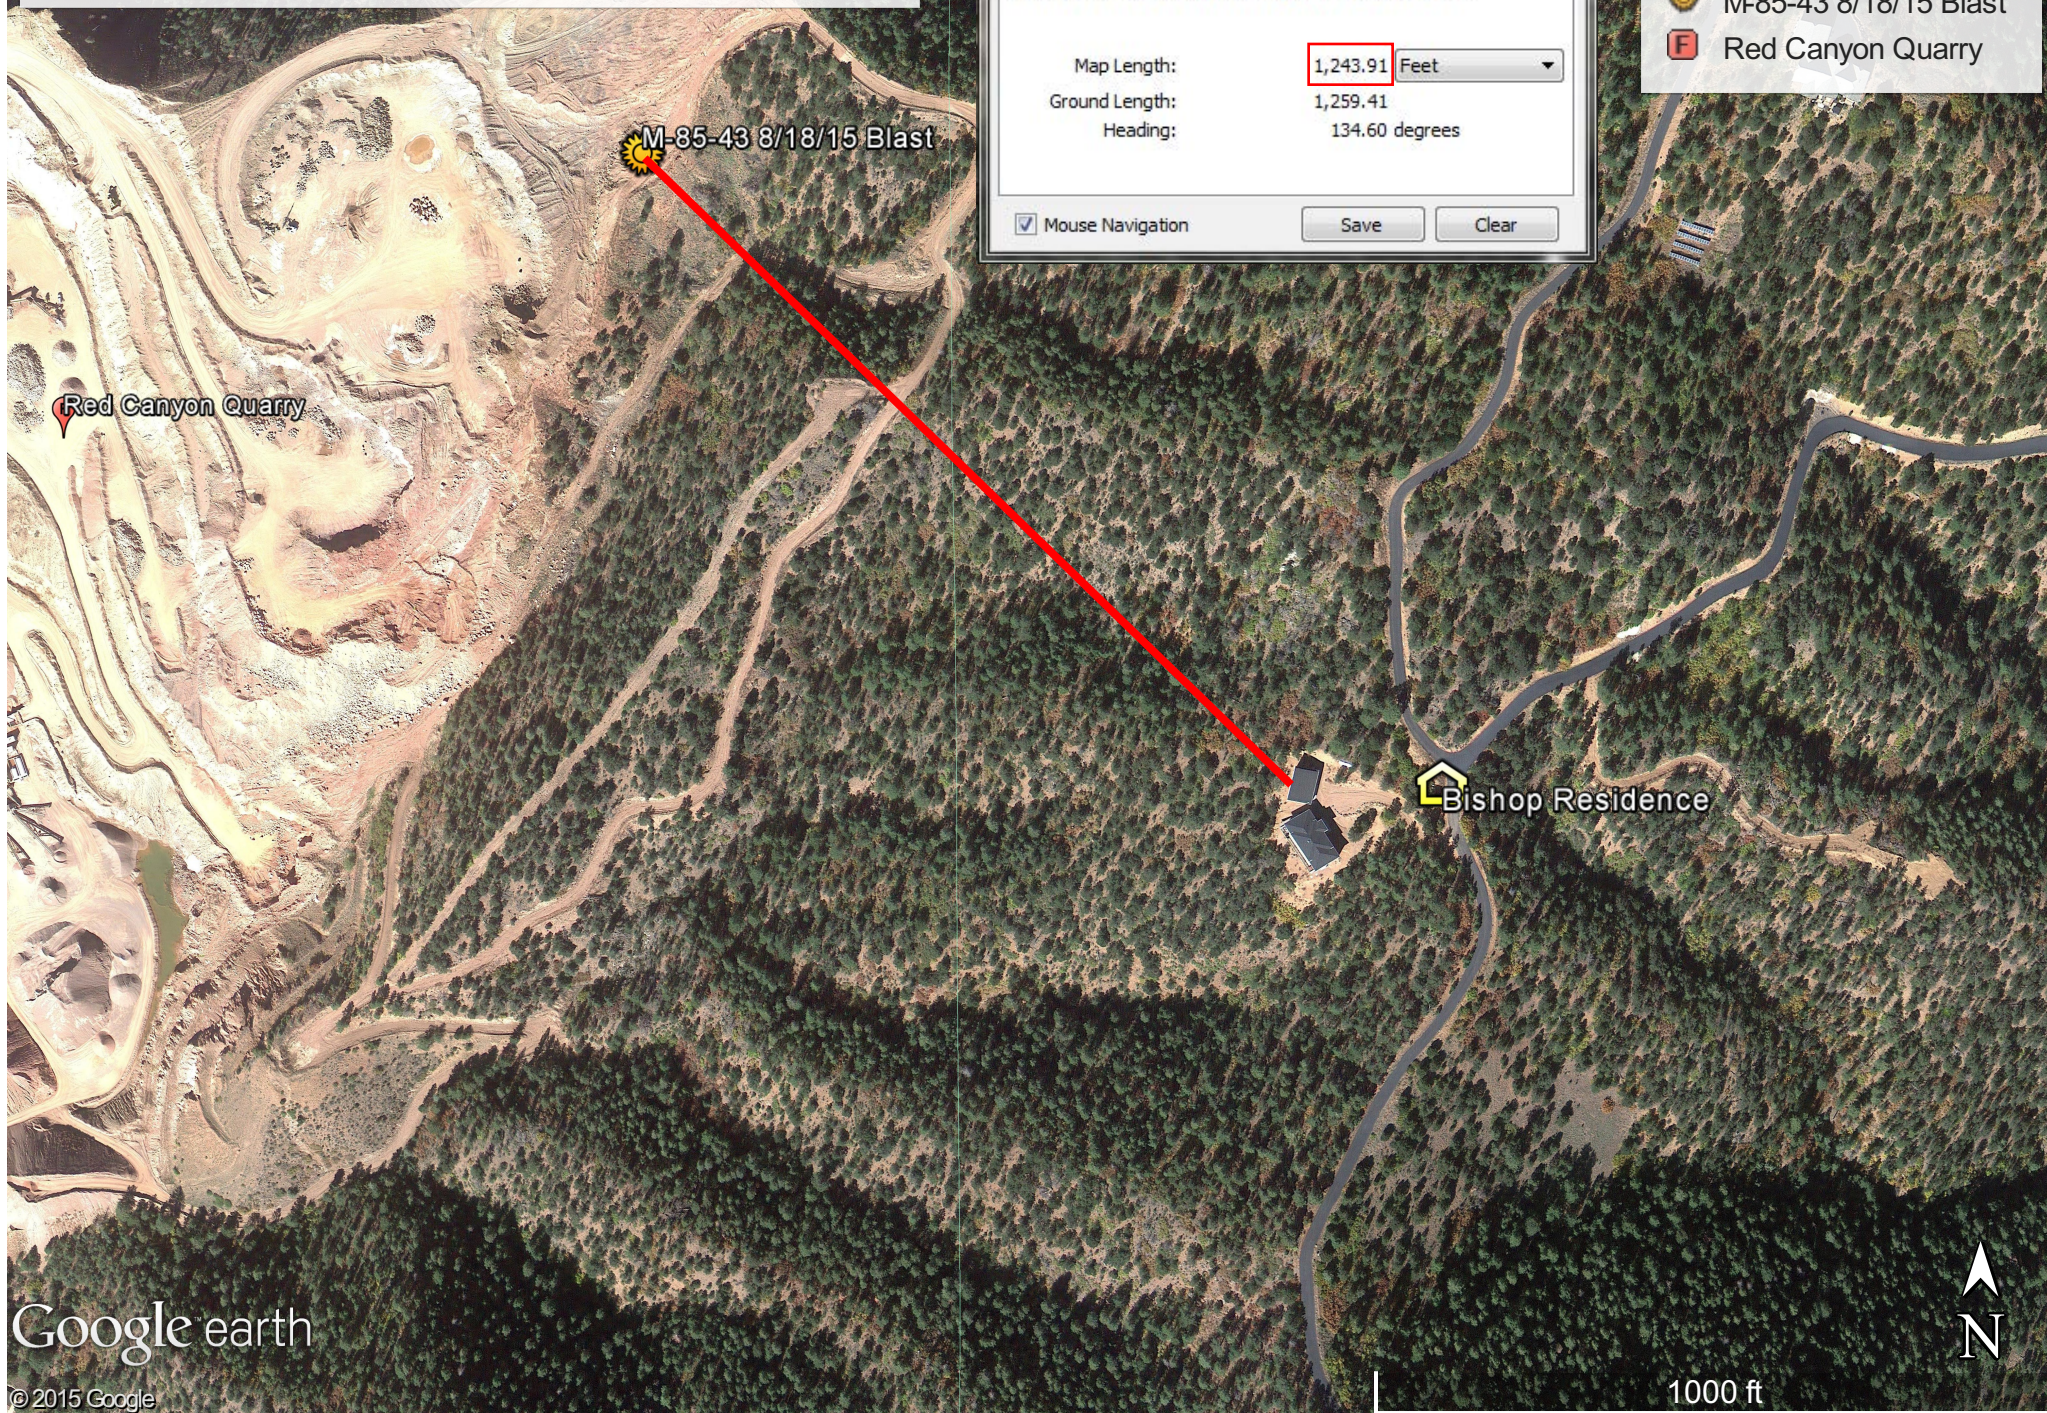
Figure 1. August 18 Blast monitoring

Satellite image is from 2011

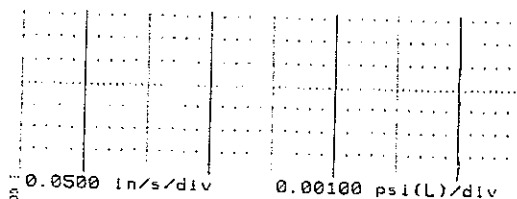
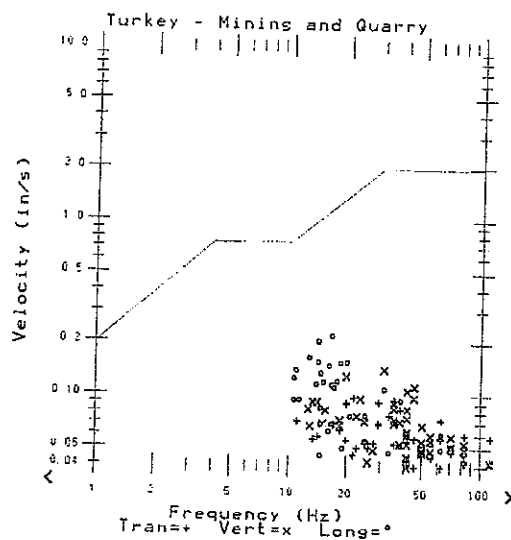
Tran	Vert	Long
DPV	0.0969	0.141	0.203 in/s
ZC Freq	22	32	17 Hz
Time	0.554	0.078	0.573 sec
Accel	0.0845	0.139	0.101 g
Pk Disp	0.00067	0.00111	0.00173 in

PVS 0.213 in/s at 0.573 Sec

PSPL 120.1 dB(L) at 0.685 Sec
4.4 Hz

The DRMS received seismograph data and the blast report on September 21, 2015. This documentation is attached. The seismograph results from the initiation point is hand-labeled "Buckley" and the from the Complainant's residence are hand-labeled "RMMA". In summary, the recorded ground vibration peak particle velocity was less than the 1 inch/second limit for a distance between 301 and 5,000 feet from the blast (0.213 and 0.130 – reported as 3.31 mm/s) at the blast initiation area and the Complainant's residence, respectively. The recorded airblasts were also below industry standard limits: Buckley's – 120.1 dB at 4.4 Hz (less than the 129 db limit @ ≤ 6 Hz) and RMMA's 119.8 dB at 1.7 Hz (less than the 133 db limit @ ≤ 2 Hz).

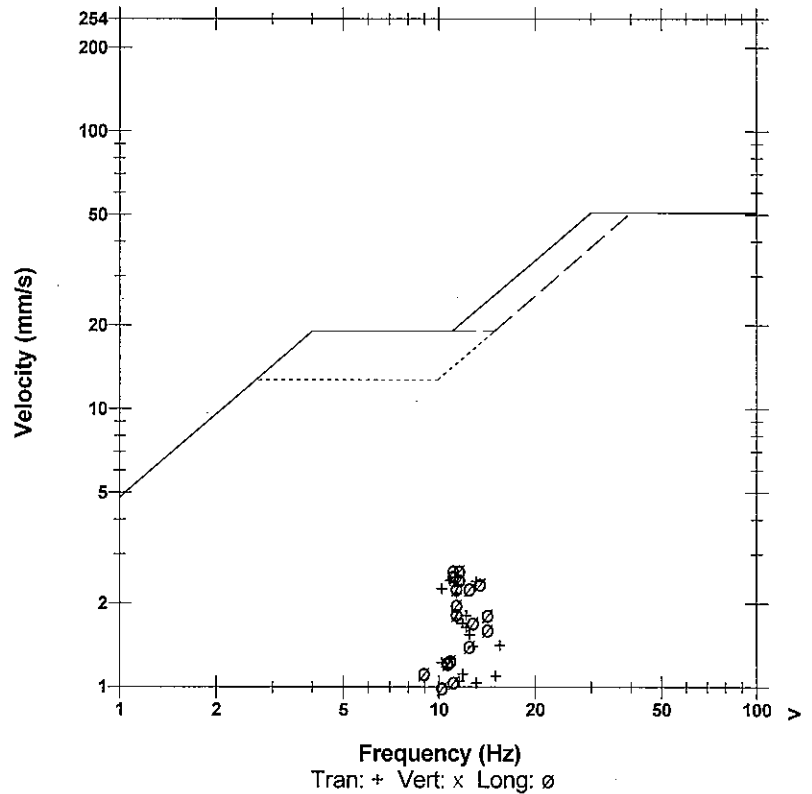
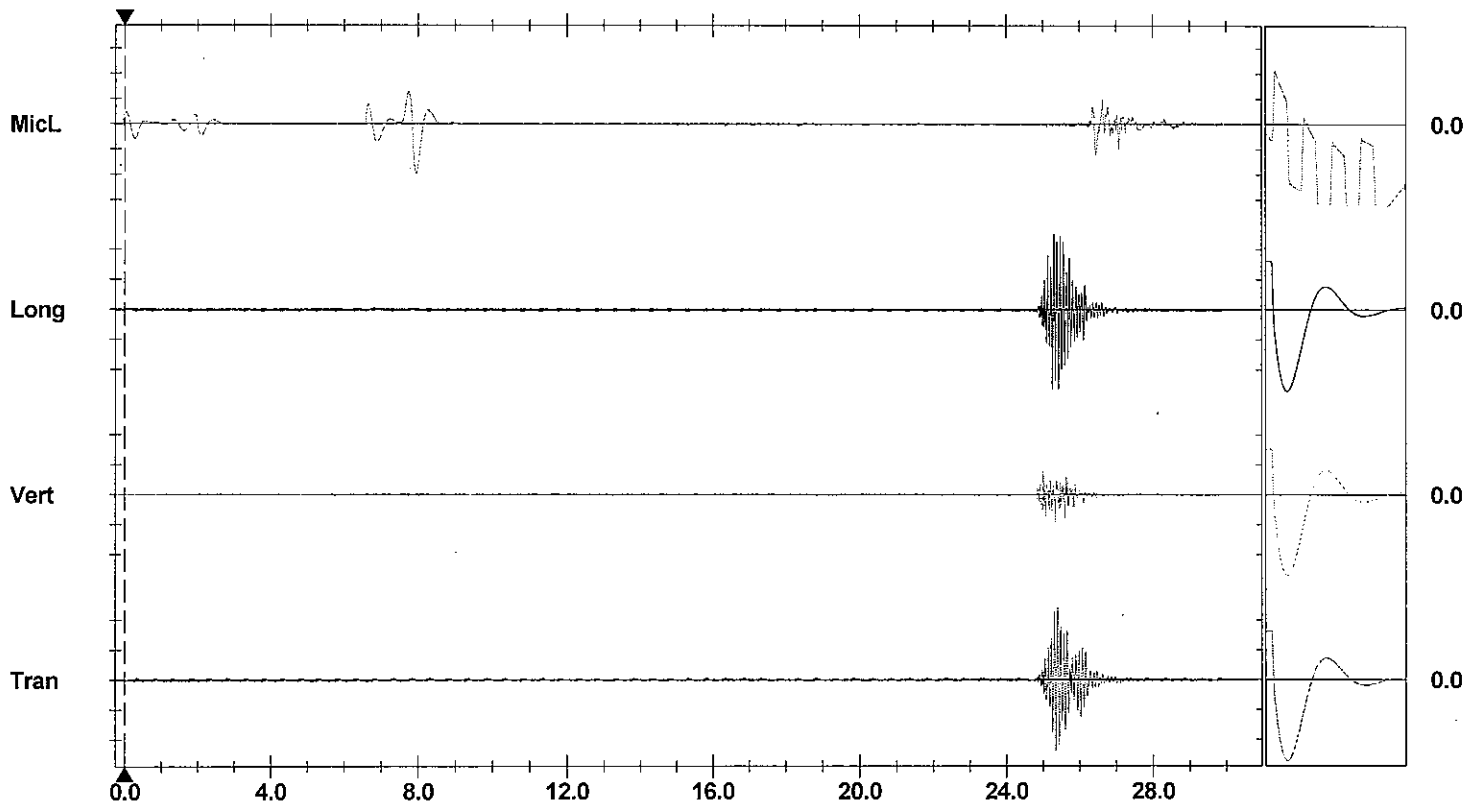
Microphone Linear Weighting
 PSPL 19.5 pa.(L) at 7.944 sec
 ZC Freq 1.7 Hz
 Channel Test Passed (Freq = 20.1 Hz Amp = 651 mv)

Tran	Vert	Long	
PPV	2.41	0.968	2.64	mm/s
ZC Freq	11	17	12	Hz
Time (Rel. to Trig)	25.405	25.342	25.271	sec
Peak Acceleration	0.0298	0.0166	0.0315	g
Peak Displacement	0.0333	0.00981	0.0359	mm
Sensor Check	Passed	Passed	Passed	
Frequency	7.4	7.6	7.5	Hz
Overswing Ratio	3.8	3.4	3.6

Peak Vector Sum 3.31 mm/s at 25.354 sec

USBM RI8507 And OSMRE
