**COLORADO DIVISION OF RECLAMATION, MINING AND SAFETY
MINERALS PROGRAM INSPECTION REPORT
PHONE: (303) 866-3567**

MINE NAME: Red Canyon Quarry	MINE/PROSPECTING ID#: M-1985-043	MINERAL: Limestone (general)	COUNTY: Fremont
INSPECTION TYPE: Blast Monitoring	INSPECTOR(S): Timothy A. Cazier	INSP. DATE: October 9, 2015	INSP. TIME: 13:00
OPERATOR: Rocky Mountain Materials and Asphalt, Inc.	OPERATOR REPRESENTATIVE: Tom Smith	TYPE OF OPERATION: 112c - Construction Regular Operation

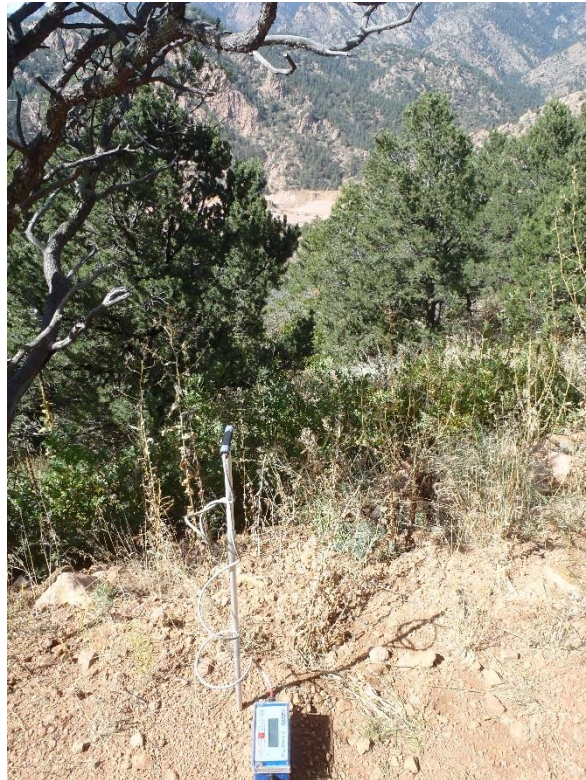
Buckley Powder set up a seismograph at the point where they initiated the blast. RMMA set up a second seismograph (see **Photo 1**) on the west side of the Complainant's residence in the same place as the previous August 18, 2015 blast, again with a clear view of, and facing the blast area (see **Photo 2**). Mr. O'Donnell observed the blast with Mr. Smith near the seismograph set up at the complainant's residence. Mr. Cazier experienced the blast in the complainant's residence at his request.

Photo 1. Seismograph setup adjacent to Complainant residence (looking NW).

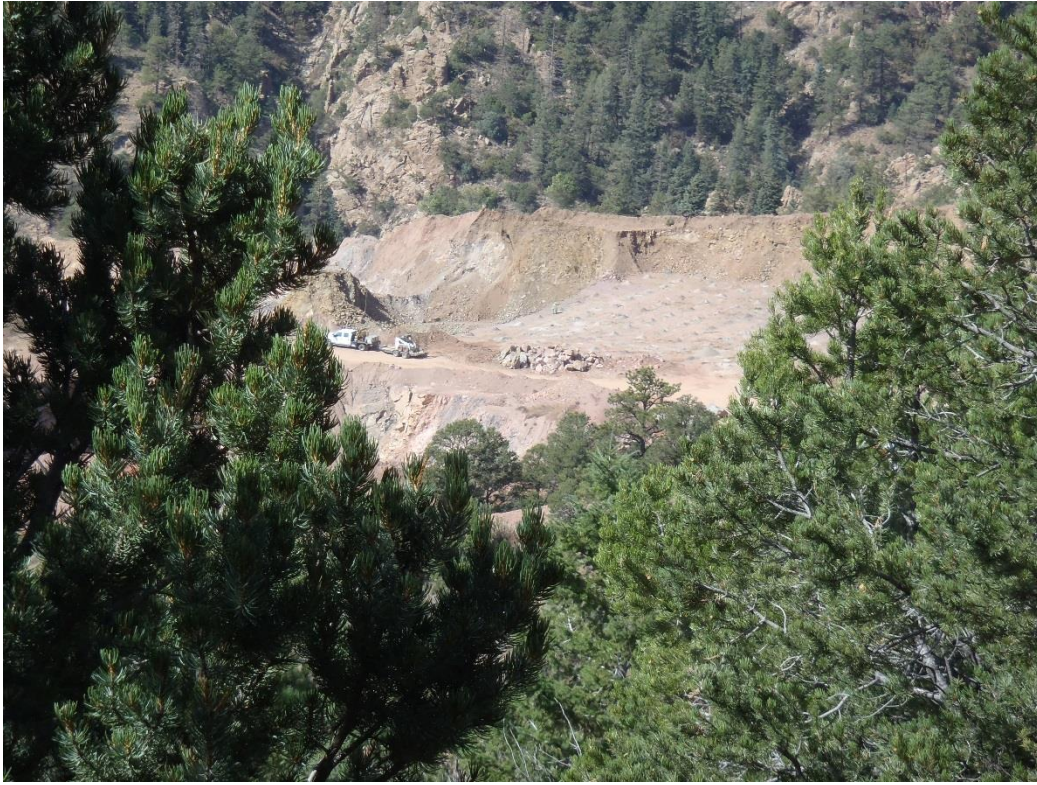
Photo 2. Telephoto view of blast area from RMMA seismograph location (looking NW).

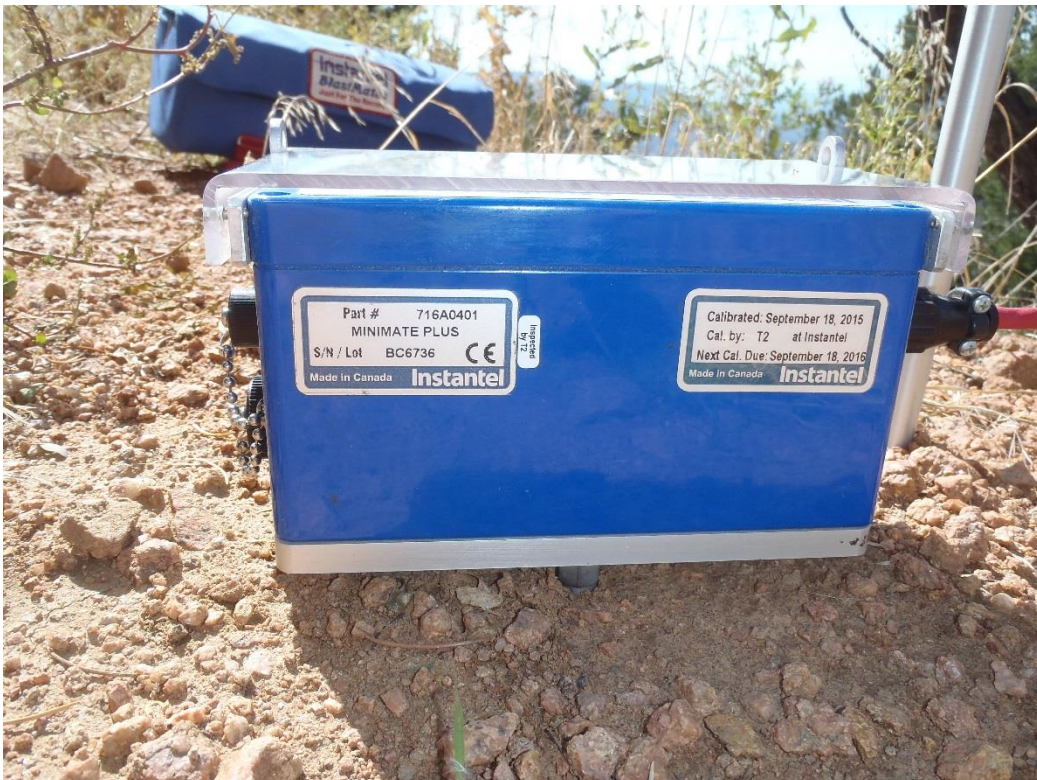
The DRMS noted RMMA's seismograph (an InstanTel Minimate Plus) was recently calibrated on September 18, 2015 (see **Photo 3**). This calibration is valid for one year.

Photo 3. Instantel Minimate Plus seismograph with valid calibration tag.

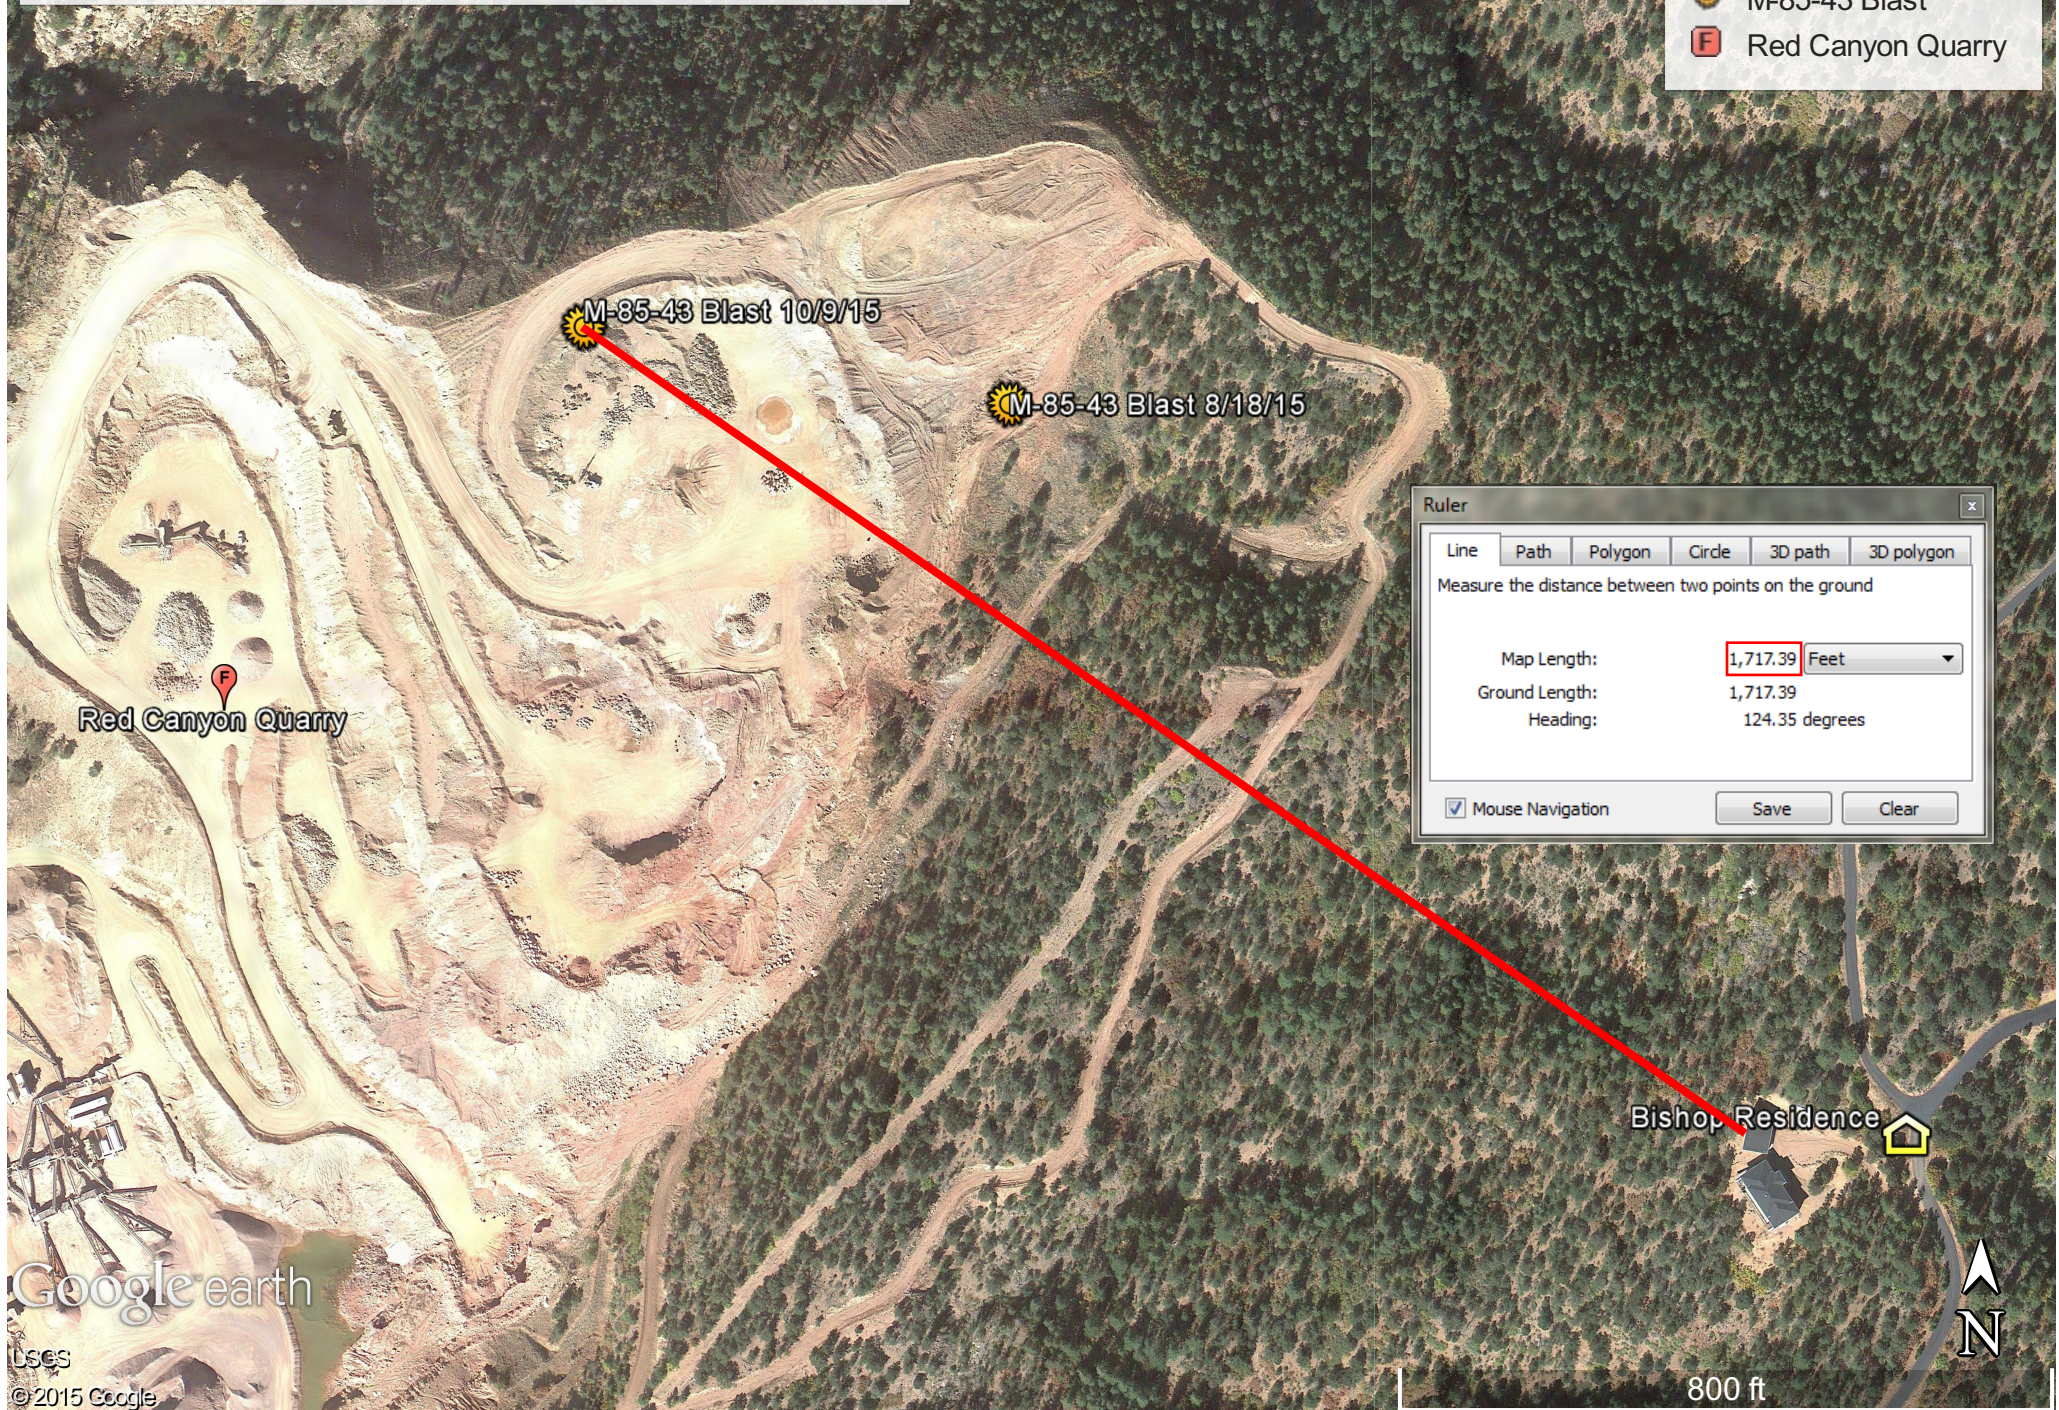
Figure 1. October 9 Blast Monitoring

Based on the blast area coordinates included in Buckley's blast report (attached), the RMMA seismograph was set up approximately 1,720 feet southeast (and upgradient) of the blast site (see **Figure 1**).

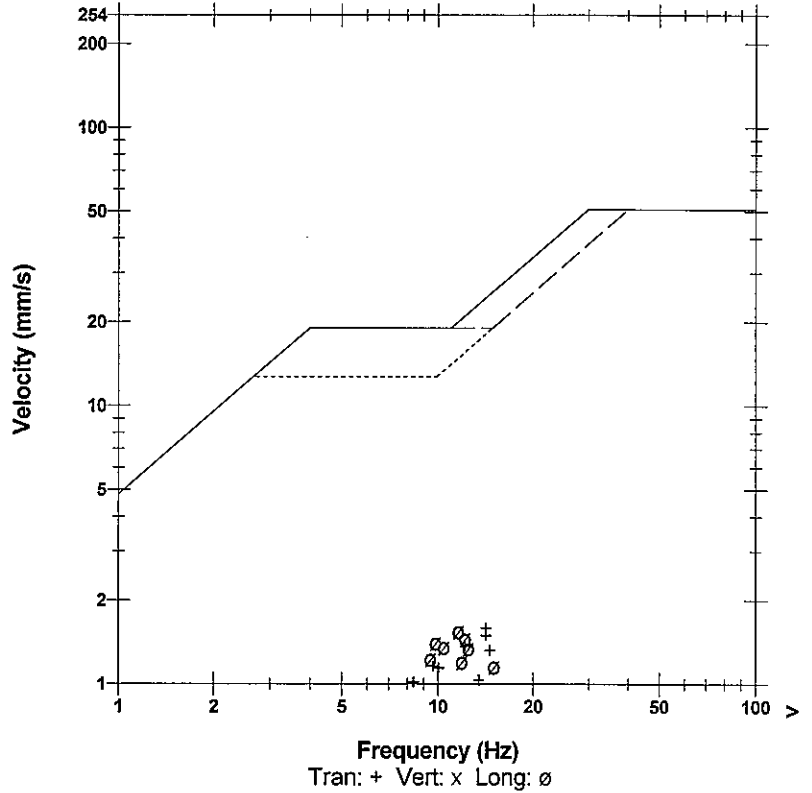
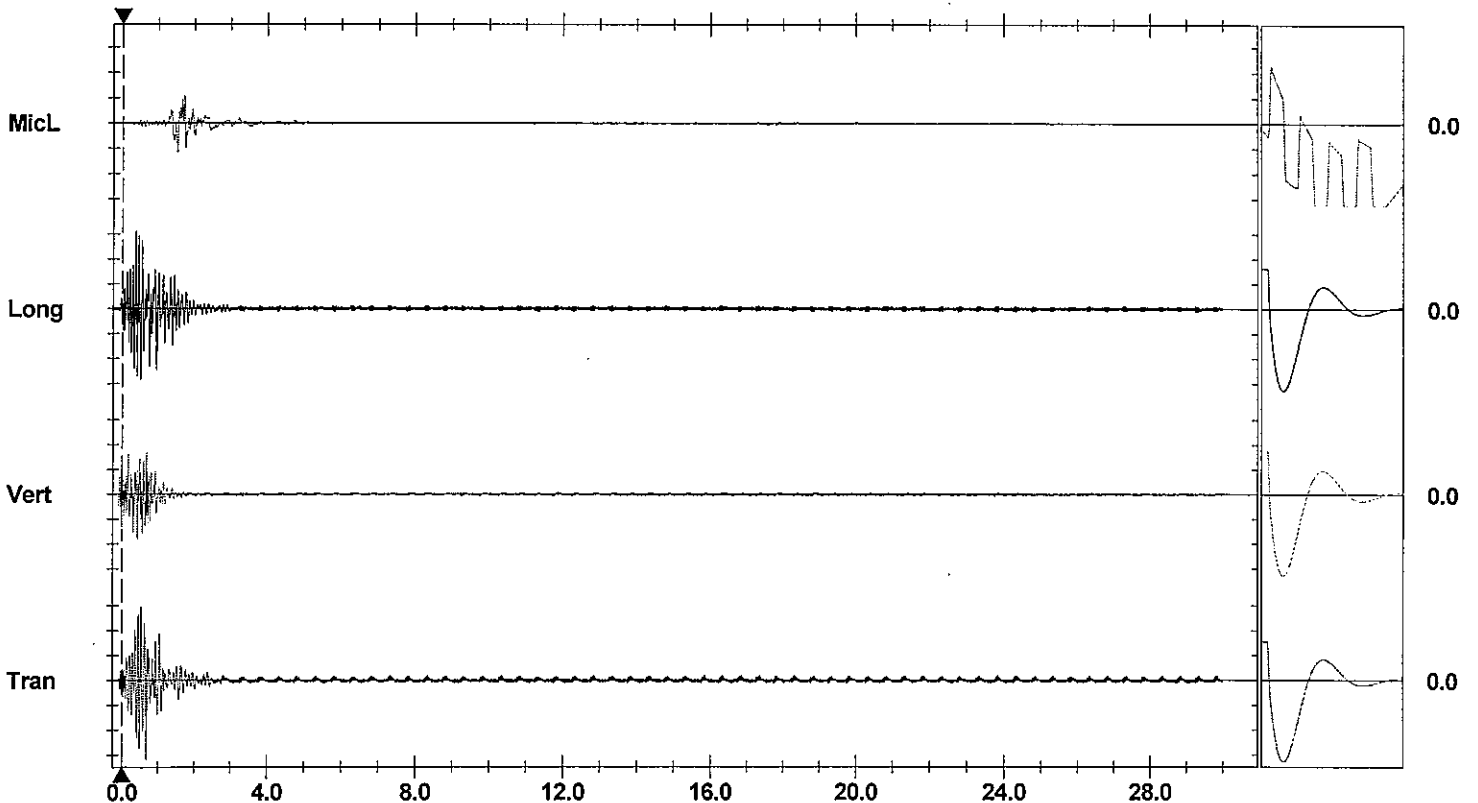
Microphone Linear Weighting
 PSPL 12.0 pa.(L) at 1.519 sec
 ZC Freq 6.6 Hz
 Channel Test Passed (Freq = 20.1 Hz Amp = 663 mv)

Tran	Vert	Long	
PPV	1.59	0.921	1.56	mm/s
ZC Freq	14	17	12	Hz
Time (Rel. to Trig)	0.692	0.440	0.376	sec
Peak Acceleration	0.0199	0.0215	0.0182	g
Peak Displacement	0.0167	0.00824	0.0195	mm
Sensor Check	Passed	Passed	Passed	
Frequency	7.2	7.5	7.3	Hz
Overswing Ratio	4.0	3.4	3.7

Peak Vector Sum 1.97 mm/s at 0.546 sec

1. RMMA should make efforts to limit air blasts to 110 dBL (or 6.3 pascals or 0.00091 psi) if possible.
2. Based on the Complainant's response and the blast monitoring data, this particular blast would not have initiated a complaint.
