**COLORADO DIVISION OF RECLAMATION, MINING AND SAFETY**  
**MINERALS PROGRAM INSPECTION REPORT**  
**PHONE: (303) 866-3567**

<b>MINE NAME:</b> Craig Ranch Pit	<b>MINE/PROSPECTING ID#:</b> M-1986-002	<b>MINERAL:</b> Sand and gravel	<b>COUNTY:</b> Mesa
<b>INSPECTION TYPE:</b> Monitoring	<b>INSPECTOR(S):</b> Stephanie J. Mitchell	<b>INSP. DATE:</b> October 28, 2015	<b>INSP. TIME:</b> 14:00
<b>OPERATOR:</b> Oldcastle SW Group, Inc. dba United Compai County	<b>OPERATOR REPRESENTATIVE:</b> Jason Burkey	<b>TYPE OF OPERATION:</b> 112c - Construction Regular Operation

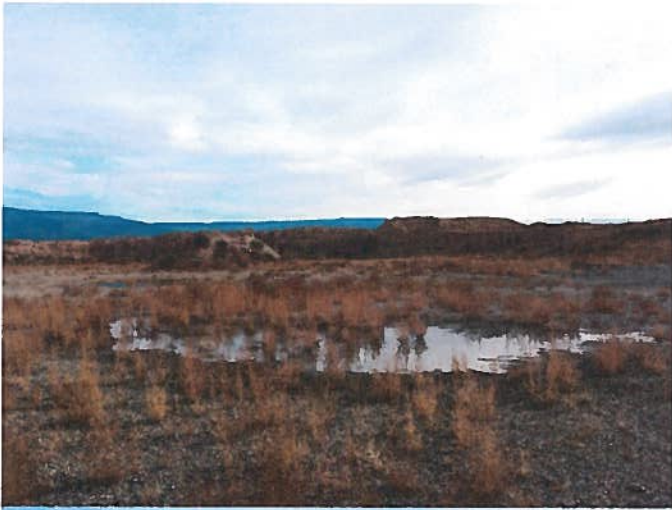
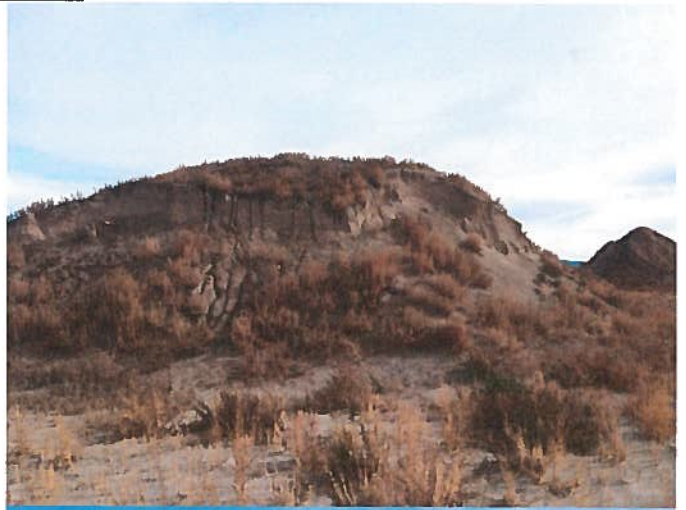
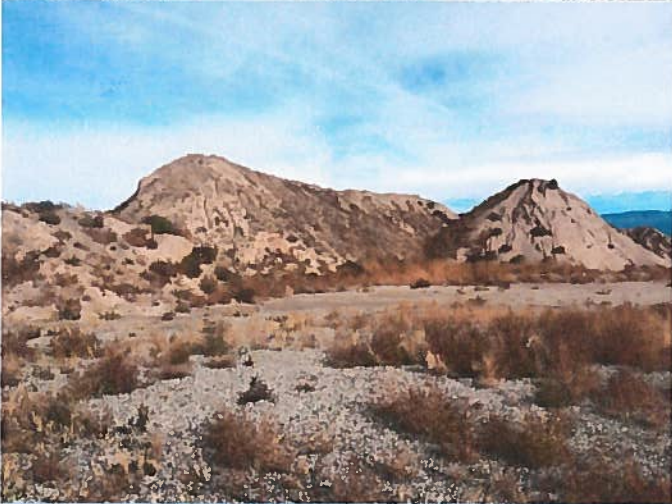
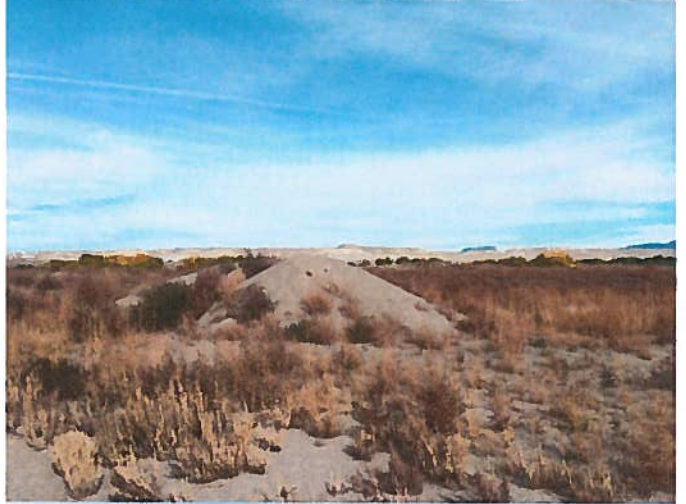
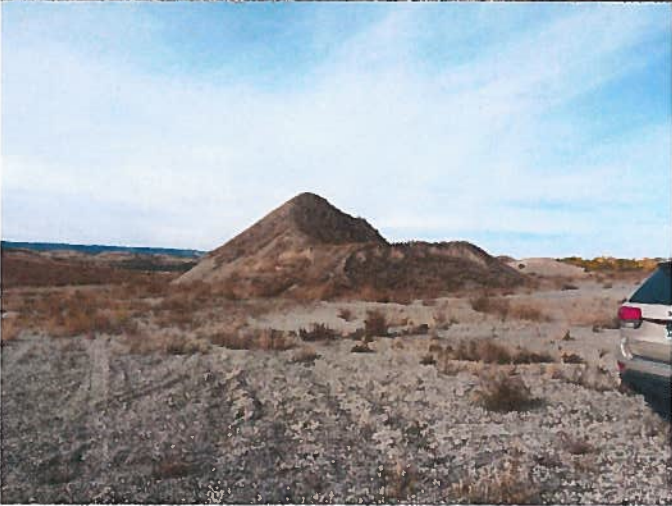
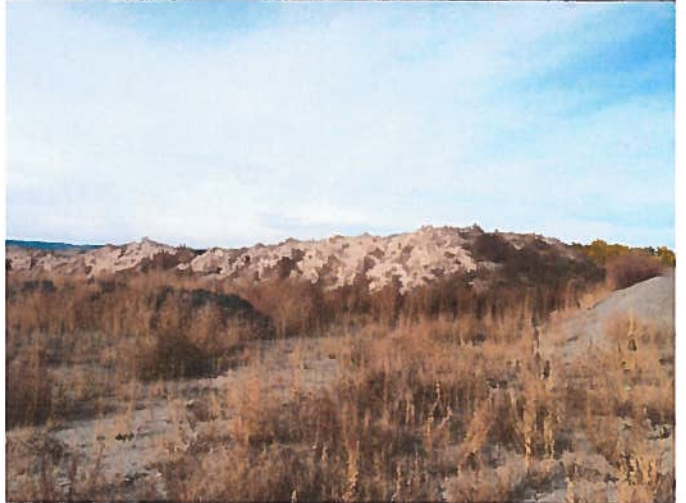
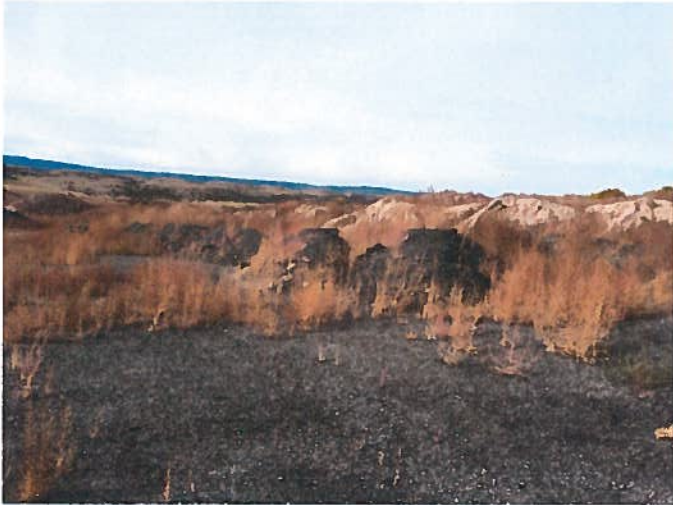
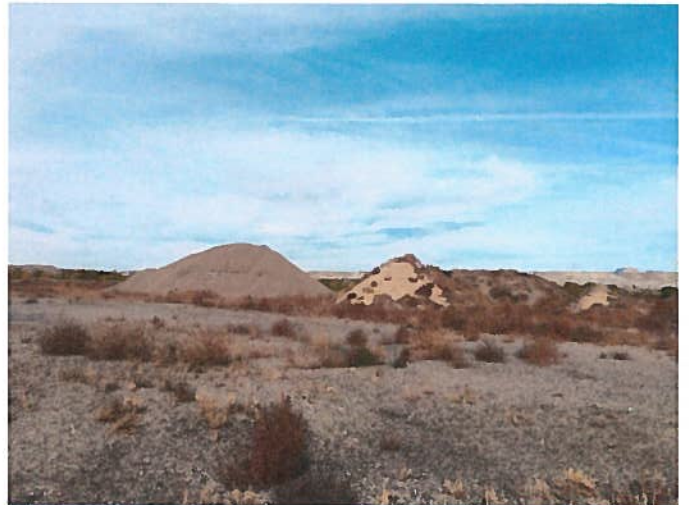
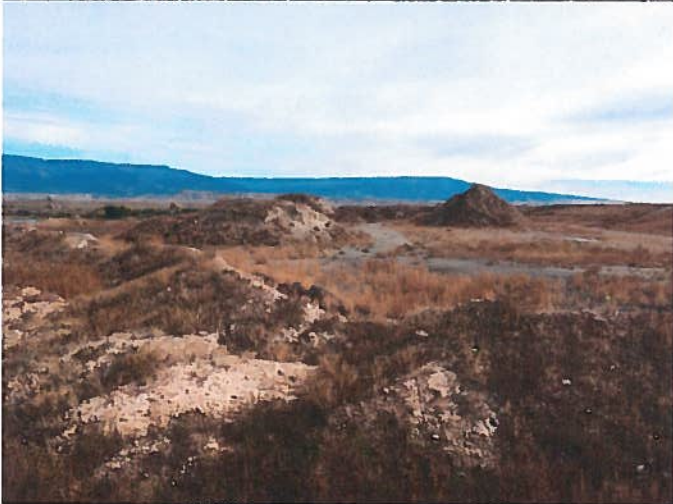
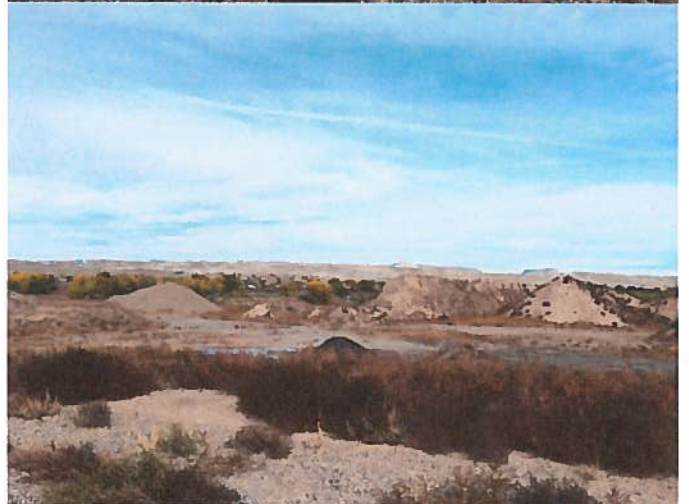
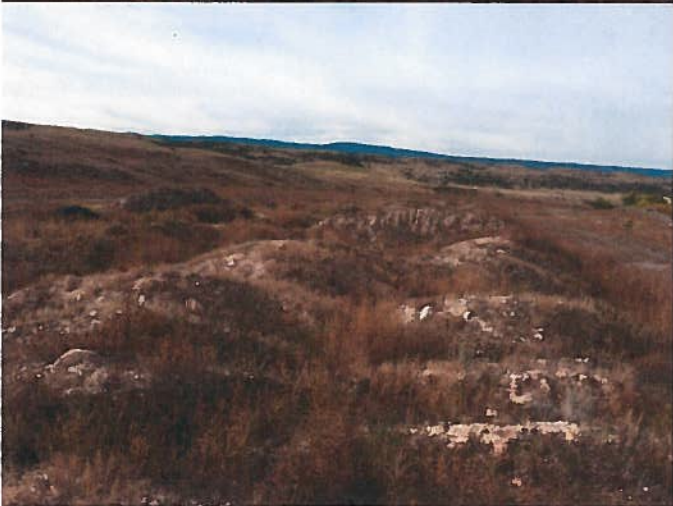
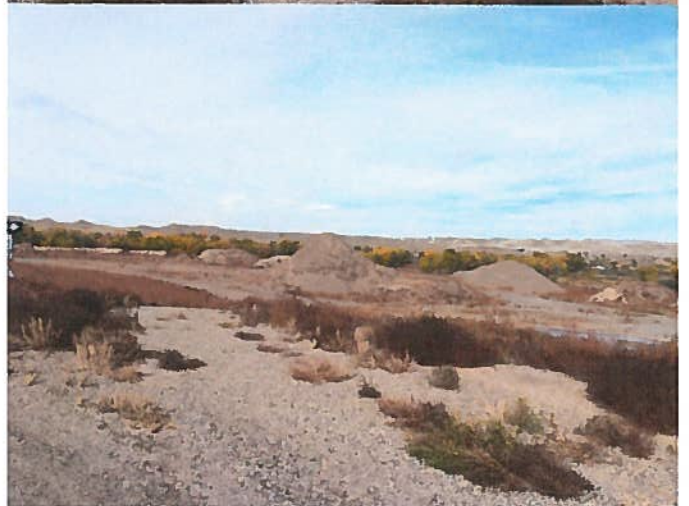
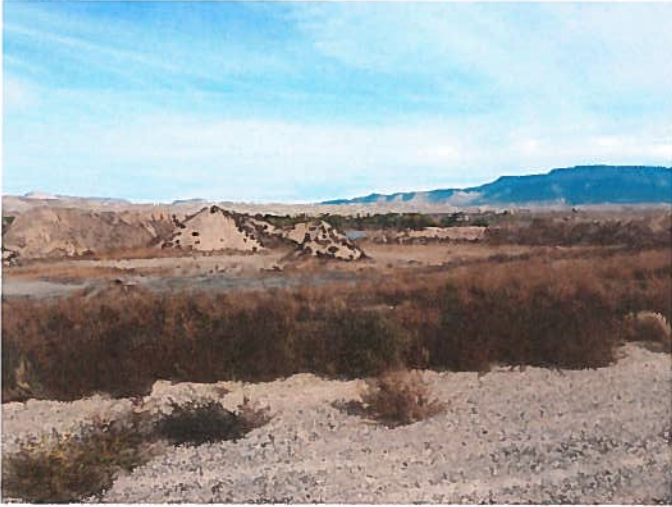
**PHOTOGRAPHS**

The Mine Identification sign was not at the entrance to the mine site in compliance per Rule 3.1.12 (2). This is cited as a problem at the beginning of this inspection report.

The current disturbance is located in the northern portion of the permit area and is approximately 14 acres in size, and moving to the west. The excavation is about 25 feet deep with a vertical highwall with an eastern The highwall appears to be in the center of the permit area. Topsoil has been stripped and is stockpiled as a berm along the northern part of the permit boundary of the site and is stabilized with vegetative cover. No erosion or sedimentation issues were observed.

There was some water present on the site, but was from a recent rain event. It appeared that it would not be retained for more than 72 hours.

There was no equipment or fuel on site.

**CORRECTIVE ACTIONS:** The operator shall, at the entrance of the mine site, post a sign which shall be clearly visible from the access road with the following: the name of the operator, a statement that a reclamation permit for the operation has been issued by the Colorado Mined Land Reclamation Board; and the permit number. The operator shall submit photo documentation that a proper sign has been posted by the corrective action date.
