Subject: Weekly Construction Quality Assurance ("CQA") Report:
AMEC: Squaw Gulch (VLF) – Weeks ending 10/17/15, 10/24/15 and 10/31/15.

**CRIPPLE CREEK & VICTOR GOLD MINING Co.
ANGLOGOLD ASHANTI (COLORADO)
SQUAW GULCH (VLF) WEEKLY REPORT**

Owner:	Cripple Creek & Victor Gold Mining Co.	Project Number:	74201125N0
Project:	Squaw Gulch Valley Leach Fill (VLF)	Week Ending:	October 17, 2015
Location:	Cripple Creek & Victor Gold Mine, CO		
Contractor:	Ames Construction, Inc.

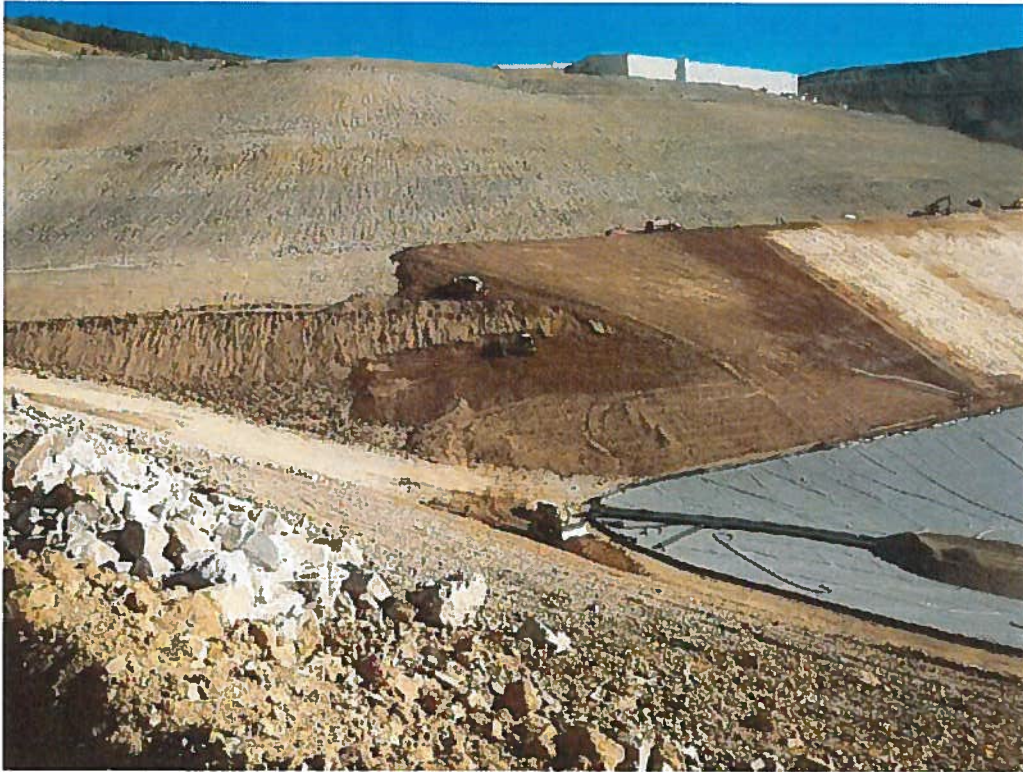
Phase 1 – SLF placement.

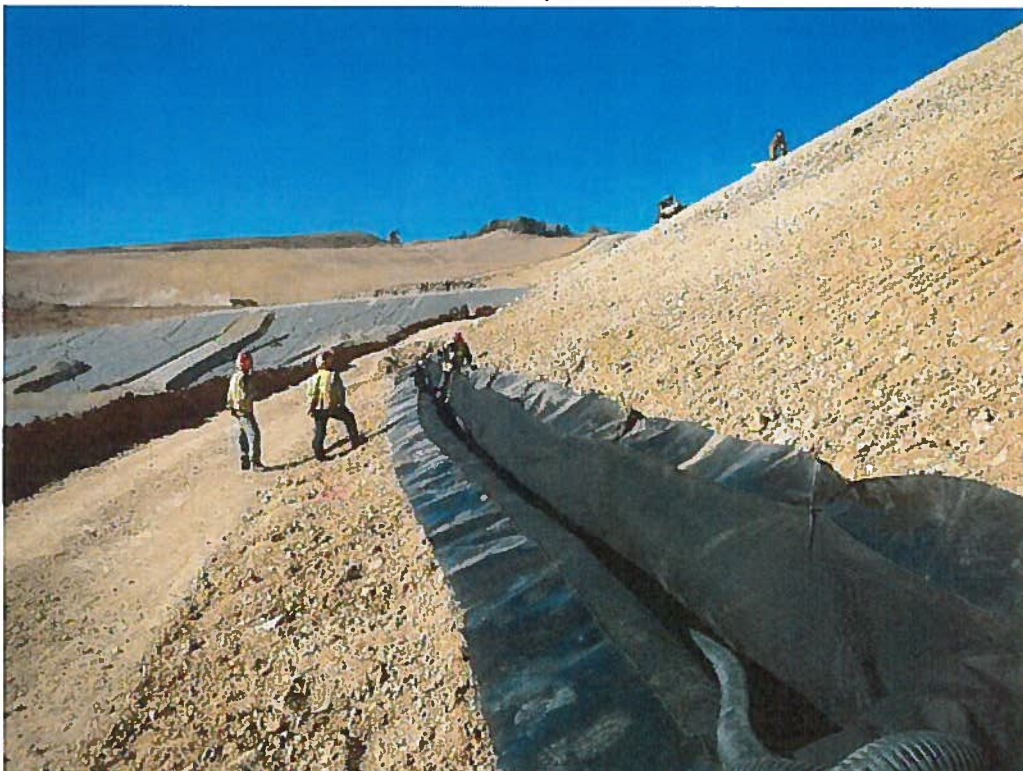
Phase 1 – Leak Detection installation.

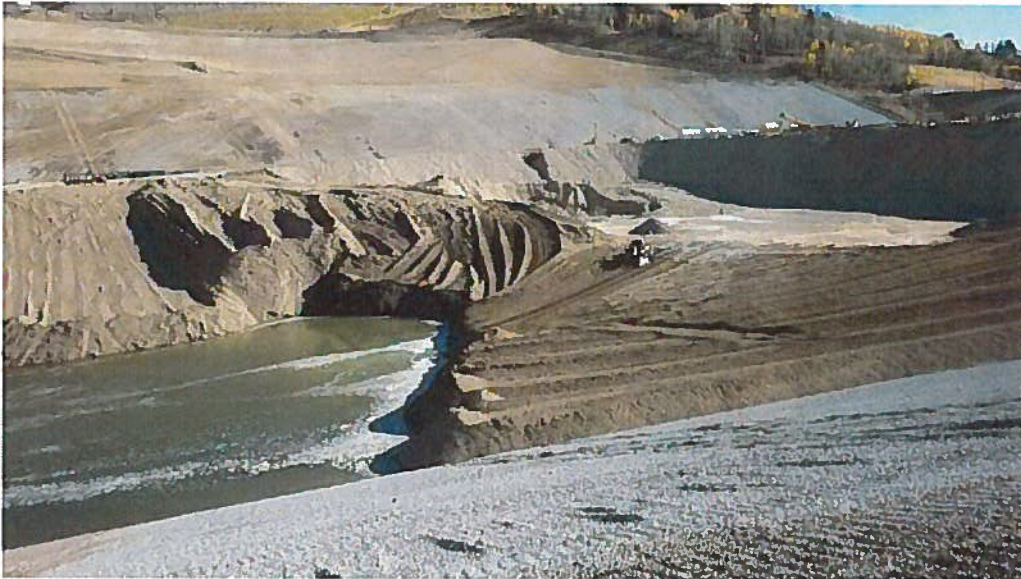
PSSA – Spent Ore grading.

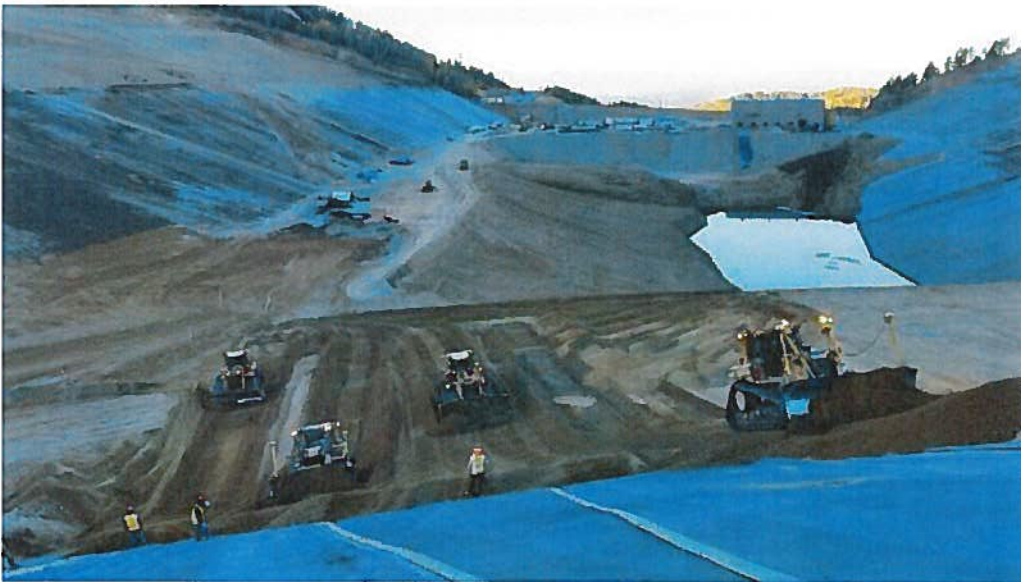
Phase 1 – DCF placement.

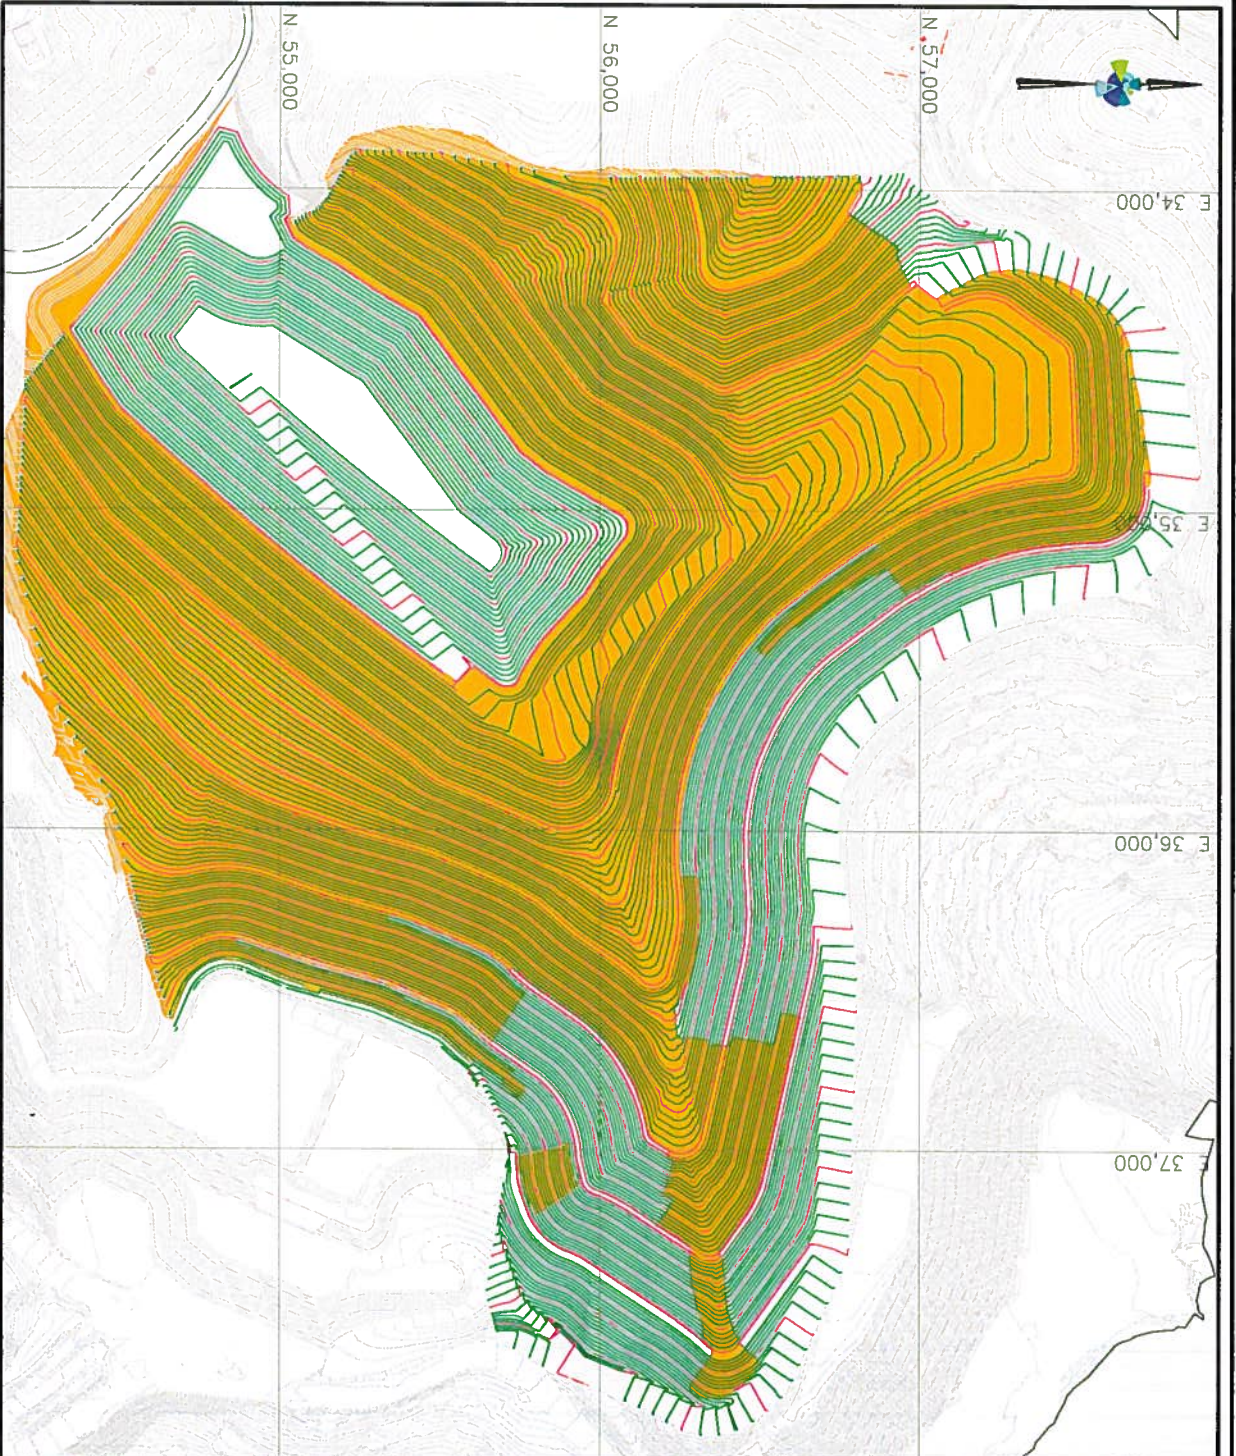
SUBGRADE ACCEPTANCE AREA

CLIENT	CRIPPLE CREEK & VICTOR MINING COMPANY
PROJECT	SQUAW GULCH VALLEY LEACH FACILITY
TITLE	WEEKLY ACCEPTANCE AREAS WEEK ENDING 10-17-15

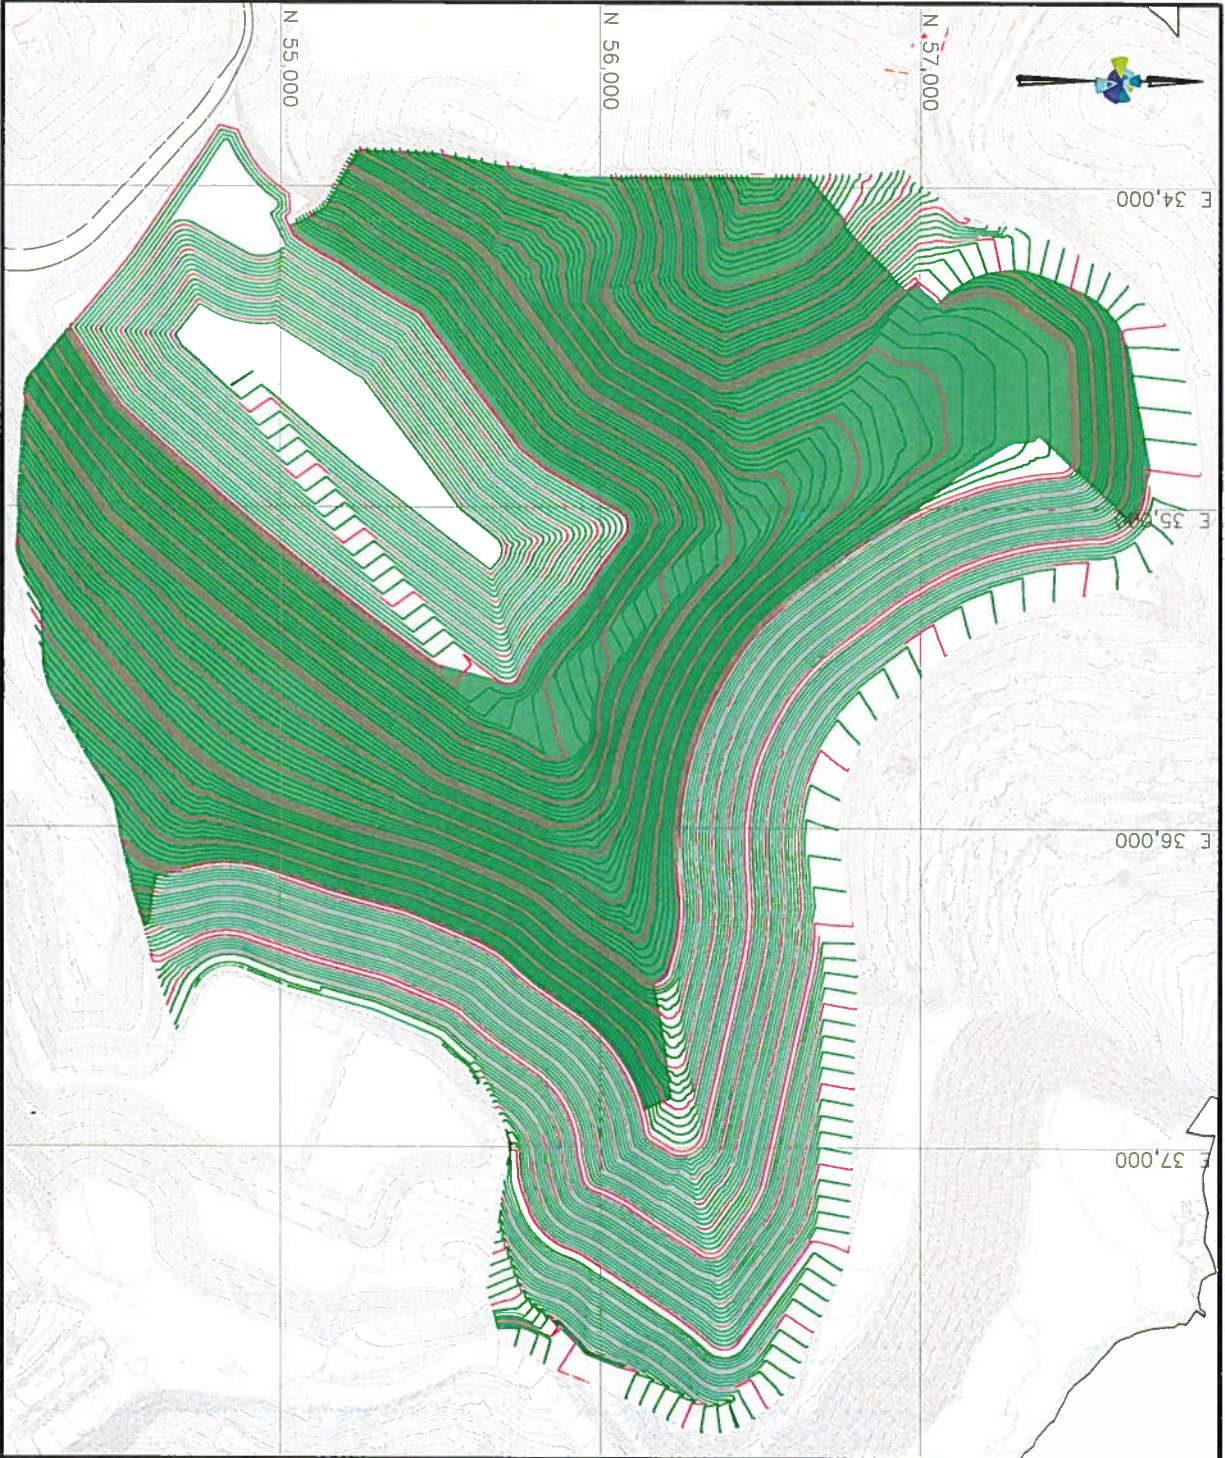
LEGEND
SLF ACCEPTANCE AREA

CLIENT	CRIPPLE CREEK & VICTOR MINING COMPANY
PROJECT	SQUAW GULCH VALLEY LEACH FACILITY
TITLE	WEEKLY ACCEPTANCE AREAS WEEK ENDING 10-17-15

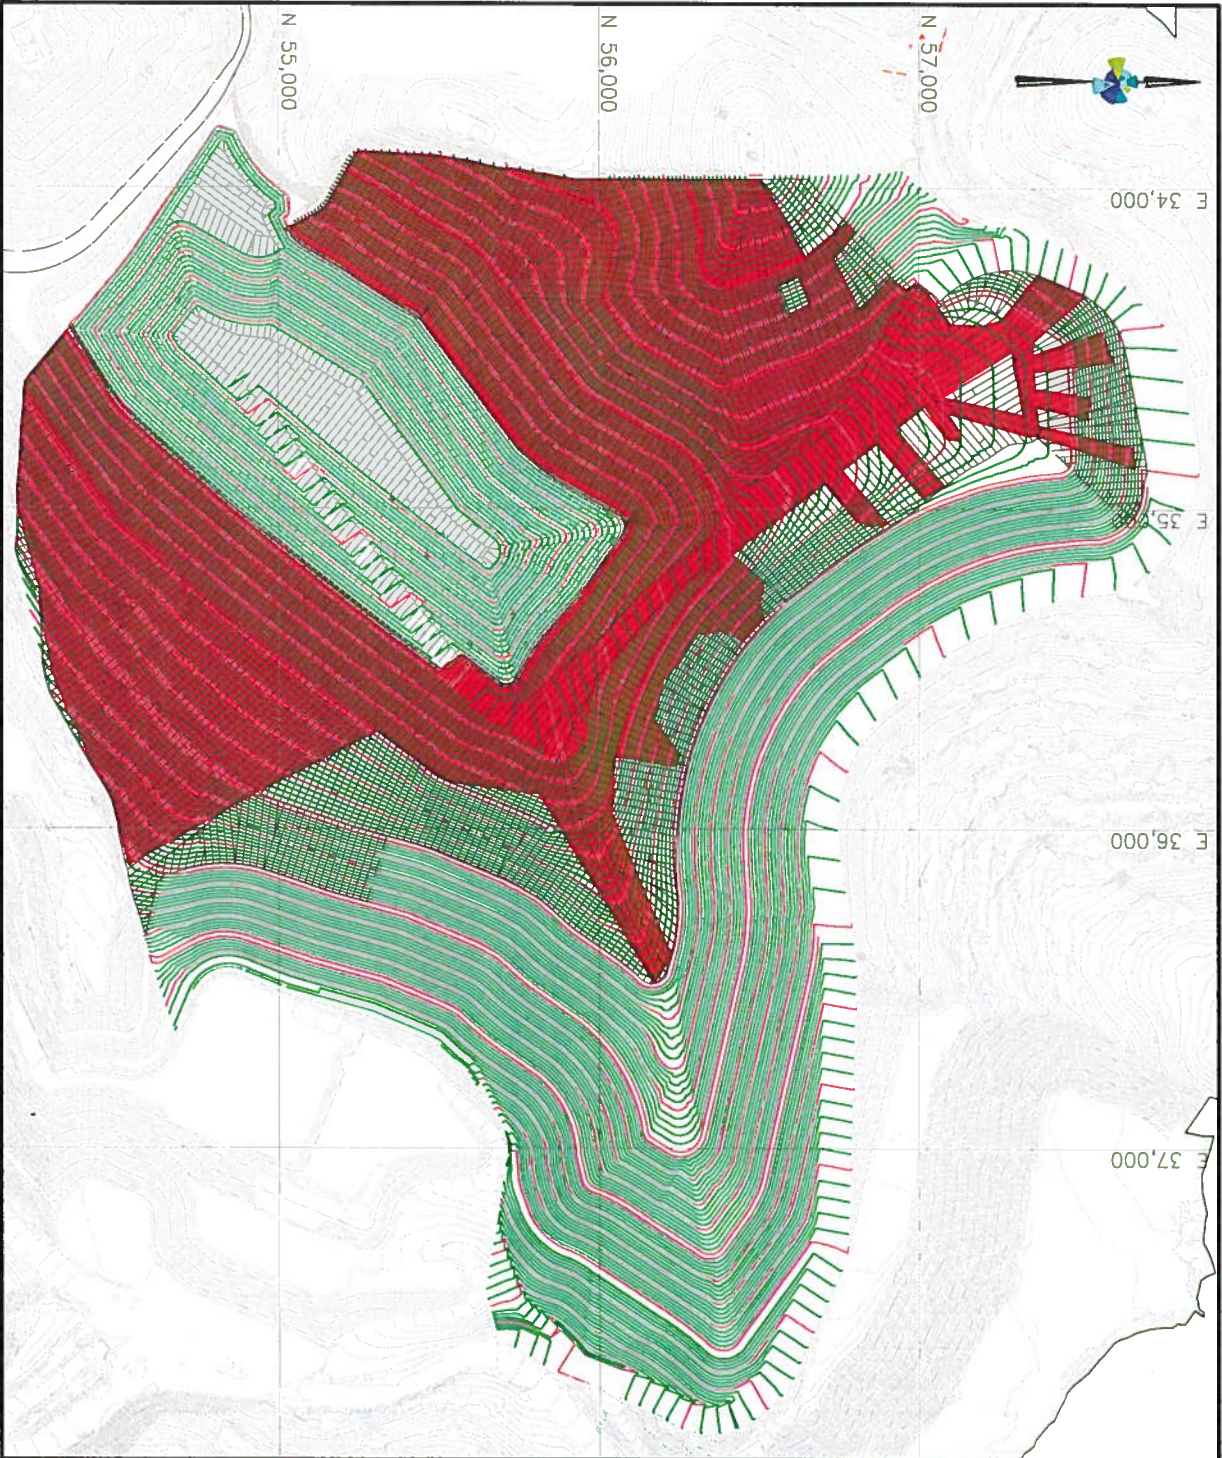
LEGEND
DCF ACCEPTANCE AREA

CHK BY RBR	CLIENT CRIPPLE CREEK & VICTOR MINING COMPANY	ISSUED DATE 10/21/15
APR BY ALM	PROJECT SQUAW GULCH VALLEY LEACH FACILITY	PROJECT No. 74201125N0
DRN BY RBR	TITLE WEEKLY ACCEPTANCE AREAS WEEK ENDING 10-17-15	FIGURE No. 1
DSN BY RBR		REV 0

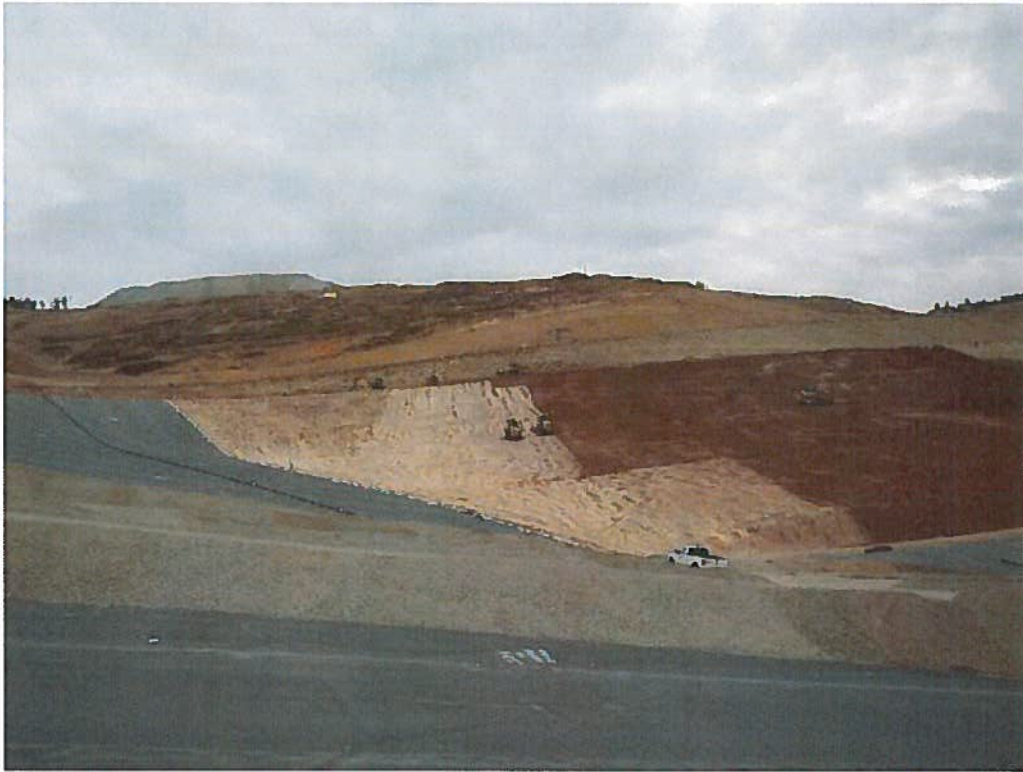
Phase 1 – SLF placement and compaction.

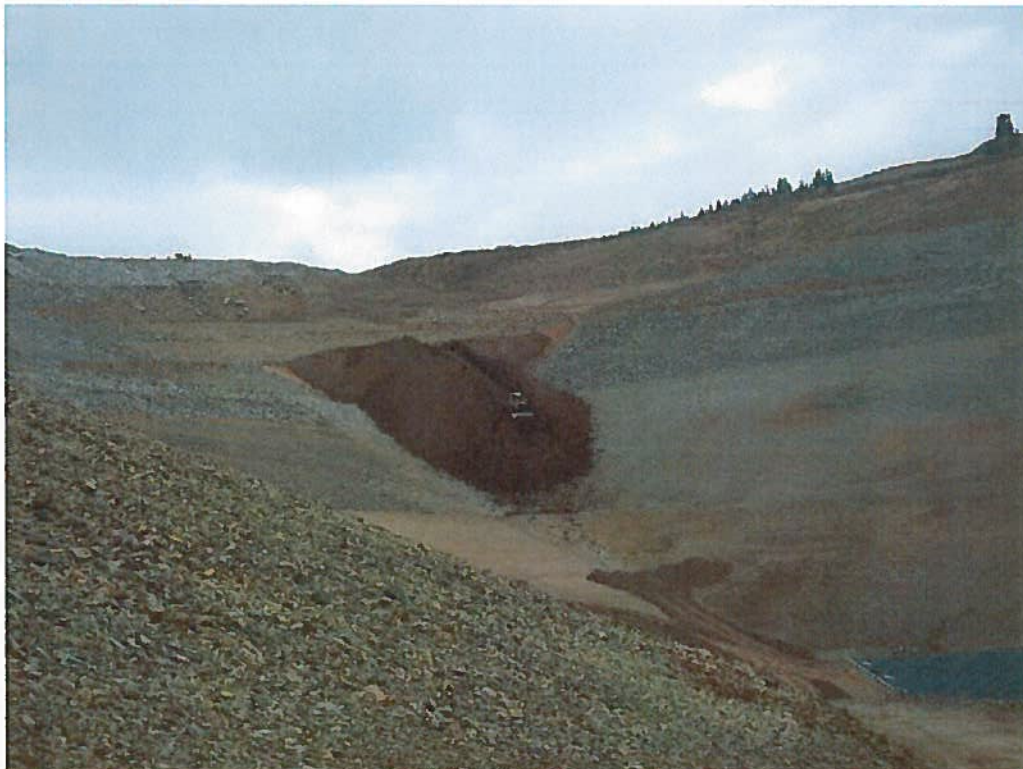
Phase 1 – Temporary SLF road construction and SLF stockpile.

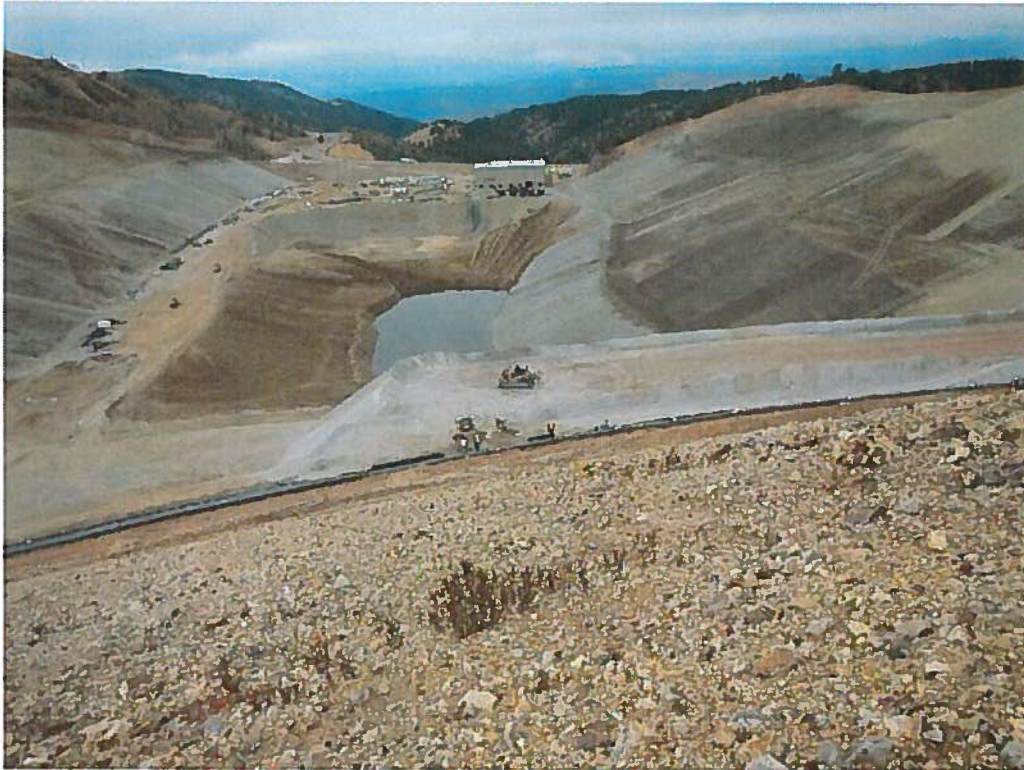
PSSA – DCF and Crushed Ore placement.

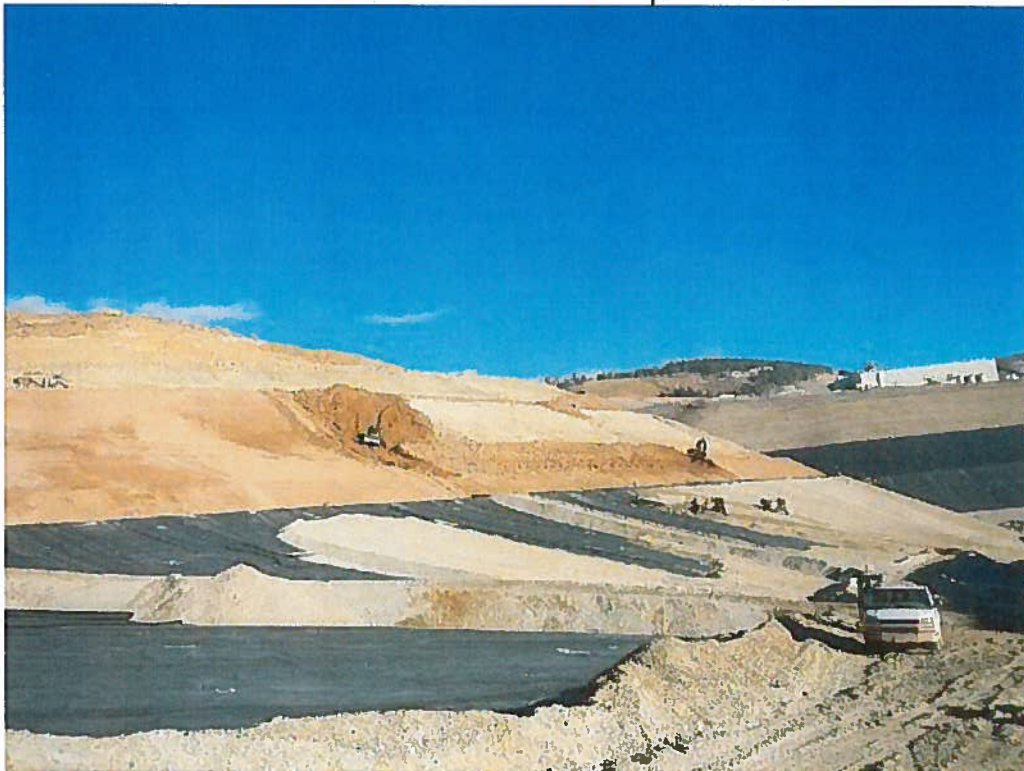
Phase 1 – DCF placement and SLF placement.

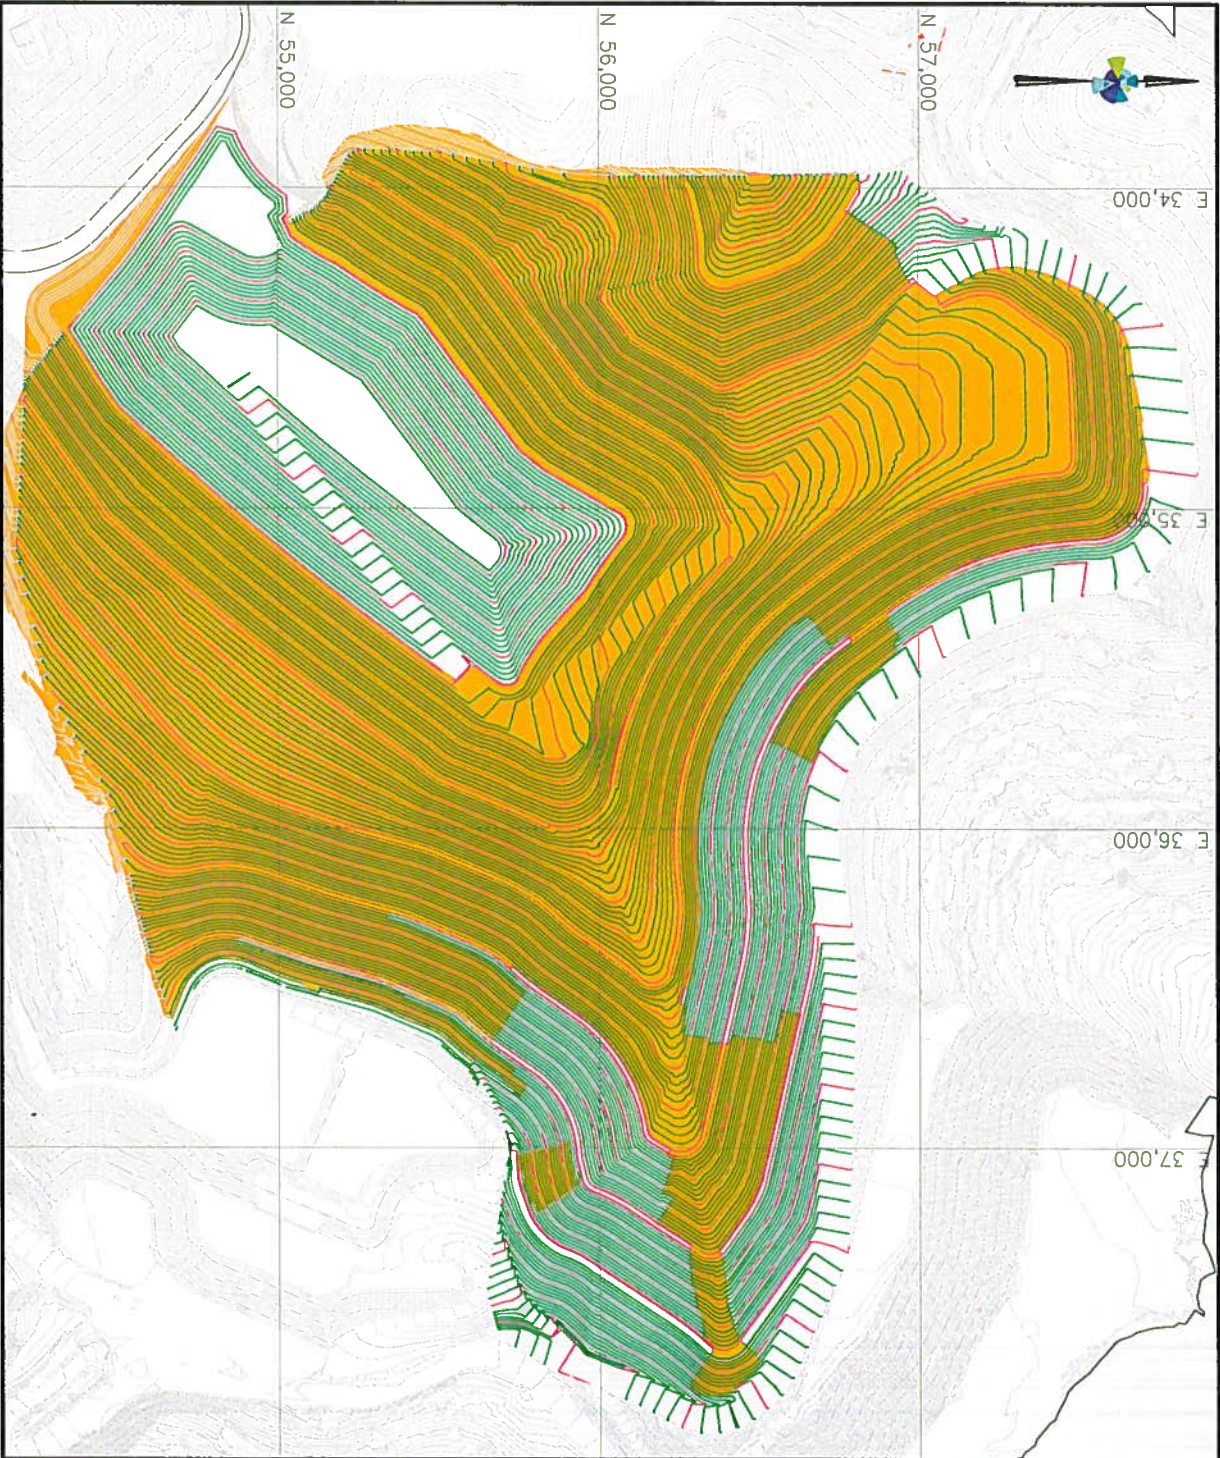
LEGEND
SUBGRADE ACCEPTANCE AREA

CHK BY RBR	CLIENT CRIPPLE CREEK & VICTOR MINING COMPANY	ISSUED DATE 10/28/15
APR BY ALM	DRN BY RBR	DSN BY RBR	PROJECT SQUAW GULCH VALLEY LEACH FACILITY	PROJECT No. 74201125NO
TITLE WEEKLY ACCEPTANCE AREAS WEEK ENDING 10-24-15			FIGURE No. 1	REV 0

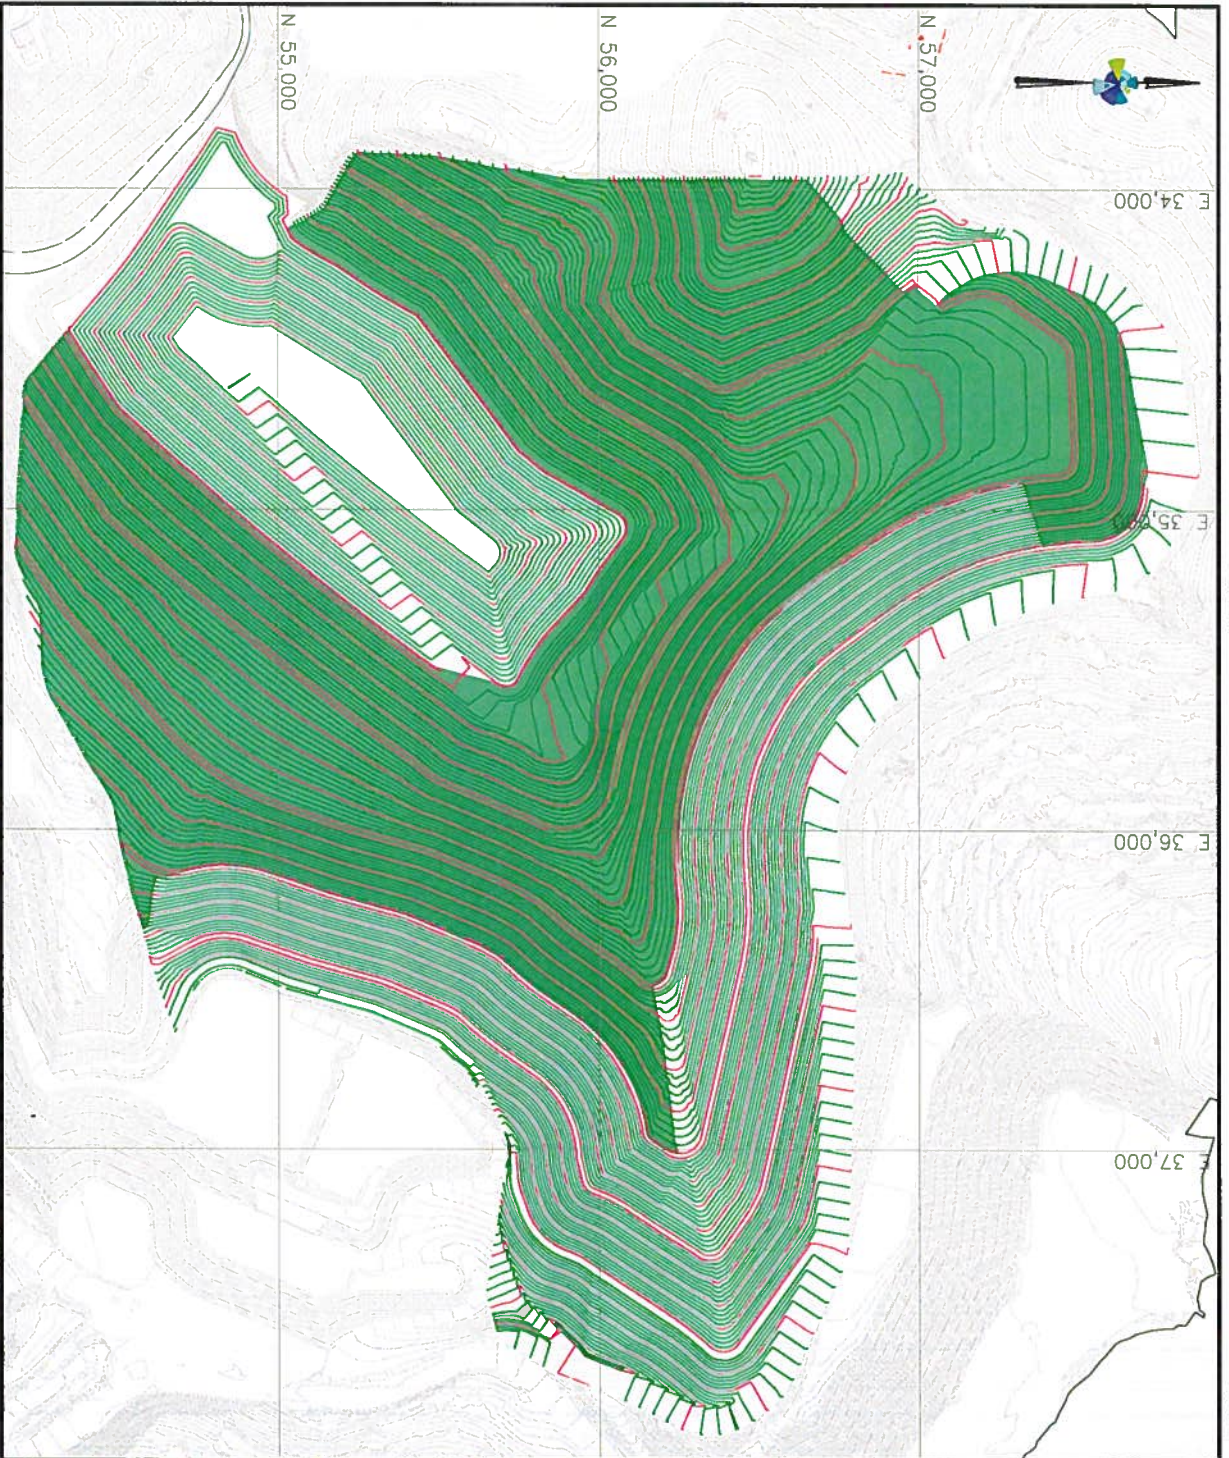
LEGEND
SLF ACCEPTANCE AREA

CHK BY RBR	CLIENT CRIPPLE CREEK & VICTOR MINING COMPANY	ISSUED DATE 10/28/15
APR BY ALM	PROJECT SQUAW GULCH VALLEY LEACH FACILITY	PROJECT No. 74201125N0
DRN BY RBR	TITLE WEEKLY ACCEPTANCE AREAS WEEK ENDING 10-24-15	FIGURE No. 1
DSN BY RBR		REV 0

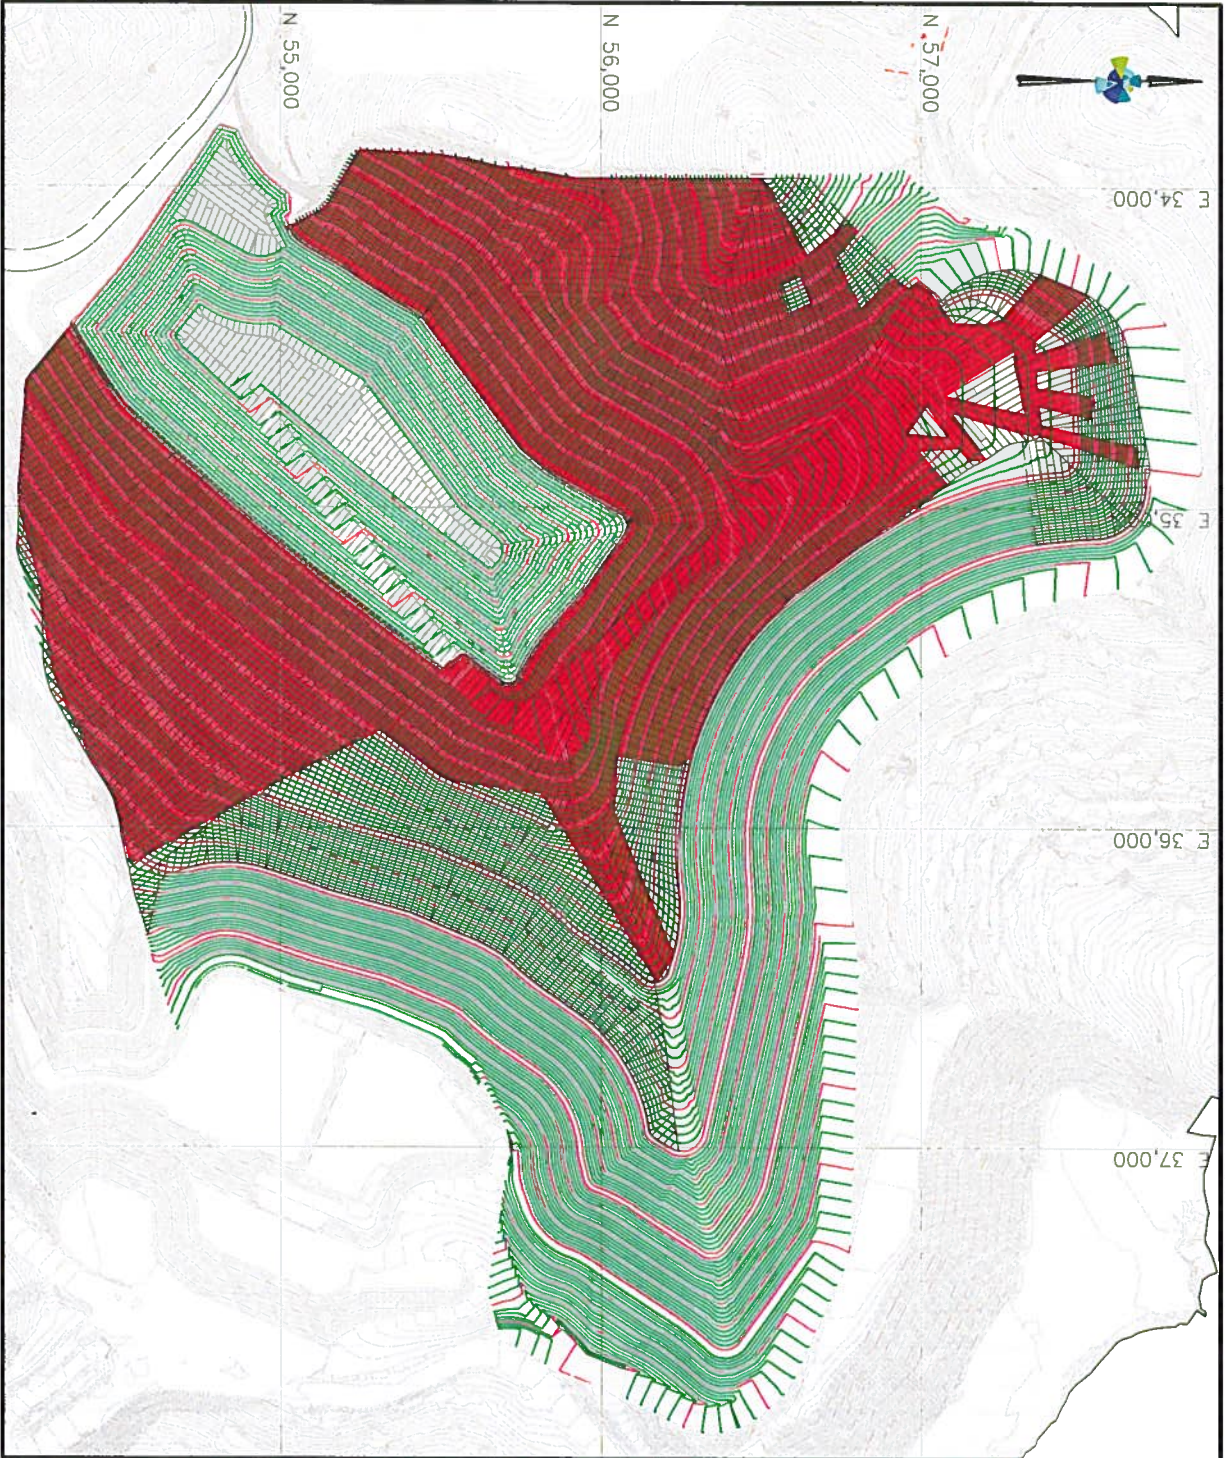
LEGEND
DCF ACCEPTANCE AREA

CHK BY RBR	CLIENT CRIPPLE CREEK & VICTOR MINING COMPANY	ISSUED DATE 10/28/15
APR BY ALM	PROJECT SQUAW GULCH VALLEY LEACH FACILITY	PROJECT No. 74201125NO
DRN BY RBR	TITLE WEEKLY ACCEPTANCE AREAS WEEK ENDING 10-24-15	FIGURE No. 1
DSN BY RBR		REV 0

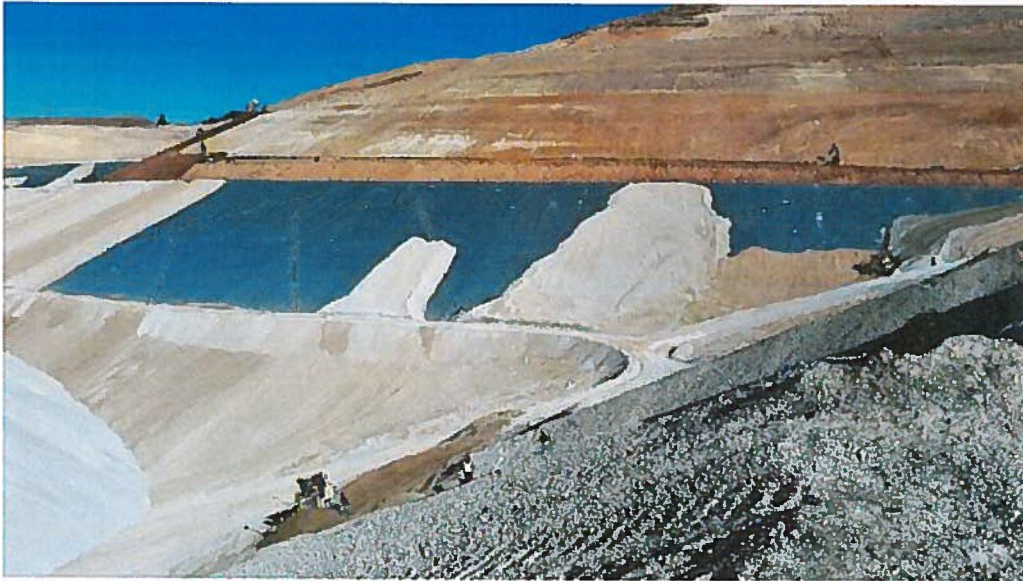
Phase 1 – DCF placement, leak detection excavation and SLF haul.

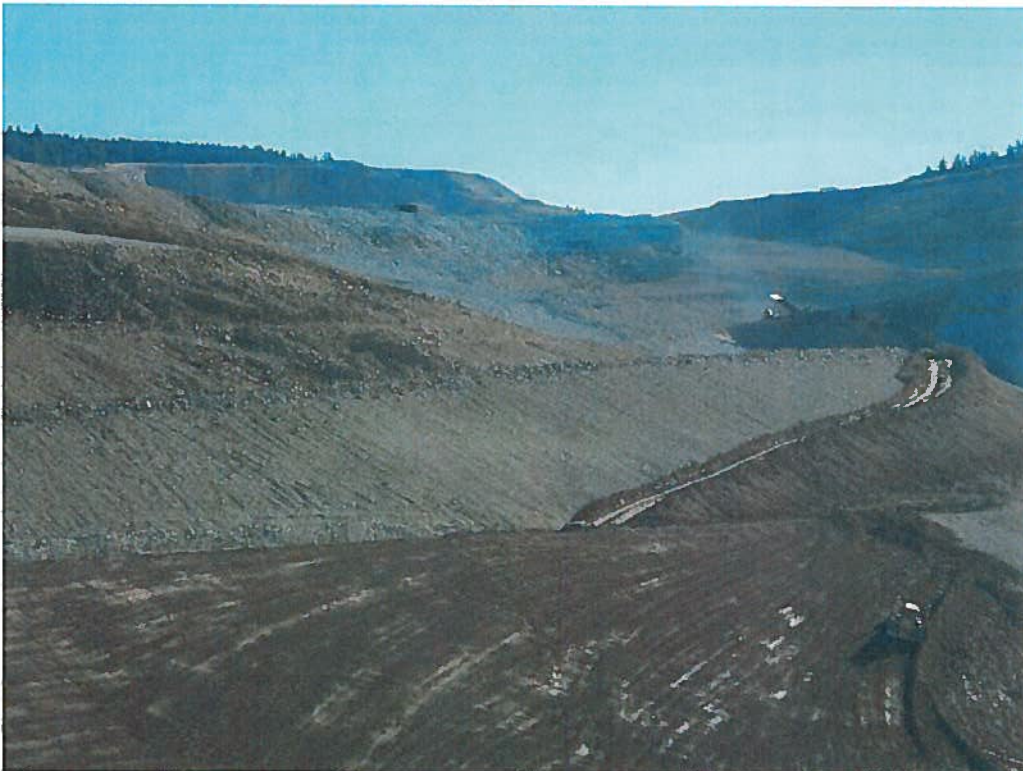
Phase 1 – SLF placement and SLF stockpile.

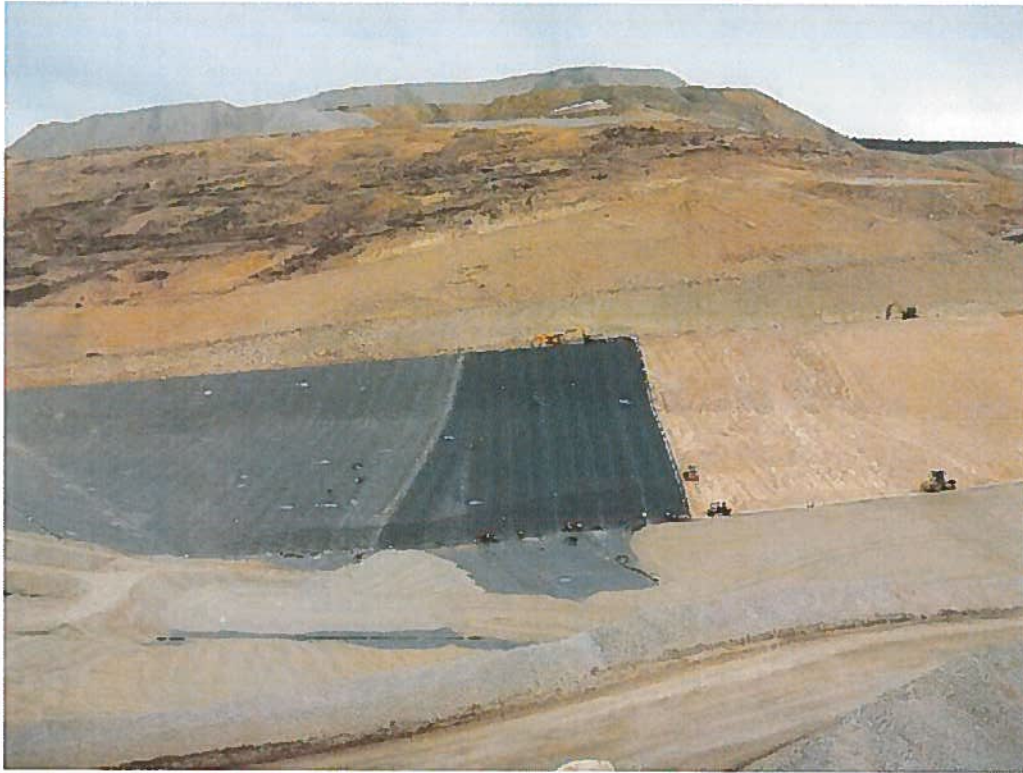
Phase 1 – Geomembrane deployment.

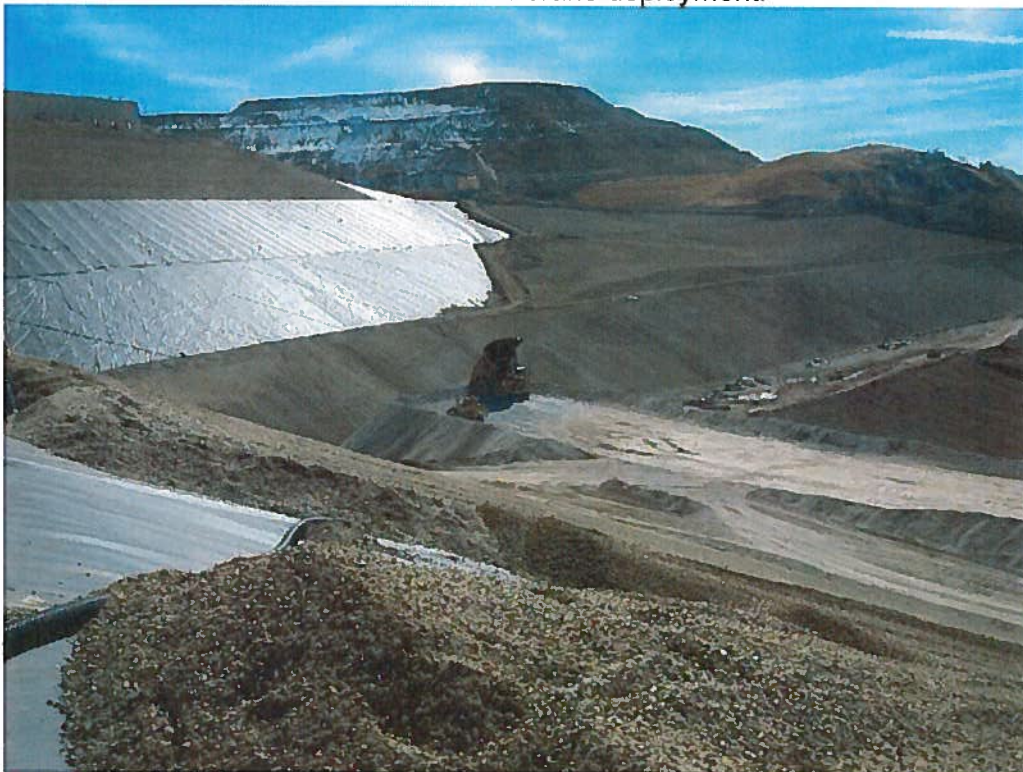
Phase 1 – Crushed Ore haul.

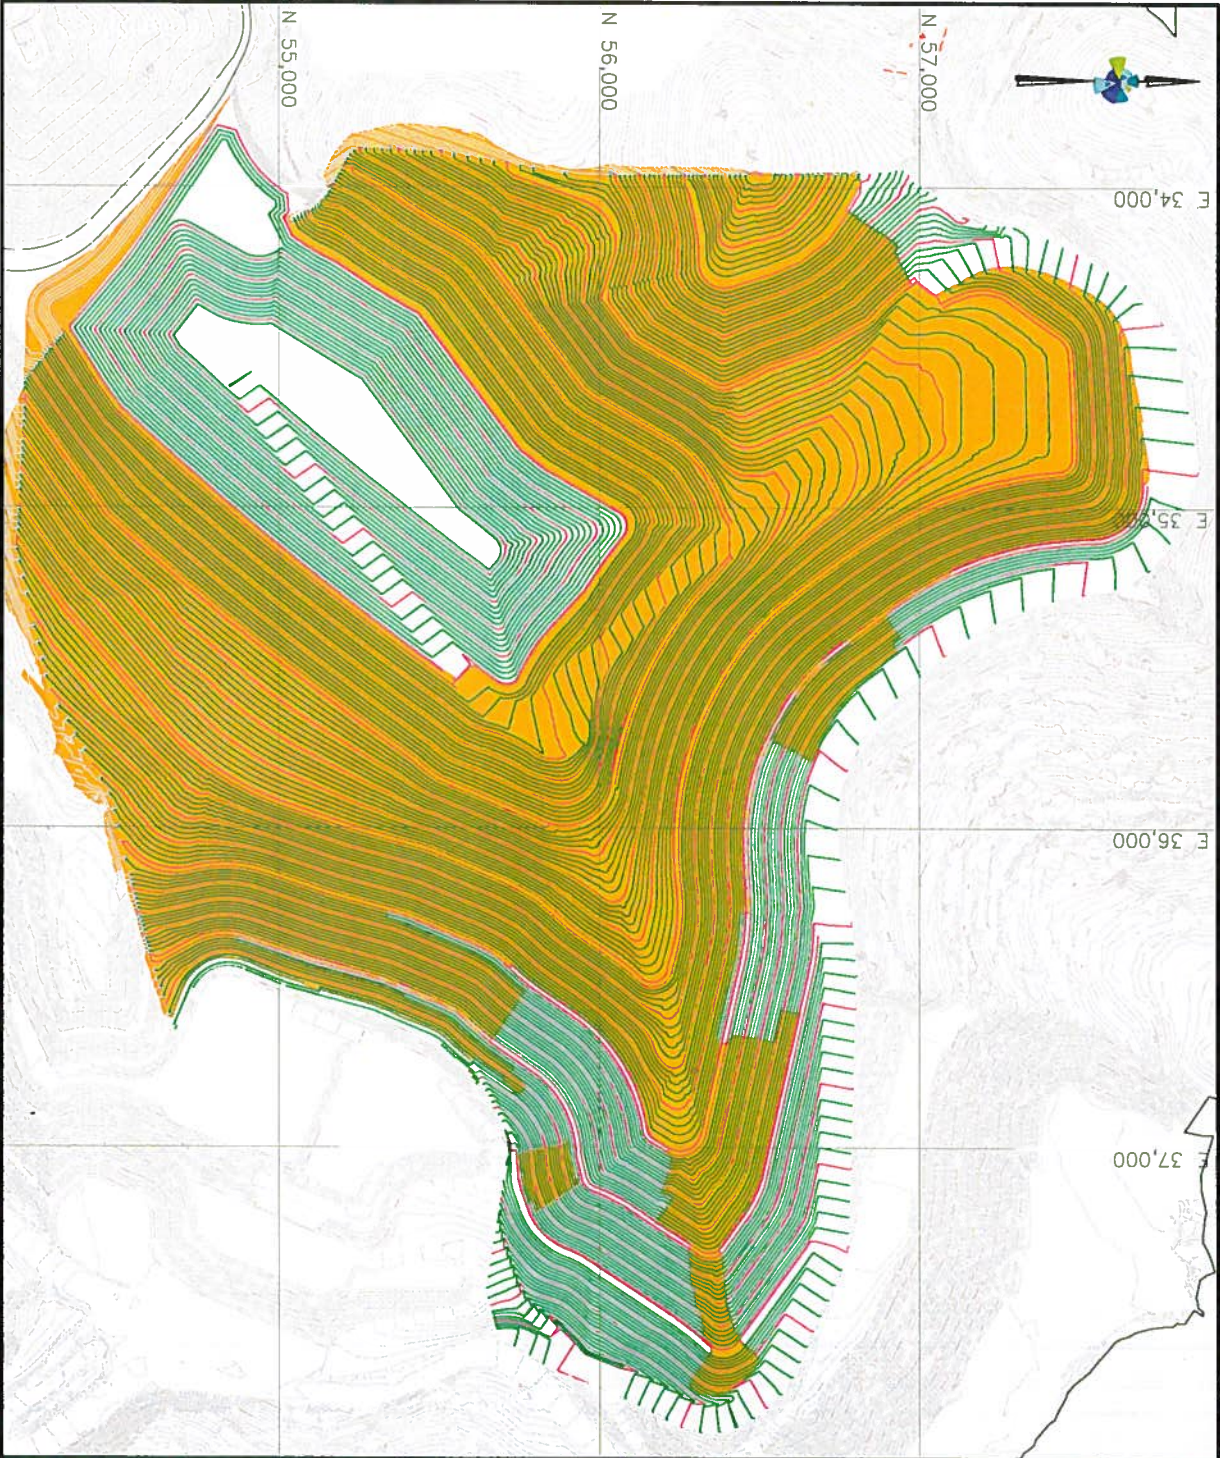
LEGEND
SUBGRADE ACCEPTANCE AREA

CHK BY RBR	CLIENT CRIPPLE CREEK & VICTOR MINING COMPANY	ISSUED DATE 11/04/15
APR BY ALM	PROJECT SQUAW GULCH VALLEY LEACH FACILITY	PROJECT No. 74201125NO
DRN BY RBR	TITLE WEEKLY ACCEPTANCE AREAS WEEK ENDING 10-31-15	FIGURE No. 1
DSN BY RBR		REV 0
