Subject: Weekly Construction Quality Assurance ("CQA") Report:
AMEC: Squaw Gulch (VLF) – Weeks ending 10/17/15, 10/24/15 and 10/31/15.

**CRIPPLE CREEK & VICTOR GOLD MINING Co.
ANGLOGOLD ASHANTI (COLORADO)
SQUAW GULCH (VLF) WEEKLY REPORT**

Owner:	Cripple Creek & Victor Gold Mining Co.	Project Number:	74201125N0
Project:	Squaw Gulch Valley Leach Fill (VLF)	Week Ending:	October 17, 2015
Location:	Cripple Creek & Victor Gold Mine, CO		
Contractor:	Ames Construction, Inc.

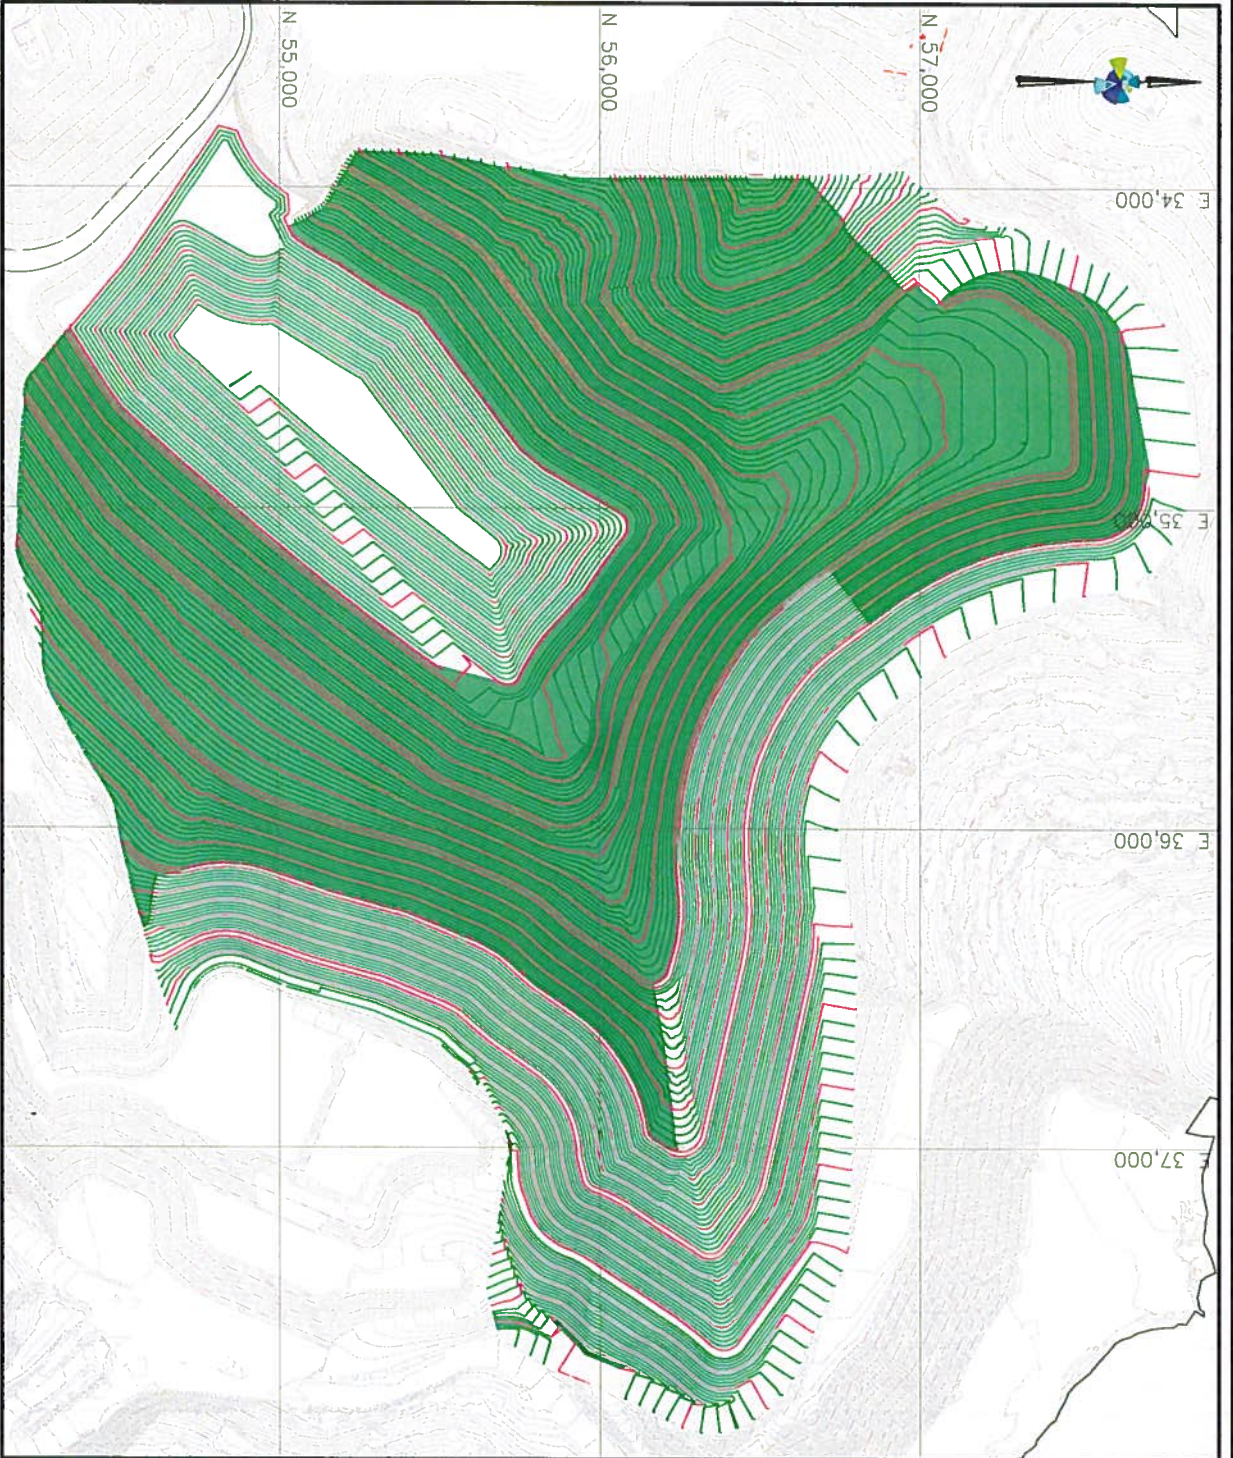
LEGEND
SLF ACCEPTANCE AREA

CHK BY RBR	CLIENT CRIPPLE CREEK & VICTOR MINING COMPANY	ISSUED DATE 11/04/15
APR BY ALM	PROJECT SQUAW GULCH VALLEY LEACH FACILITY	PROJECT No. 74201125N0
DRN BY RBR	TITLE WEEKLY ACCEPTANCE AREAS WEEK ENDING 10-31-15	FIGURE No. 1
DSN BY RBR		REV 0

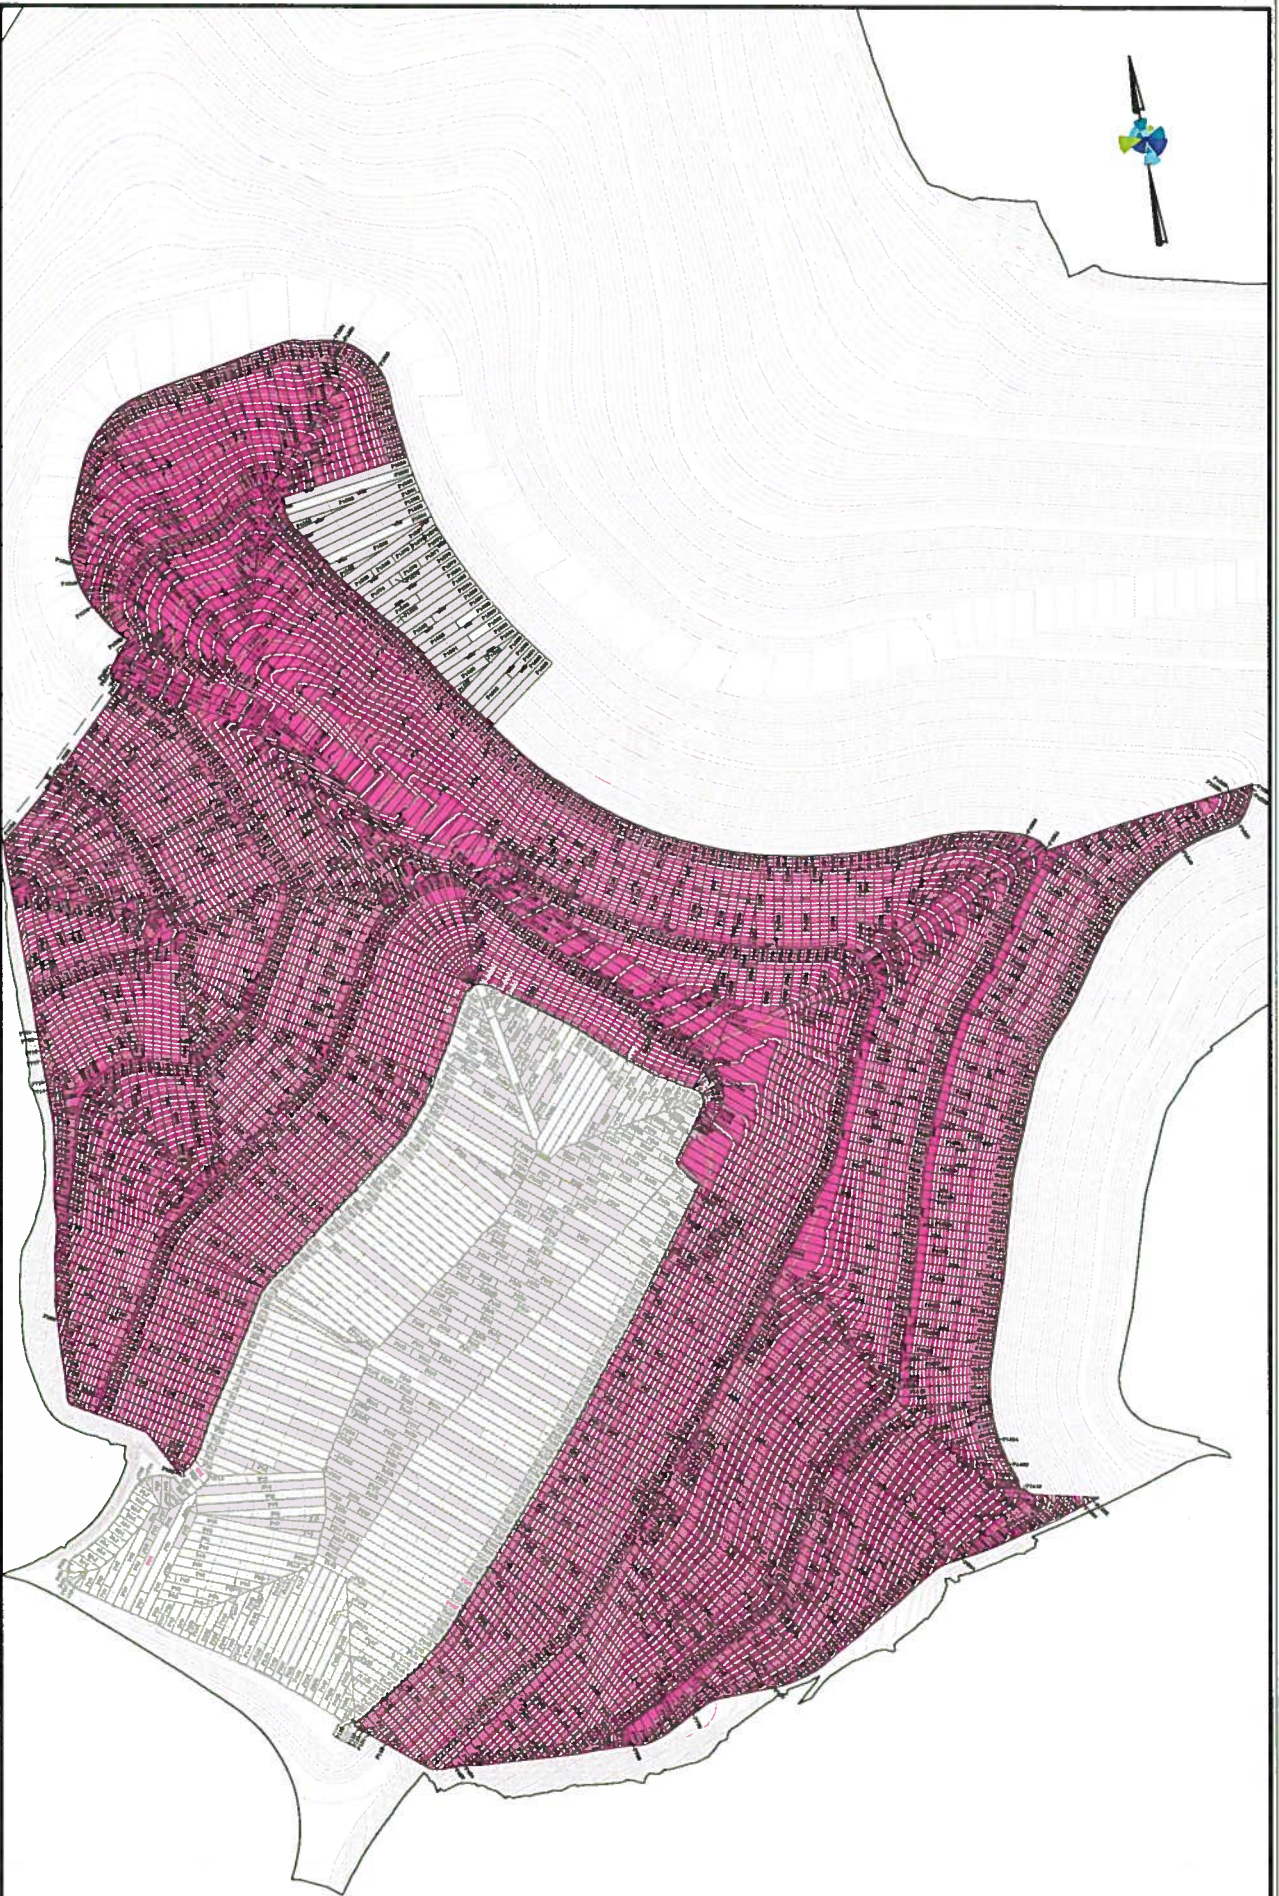
CHK BY RBR	CLIENT CRIPPLE CREEK & VICTOR MINING COMPANY	ISSUED DATE 11/04/15
APR BY ALM	PROJECT SQUAW GULCH VALLEY LEACH FACILITY	PROJECT No. 74201125NO
DRN BY MGC	TITLE WEEKLY LINER ACCEPTANCE 10/31/15	FIGURE No. 1
DSN BY RBR		REV 0

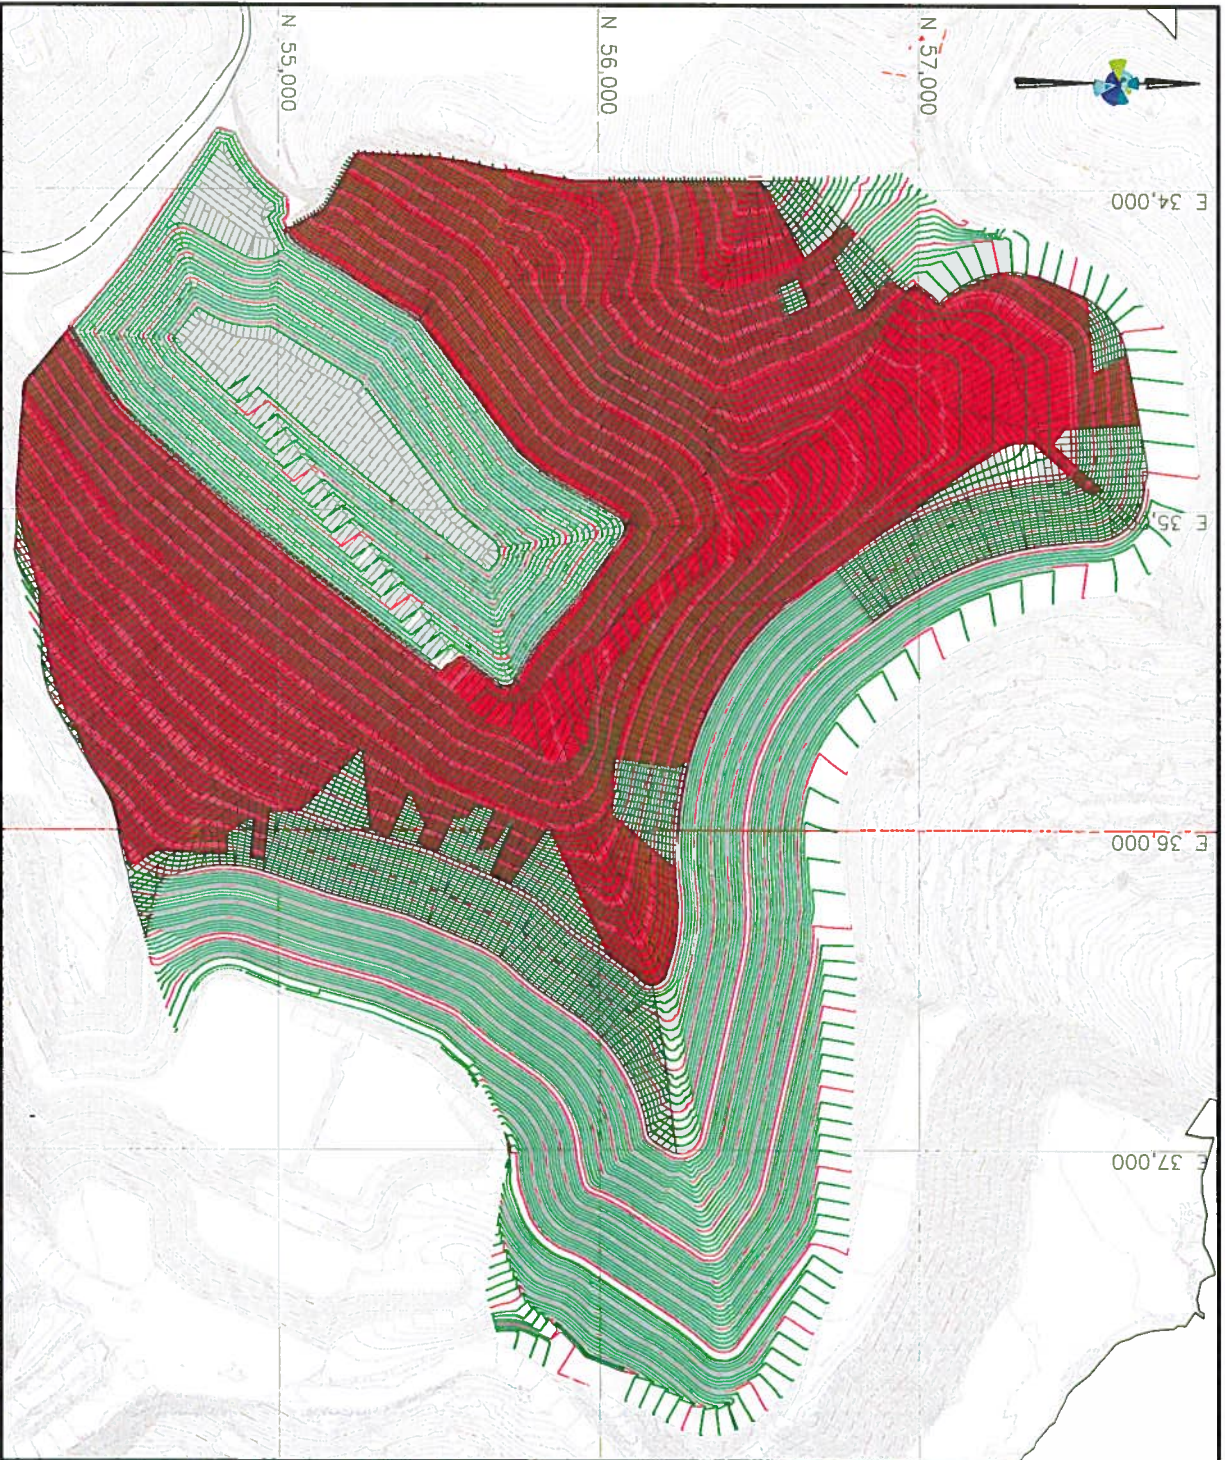
LEGEND
DCF ACCEPTANCE AREA

CLIENT	CRIPPLE CREEK & VICTOR MINING COMPANY
PROJECT	SQUAW GULCH VALLEY LEACH FACILITY
TITLE	WEEKLY ACCEPTANCE AREAS WEEK ENDING 10-31-15
