COLORADO DIVISION OF RECLAMATION, MINING AND SAFETY
MINERALS PROGRAM INSPECTION REPORT
PHONE: (303) 866-3567

MINE NAME: West Sunday	MINE/PROSPECTING ID#: M-1981-021	MINERAL: Uranium and vanadium	COUNTY: San Miguel
INSPECTION TYPE: Multi Person Inspection	INSPECTOR(S): Lucas J. West, Russ Means	INSP. DATE: November 23, 2015	INSP. TIME: 12:15
OPERATOR: Pinon Ridge Mining LLC	OPERATOR REPRESENTATIVE: None	TYPE OF OPERATION: 112d-3 - Designated Mining Operation

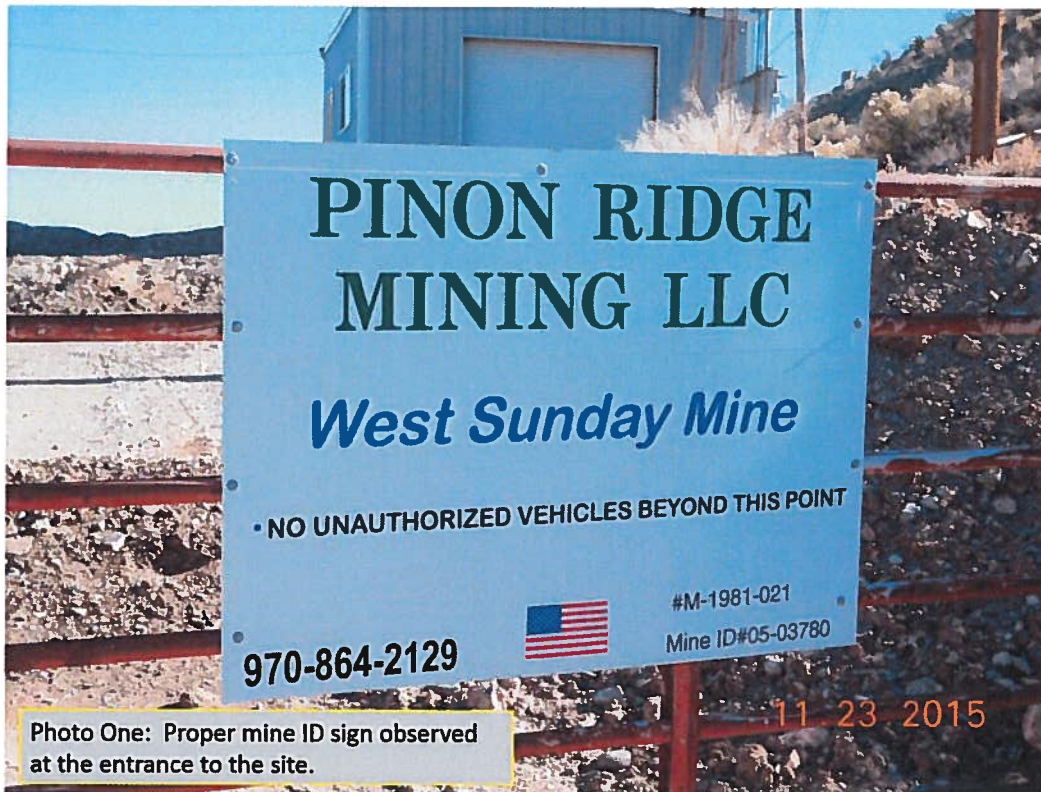
As seen in Photo One, the permit ID sign was observed at the entrance to the site. The permit boundary markers were also observed. The remote vent shaft sites were not inspected at this time. Photos Two and Three show evidence that the diversion ditches and storm water control devices are functioning as designed and no significant erosion was observed throughout the site.

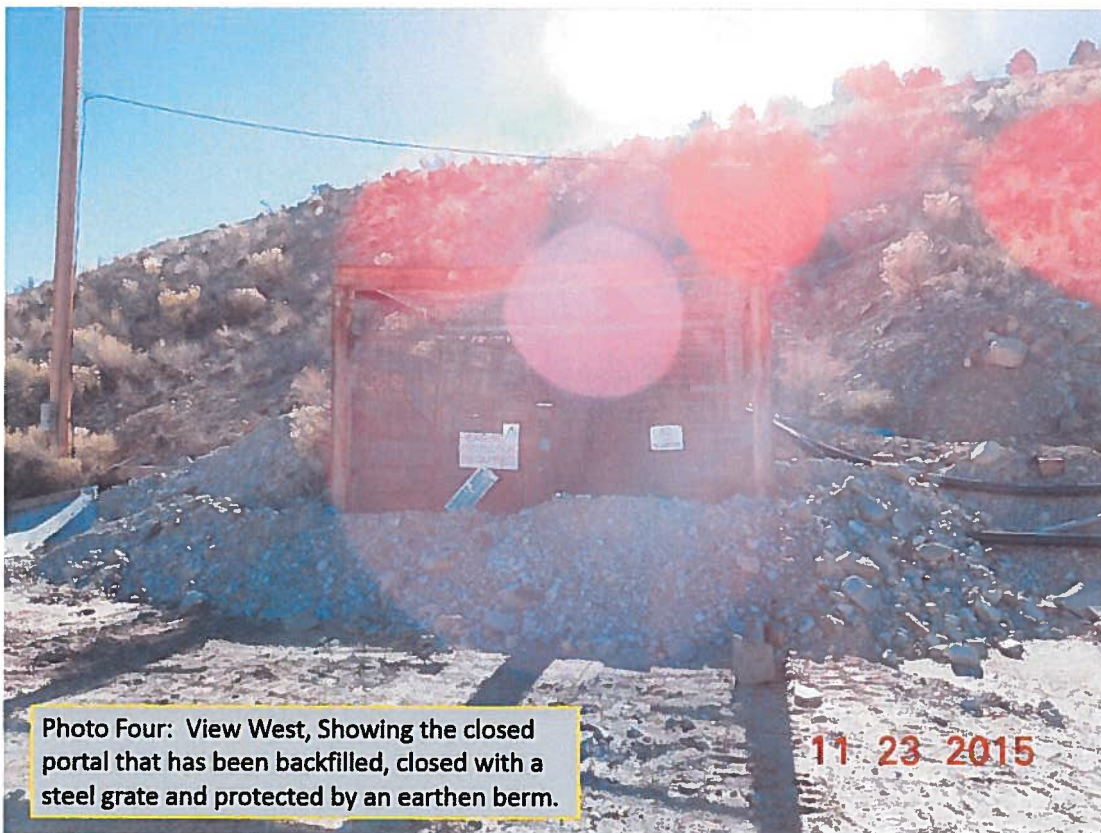
All work and shop facilities onsite were secured and appeared to be in good condition. The portal located on site was also secured, it has been backfilled, closed off with steel grates as well as encompassed by a small berm as seen in Photo Four. Two fuel storage containers were observed on site but were empty and appear to have not been utilized in some time. Various other debris was observed on site however it was stored in an orderly fashion and was not a concern at this time.
