**COLORADO DIVISION OF RECLAMATION, MINING AND SAFETY**  
**MINERALS PROGRAM INSPECTION REPORT**  
**PHONE: (303) 866-3567**

<b>MINE NAME:</b> Topaz Mine	<b>MINE/PROSPECTING ID#:</b> M-1980-055-HR	<b>MINERAL:</b> Uranium and vanadium	<b>COUNTY:</b> San Miguel
<b>INSPECTION TYPE:</b> Multi Person Inspection	<b>INSPECTOR(S):</b> Lucas J. West	<b>INSP. DATE:</b> November 23, 2015	<b>INSP. TIME:</b> 12:55
<b>OPERATOR:</b> Pinon Ridge Mining LLC	<b>OPERATOR REPRESENTATIVE:</b> None	<b>TYPE OF OPERATION:</b> 112d-3 - Designated Mining Operation

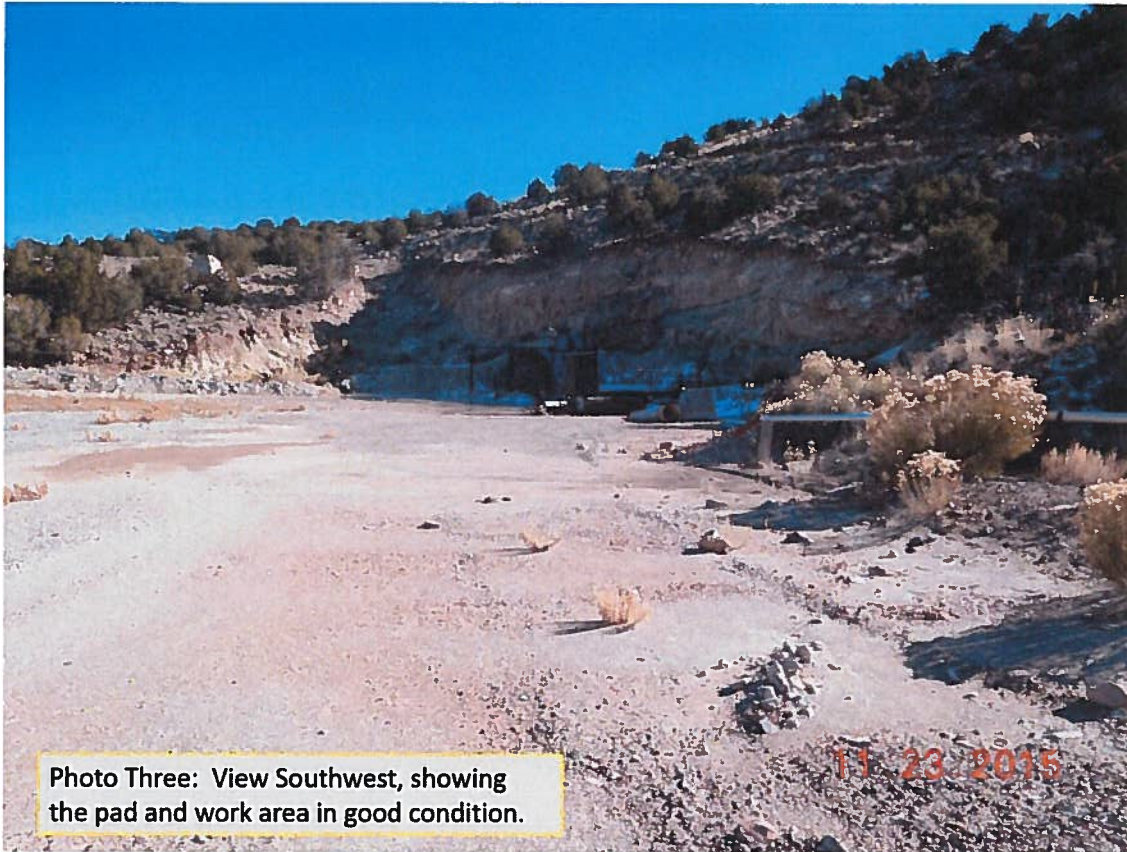
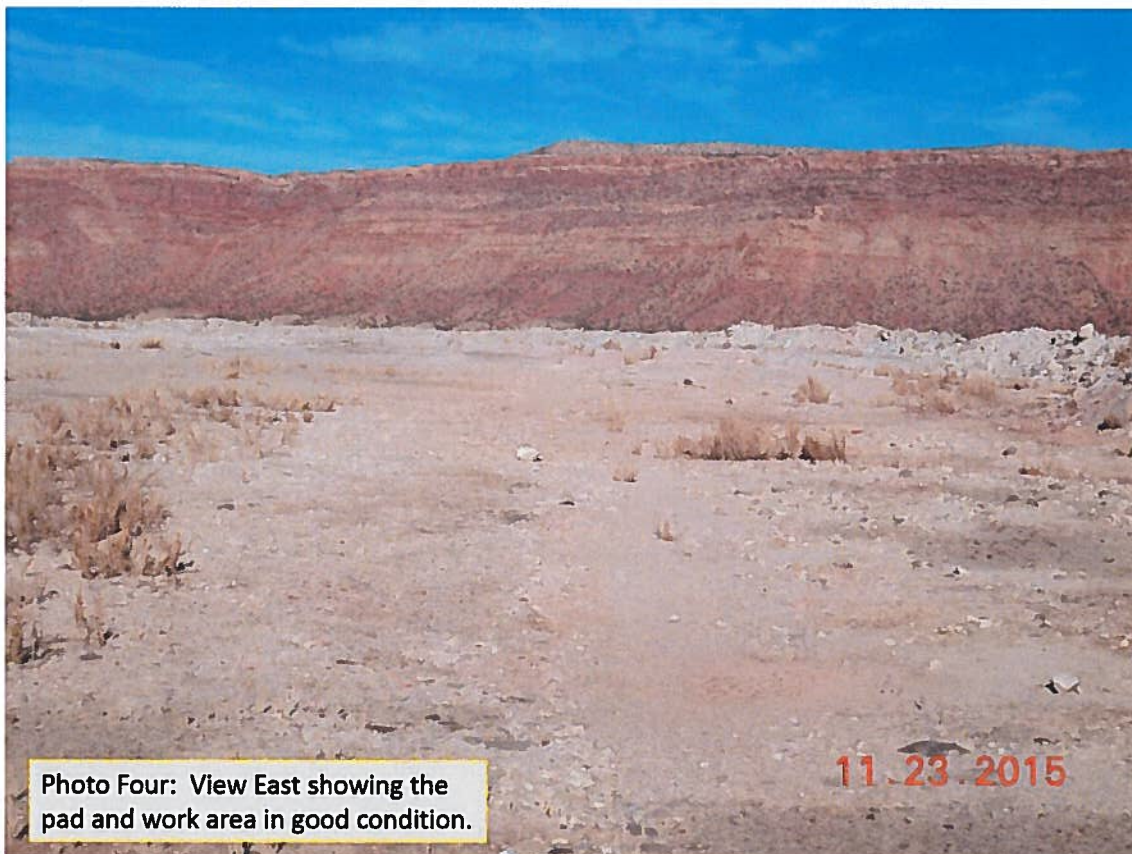
The main pad and work area was in good condition as seen in Photos Three and Four, evidence of weed management during the growing season was observed. The whole site exhibits positive drainage and no erosional issues were observed at this time. The overall footprint of the site was in good condition and free from excessive trash and debris.
