COLORADO DIVISION OF RECLAMATION, MINING AND SAFETY
MINERALS PROGRAM INSPECTION REPORT
PHONE: (303) 866-3567

MINE NAME: St Jude Mine	MINE/PROSPECTING ID#: M-1978-039-HR	MINERAL: Uranium and vanadium	COUNTY: San Miguel
INSPECTION TYPE: Multi Person Inspection	INSPECTOR(S): Lucas J. West	INSP. DATE: November 23, 2015	INSP. TIME: 12:35
OPERATOR: Pinon Ridge Mining LLC	OPERATOR REPRESENTATIVE: None	TYPE OF OPERATION: 110d - Designated Limited Impact	
REASON FOR INSPECTION: Normal I&E Program	BOND CALCULATION TYPE: None	BOND AMOUNT: \$47,700.00	
DATE OF COMPLAINT: NA	POST INSP. CONTACTS: None	JOINT INSP. AGENCY: None	
WEATHER: Clear	INSPECTOR'S SIGNATURE:

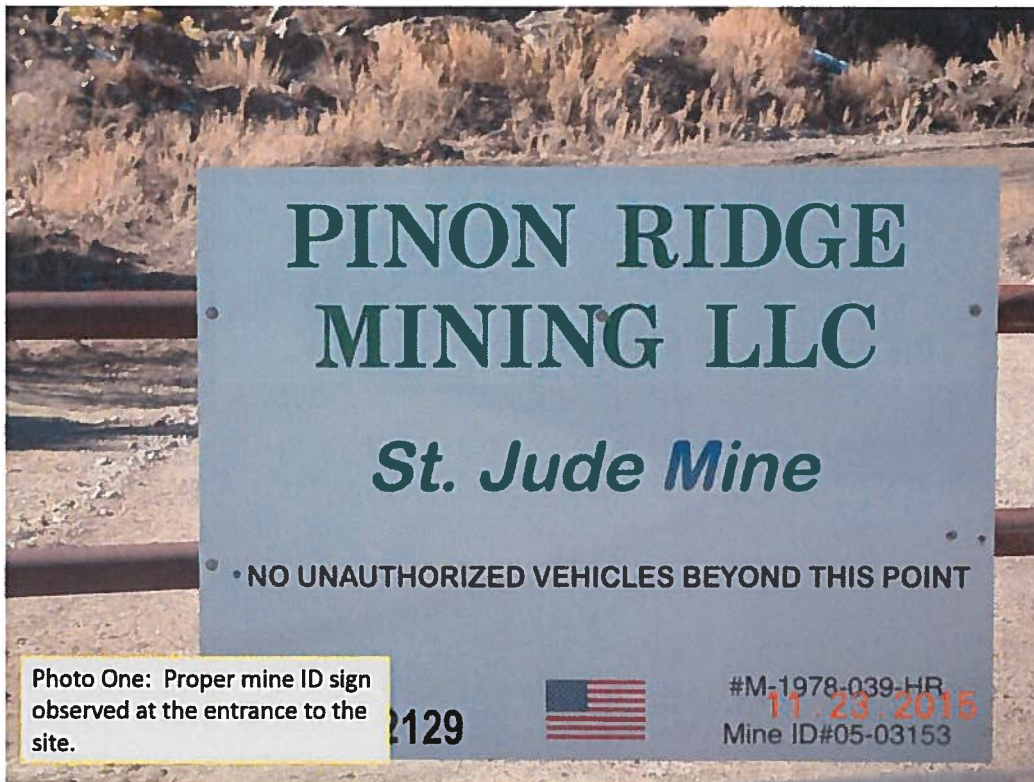
As seen in Photo One, the permit ID sign was observed at the entrance to the site. The permit boundary markers were also observed. The remote vent shaft sites were not inspected at this time. Photos Two and Three show evidence that the diversion ditches and storm water control devices are functioning as designed and no significant erosion was observed throughout the site.

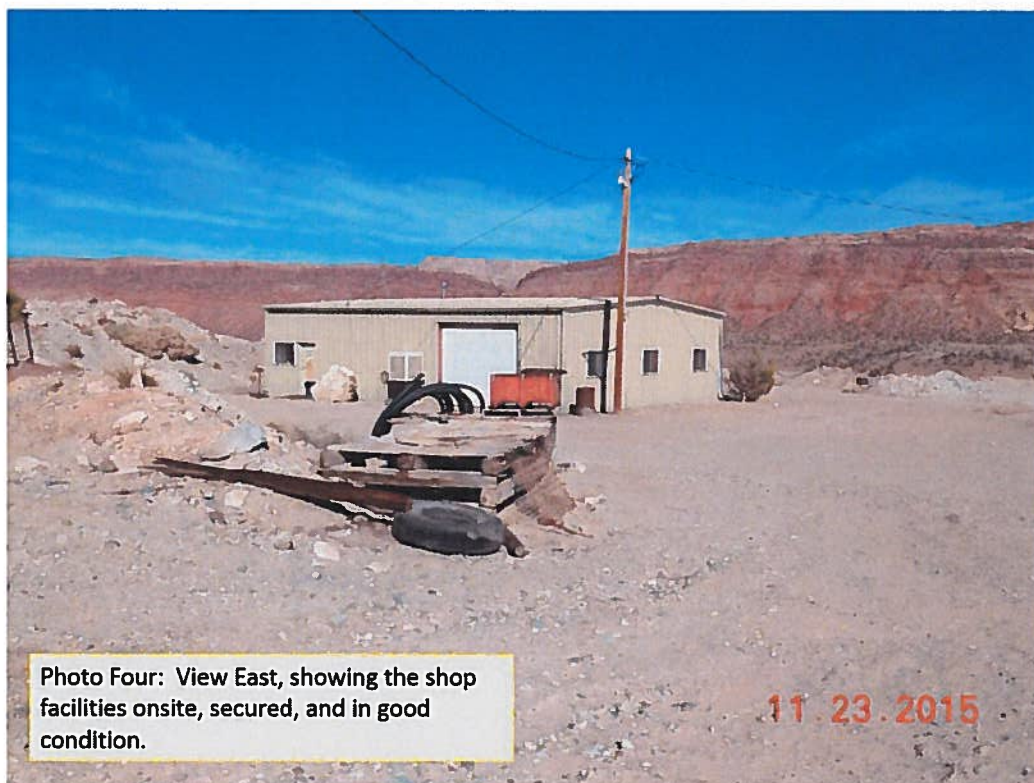
All work and shop facilities onsite were secured and appeared to be in good condition as seen in Photo Four. No fuel storage containers were observed on site. Various other debris was observed on site however it was stored in an orderly fashion and was not a concern at this time.
