COLORADO DIVISION OF RECLAMATION, MINING AND SAFETY
MINERALS PROGRAM INSPECTION REPORT
PHONE: (303) 866-3567

MINE NAME: Bromley Lakes	MINE/PROSPECTING ID#: M-1987-049	MINERAL: Sand and gravel	COUNTY: Adams
INSPECTION TYPE: Monitoring	INSPECTOR(S): Tyler V. O'Donnell	INSP. DATE: May 19, 2015	INSP. TIME: 12:15
OPERATOR: Ready Mixed Concrete Company	OPERATOR REPRESENTATIVE: Bill Timmons	TYPE OF OPERATION: 112c - Construction Regular Operation

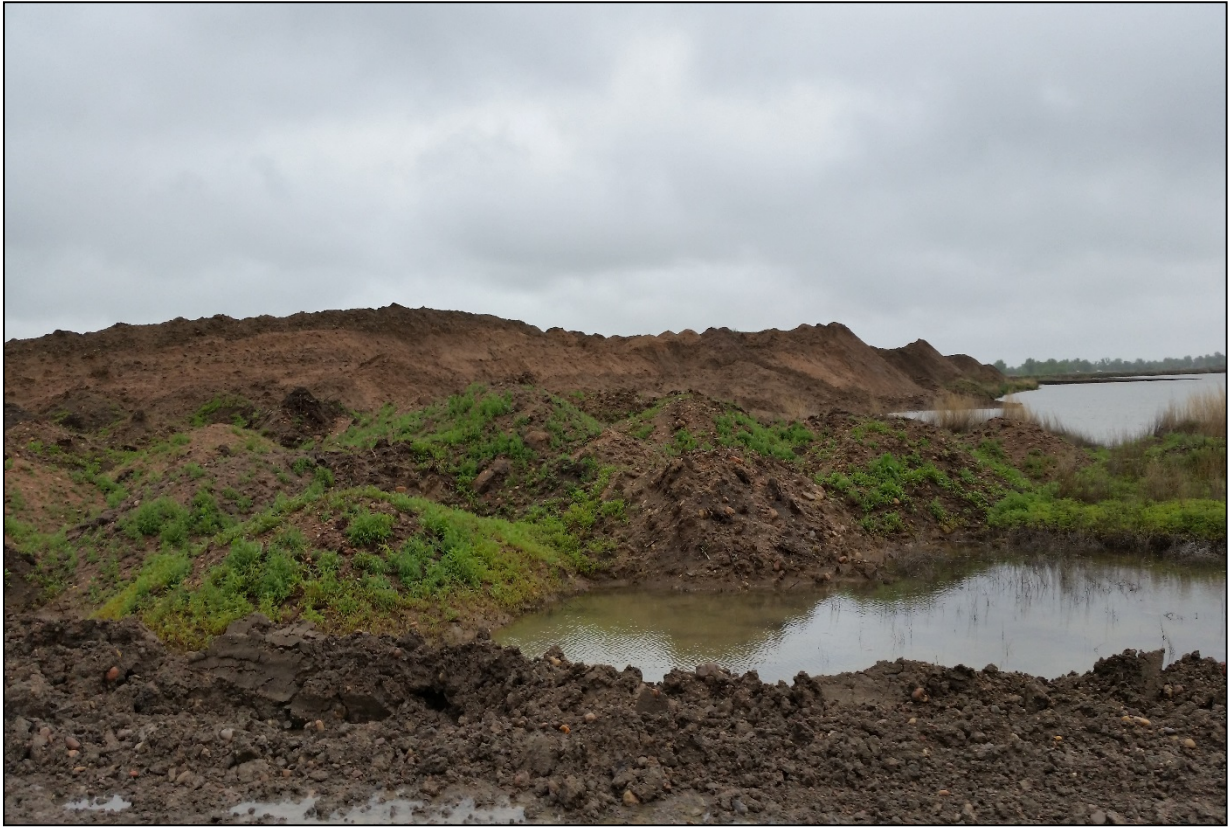
Photo 1: Imported fill from the clean out of Cell No.1 stockpiled along the western bank of Cell No. 2.

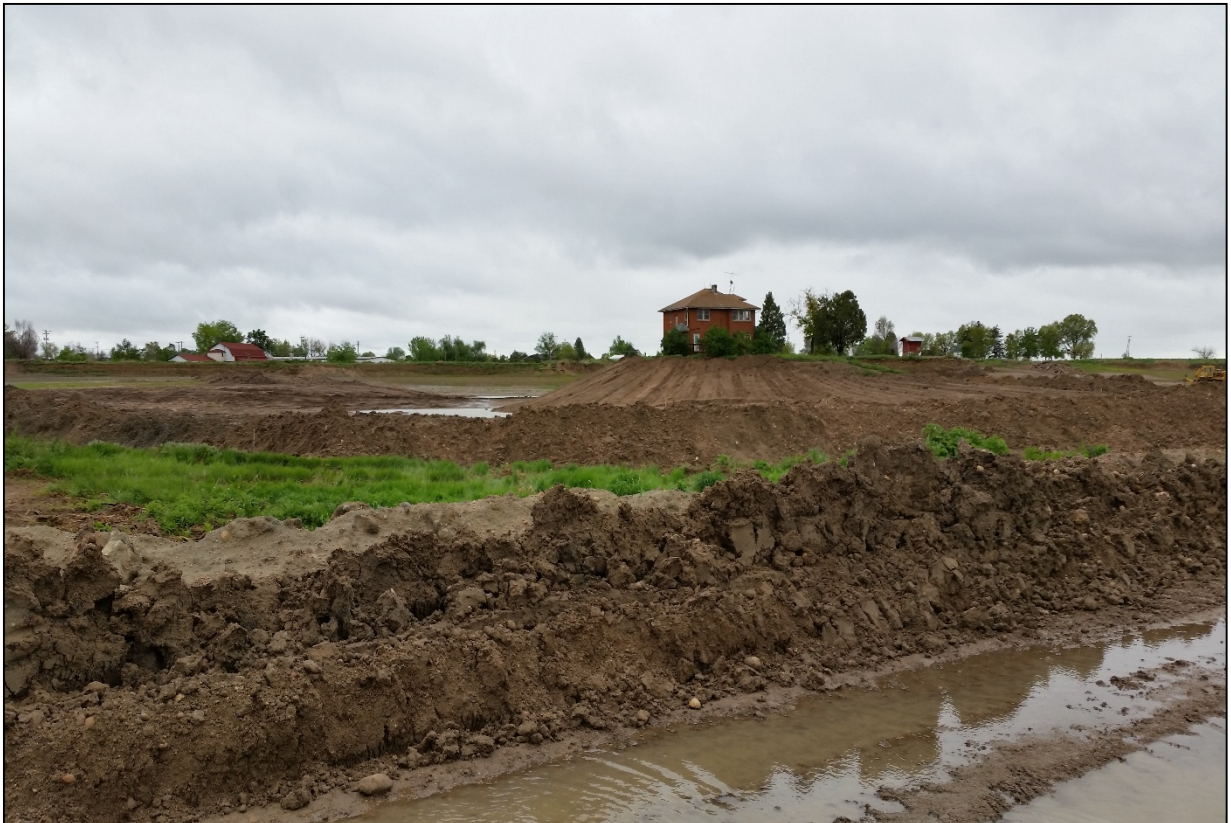
Photo 2: Area in Phase 16 where imported filled from the clean out of Cell No.1 has been placed and where additional fill will be placed when weather conditions approve.
