Re: **Consideration for possible violation for failure to post additional financial warranty within Sixty (60) days of notice of increase. Toltec No. 2, Permit Number: M-1984-039**

COLORADO DIVISION OF RECLAMATION, MINING AND SAFETY MINERALS PROGRAM INSPECTION REPORT

| MINE NAME: Toltec No 2 | MINE/PROSPECTING ID#: M-1984-039 | MINERAL: Silver, gold, copper, | COUNTY: San Juan |
| INSPECTION TYPE: Monitoring | INSPECTOR(S): Wallace H. Erickson | INSP. DATE: September 25, 2012 | INSP. TIME: 09:30 |

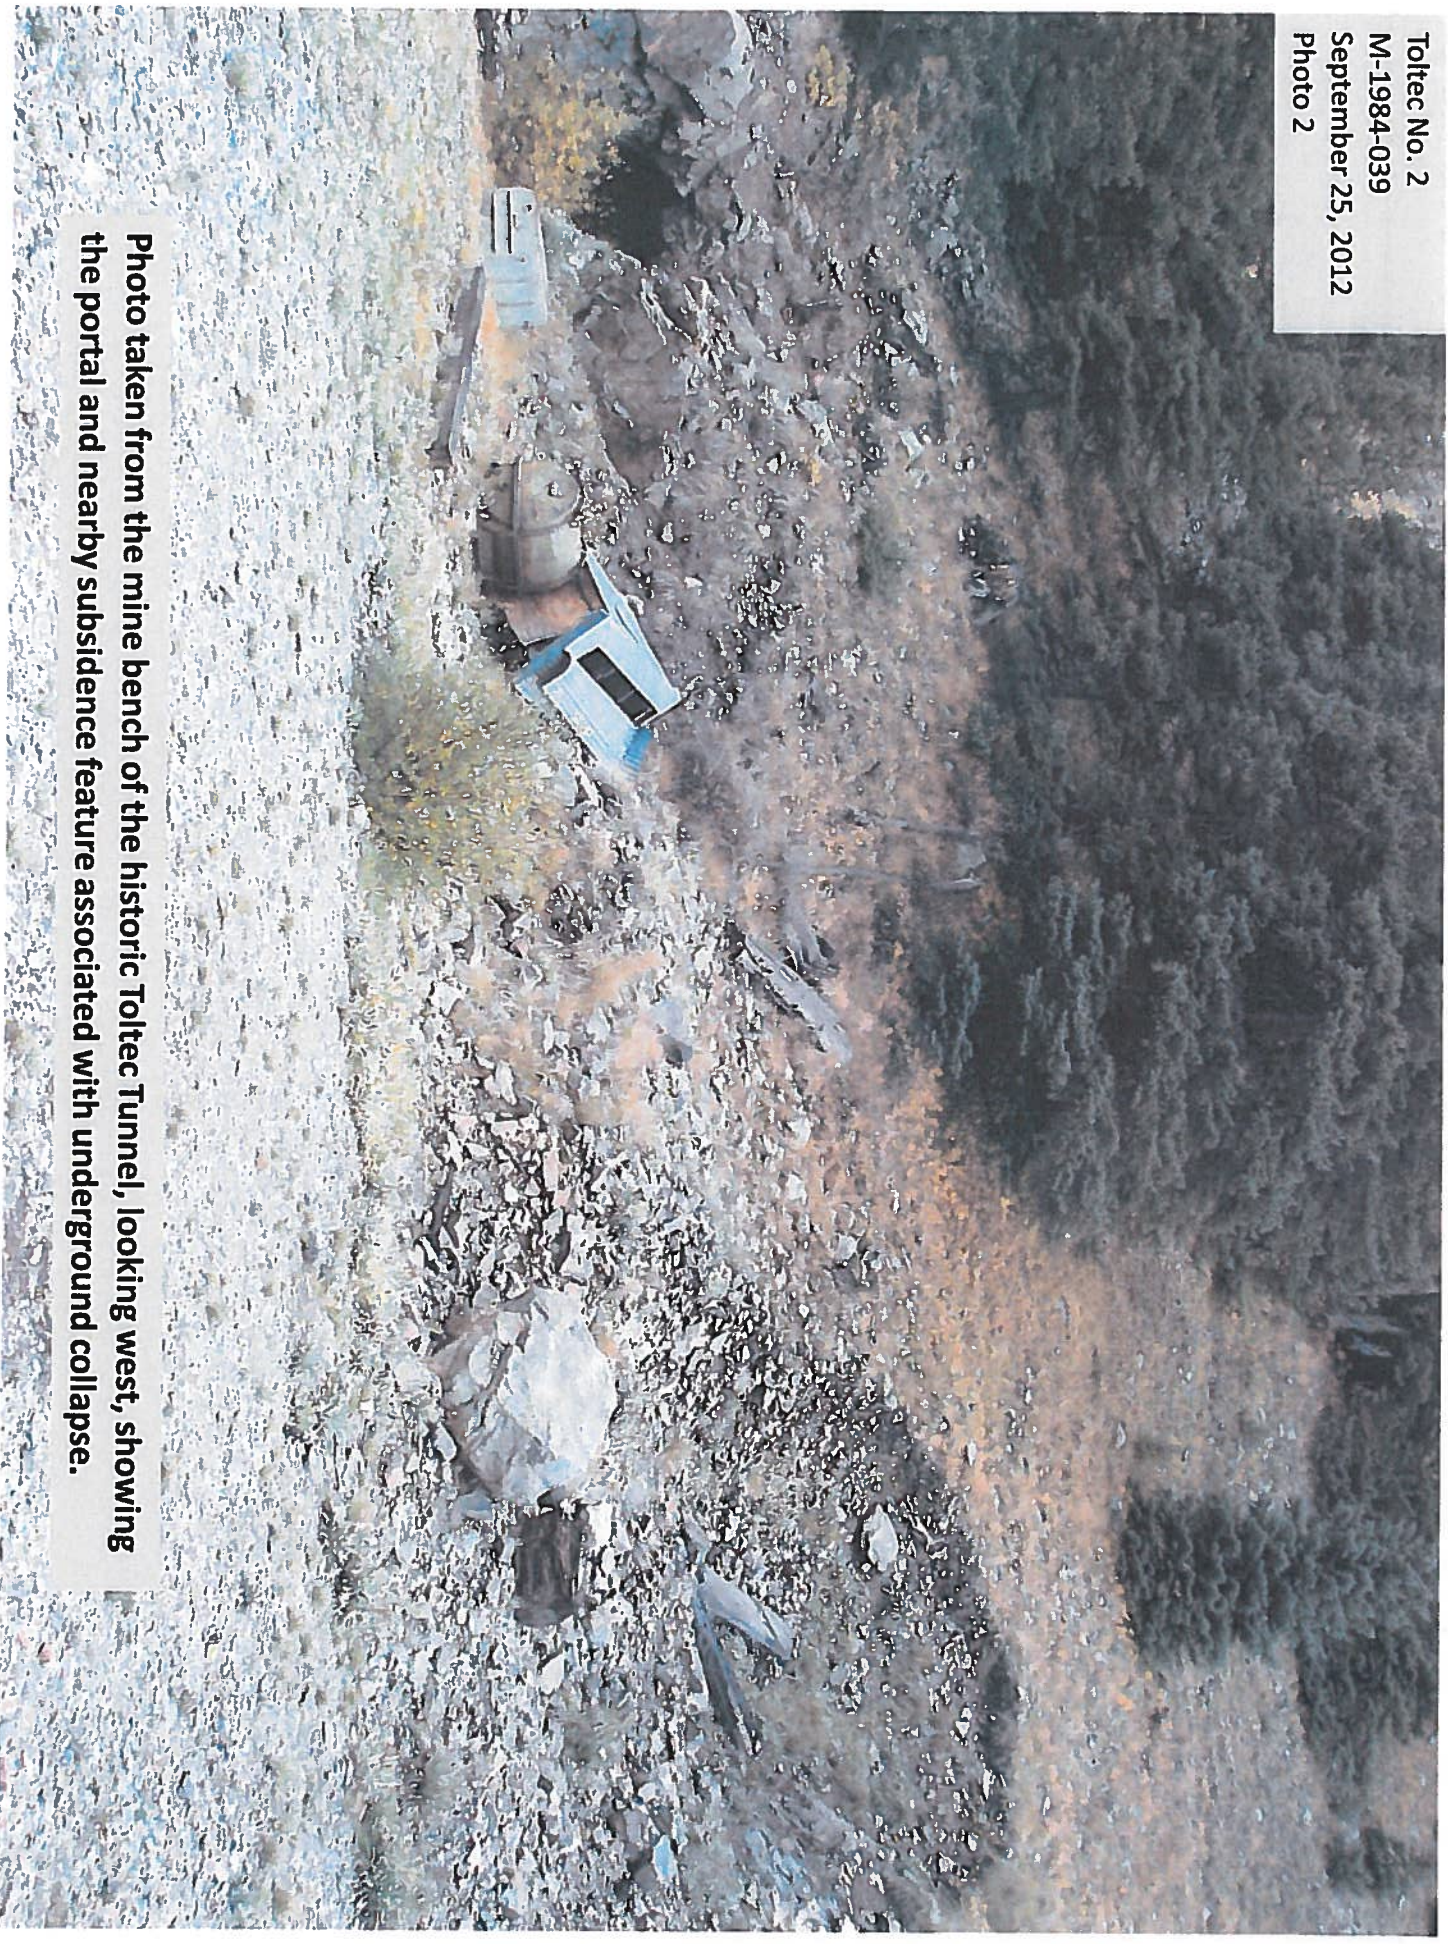
Toltec No. 2
M-1984-039
September 25, 2012
Photo 2

Photo taken from the mine bench of the historic Toltec Tunnel, looking west, showing the portal and nearby subsidence feature associated with underground collapse.

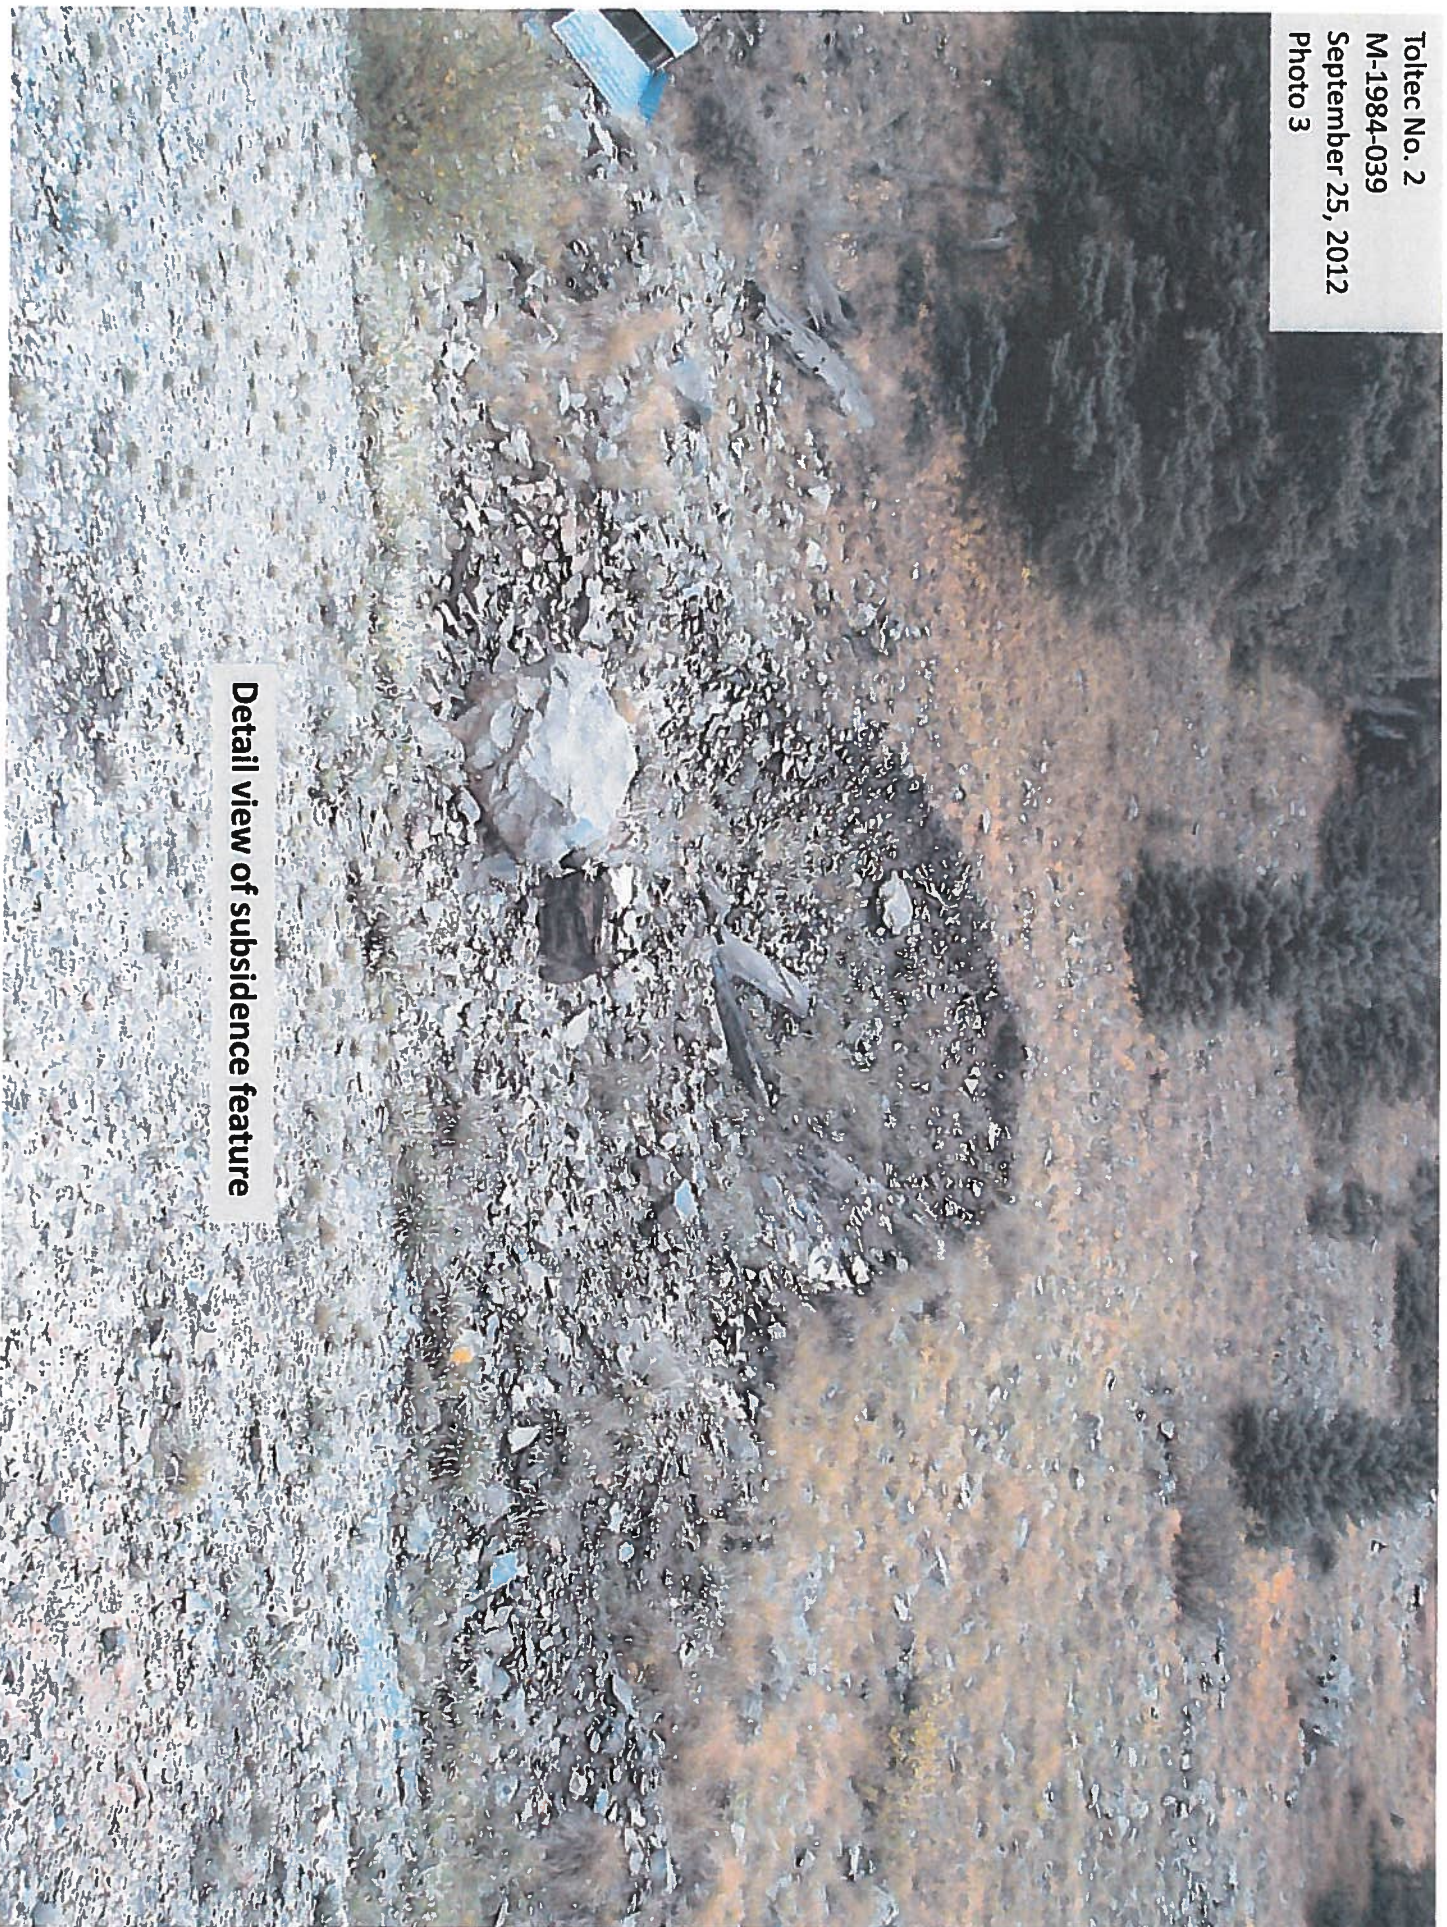
Toltec No. 2
M-1984-039
September 25, 2012
Photo 3

Detail view of subsidence feature

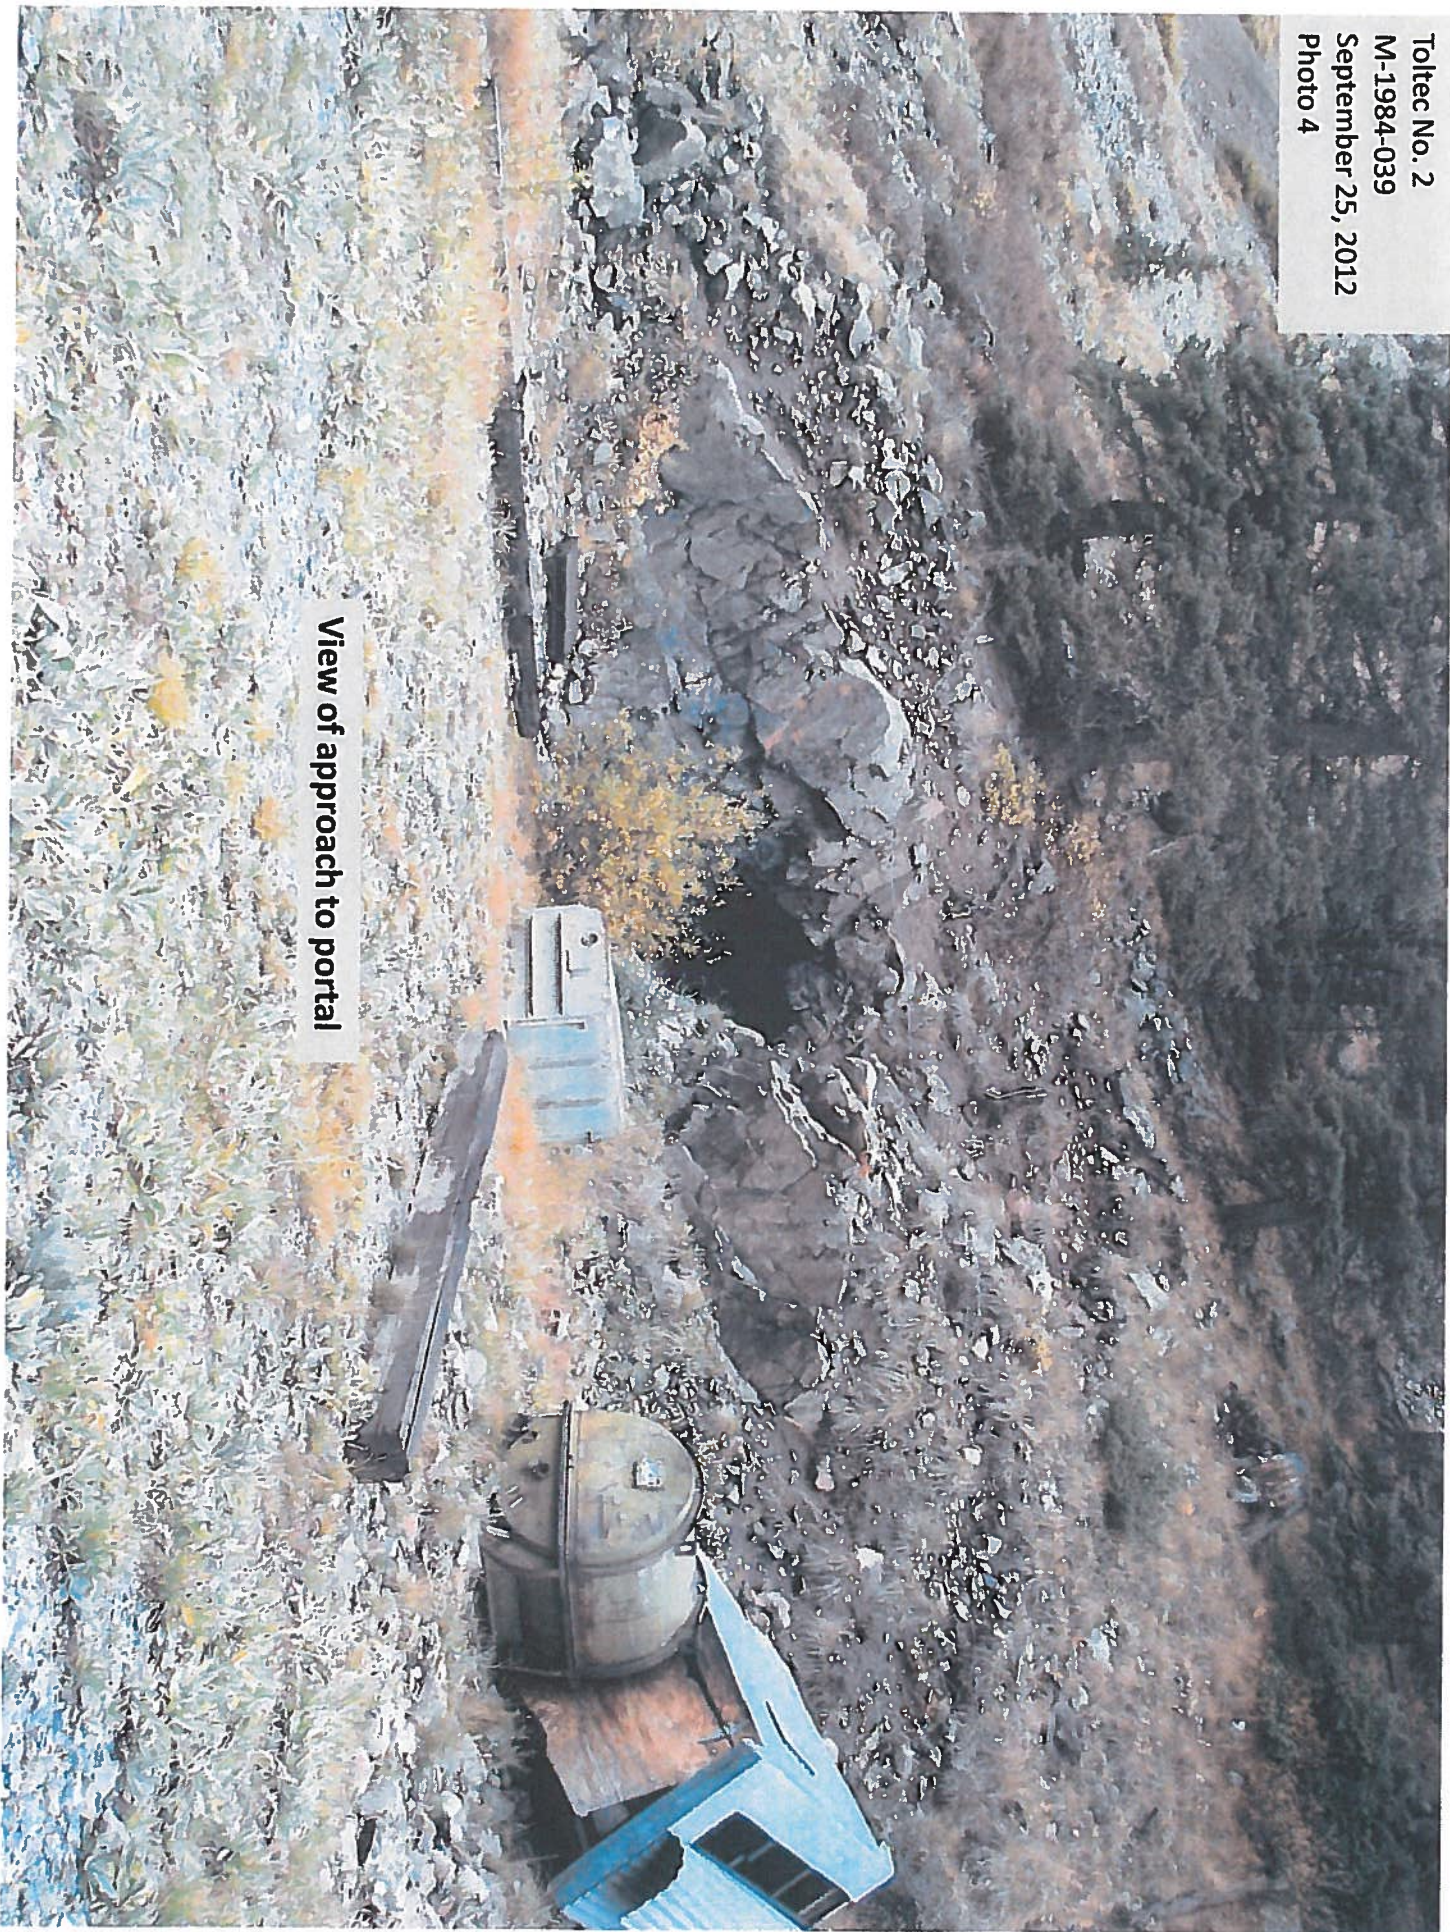
Toltec No. 2
M-1984-039
September 25, 2012
Photo 4

View of approach to portal

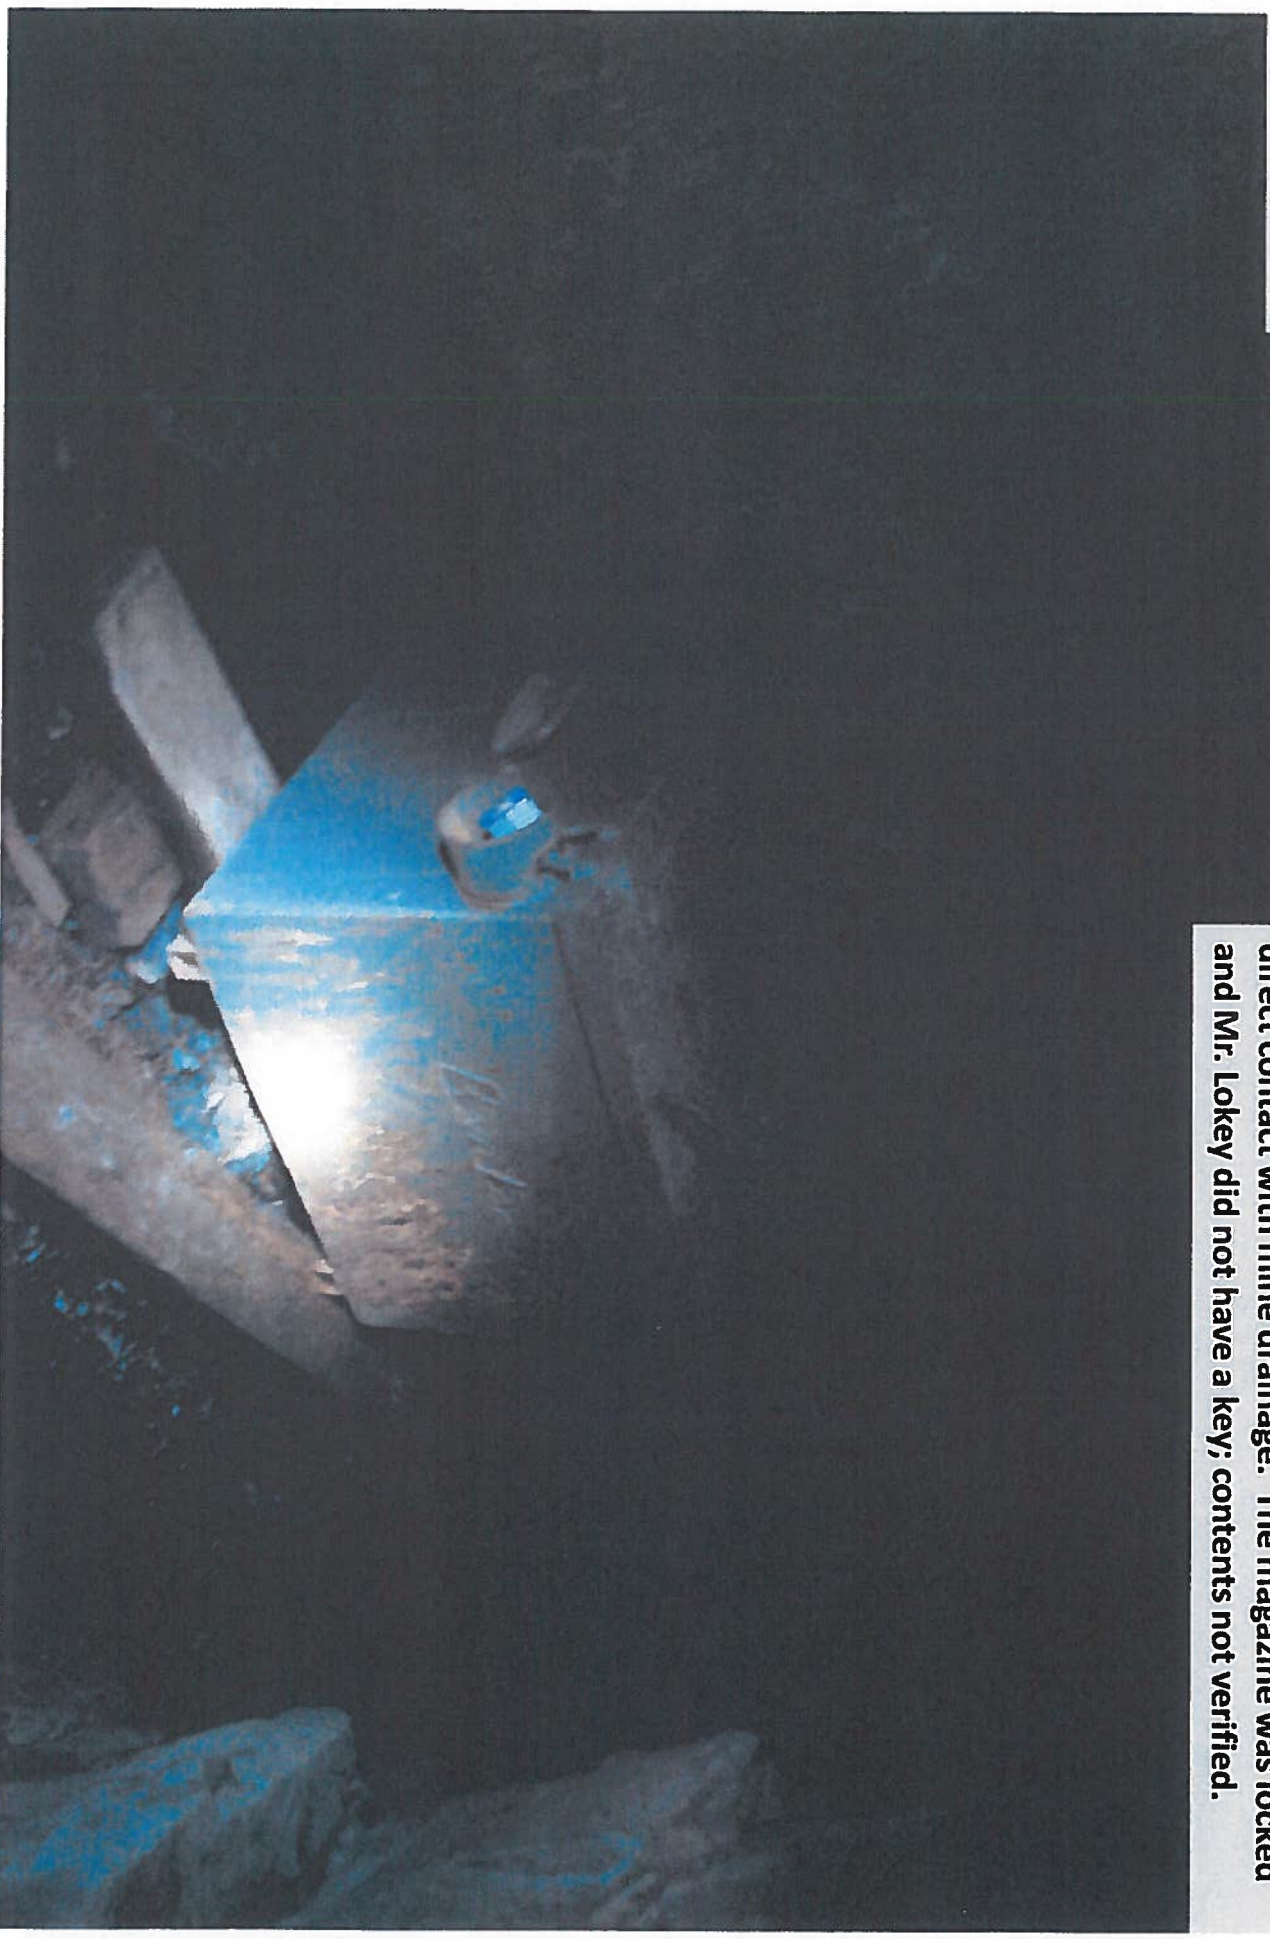
Toltec No. 2
M-1984-039
September 25, 2012
Photo 7

A second magazine was located approximately 30 feet in from the portal, at a T-intersection in the underground workings. The second magazine was set on mine timbers and not in direct contact with mine drainage. The magazine was locked and Mr. Lokey did not have a key; contents not verified.

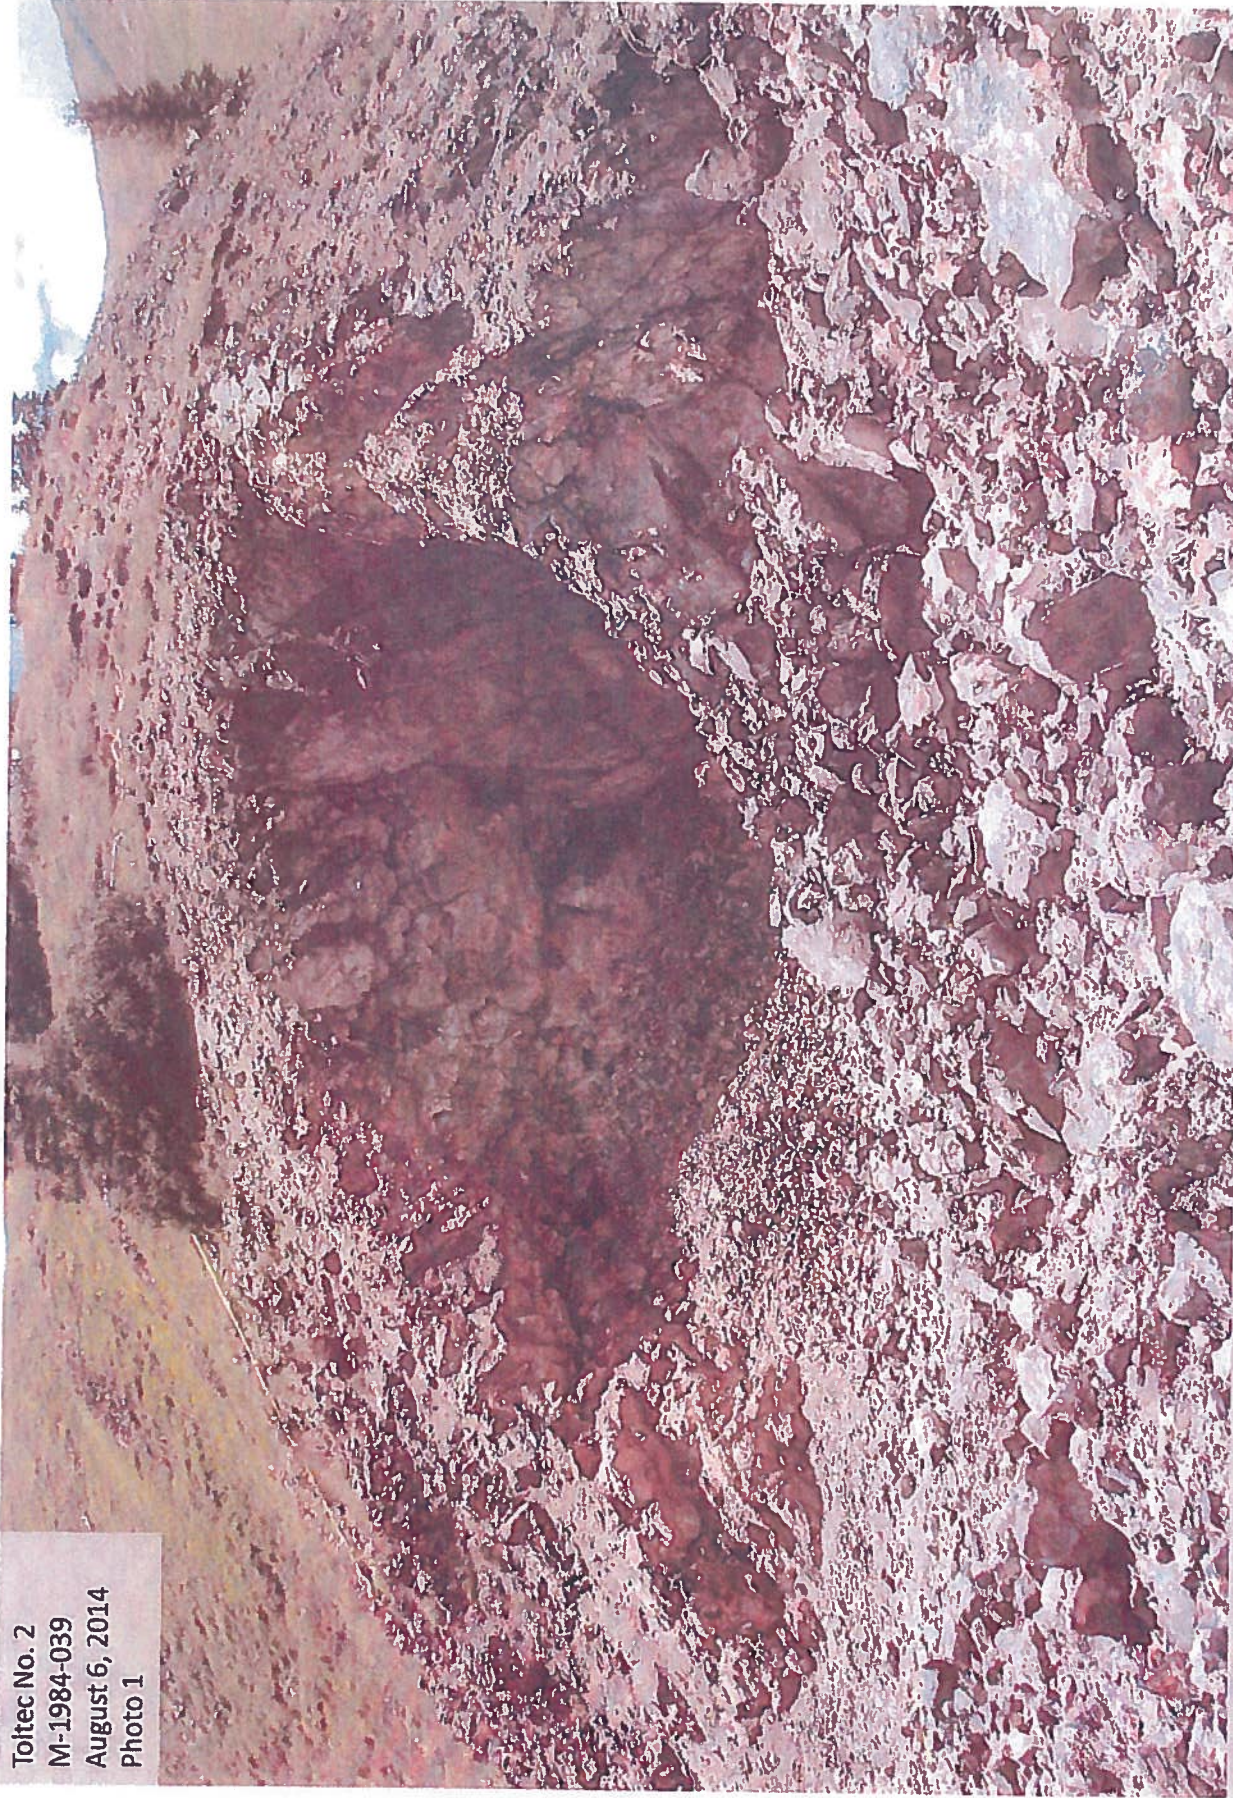
Toltec No. 2
M-1984-039
August 6, 2014
Photo 1

Mining and reclamation activities were dormant. As shown in Photos 1, 2 and 3, evidence of recent mining activity, limited to blasting, was observed nearby the northeast corner of the Toltec No. 2 mine claim. Affected lands were estimated at 0.25 acres.

Photo of a blast site previously documented in the Division's inspection report generated from the September 26, 2013 inspection (see Photo 1 from the previous inspection report). Evidence of recent reclamation activity was not observed.

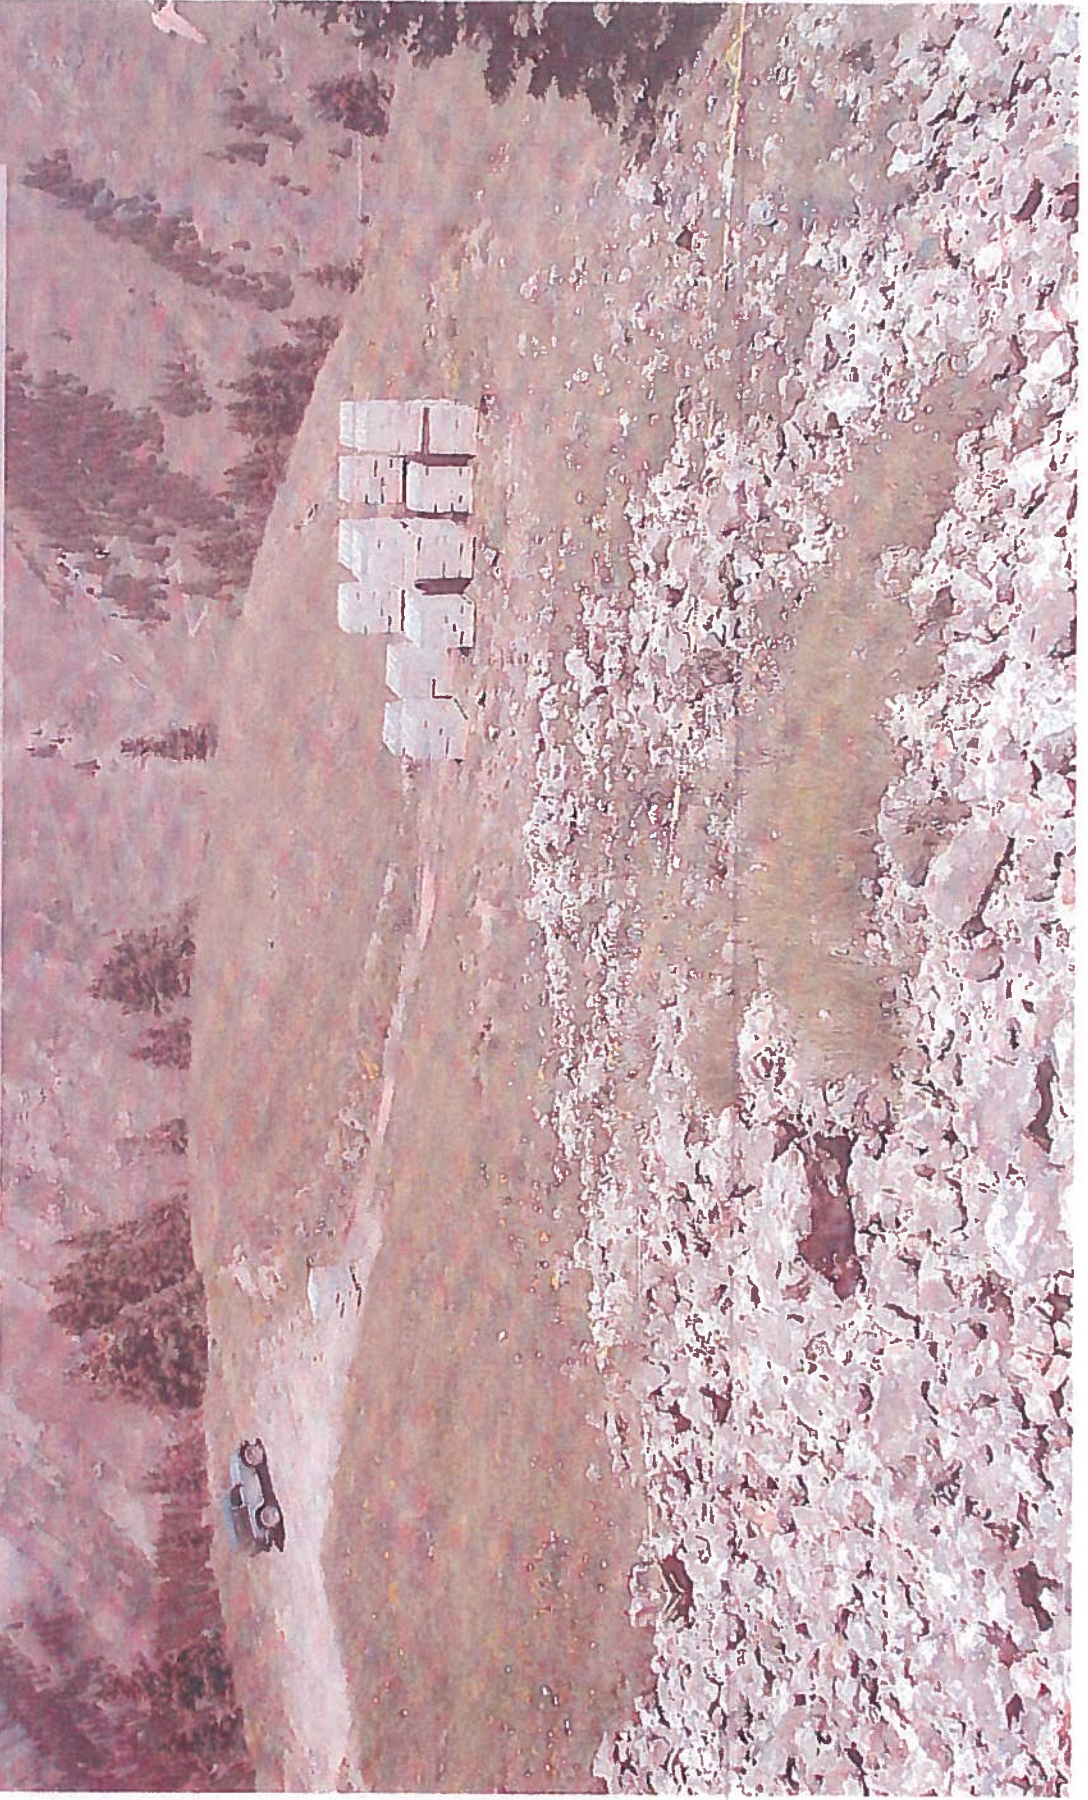
Photo 2

Photo of cast rock from a blast previously documented in the Division's inspection report generated from the September 26, 2013 inspection (see Photos 2 and 3 from the previous inspection report). Evidence of recent activity at the site was limited to the 18 pallets of cinder block featured in this photo. The purpose of the cinder block is unknown and suspected to be unrelated to the mine operation.

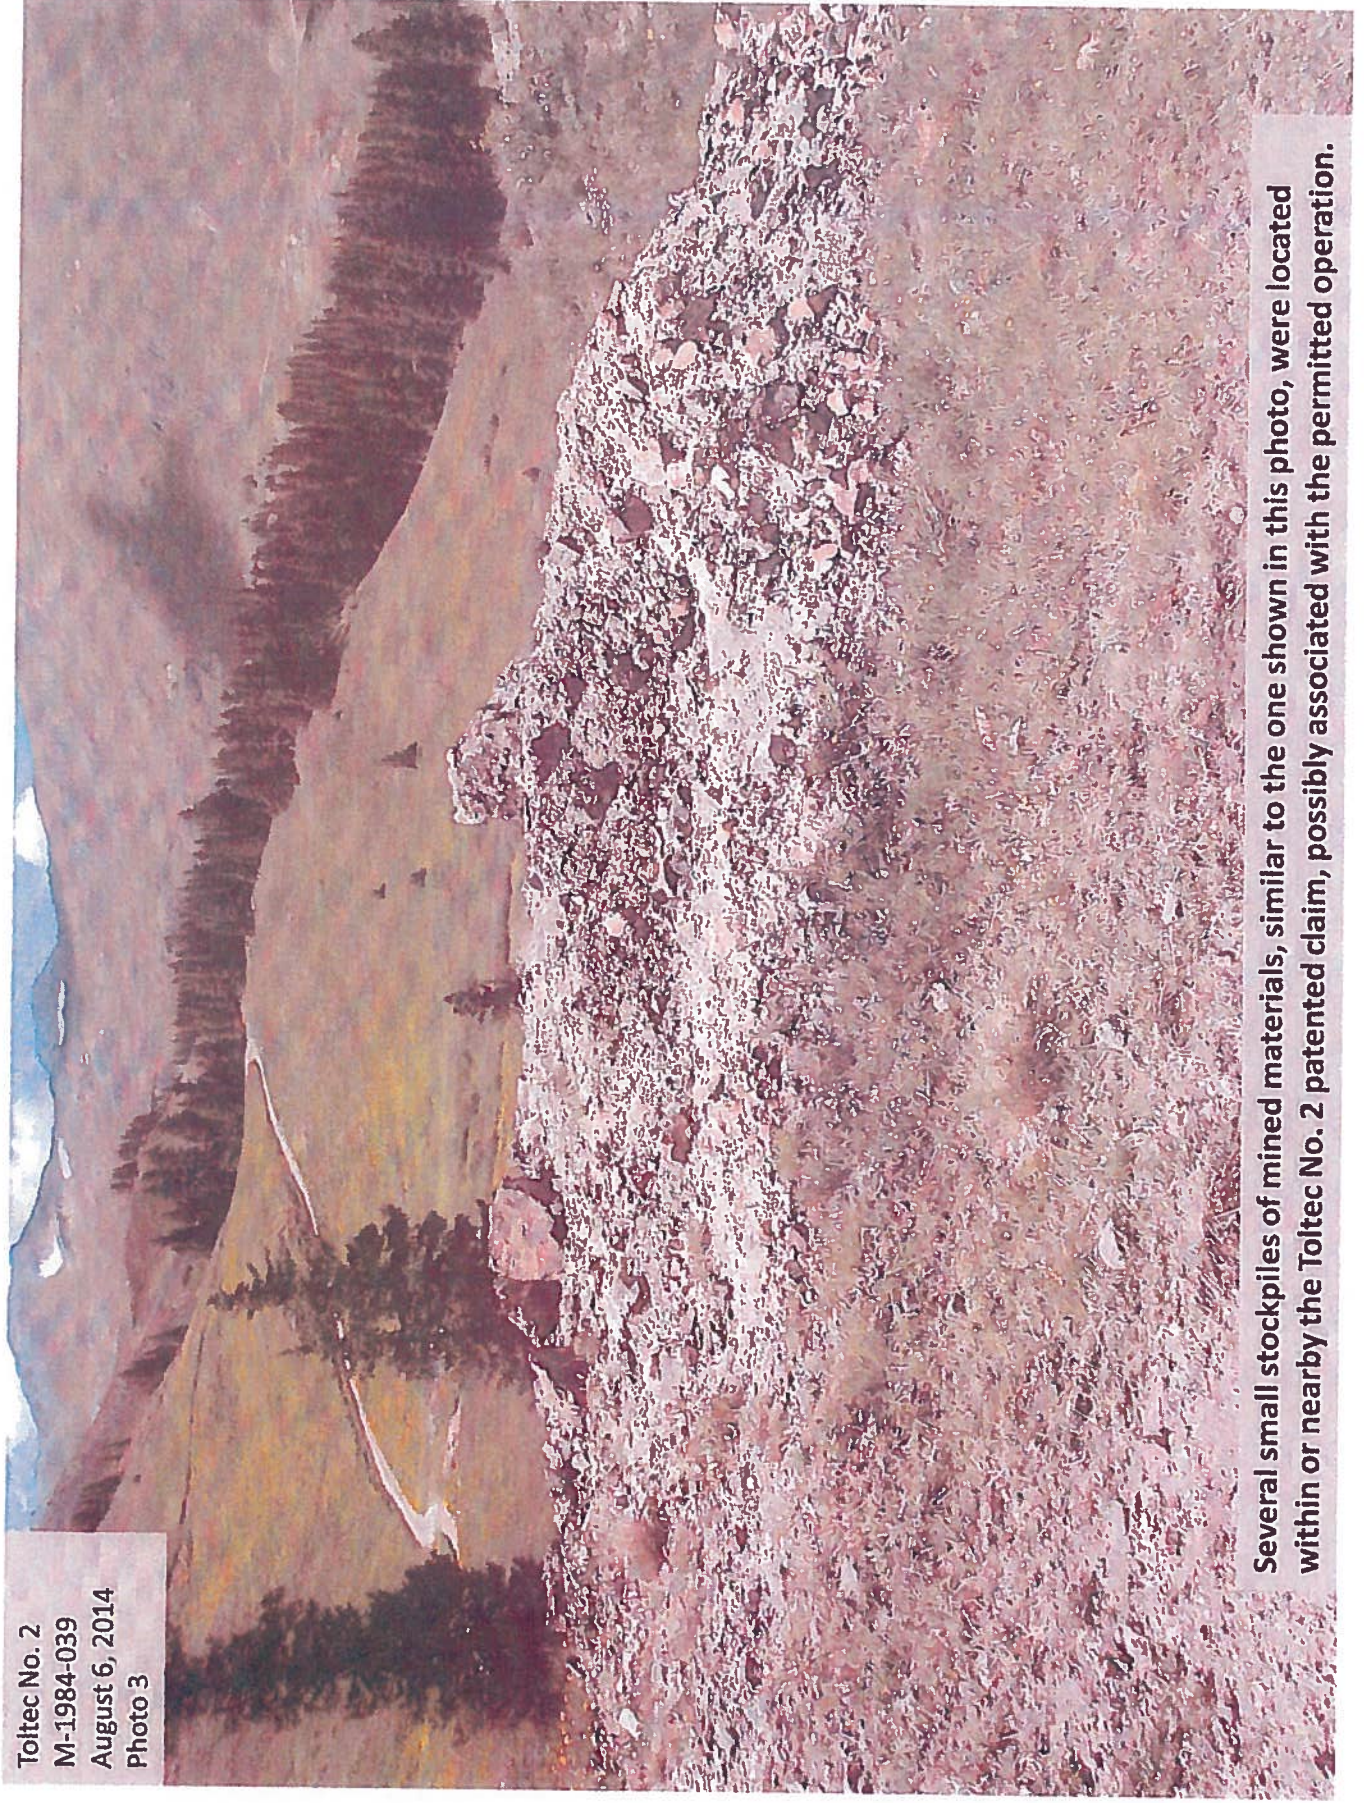
Toltec No. 2
M-1984-039
August 6, 2014
Photo 3

Several small stockpiles of mined materials, similar to the one shown in this photo, were located within or nearby the Toltec No. 2 patented claim, possibly associated with the permitted operation.
