COLORADO DIVISION OF RECLAMATION, MINING AND SAFETY
MINERALS PROGRAM INSPECTION REPORT
PHONE: (303) 866-3567

MINE NAME: Brandstadt Rock Pit	MINE/PROSPECTING ID#: M-1986-004	MINERAL: Sand and gravel	COUNTY: Delta
INSPECTION TYPE: Monitoring	INSPECTOR(S): Stephanie J. Mitchell	INSP. DATE: January 12, 2016	INSP. TIME: 12:00
OPERATOR: Melvin J. Brandstadt	OPERATOR REPRESENTATIVE: Melvin Brandstadt	TYPE OF OPERATION: 110c - Construction Limited Impact

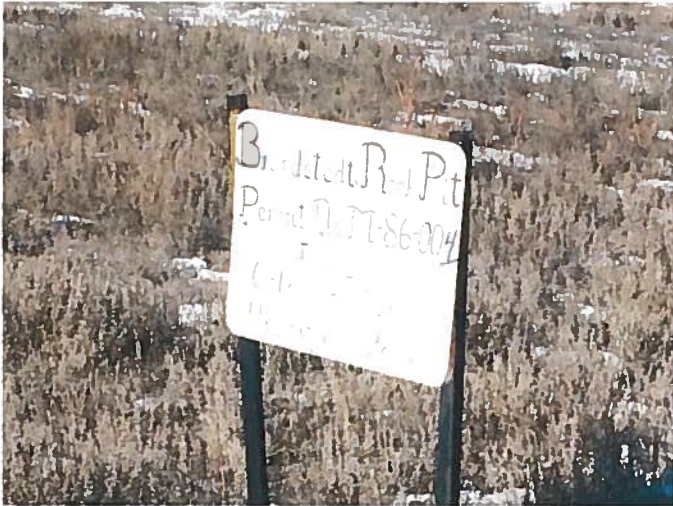
The Mine Identification sign was located at the entrance to the mine site. The permit boundary markers were delineated by a fence.

Mine ID Sign

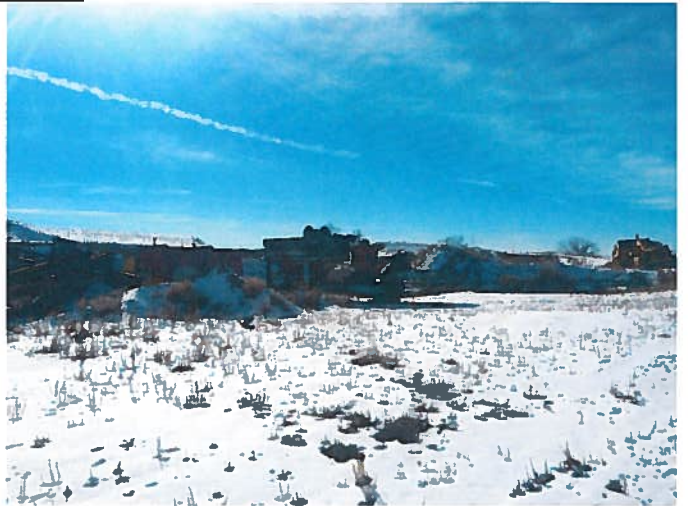
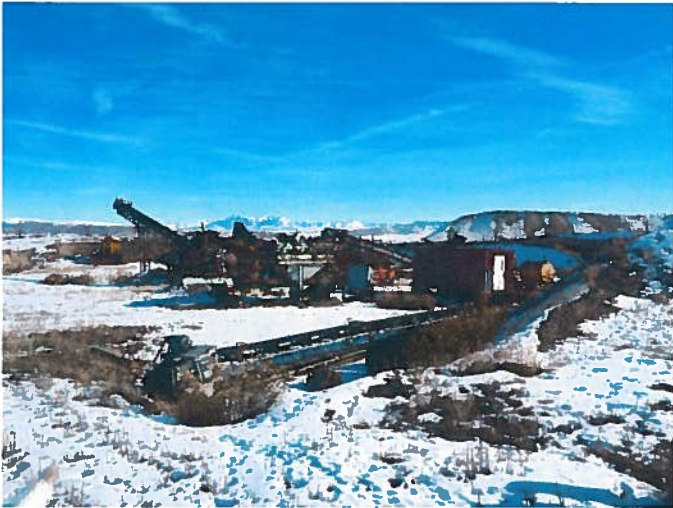
The current disturbance is located in the southern portion of the permit area and is approximately 2.75 acres in size. The excavation is about 25-30 feet deep with a vertical highwall. The highwall is in the southern portion of the permit area. Topsoil has been stripped and is stockpiled in the southern and western parts of the permit boundary of the site and is stabilized with vegetative cover. No erosion or sedimentation issues were observed.

Overall Site- Looking East

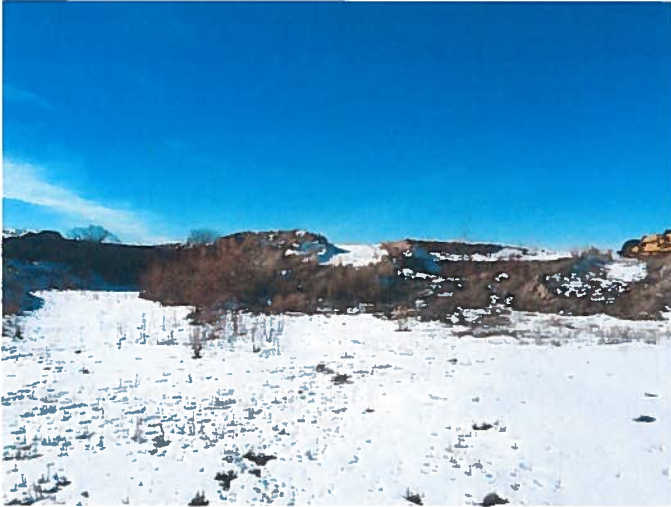
Looking South

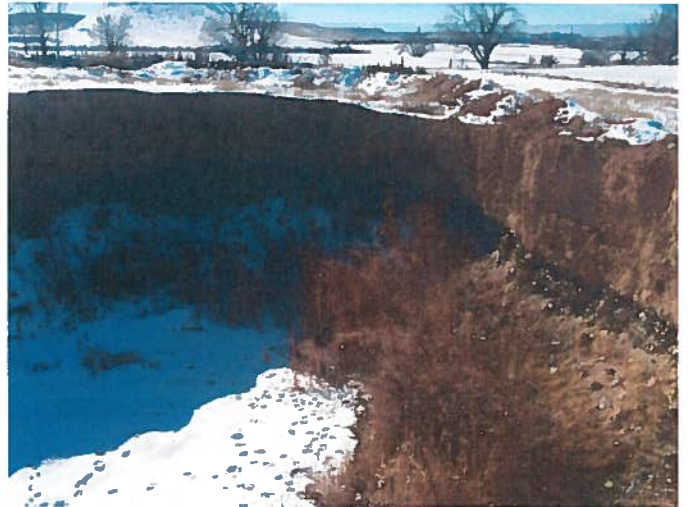
Highwall

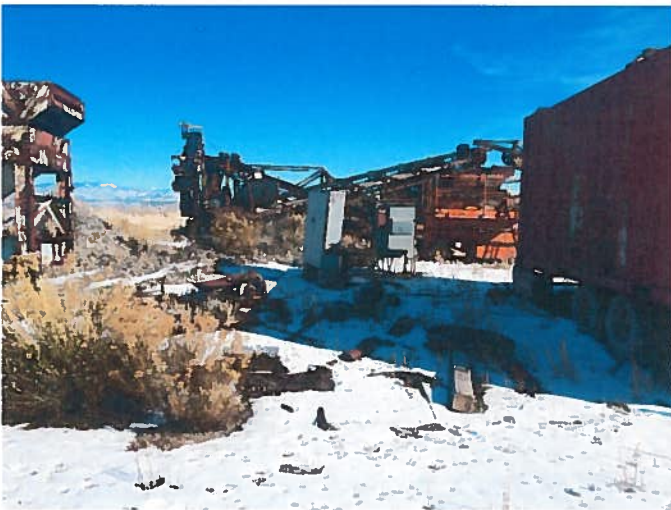
There was no fuel on site. The equipment on site consisted of some crushers, a loader, and a zircon type trailer. All appeared to not be in operation.

The site has been inactive for years. Rule 1.13.5 states, if an Operator temporarily ceases production of the mining operation for one hundred eighty (180) days or more, the Operator must file a Notice of Temporary Cessation in writing to the Office. The Division recommends the Operator file for Temporary Cessation. The start date of the initial 5 year Temporary Cessation period is retroactive to the last date the pit was active. If that date is more than 5 years ago, the operator is required ask the Board for a 5 year extension to the Temporary Cessation period (per rule 1.13.5 (3) and 1.13.8 (b) or begin reclamation. **This is cited as a problem at the beginning of the inspection report.**

Equipment – Not in Operation

CORRECTIVE ACTIONS: The Division recommends the Operator file for Temporary Cessation. The start date of the initial 5 year Temporary Cessation period is retroactive to the last date the pit was active. If that date is more than 5 years ago, the operator is required ask the Board for a 5 year extension to the Temporary Cessation period (per rule 1.13.5 (3) and 1.13.8 (b) or begin reclamation.

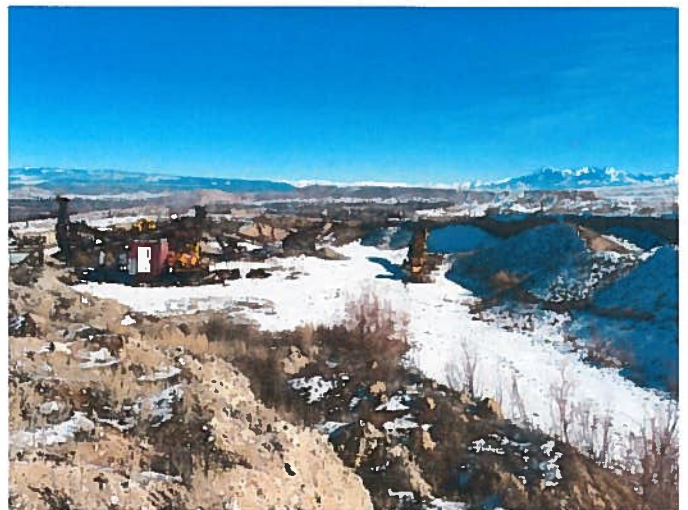
Overall Site looking North
