COLORADO DIVISION OF RECLAMATION, MINING AND SAFETY
MINERALS PROGRAM INSPECTION REPORT
PHONE: (303) 866-3567

MINE NAME: Ordway Pit	MINE/PROSPECTING ID#: M-2006-054	MINERAL: Sand and gravel	COUNTY: Crowley
INSPECTION TYPE: Surety-Related Inspection	INSPECTOR(S): Amy Eschberger	INSP. DATE: January 13, 2016	INSP. TIME: 11:00
OPERATOR: Carder, Inc.	OPERATOR REPRESENTATIVE: None	TYPE OF OPERATION: 112c - Construction Regular Operation

M2006-054 / Ordway Pit / Carder, Inc.

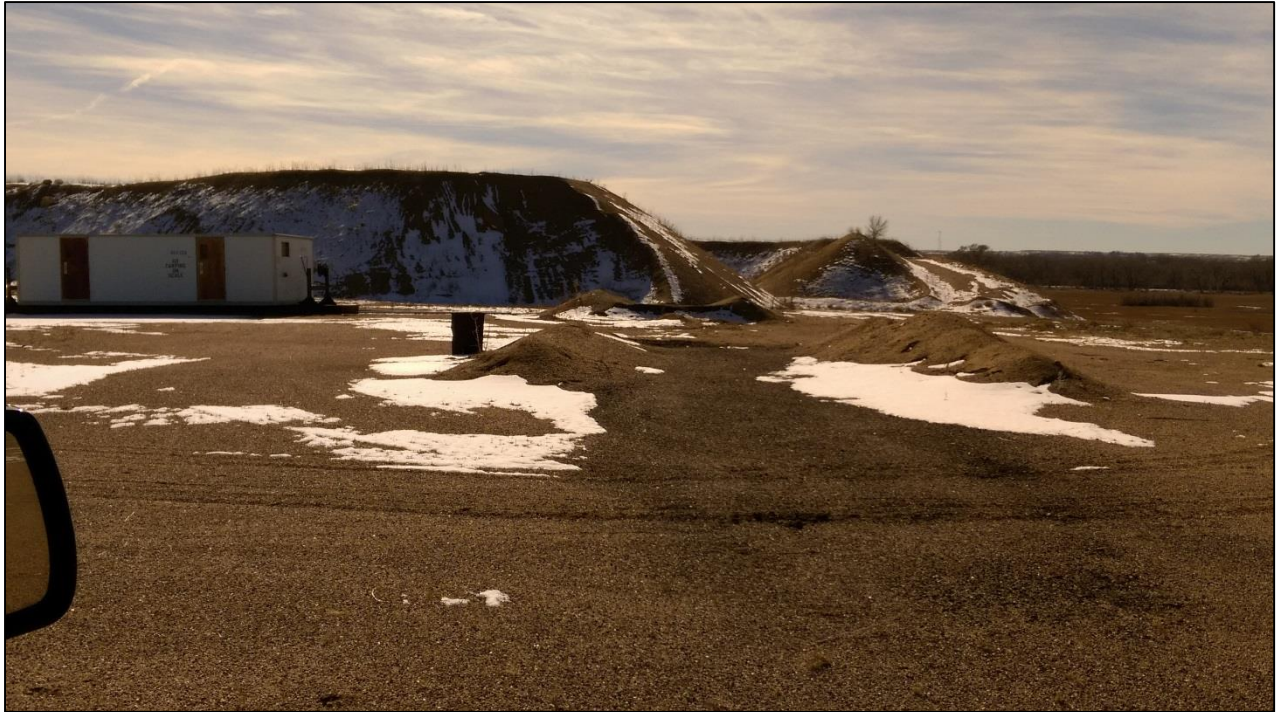
At the time of the inspection, the weather was clear, sunny and cool. No standing water was observed on site. A permit sign was posted at the eastern entrance to the site. The northern and western permit boundaries were delineated by property fencelines, and most of the southern permit boundary was delineated by the existing road. The eastern permit boundary was relatively parallel to an adjacent dry creek bed. However, the Division did not observe a marker for the southeastern corner of the permit boundary, which would help delineate the eastern and southern permit boundaries near the area of disturbance. The Division recommends the operator be sure to mark the southeastern corner of the permit boundary in accordance with Rule 3.1.12(2), which requires the boundaries of the affected area to be marked by monuments or other markers that are clearly visible and adequate to delineate such boundaries. The site was not active during the inspection, and no equipment was stored on site. A small trailer was present at the top of the terrace near an area that appeared to be used as a scale when the operation was active (**Photo 1**).

Photo 1. View looking south from pit floor, showing small trailer and scale area located near center of pit. Note a portion of large sand stockpile stored along southern edge of pit shown behind trailer.

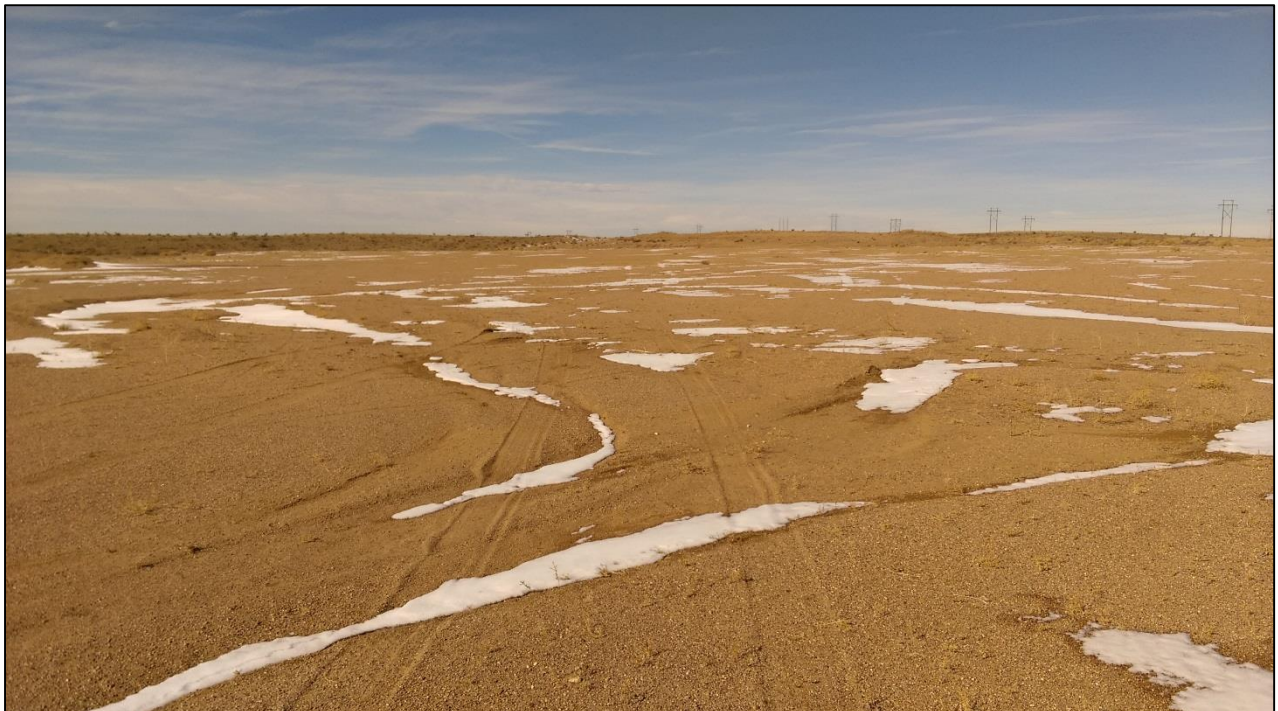
Photo 2. View looking west from eastern edge of pit, showing relatively flat pit floor where ridge top was removed. No highwalls present.

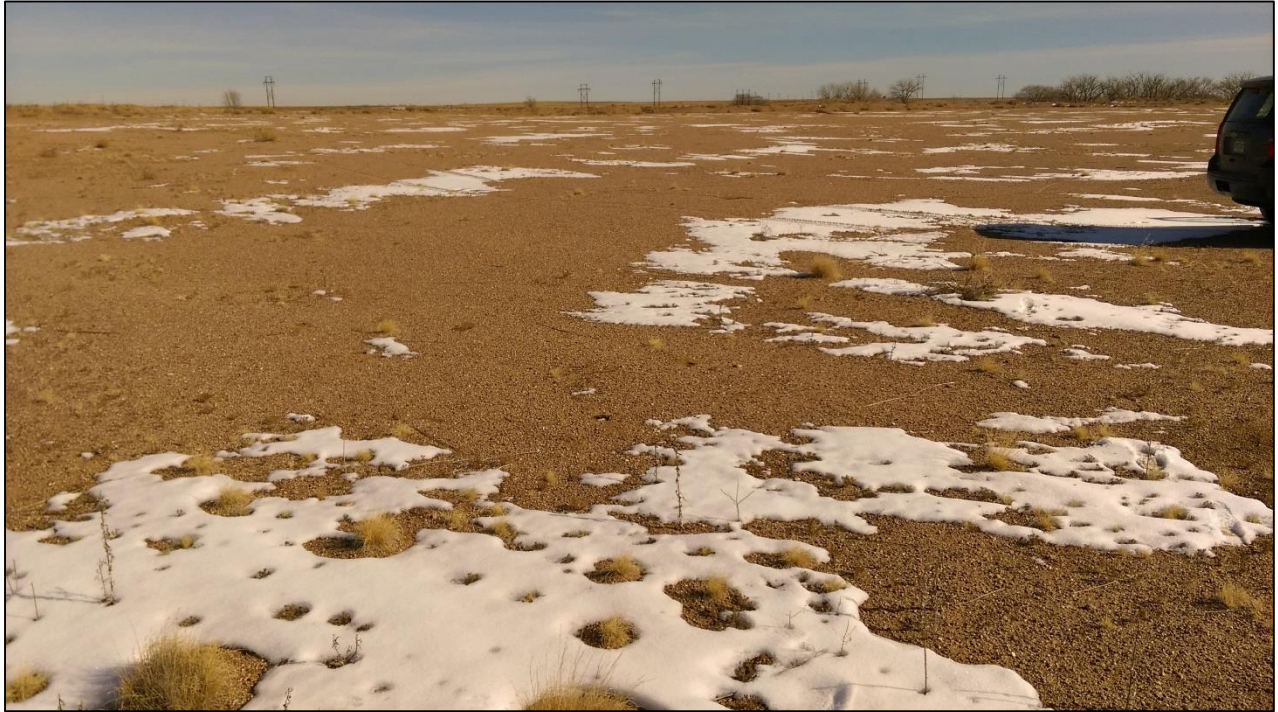
Photo 3. View looking east from western edge of pit, showing relatively flat pit floor where ridge top was removed. No highwalls present.

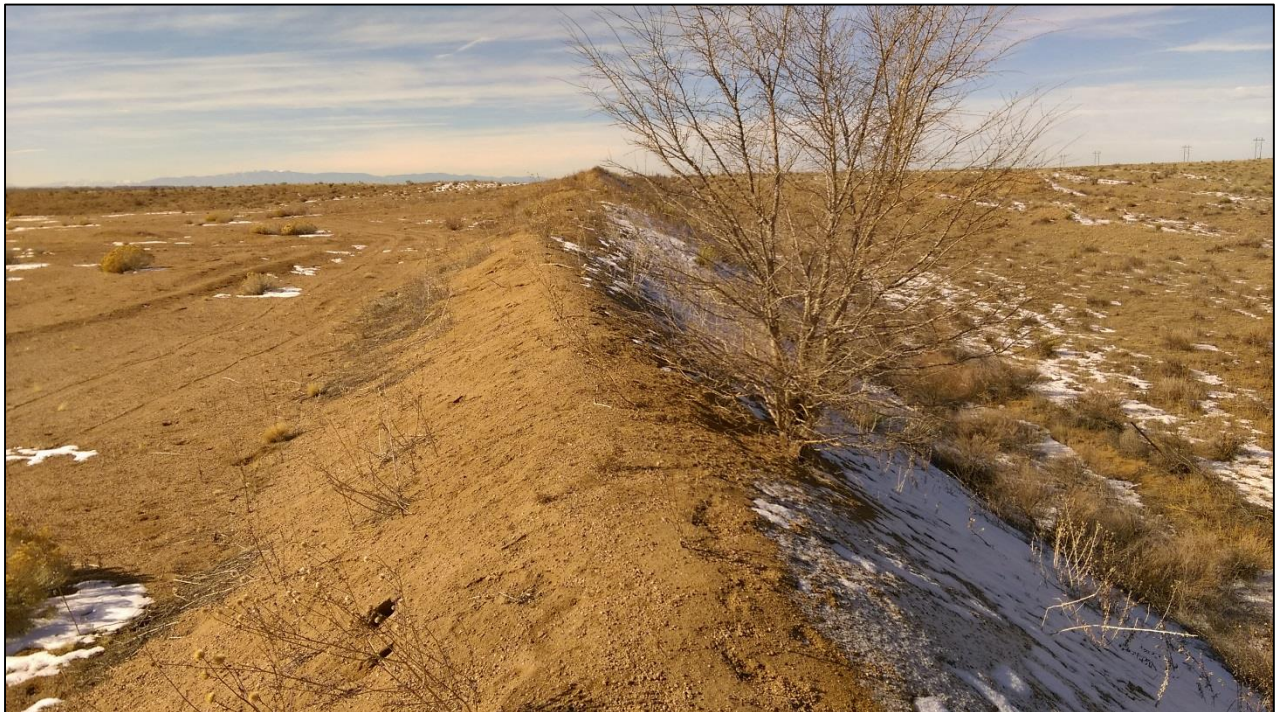
Photo 4. View looking west along northern edge of pit, showing low-lying topsoil berm stored along northern pit perimeter.

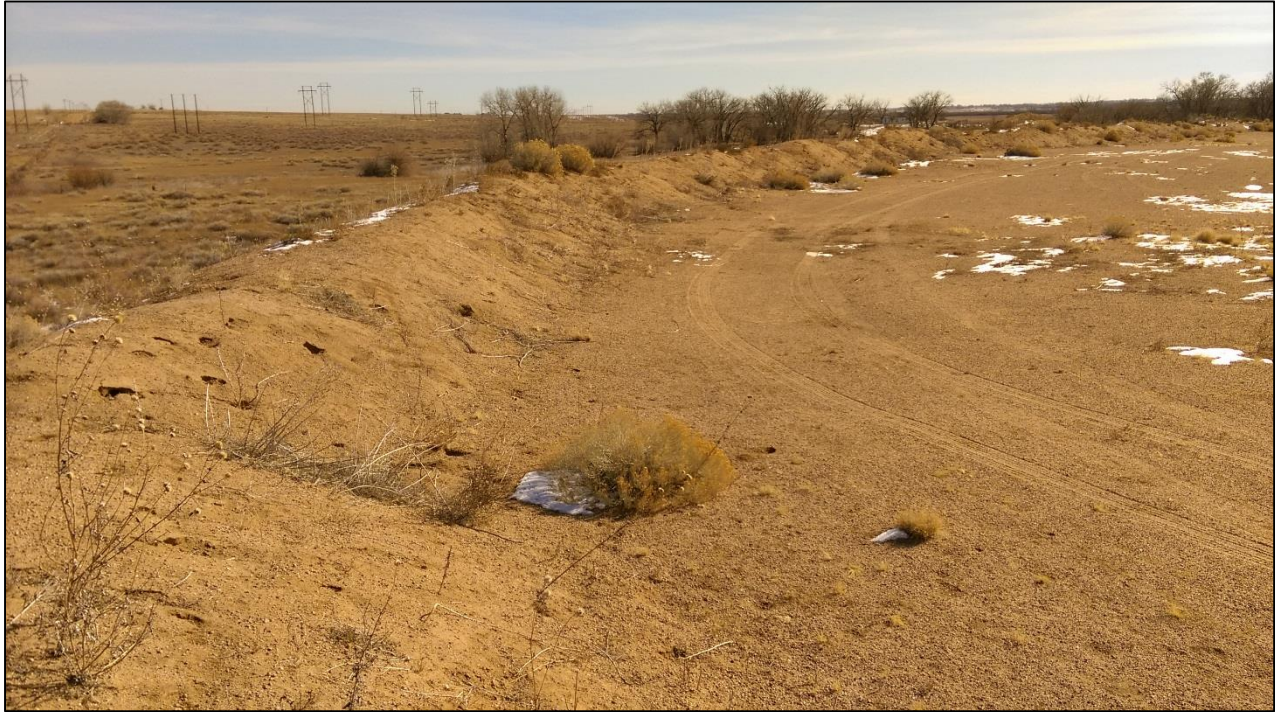
Photo 5. View looking south along eastern edge of pit, showing low-lying topsoil berm stored along eastern pit perimeter.

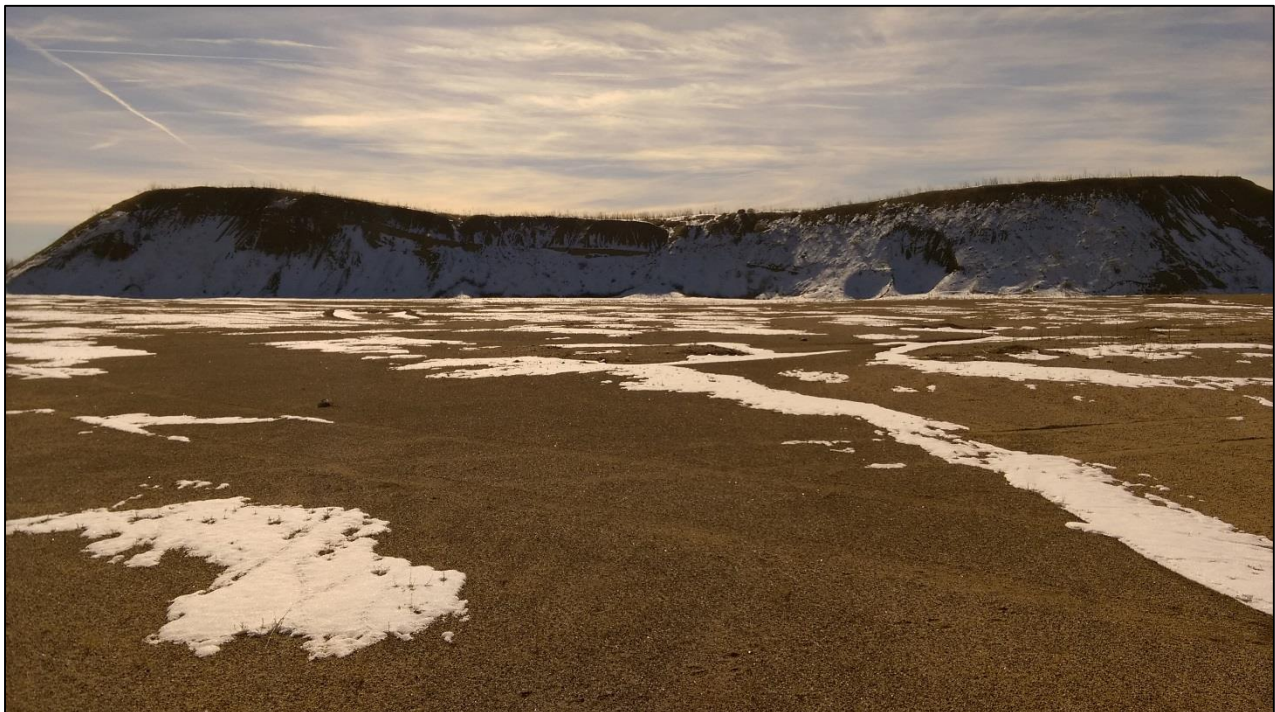
The Division estimates current disturbance inside the permit area to cover 27.5 acres (see enclosed Google Earth images of site), including a relatively flat pit floor with no highwalls (where the ridge top was removed; **Photos 2 and 3**), low-lying topsoil berms stored along the northern (**Photo 4**) and eastern (**Photo 5**) perimeter of the pit, and a large sand stockpile stored along the southern permit boundary (**Photos 6 and 7**). The sand stockpile is approximately 20-25 feet in height and occupies a footprint of approximately 2 acres.

Photo 6. View looking south from center of pit, showing north side of large sand stockpile stored along southern edge of pit, covering approximately 2 acres, with height of approximately 20-25 feet.

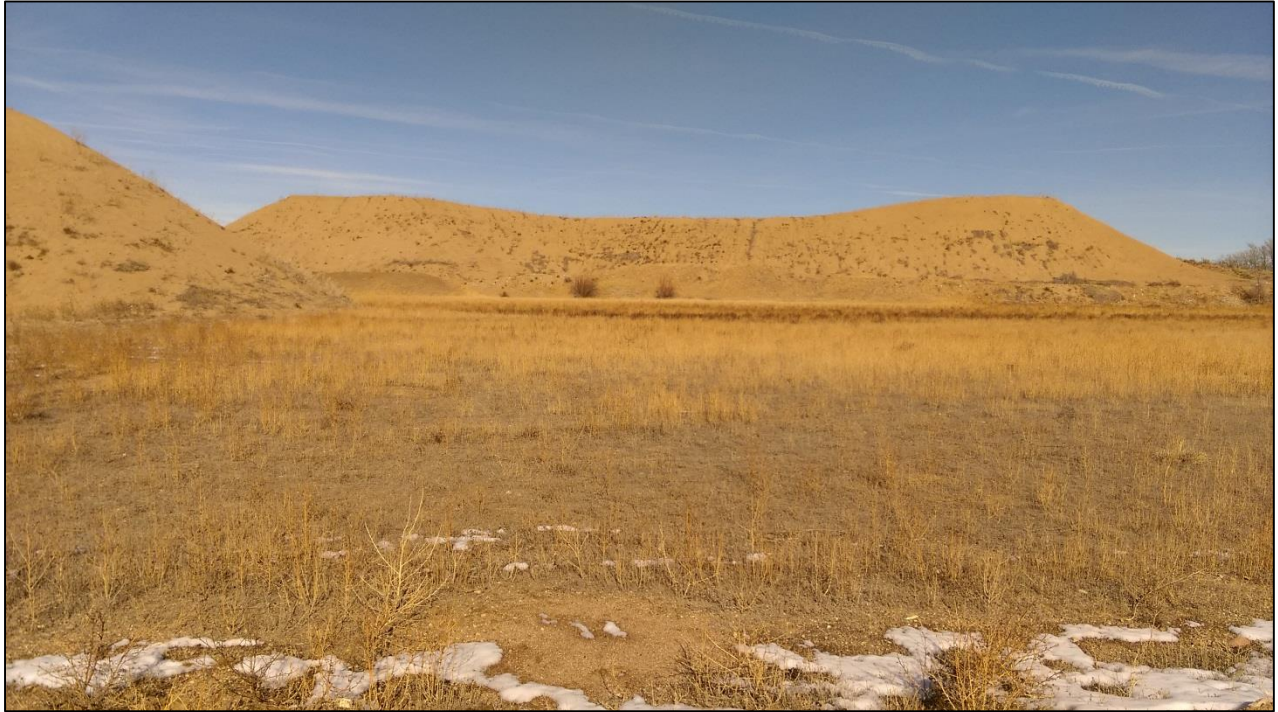
Photo 7. View looking north from access road located south of permit boundary, showing south side of large sand stockpile stored along southern edge of pit.

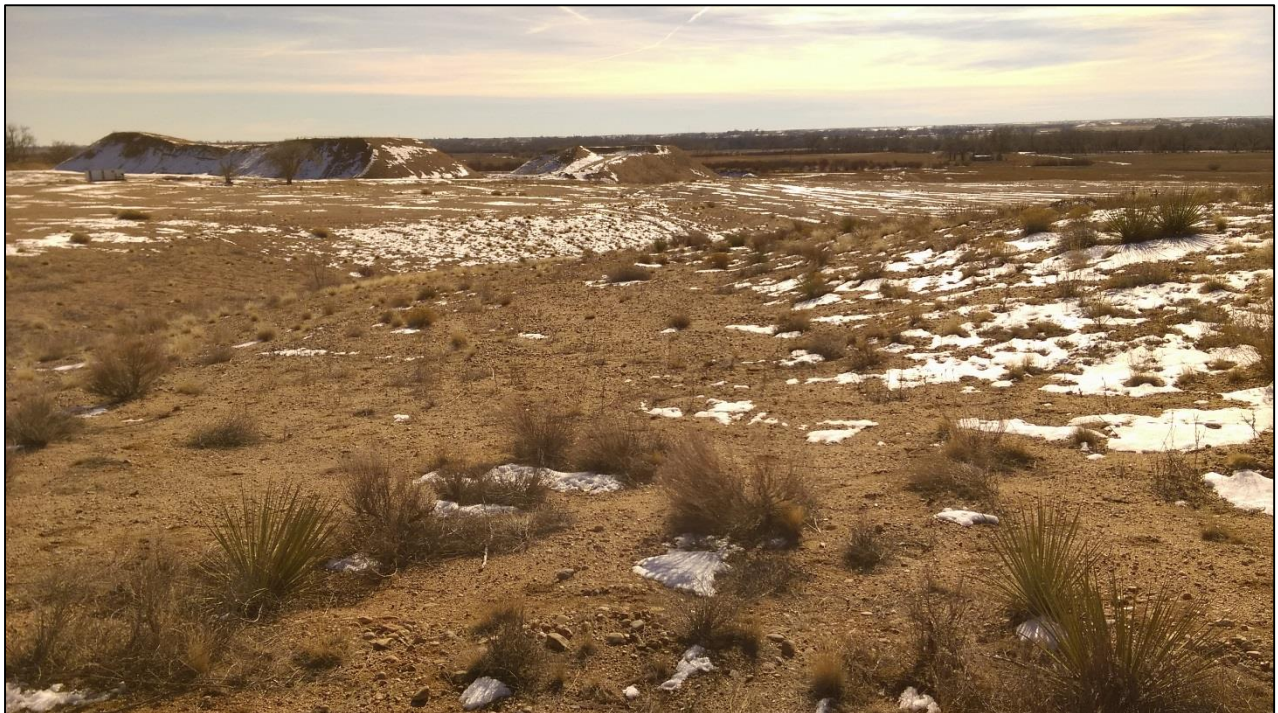
Approximately 7.5 acres along the western edge of the pit has been graded to 3H:1V or flatter, and appears to have had topsoil replaced (**Photos 8-10**). Some native grasses, shrubs, and annual weeds are volunteering across this graded area. The Division would like to remind the operator that the approved maximum allowed disturbed acreage at any time is 20 acres, with reclamation of disturbed areas to occur as the operation advances. Areas that have been graded and retopsoiled will not be included in the maximum allowed disturbed acreage; however, the Division will still be required to include in the required financial warranty costs for revegetating these areas. Prior to disturbing more than 20 acres, a Technical Revision would need to be submitted to increase the maximum allowed disturbed acreage (see enclosed form). At that time, the Division would reassess the required financial warranty.

Photo 8. View looking southeast across northern portion of western 7.5 acres that was graded to 3H:1V or flatter and retopsoiled. Note some native grasses and shrubs volunteering into this area.

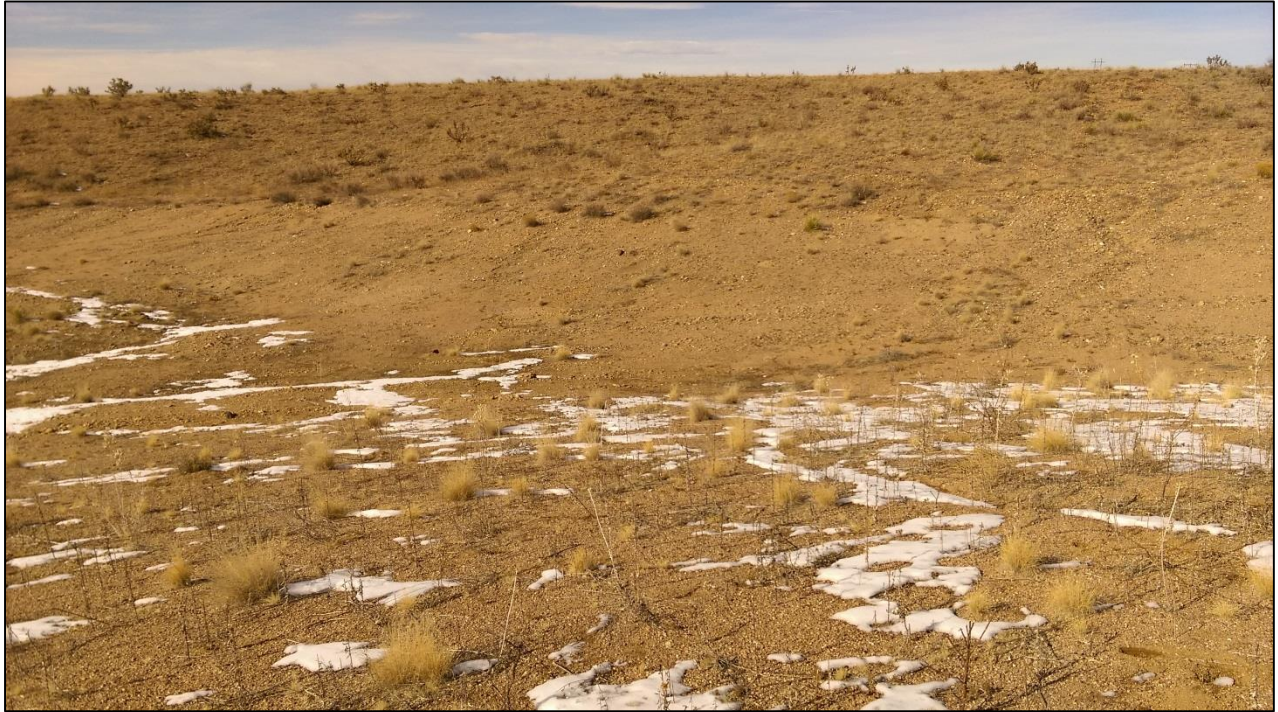
Photo 9. View looking west across central portion of western 7.5 acres that was graded to 3H:1V or flatter and retopsoiled. Note some native grasses volunteering into this area.

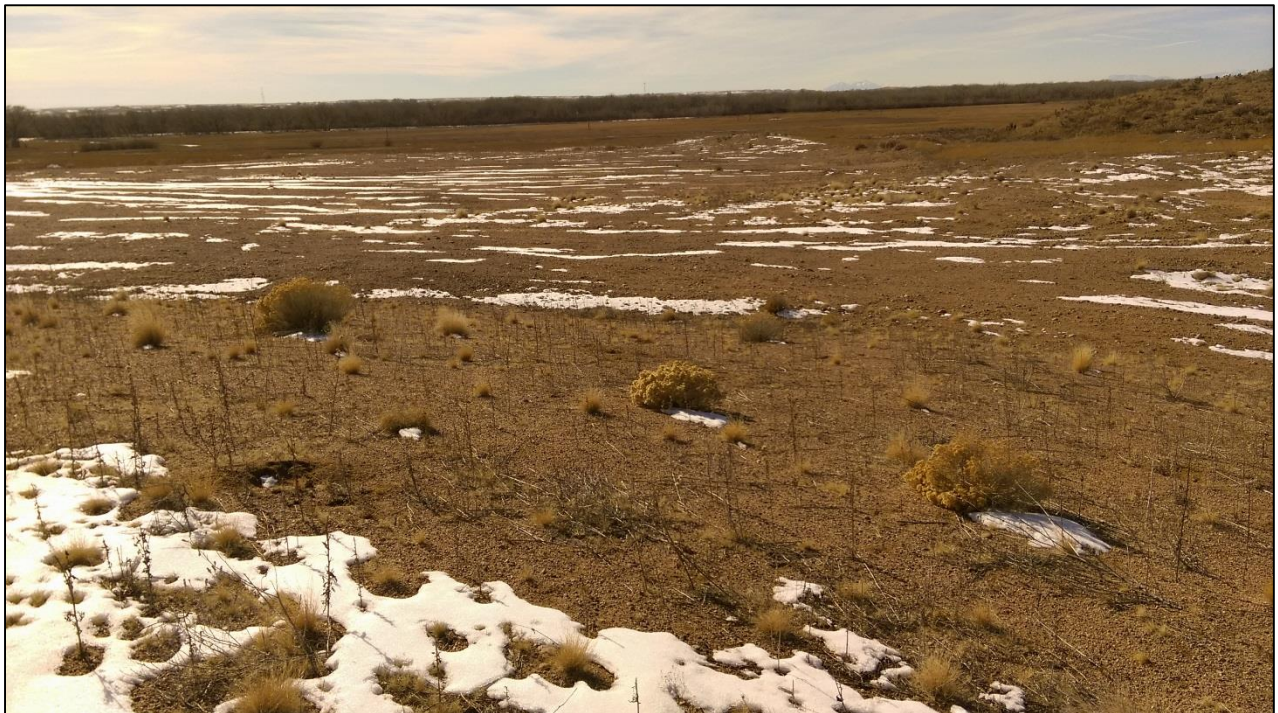
Photo 10. View looking south across southern portion of western 7.5 acres that was graded to 3H:1V or flatter and retopsoiled. Note some native grasses and shrubs volunteering into this area.

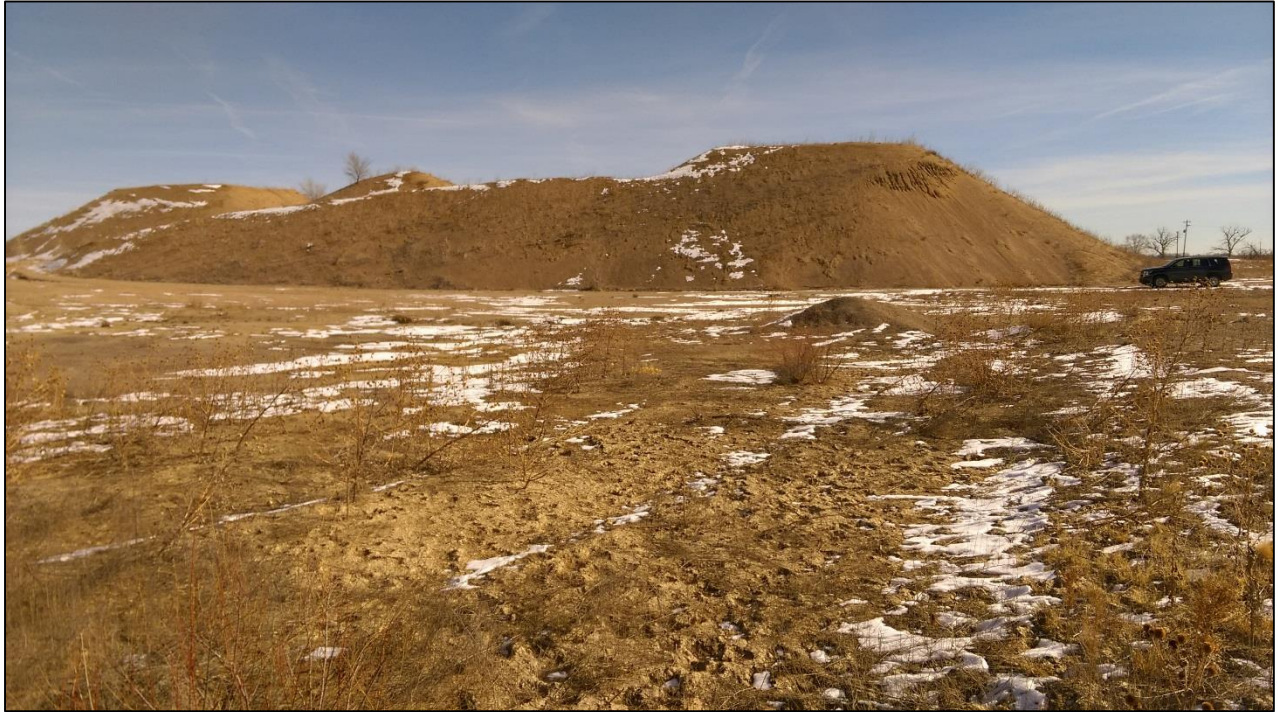
During the inspection, the Division observed approximately 3.4 acres of disturbance outside of the southern permit boundary, which included a large gravel stockpile that is located partially inside of and partially outside of the permit area (**Photos 11 and 12**). This stockpile is approximately 20-25 feet in height and occupies a footprint of approximately 1.7 acres. The adjacent disturbance also includes an area that appears to have been stripped of topsoil, including a topsoil berm and a small sand stockpile (located west of the haul road; **Photo 13**) and a small stockpile of reclaimed asphalt pavement (RAP; located east of the haul road; **Photo 14**). According to the operator, this disturbance was created by a temporary asphalt batch plant that was operated adjacent to the permit area in 2011 by Lafarge. The landowner allowed Lafarge to operate the batch plant on 10 acres located just south of the permitted mine site for approximately 3 months to fulfill a construction contract for a road project located south of La Junta. The operator (and successor operator) should be aware that disturbance such as this (including a large stockpile) which is located directly adjacent to the permit boundary could easily be mistaken by the Division as off-site damage associated with the current permitted operation. In such case, a possible violation would be cited, requiring a hearing before the Mined Land Reclamation Board. To reduce any confusion over the matter in the future, the Division recommends the stockpiled material either be removed from the site, relocated to within the approved permit area, or incorporated into the permit area through the submittal of a permit Amendment.

Photo 11. View looking east, showing western side of large gravel stockpile located east of haul road, partially inside of and partially outside of permit boundary. Note vehicle for scale (parked at far right). This stockpile was associated with the temporary asphalt batch plant that Lafarge operated here in 2011.

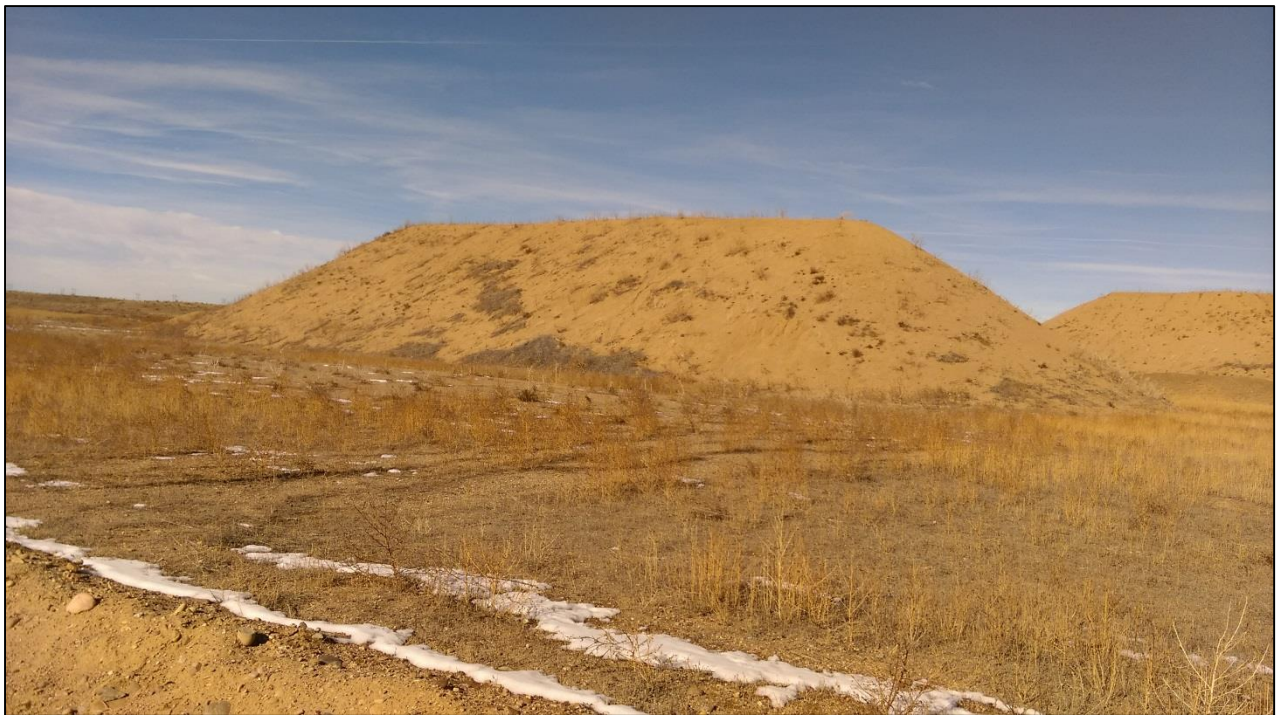
Photo 12. View looking northwest from access road located south of permit boundary, showing southern side of large gravel stockpile located partially inside of and partially outside of permit boundary. This stockpile was associated with the temporary asphalt batch plant that Lafarge operated here in 2011.

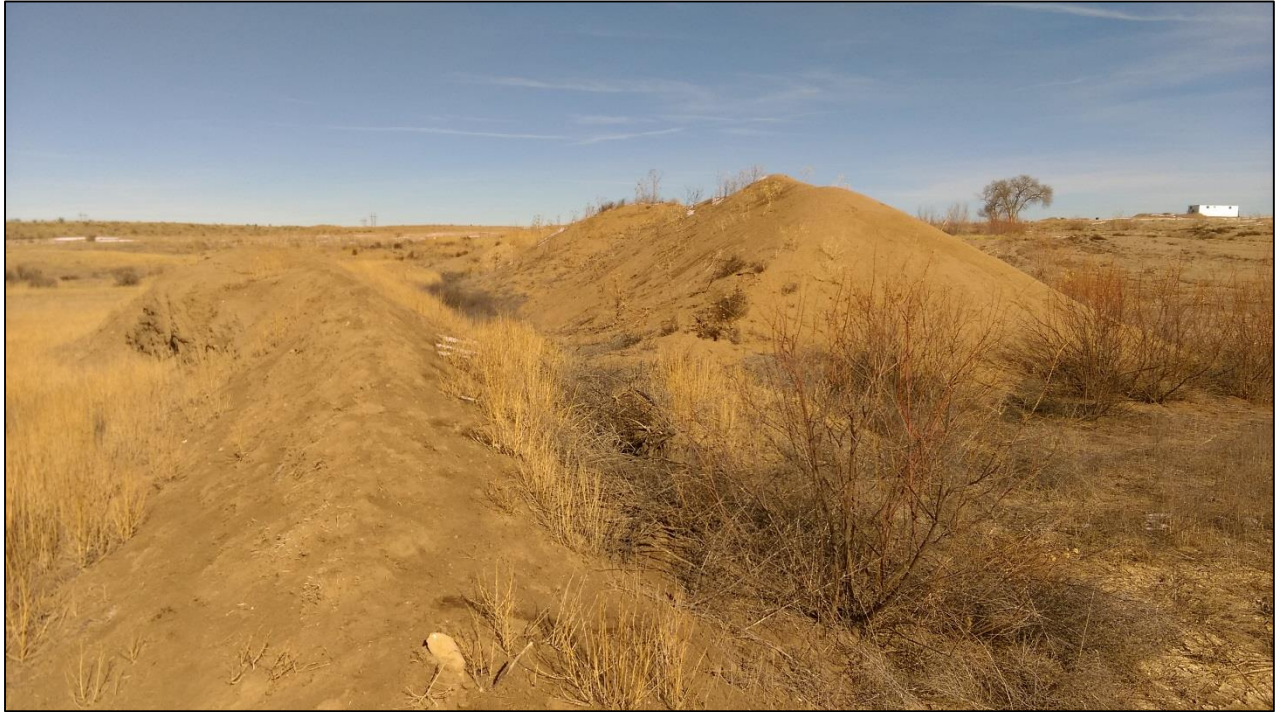
Photo 13. View looking north, showing disturbance (topsoil berm and small sand stockpile) located south of permit boundary associated with temporary asphalt batch plant operated by Lafarge in 2011.

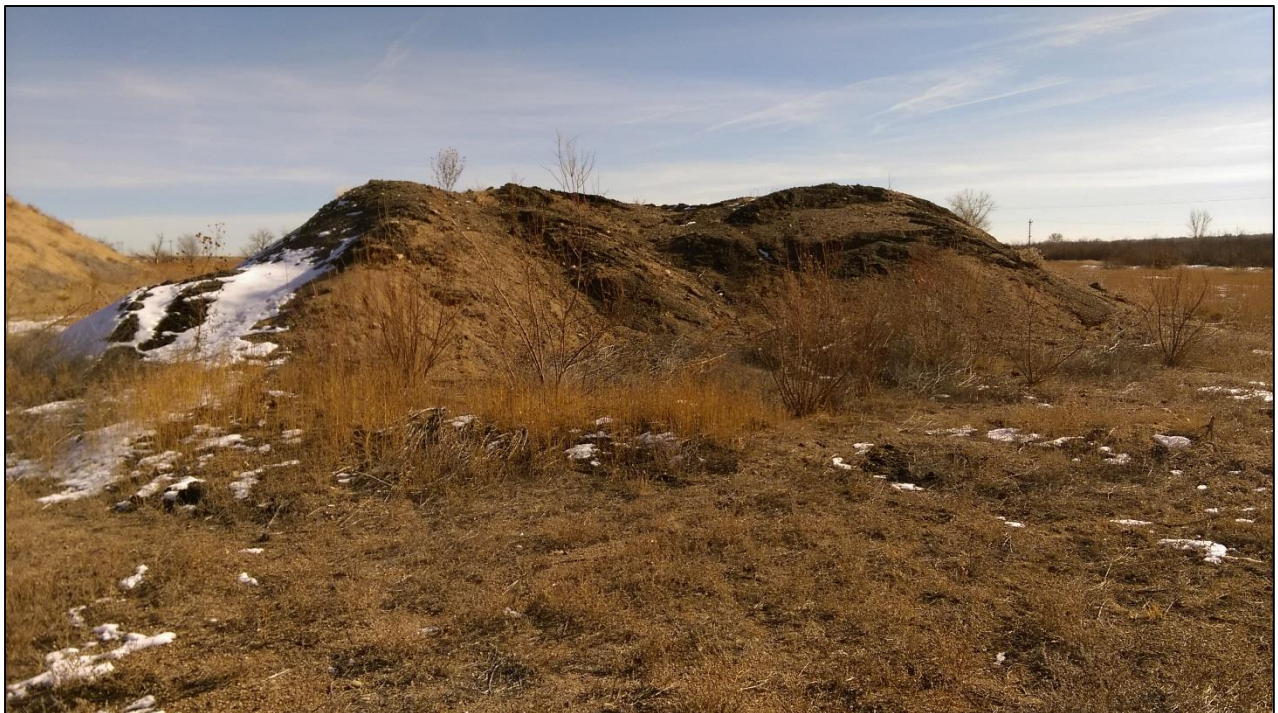
Photo 14. View looking east, showing small stockpile of what appears to be unprocessed reclaimed asphalt pavement (RAP) millings associated with temporary asphalt batch plant operated by Lafarge in 2011.

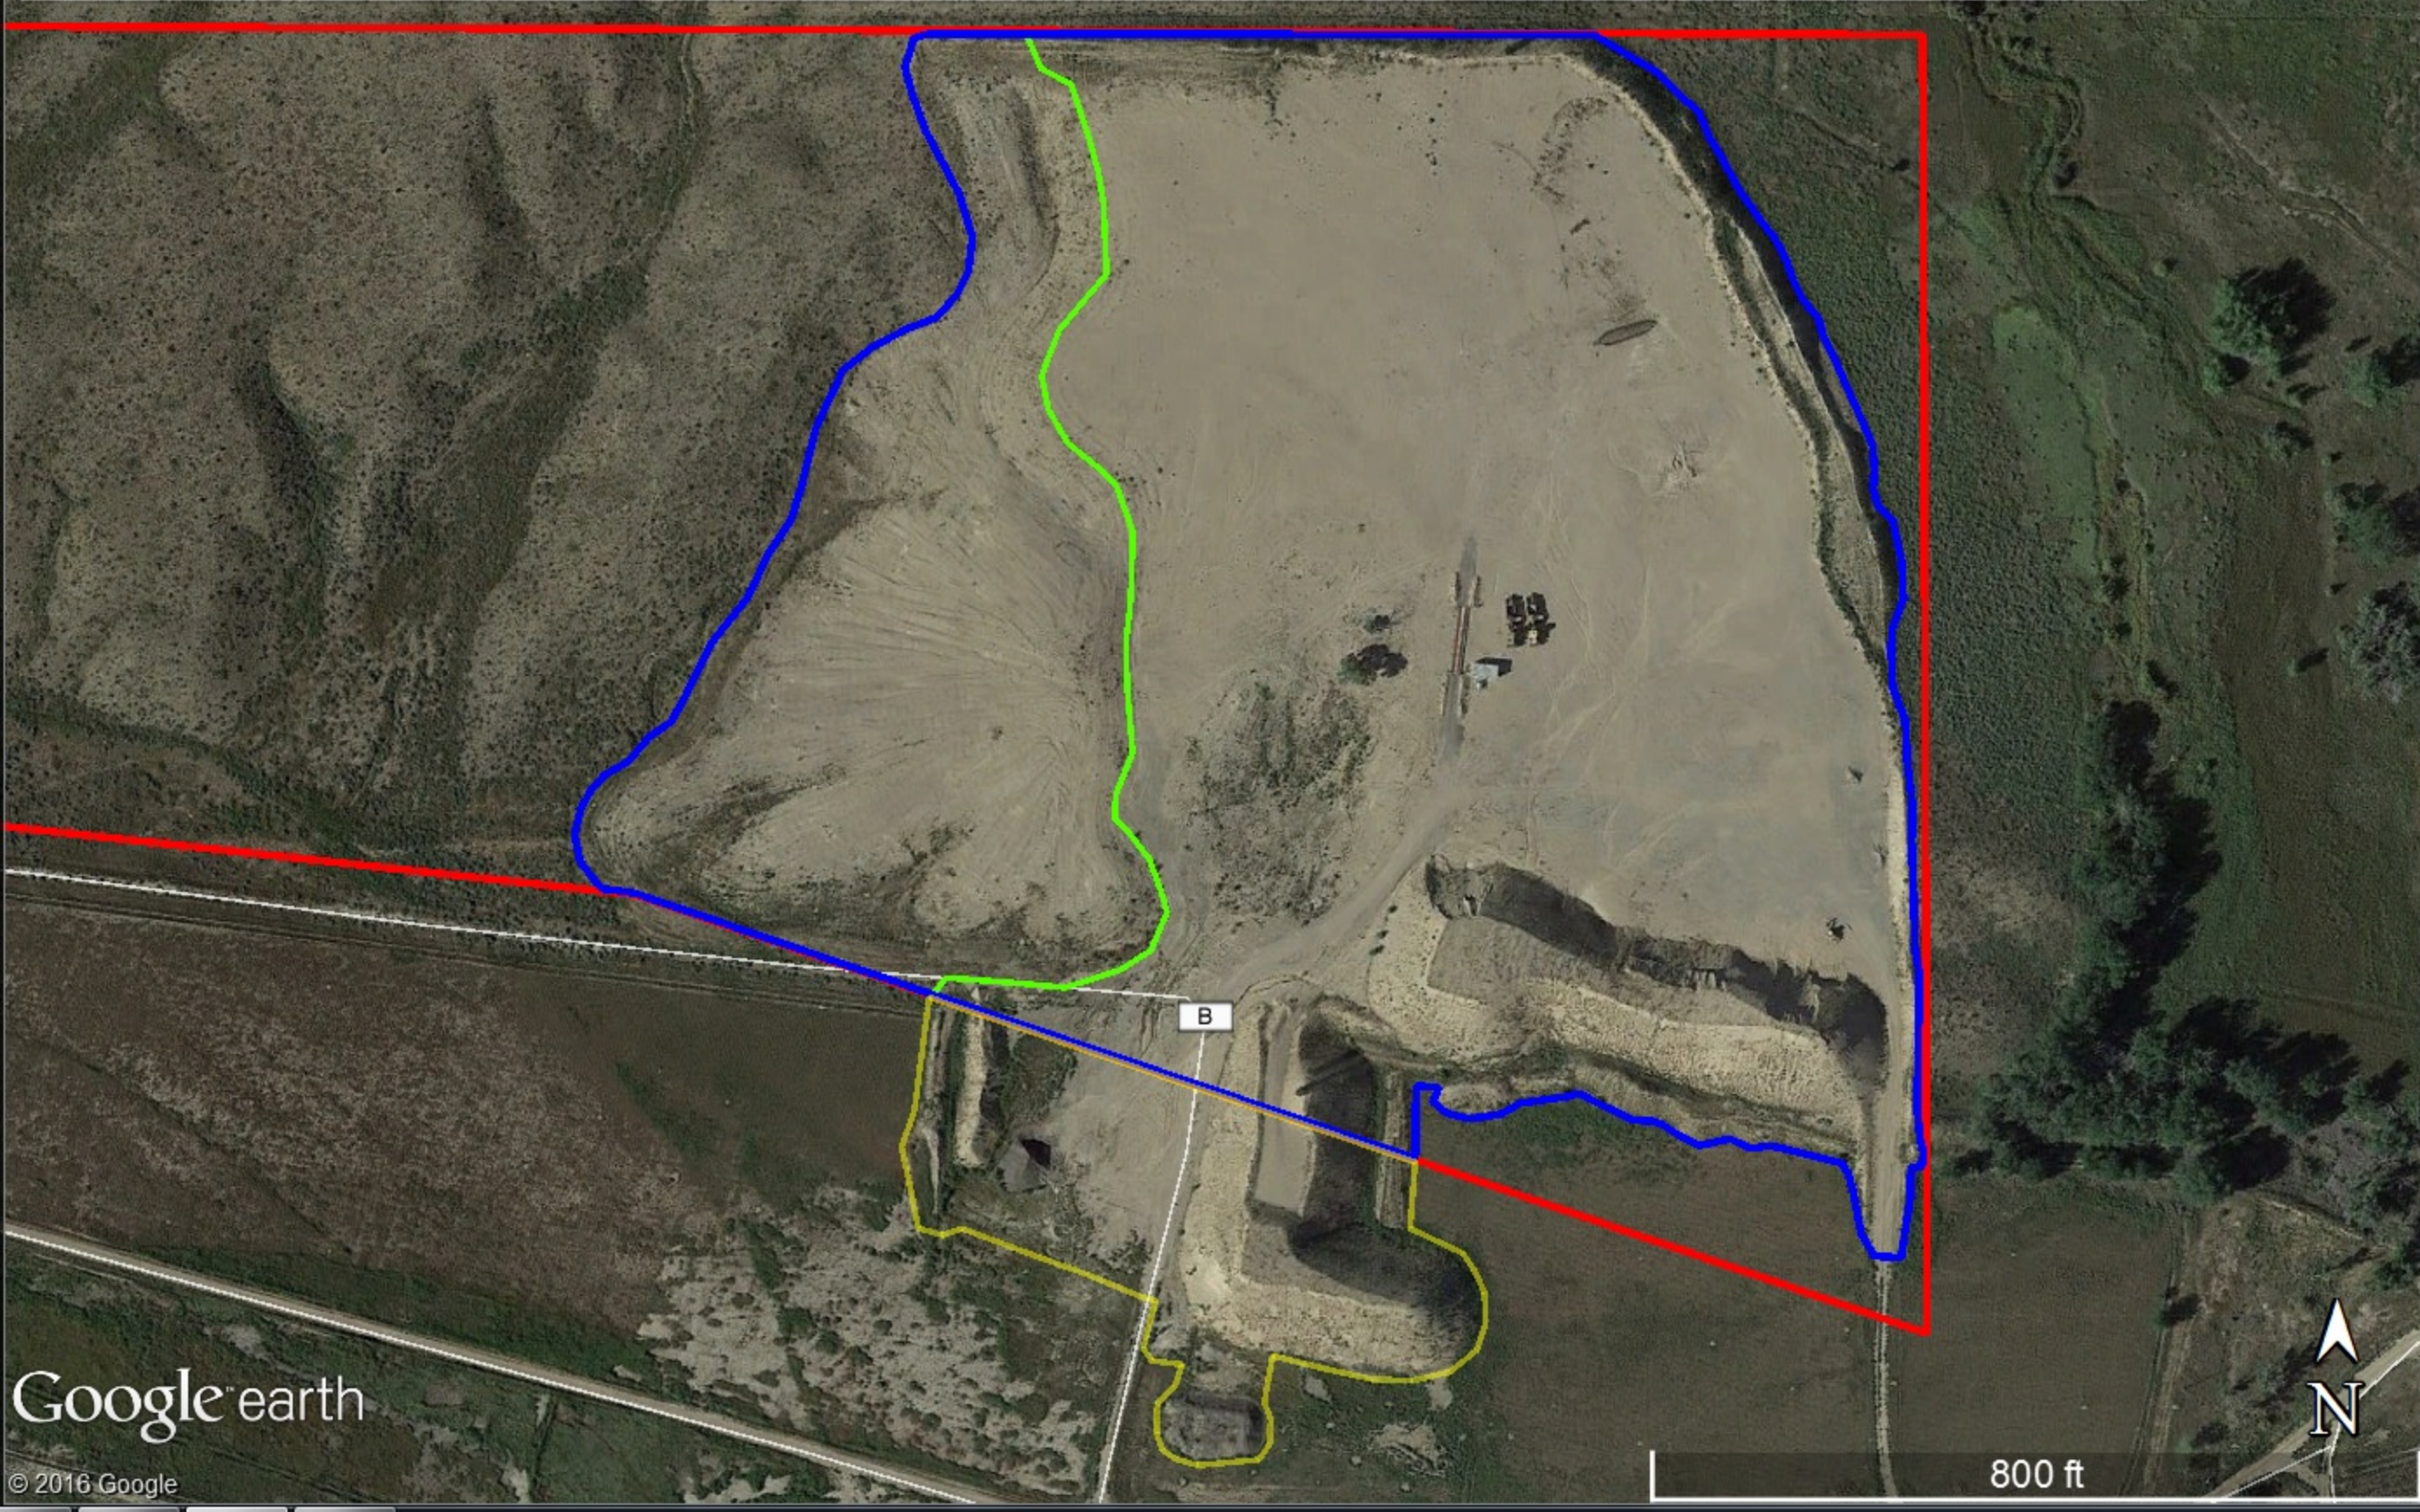
M2006-054 / Ordway Pit / Carder, Inc.

Red Outline = 98 acres = Approved Permit Area

Blue Outline = 27.5 acres = Disturbed land inside Permit Area (as of 1/13/16 inspection)

Green Line = Separates 7.5 acres partially reclaimed land (west of line) from 20 acres disturbed land (east of line)

Yellow Outline = 3.4 acres = Disturbed land outside Permit Area (assoc. with temporary asphalt batch plant operated by Lafarge in 2011)
