COLORADO DIVISION OF RECLAMATION, MINING AND SAFETY
MINERALS PROGRAM INSPECTION REPORT
PHONE: (303) 866-3567

MINE NAME: 90 Road Pit	MINE/PROSPECTING ID#: M-2008-043	MINERAL: Sand and gravel	COUNTY: Montrose
INSPECTION TYPE: Monitoring	INSPECTOR(S): Dustin Czapla	INSP. DATE: March 16, 2016	INSP. TIME: 13:30
OPERATOR: Rocky Mountain Aggregate & Construction, I	OPERATOR REPRESENTATIVE: None	TYPE OF OPERATION: 110c - Construction Limited Impact	
REASON FOR INSPECTION: Normal I&E Program	BOND CALCULATION TYPE: Partial Bond	BOND AMOUNT: \$26,832.00	
DATE OF COMPLAINT: NA	POST INSP. CONTACTS: None	JOINT INSP. AGENCY: None	
WEATHER: Clear	INSPECTOR'S SIGNATURE:

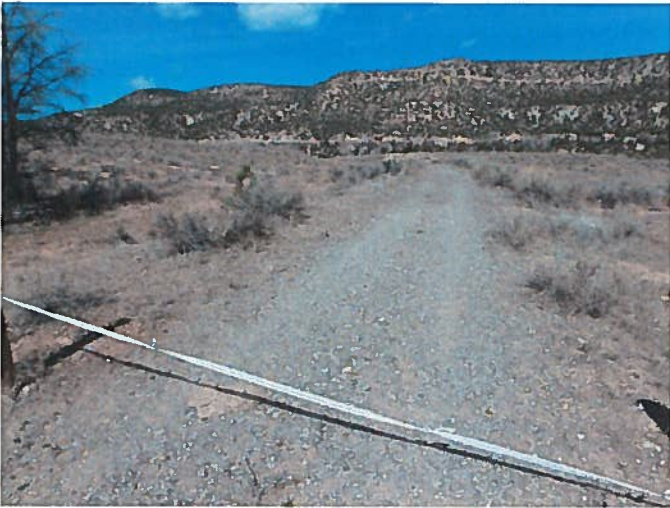
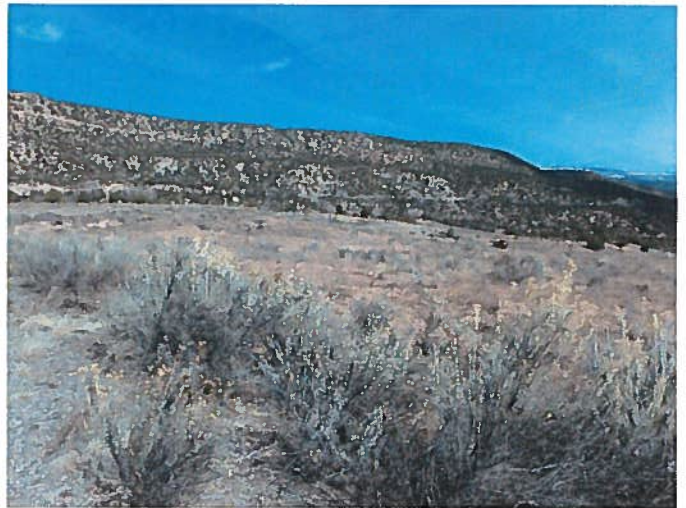
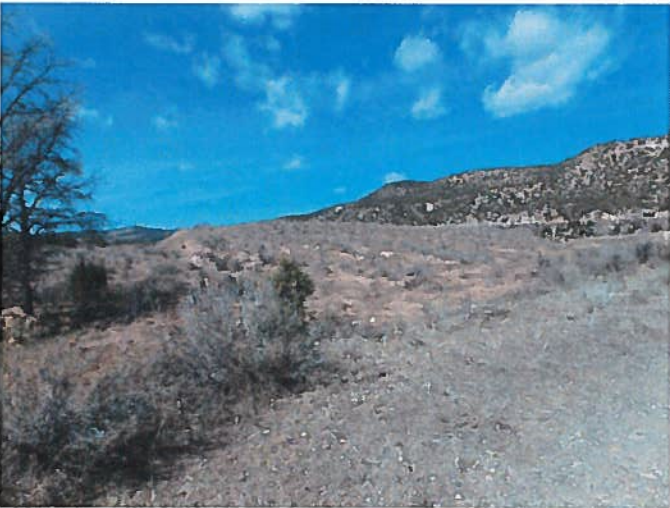
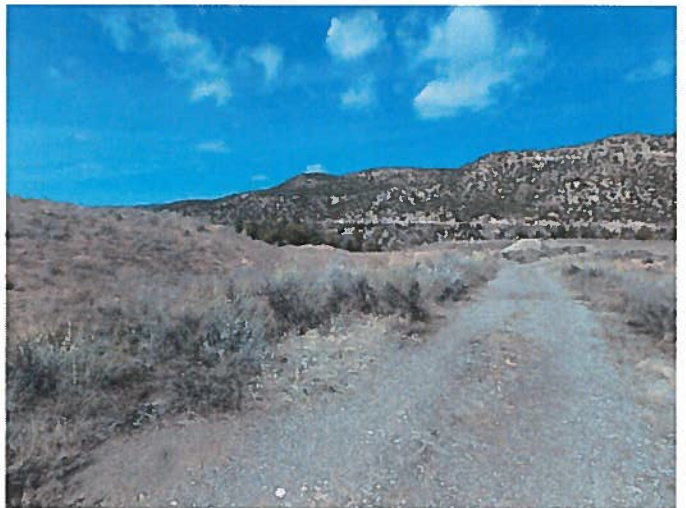
PHOTOGRAPHS

Adequate mine identification signage was not noted at the entrance to the site. This has been noted as a problem.

This inspection verified that mining has not yet commenced at this site. There was no equipment on site and no sign of any mining disturbance.

CORRECTIVE ACTIONS: The operator shall, at the entrance of the mine site, post a sign which shall be clearly visible from the access road with the following: the name of the operator, a statement that a reclamation permit for the operation has been issued by the Colorado Mined Land Reclamation Board; and the permit number. The operator shall submit photo documentation that a proper sign has been posted by the corrective action date.
