COLORADO DIVISION OF RECLAMATION, MINING AND SAFETY
MINERALS PROGRAM INSPECTION REPORT
PHONE: (303) 866-3567

MINE NAME: West End Gravel Pit #1	MINE/PROSPECTING ID#: M-1994-011	MINERAL: Gravel	COUNTY: Montrose
INSPECTION TYPE: Monitoring	INSPECTOR(S): Dustin Czapla	INSP. DATE: March 16, 2016	INSP. TIME: 13:00
OPERATOR: West End Gravel Company	OPERATOR REPRESENTATIVE: None	TYPE OF OPERATION: 112c - Construction Regular Operation	
REASON FOR INSPECTION: Normal I&E Program	BOND CALCULATION TYPE: None	BOND AMOUNT: \$50,075.00	
DATE OF COMPLAINT: NA	POST INSP. CONTACTS: None	JOINT INSP. AGENCY: None	
WEATHER: Clear	INSPECTOR'S SIGNATURE:

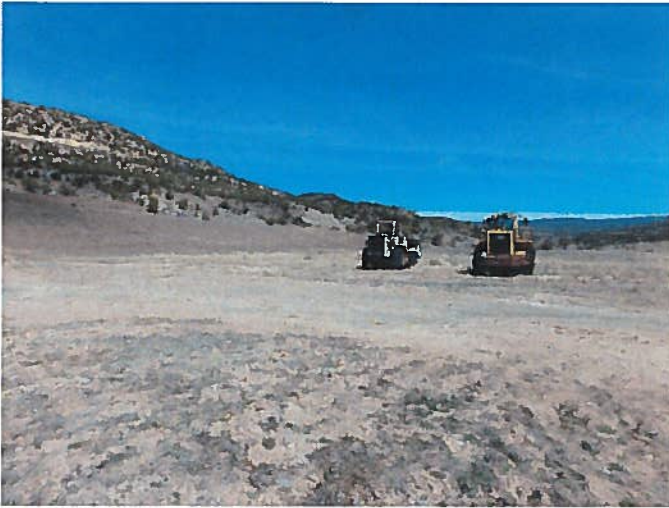
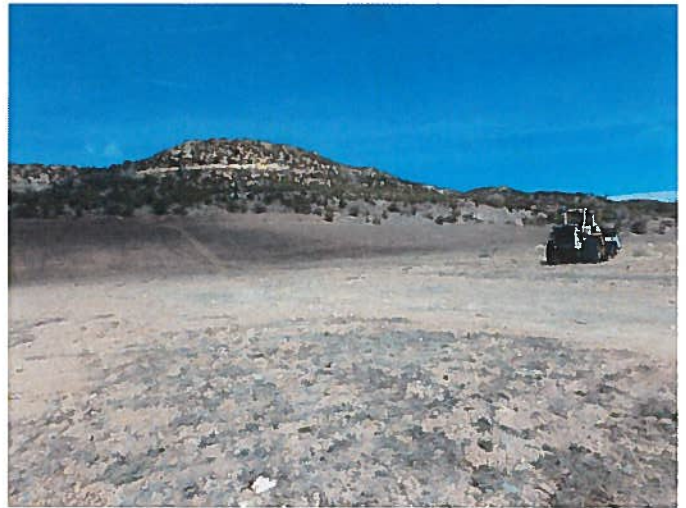
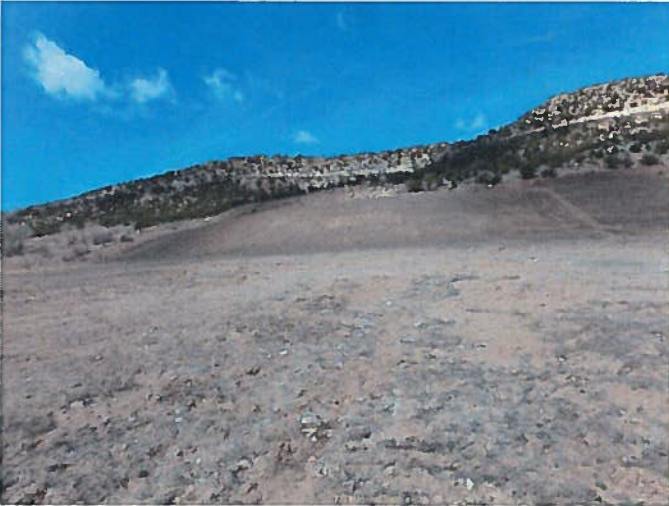
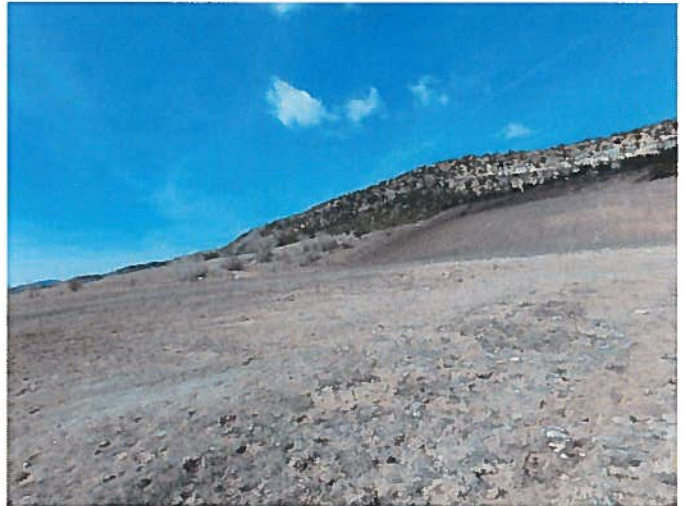
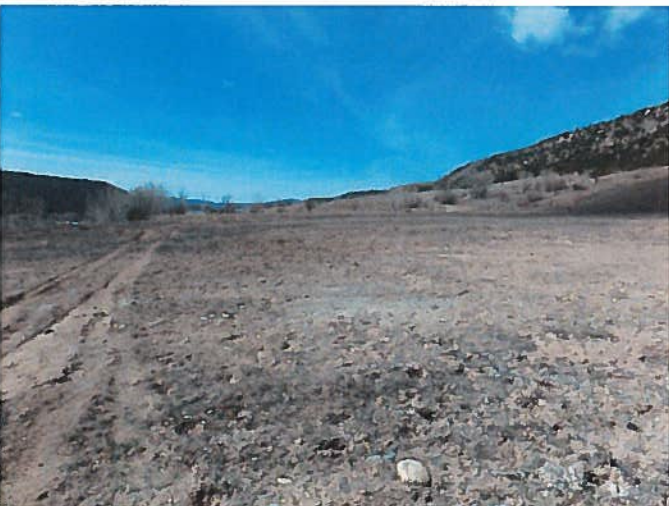
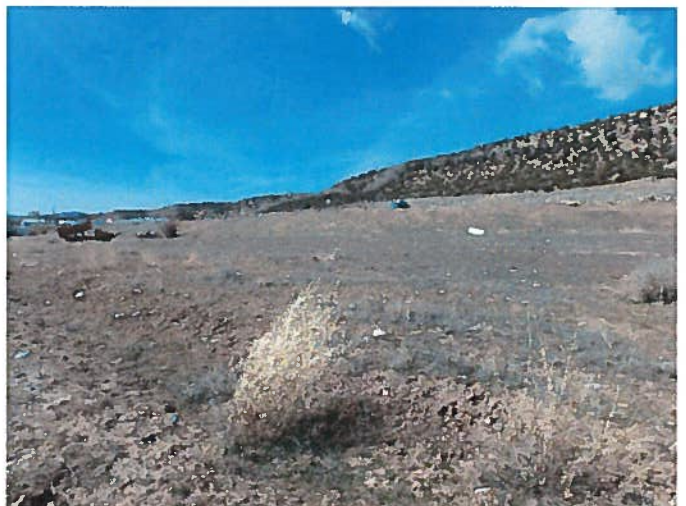
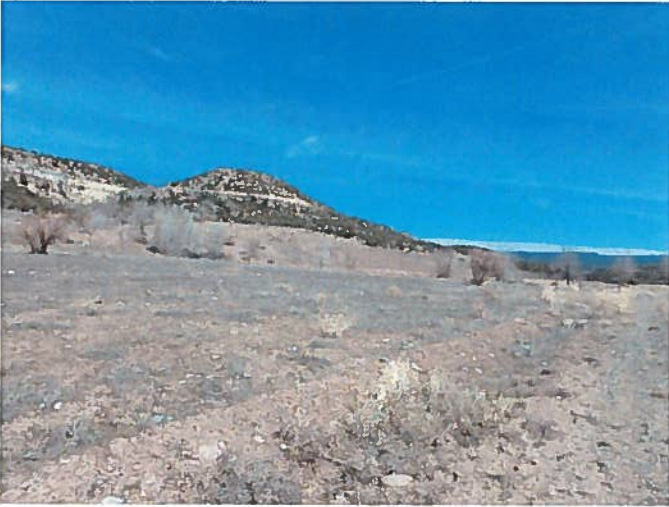
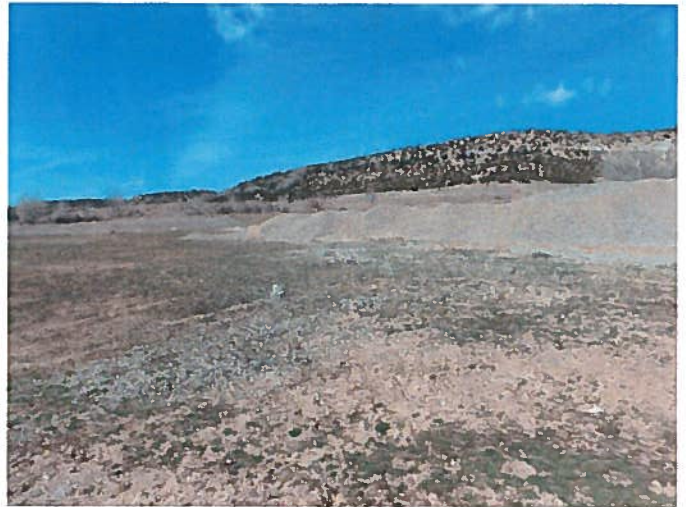
PHOTOGRAPHS

Adequate mine identification signage was noted at the entrance to the site.

Reclamation grading has been completed and is adequate. The slopes appear stable and no erosion concerns were noted. Topsoil has been replaced, and according to the Operator's annual reports the site has been seeded. Vegetation is sparse throughout the reclamation area though and additional seeding may be required. The Division will monitor the site through routine inspections and notify the Operator whether or not additional seeding should occur.

Several gravel stockpiles remain on site in the south part of the permit area for the landowners use.
