Letter of Concern related to Hitch Rack Ranch Quarry

Concerns of Eagles Nest Landowners

on Hitch Rack Ranch

**Prepared by Dr. Nancy Reed
April 2016**

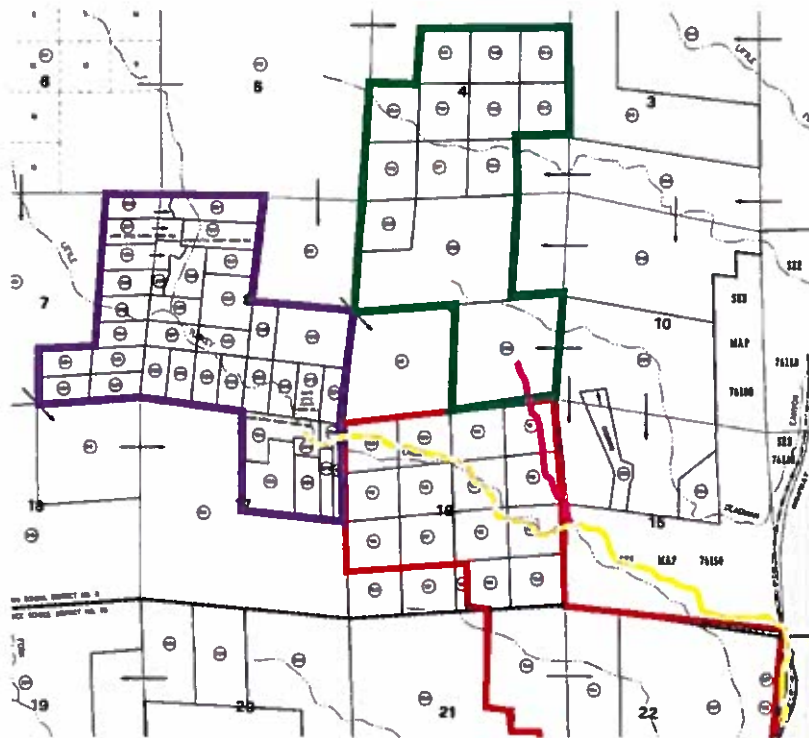
Figure 1 Ingress/Egress Road Easement

The background for Figure 1 below is parcel map 76000 from the El Paso County Assessor's database. The yellow line shows the location of the easement road defined in the 1968 court settlement. This road is used by landowners with property within Eagles Nest (highlighted in purple), located to the west of the proposed quarry. The fuchsia line shows the location of another segment of Little Turkey Creek Road used by landowners with property within the former Bauer's Ranch (highlighted in green). As can be seen, these two segments of Little Turkey Creek Road go right through the middle of the proposed quarry operations area, which is within Section 16 on Hitch Rack Ranch (outlined in red).

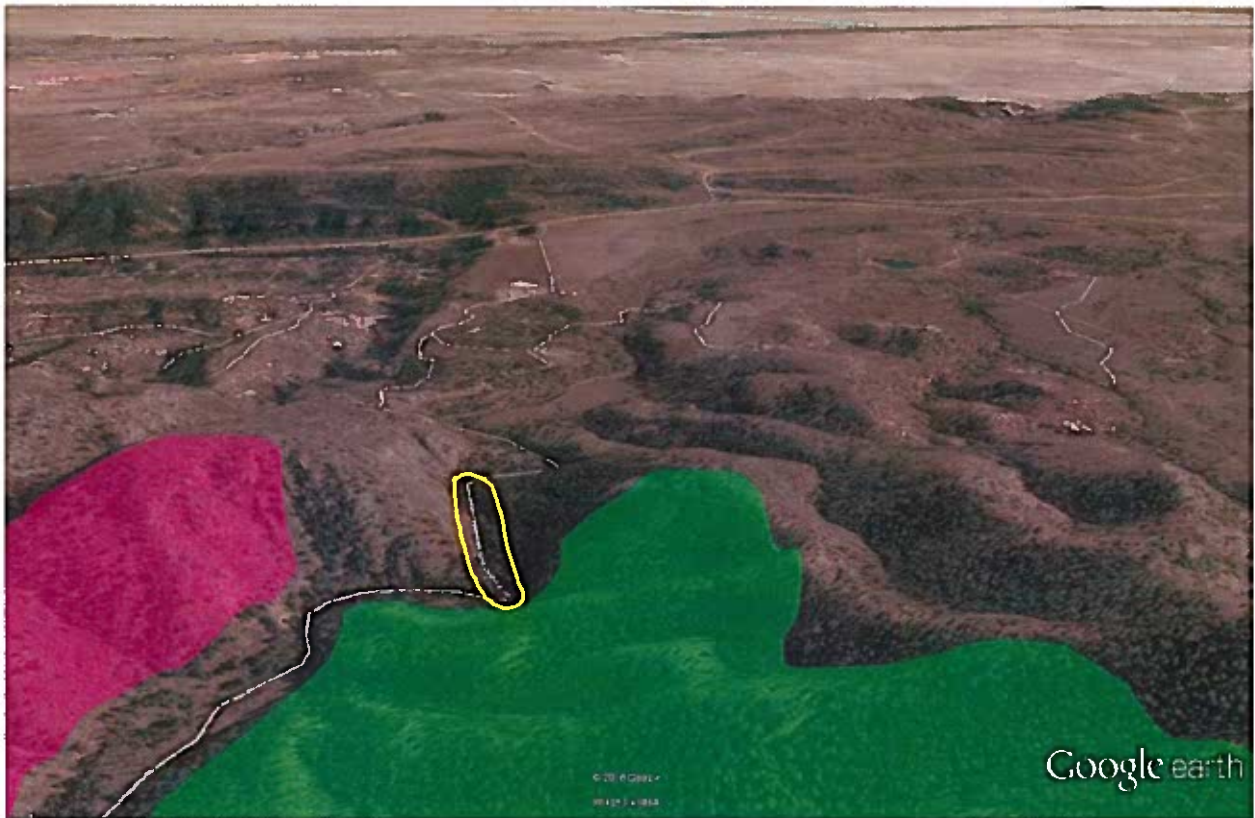
Figure 5 Google Earth View of Lower Canyon Road

Figure 5 provides a view of that section of the road using Google Earth, looking towards the east from the quarry operations area. The pink area is the North Pit. The green area is the south pit. The yellow line highlights the portion of the road that is susceptible to landslides. Note the steep slope to the north of the road.

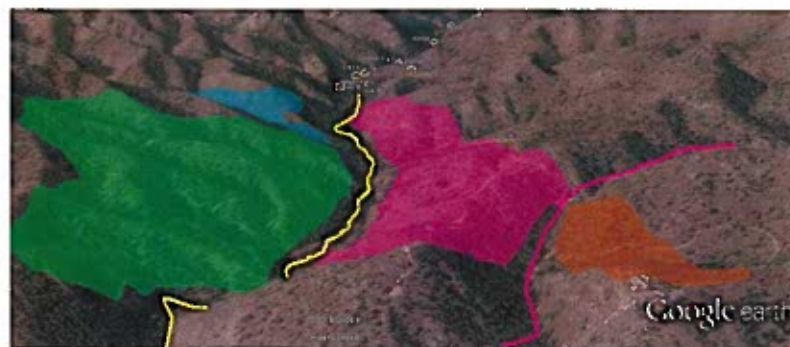
Figure 7 Google Earth View of Road Below Quarry Pits

Figure 7 shows a Google Earth view looking towards the west into the proposed quarry pits. The yellow line is the segment of Little Turkey Creek Road that is within Little Turkey Creek canyon. The fuchsia line is the segment of Little Turkey Creek Road that is within Deadman Creek canyon. The pink area is the North Pit. The orange area is the North Pit Extension. The green area is the South Pit. As can be seen, Little Turkey Creek Road lies directly beneath the quarry pits. Landslides that flow out of those pits might reach the road.

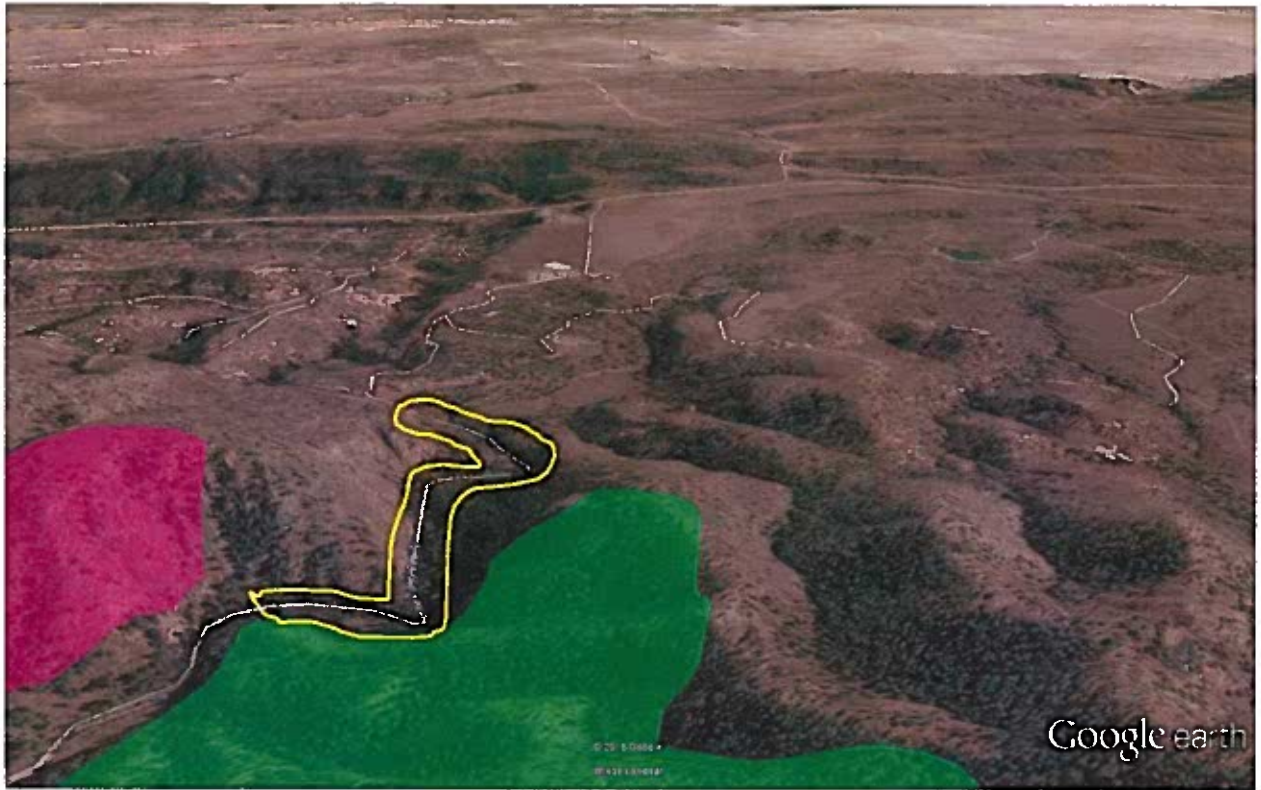
Figure 10 Google Earth View of Lower Little Turkey Creek Canyon

Removal of vegetation within the quarry operations area will increase the frequency and severity of flooding within the lower canyon, resulting in even greater risks to blockage of portions of the road during heavy rains. Figure 10 presents a view of lower Little Turkey Creek Canyon using Google Earth, looking towards the east from the quarry operations area. The white line is Little Turkey Creek Road. The pink area is the proposed North Pit. The green area is the proposed South Pit. The yellow line outlines the lower canyon. As can be seen, the canyon is quite narrow to the east of the proposed quarry operations area. Given the topography of the canyon with its steep canyon walls, flooding within the lower Little Turkey Creek canyon might be as severe as flooding experienced in other areas of Colorado where vegetation was destroyed by wildfires.

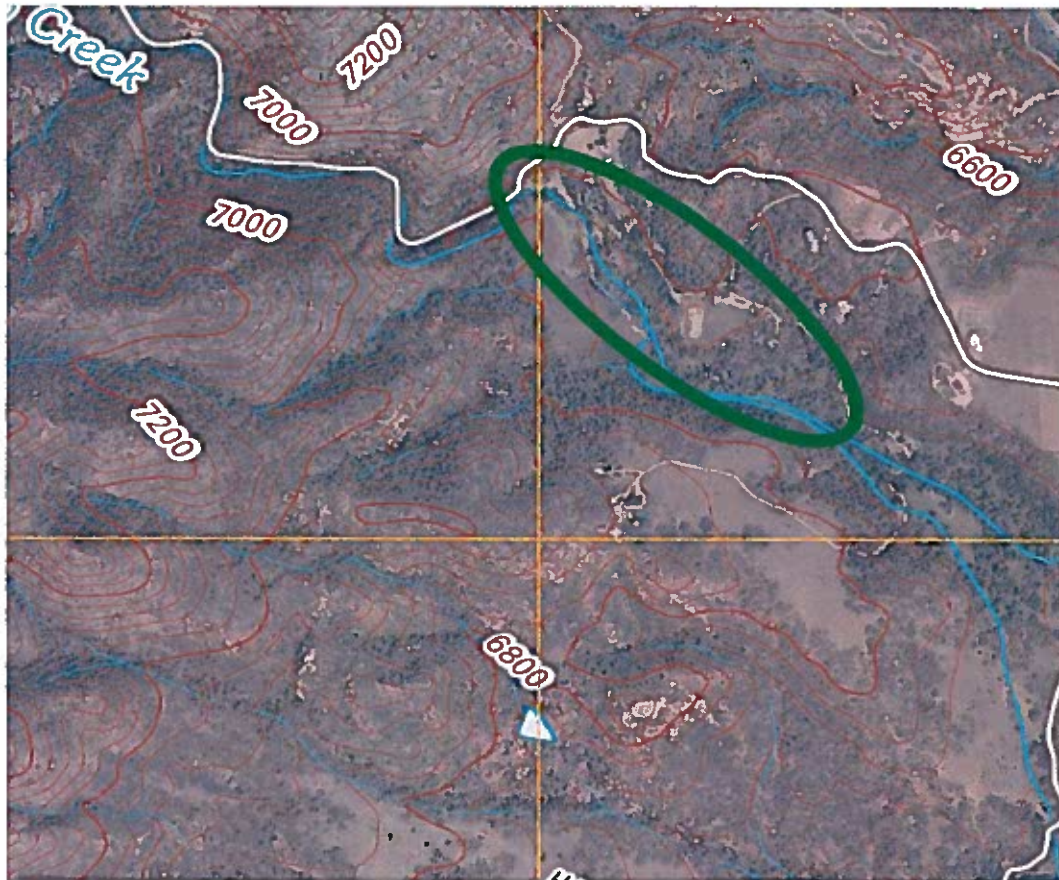
Figure 16 Area at Mouth of Little Turkey Creek Canyon Vulnerable to Flooding

Catastrophic flood events, which may be more frequent or more severe due to removal of vegetation within the Little Turkey Creek watershed, may damage property and houses located outside the canyon along Little Turkey Creek. Figure 16 shows a small segment of the 2011 Mount Big Chief Colorado Map. The blue line is Little Turkey Creek. The white line is Little Turkey Creek Road. The green oval highlights properties located at the mouth of the canyon

vulnerable to flood events within the Little Turkey Creek watershed. While this property damage will not directly impact Eagles Nest owners, it will certainly impact our neighbors who live further down our road.

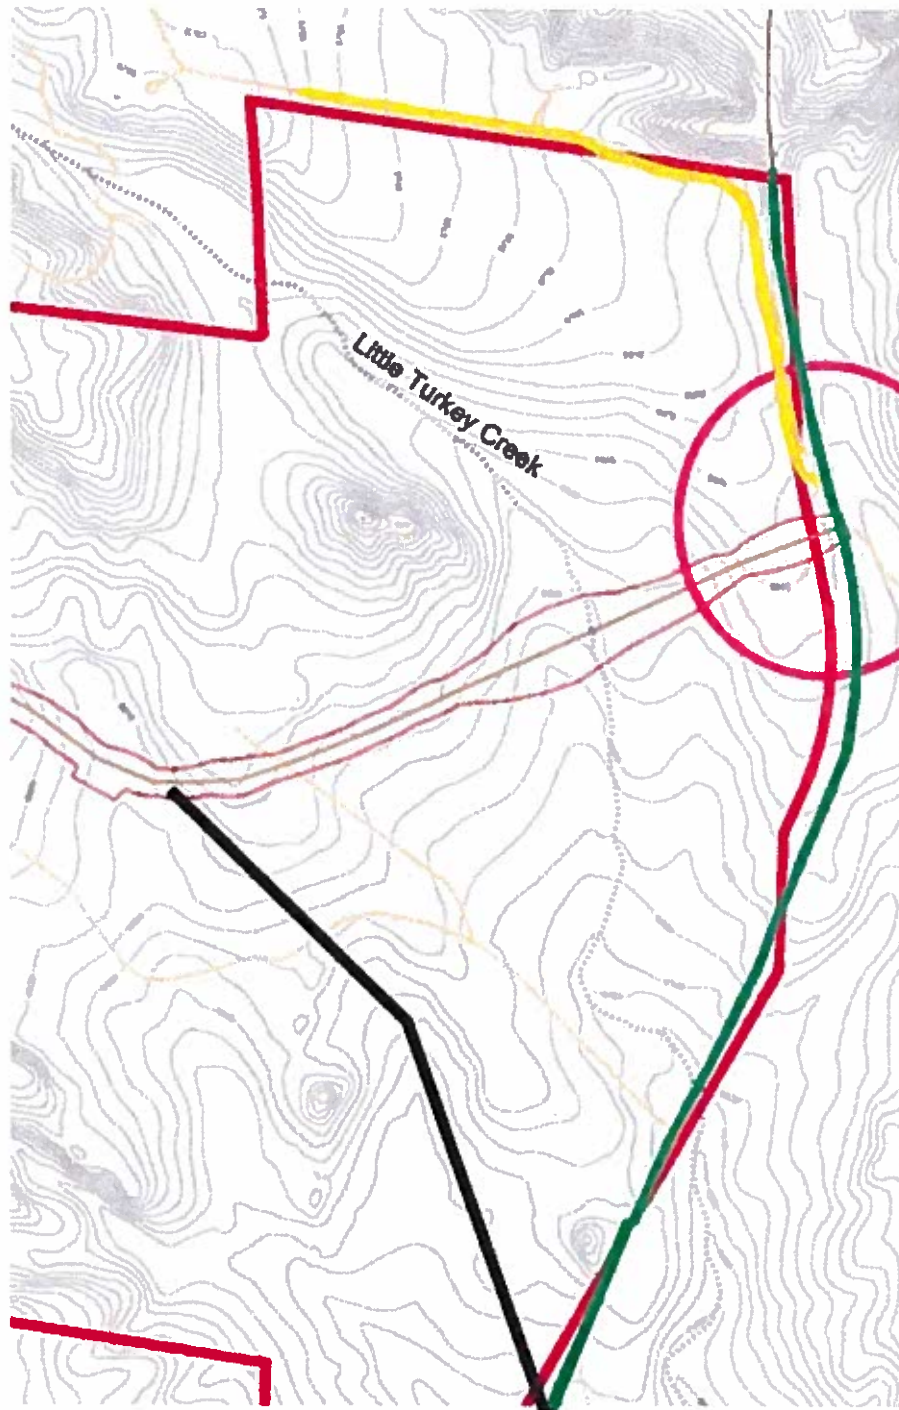
Figure 20 Intersection of New Quarry Road and Highway 115

Figure 20 is a portion of the map provided by Transit Mix which shows the proposed new quarry road coming out to Highway 115 a short distance south of Little Turkey Creek Road. The

yellow line is the existing Little Turkey Creek Road. The green line is Highway 115. The fuchsia circle highlights the intersection.
