COLORADO DIVISION OF RECLAMATION, MINING AND SAFETY
MINERALS PROGRAM INSPECTION REPORT
PHONE: (303) 866-3567

MINE NAME: Krehmeyer Pit	MINE/PROSPECTING ID#: M-2005-070	MINERAL: Sand and Gravel	COUNTY: Phillips
INSPECTION TYPE: Monitoring	INSPECTOR(S): Elliott R. Russell	INSP. DATE: April 20, 2016	INSP. TIME: 13:15
OPERATOR: Ritchey's Redi-Mix Concrete, Inc.	OPERATOR REPRESENTATIVE: Jerry Ritchey	TYPE OF OPERATION: 110c - Construction Limited Impact

Krehmeyer Pit (M-2005-070)

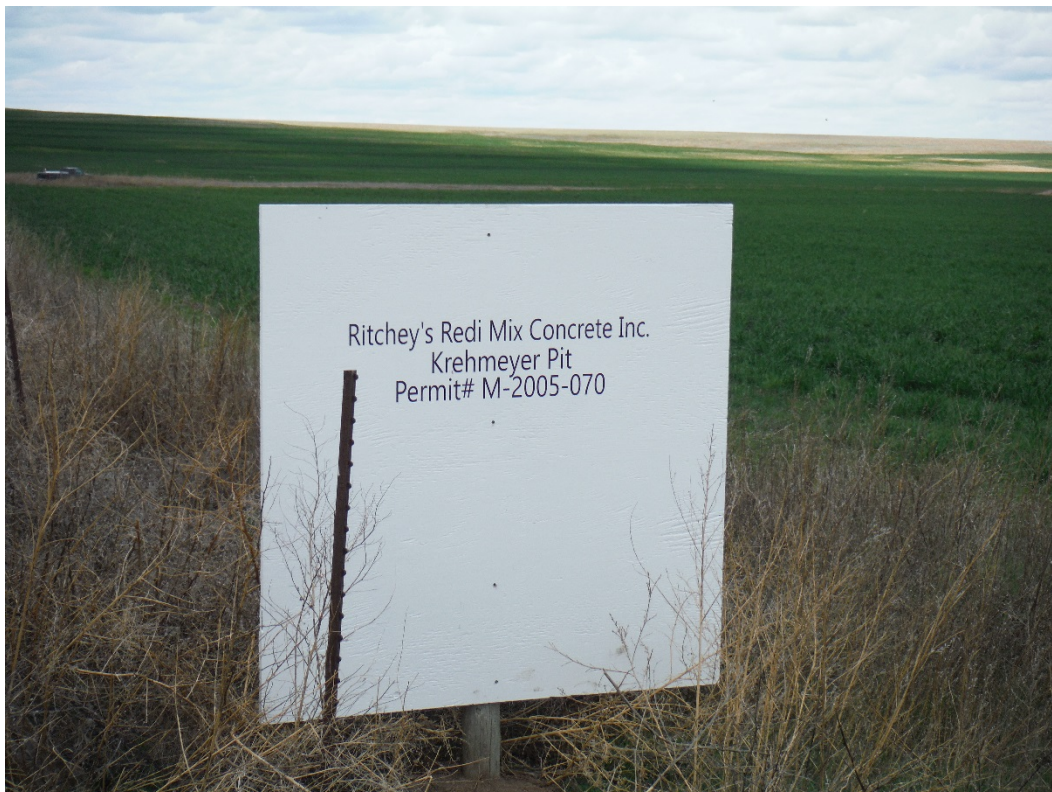
The mine site identification sign was posted along County Road 16 and was in compliance with Rule 3.1.12(1). The permit boundary was delineated by a metal t-posts. The Division observed evidence of recent reclamation activities and one front-end loader and one bulldozer was on-site.

Mine identification sign posted at County Road 16; looking north.

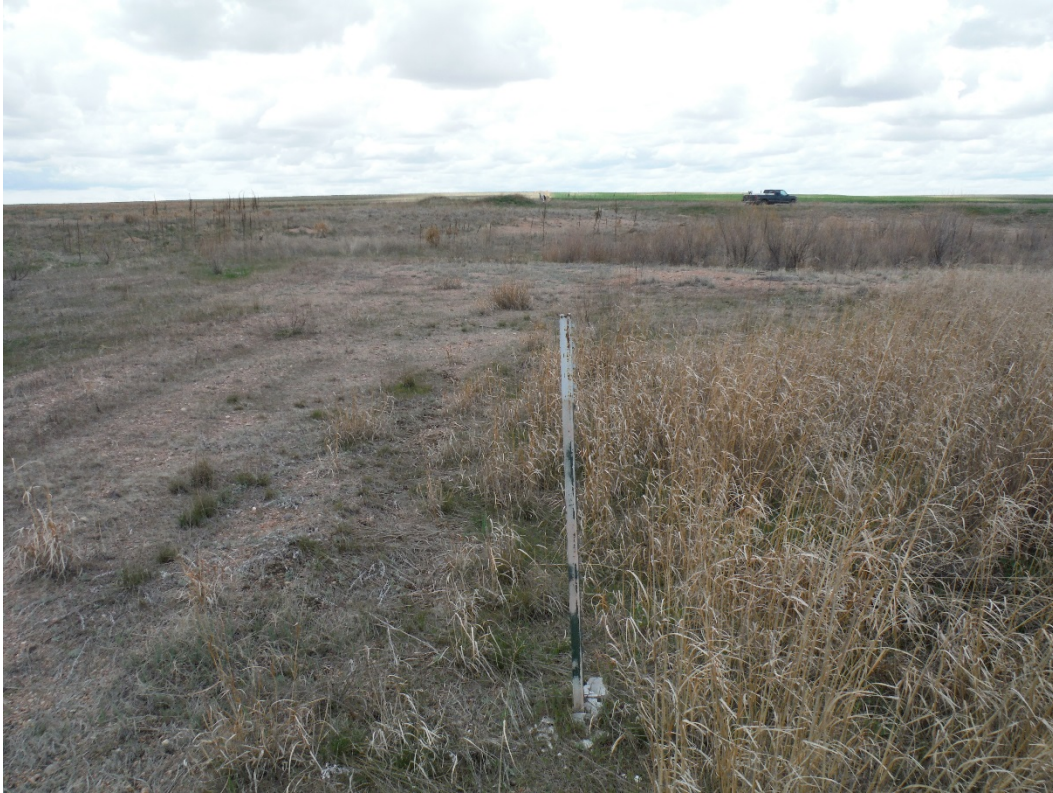
Southwest boundary marker; looking north across Sandy Creek.

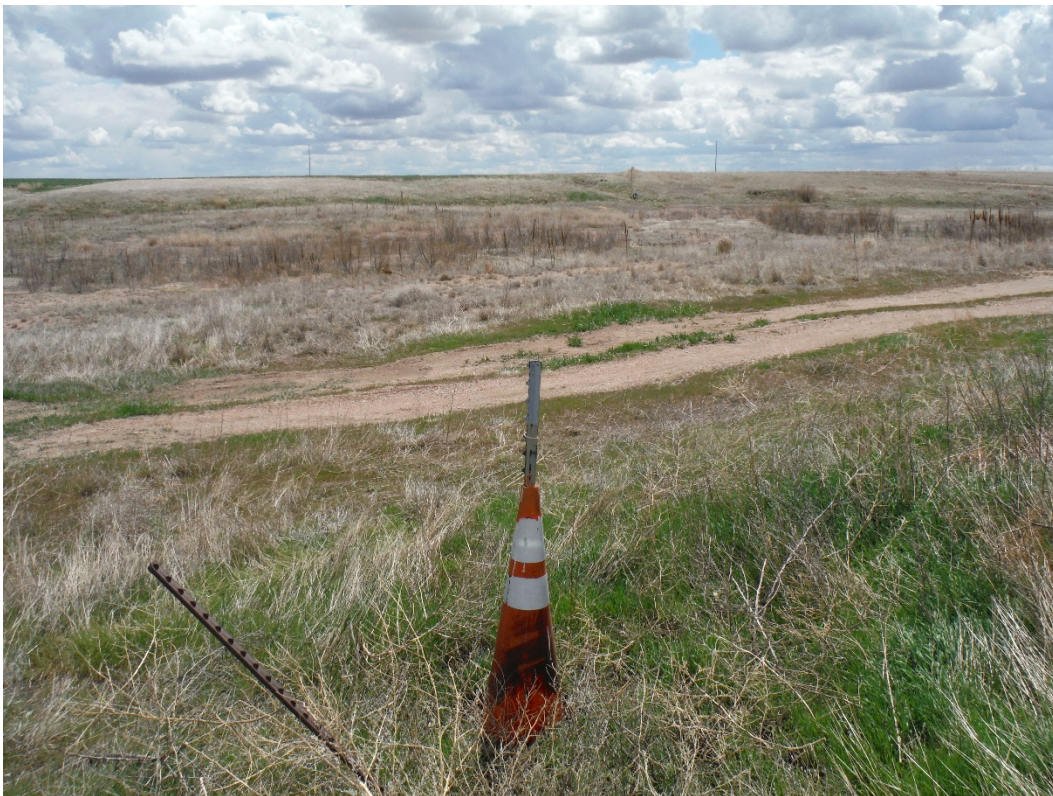
Northwest boundary marker; looking south across Sandy Creek.

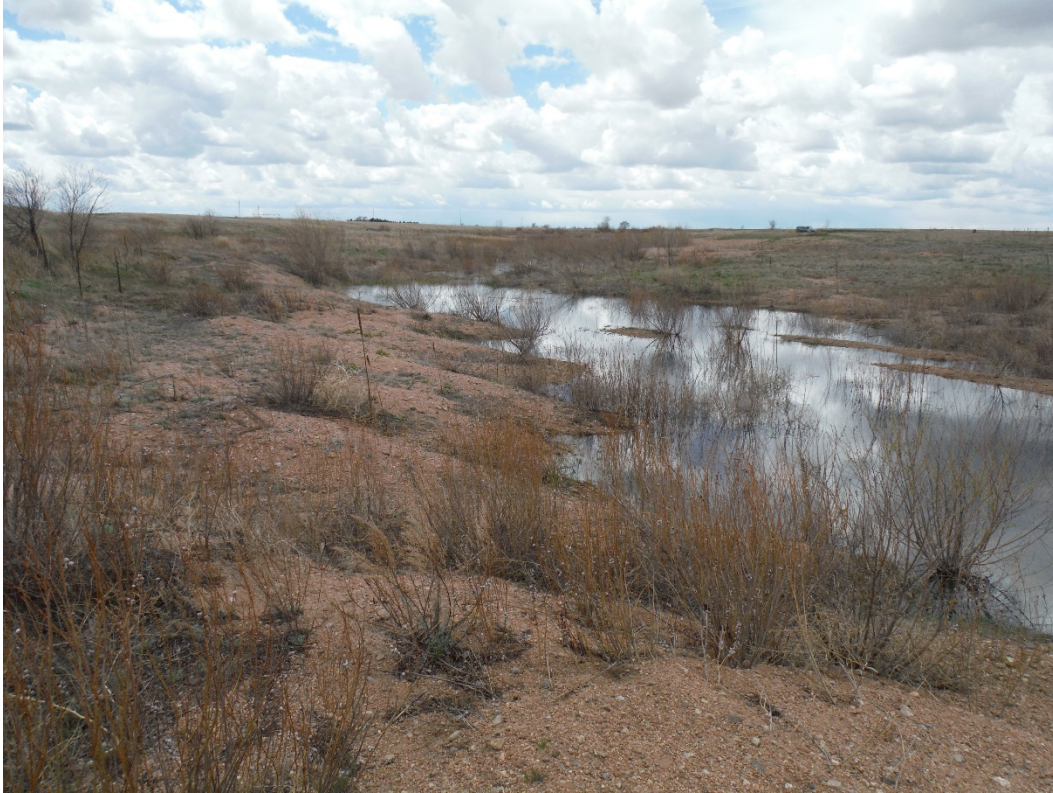
The west end of the operation mined material from within the creek. At the east end, the operation has advanced through the northern creek bank, outside of the approved permit boundary and into the adjacent field on the north side of the creek. The native elevations of the creek channel immediately downstream of the mine site are higher than the elevation of the excavated areas and without the northern creek bank intact, creek flow may be diverted from the natural channel and flow down the excavated area. Thus, the off-site excavation has potential to disrupt the natural flow of the native channel.

Excavated creek channel (western portion of the site); looking southwest from the southern creek bank.

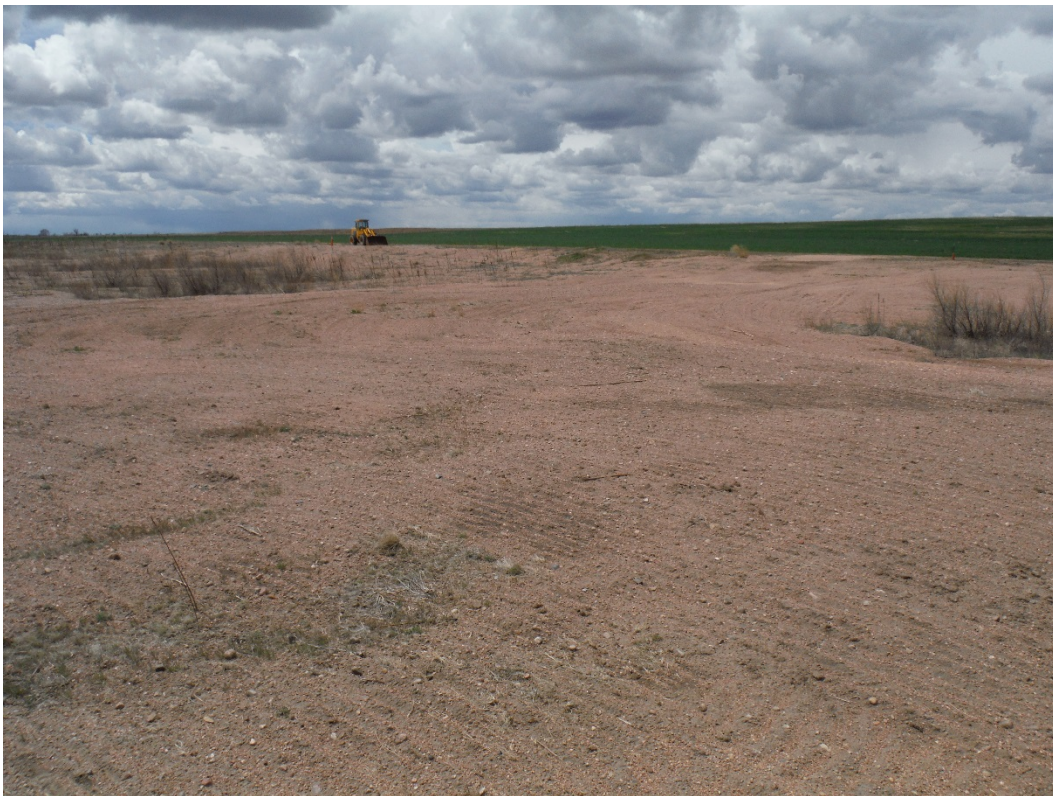
POSSIBLE VIOLATION: The operation has affected approximately seven acres outside of the approved permit boundary. Pursuant to C.R.S. 34-32.5-123(2), this is a possible violation of C.R.S. 34-32.5-109(1) for failure to first obtain from the board or office a reclamation permit prior to engaging in a new operation.

Excavated field (eastern portion of the site); looking northwest.

CORRECTIVE ACTIONS: This possible violation has been scheduled to be considered by the Mined Land Reclamation Board, during the June 22-23, 2016 Board meeting. Official notice of the schedule and other details for the MLRB hearing will be provided under a separate document to be sent via certified mail to the operator.

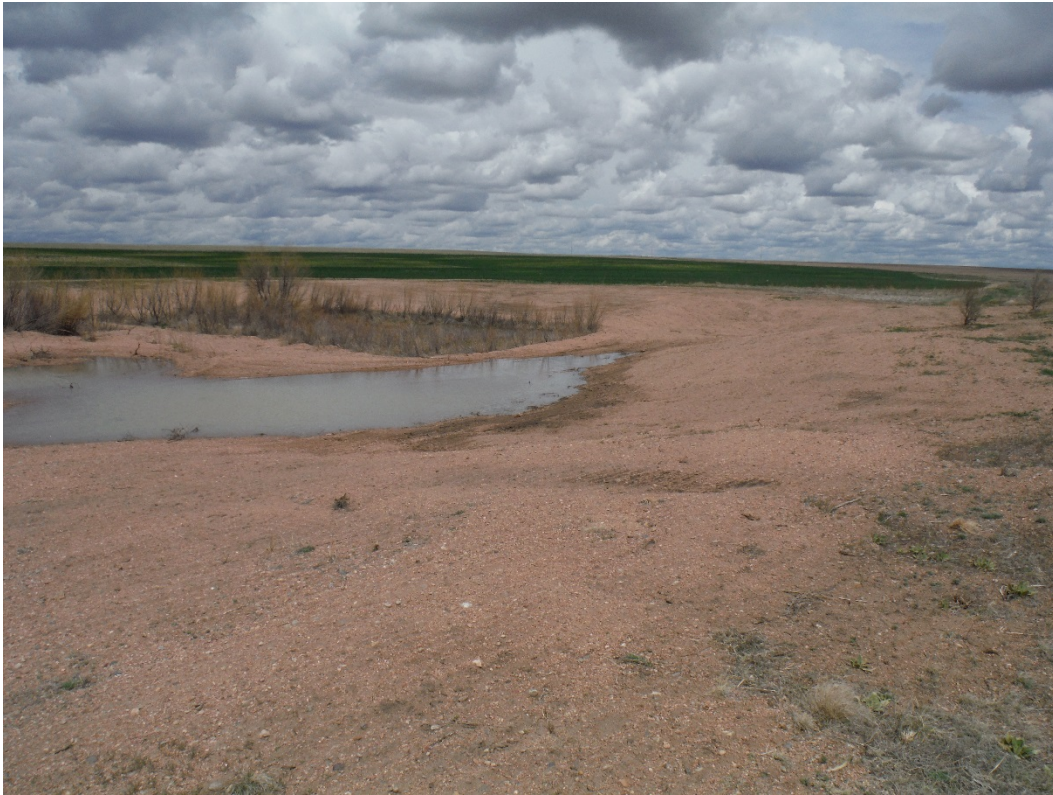
Excavated field (eastern portion of the site); looking northeast.

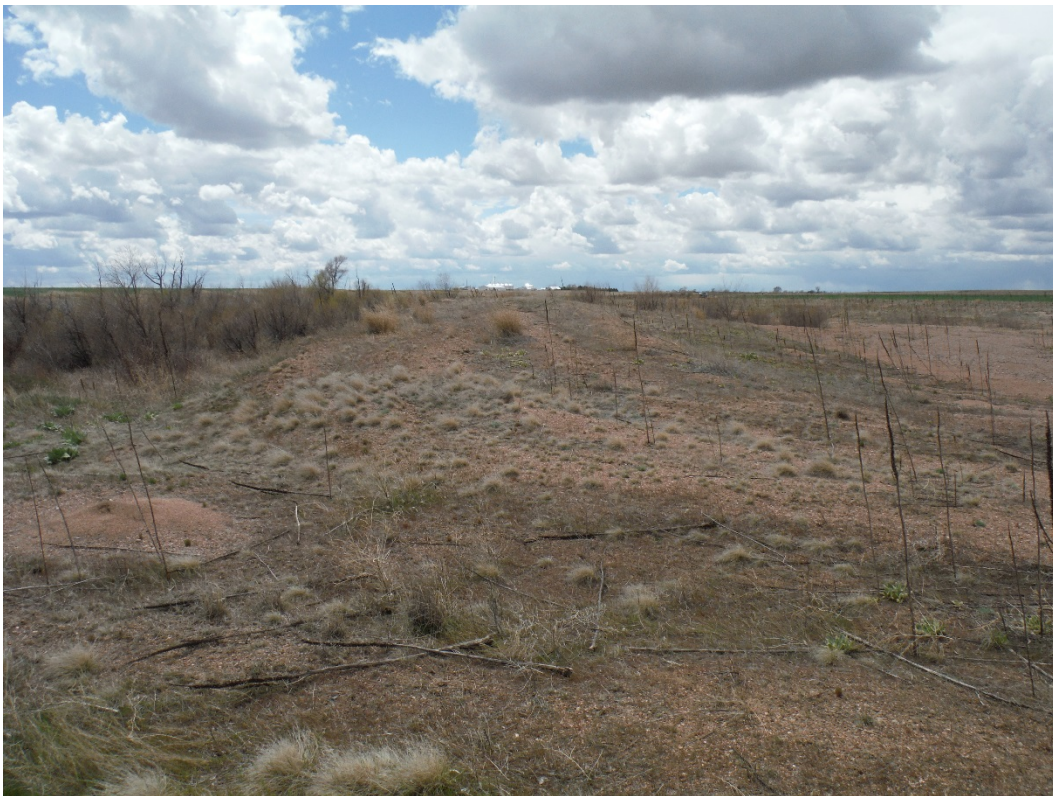
Eastern portion of the site, undisturbed creek channel (left) and excavated field (right) separated by a long stockpile/berm; looking southwest.

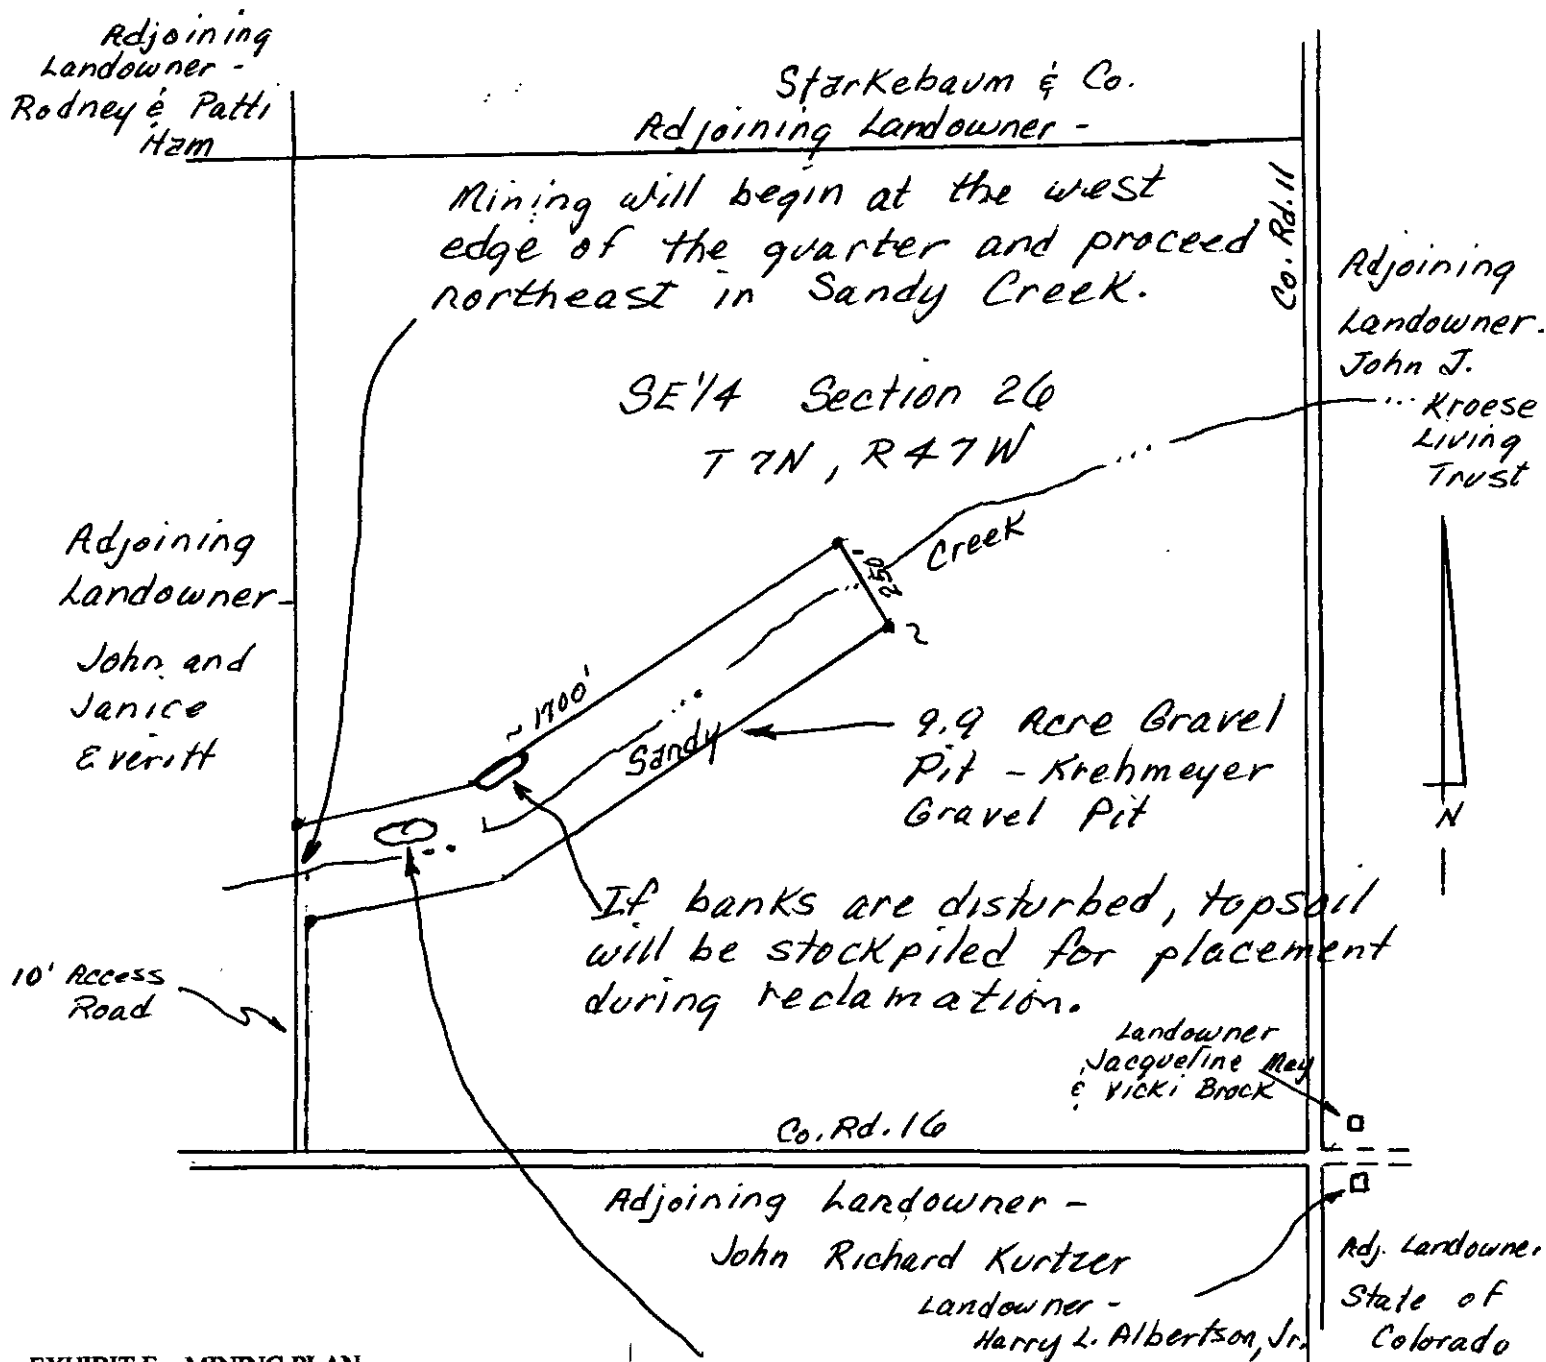
EXHIBIT E - MINING PLAN

- Green line - the approximate approved permit boundary which was determined from the approved Mining Plan Map (attached as *9-4-2005 Mining Plan Map M2005070*).
- Red Line - the approximate limits of the mine site disturbance which was determined from a review of the February 26, 2016 Google Earth aerial image and the April 20, 2016 site inspection observations.
- Yellow Line – the approximate proposed 2007 expansion boundary which was determined from the Conversion Application Site Map (attached as *7-7-2007 CN Site Map M2005070*). This is described in more detail in the following paragraph.

If gravel is stockpiled during mining, it will be placed in line with the drainage so as not to block any flows after a heavy rainfall.

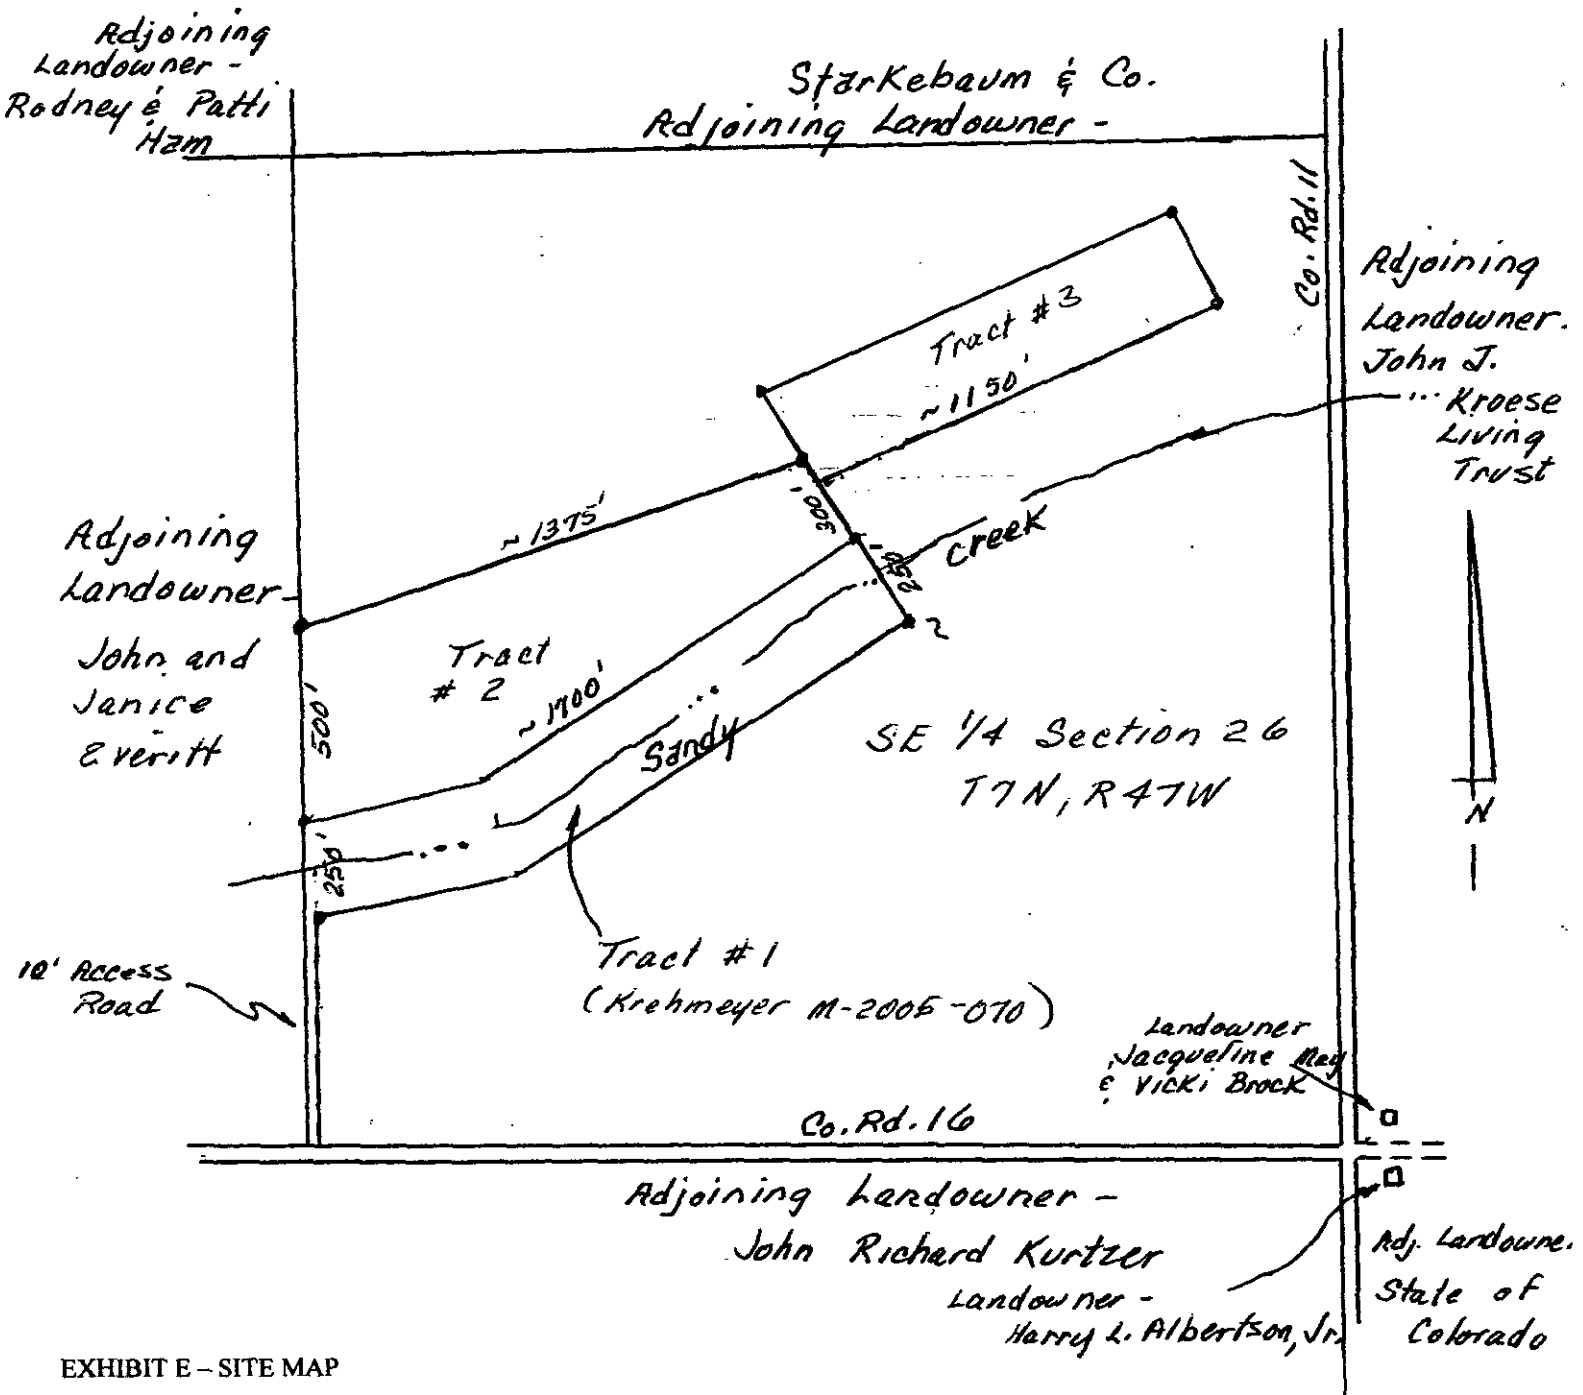
EXHIBIT E - SITE MAP

On June 22, 2007, the Division received a 112c Conversion Application for the Krehmeyer Pit, which proposed to add 22.7 additional acres on the north side of the creek. The Division responded to the Operator stating that C.R.S. 34-32.5-110(5)(a) requires an operator to hold a 110c permit for two consecutive years or more before
