MINERALS PROGRAM INSPECTION REPORT

MINE NAME: East Wolf Creek Pit	MINE/PROSPECTING ID#: M-2011-038	MINERAL: Stone	COUNTY: Mineral
INSPECTION TYPE: Monitoring	INSPECTOR(S): Travis H. Marshall	INSP. DATE: July 14, 2016	INSP. TIME: 16:15
OPERATOR: KW Enterprises LLC	OPERATOR REPRESENTATIVE: Steven J. Winer	TYPE OF OPERATION: 111 - Construction by Government Agency

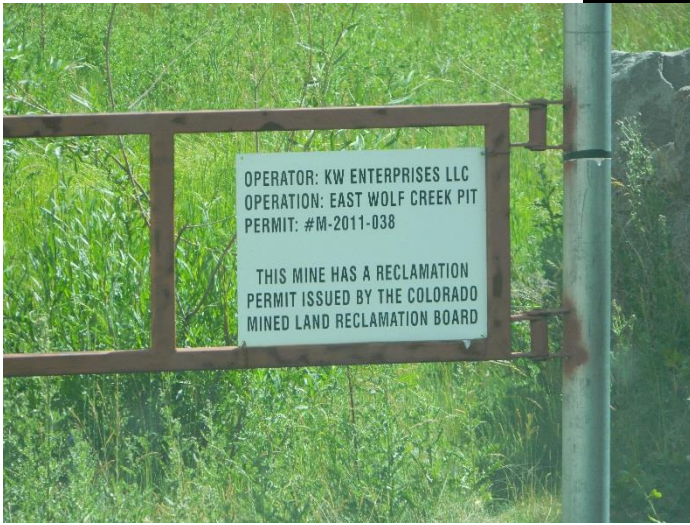
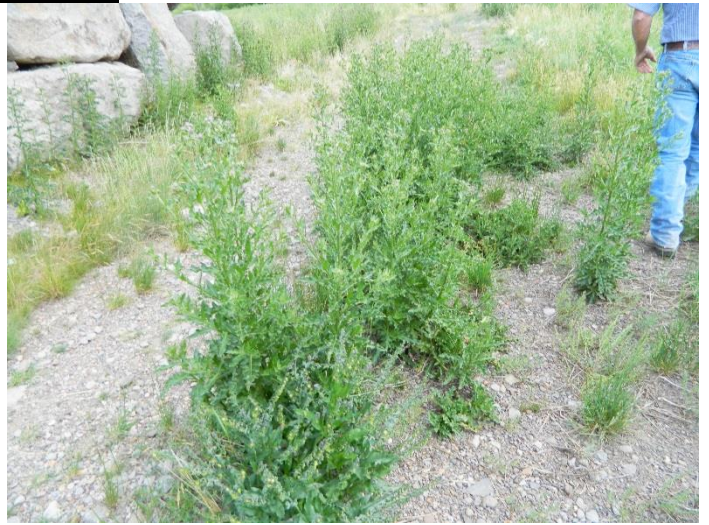
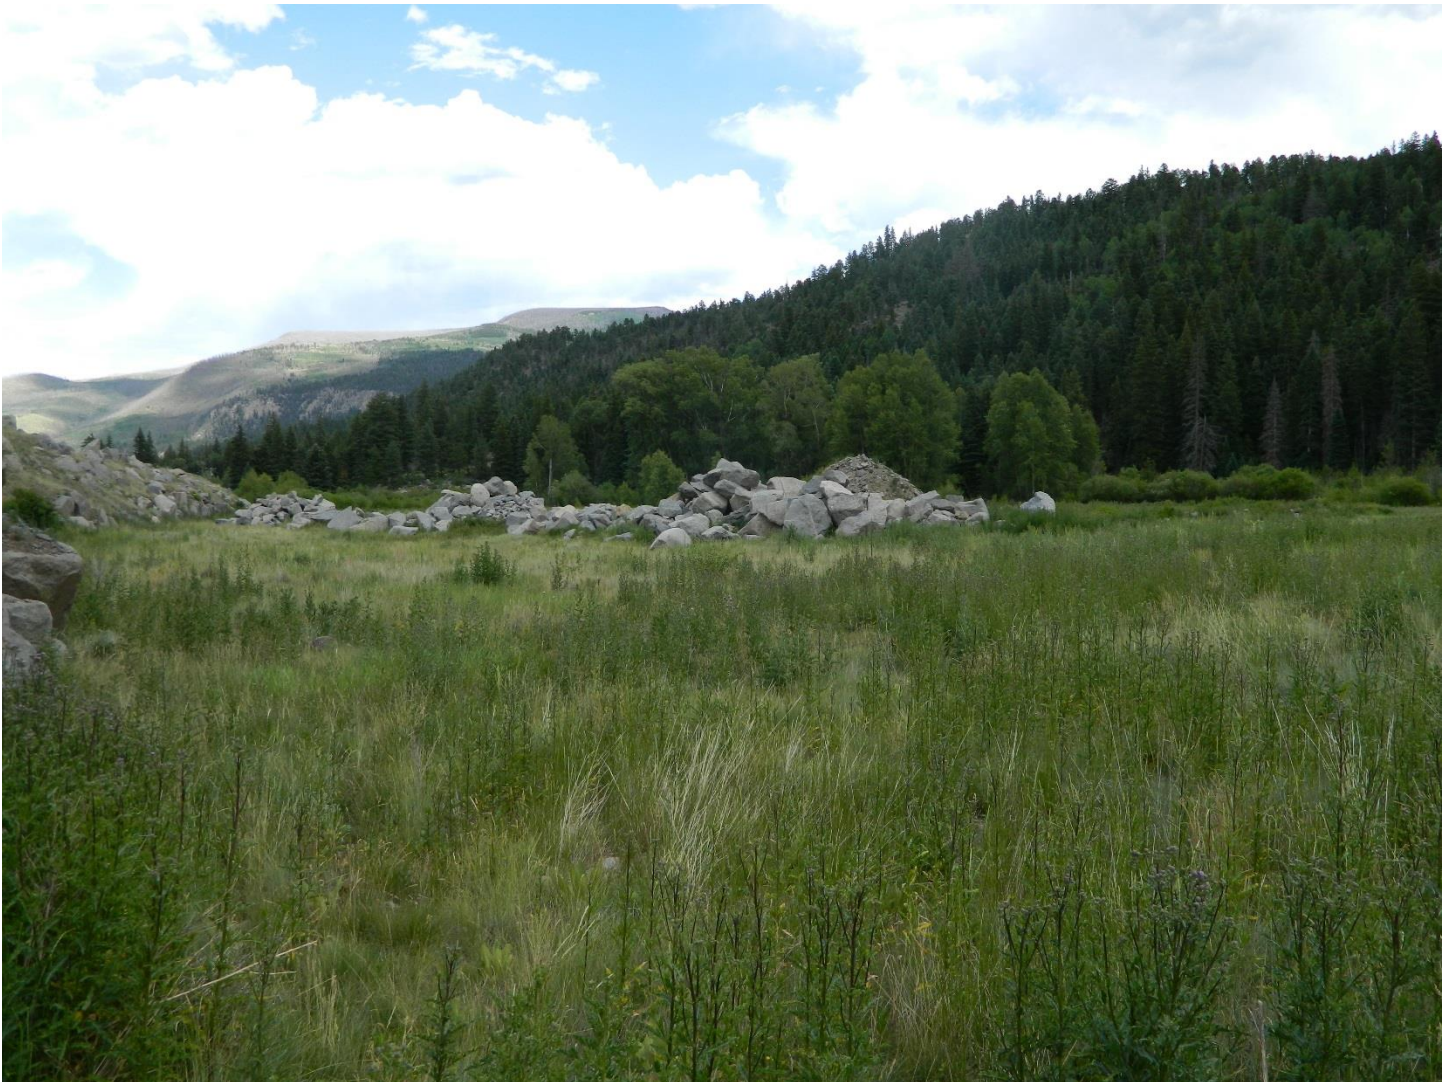
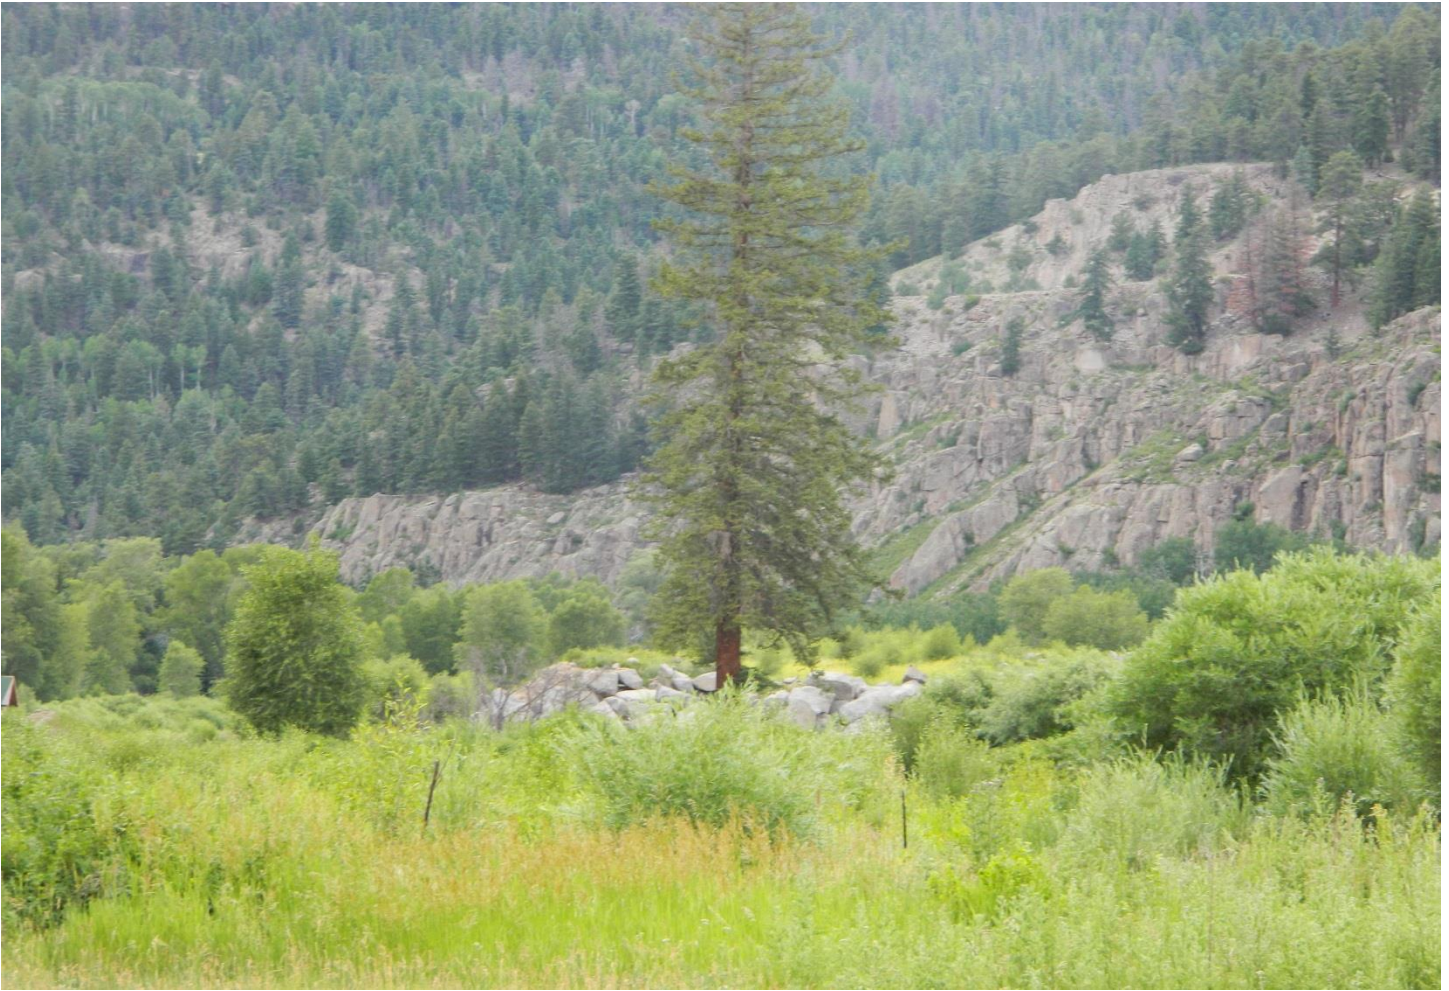
PHOTOGRAPHS

The mine identification sign and affected area boundary markers are in place and in compliance with rule 3.1.12. The mine identification was sign was observed at the main entrance during the inspection.

An abundance of Canada Thistle was observed on the site and the infestation is noted as a problem. Demonstrated control of the noxious weed infestation must be established in order for the site to be eligible for a future permit release if that is the operator's plan for the site. Please submit photo-documentation of exhibited weed control prior to August 19, 2016 to avoid enforcement action.

No off-site damage, significant erosional features or unnecessary debris was observed within the permit area. The site was in a very orderly condition aside from the presence of noxious weeds during the inspection.

CORRECTIVE ACTIONS: Implement approved weed control plan and provide proof to the Division that this has been done. If a weed control plan is not already in place, the operator shall develop a weed control and management plan in accordance with Section 3.1.10 (6) of the Rule. This plan should be developed in consultation with the county extension agency, or weed control district office and should include specific control measures to be applied, a schedule for when control measures will be applied and a post-treatment monitoring plan. This weed control plan shall be submitted to the Division as a Technical Revision to the approved plan with the appropriate Technical Revision fee of \$216.00 by the corrective action date.
