**COLORADO**Division of Reclamation,
Mining and Safety

MINERALS PROGRAM INSPECTION REPORT**PHONE: (303) 866-3567**

MINE NAME: Mancos Gravel Pit	MINE/PROSPECTING ID#: M-1985-031	MINERAL: Sand and gravel	COUNTY: Montezuma
INSPECTION TYPE: Surety-Related Inspection	INSPECTOR(S): Lucas J. West	INSP. DATE: July 21, 2016	INSP. TIME: 09:45
OPERATOR: Montezuma County	OPERATOR REPRESENTATIVE: Randy Smith	TYPE OF OPERATION: 112c - Construction Regular Operation	
REASON FOR INSPECTION: Surety Related	BOND CALCULATION TYPE: None	BOND AMOUNT: \$0.00	
DATE OF COMPLAINT: NA	POST INSP. CONTACTS: None	JOINT INSP. AGENCY: None	
WEATHER: Clear	INSPECTOR'S SIGNATURE:

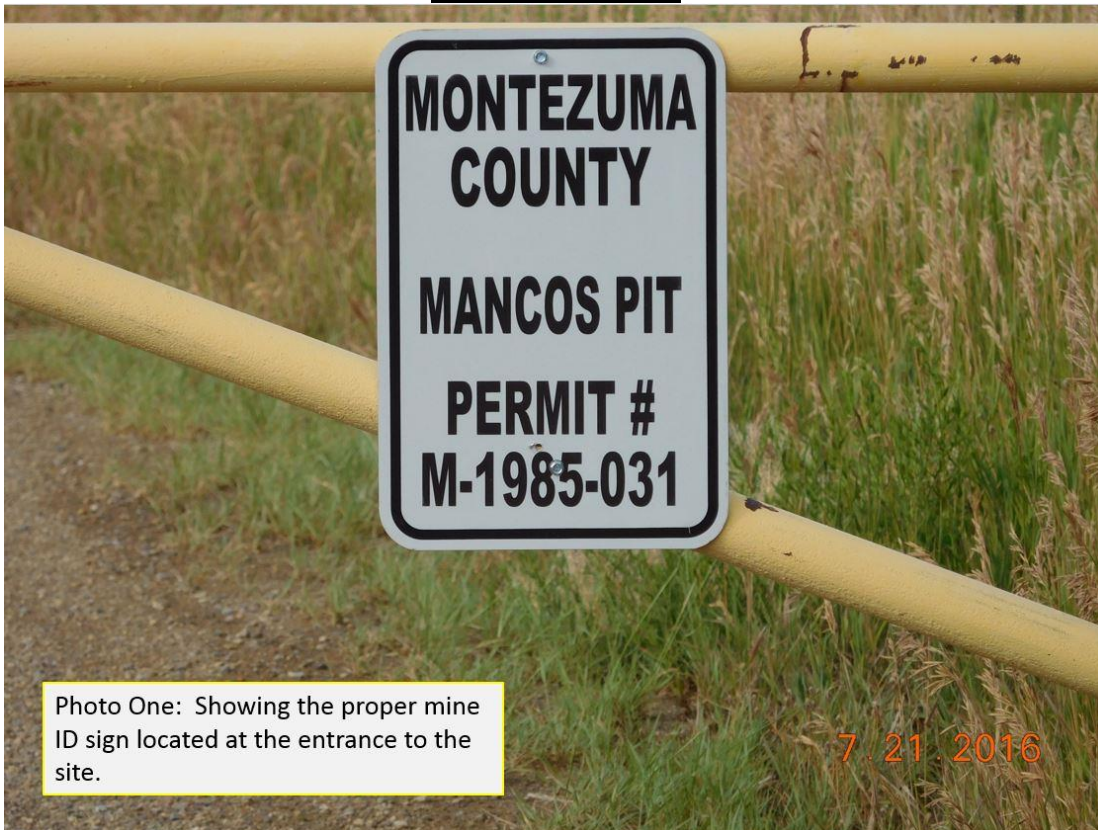
The proper mine identification signage was observed at the entrance to the site shown in Photo One. The site was not active during the inspection. This was a complete inspection of the site. Several stockpiles were observed in the active area of the pit which appeared to be stable and in good condition. The stockpiles are shown in Photo Two. The stockpiles included various sized materials, as well as separated overburden and topsoil stockpiles. The small mining face located in the northern part of the disturbed area appeared to be stable and in good condition. Residual storm water was noted on the pit floor following a precipitation event the night before the inspection.

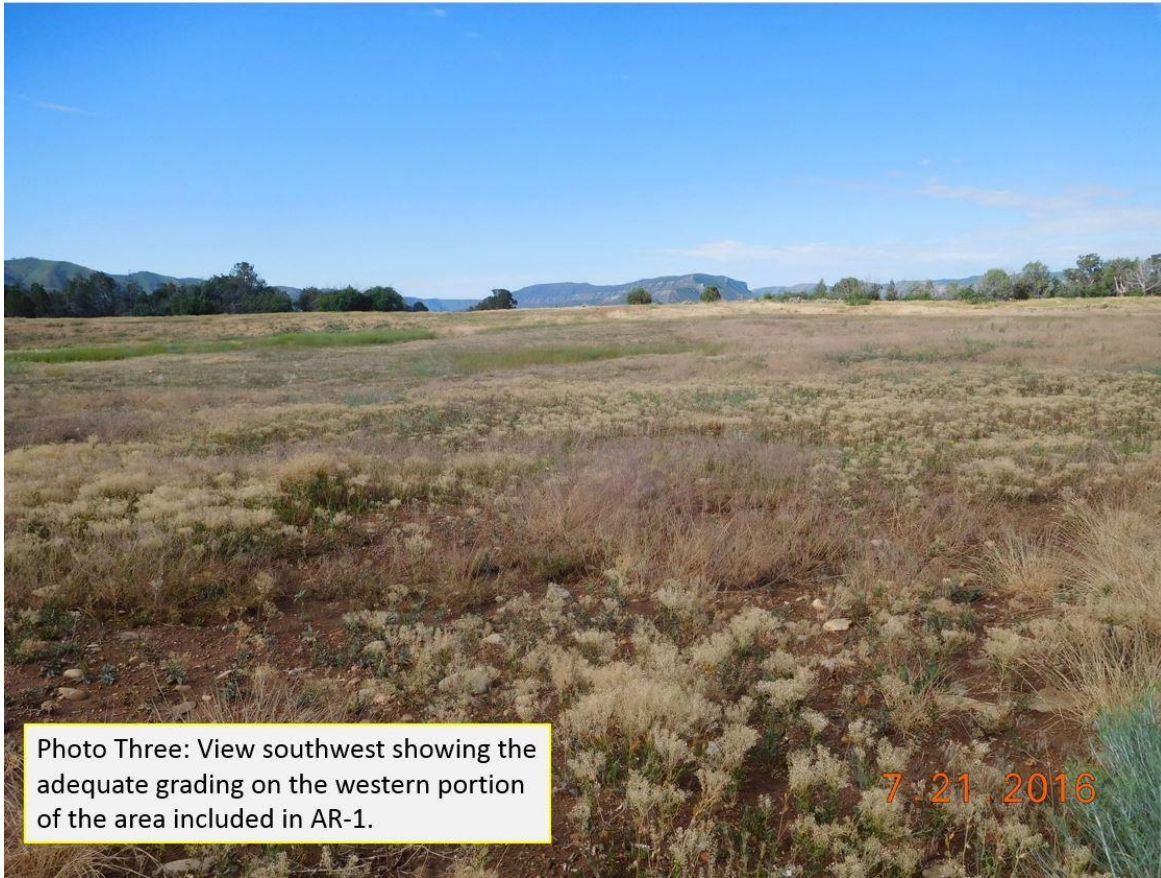
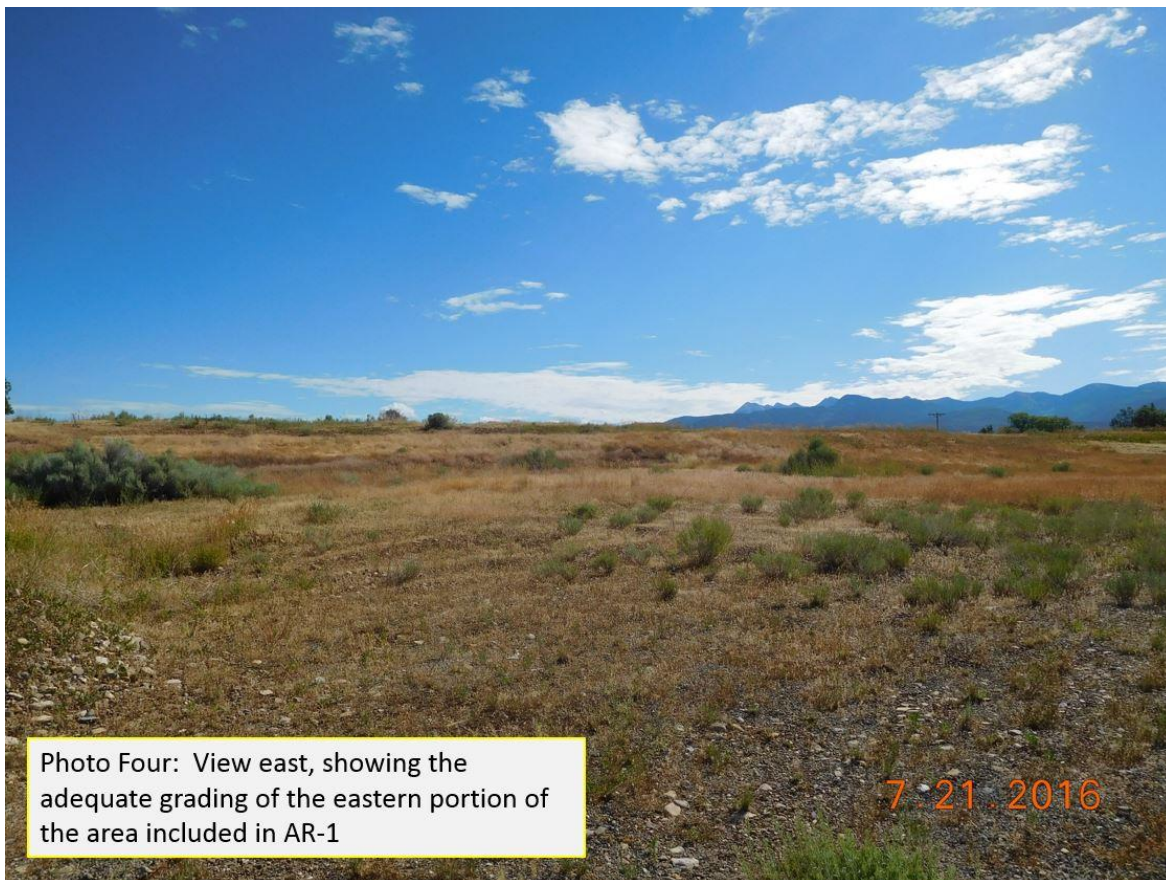
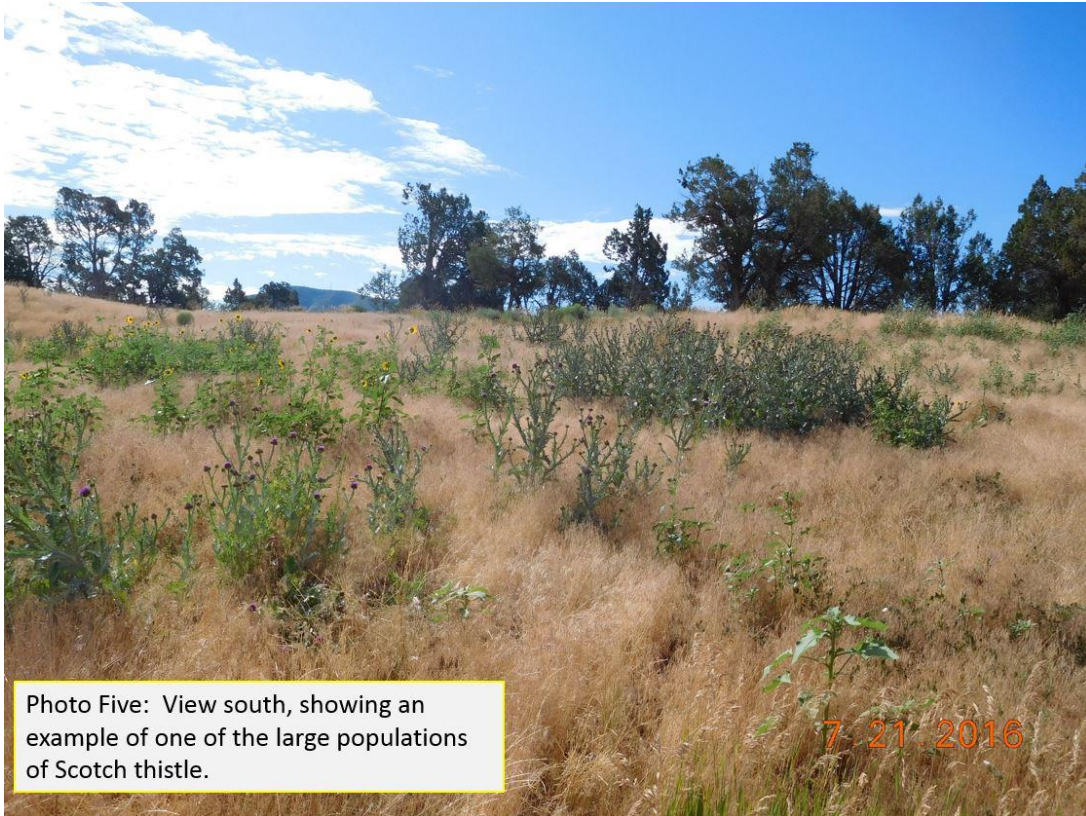
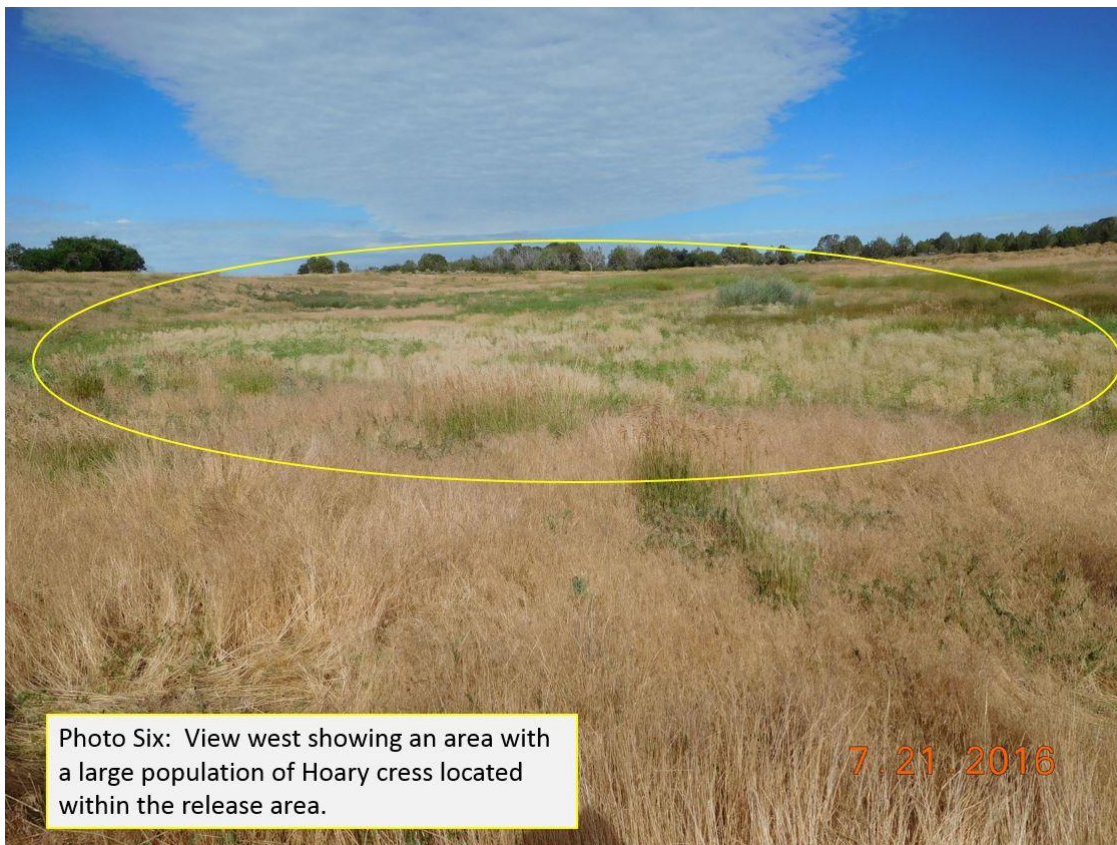
The area to be released consisted of 13 acres of previously mined areas within the permit boundaries. Reclamation is to be completed to support a post mining land use of rangeland. All grading and earthwork appears to be stable and adequate to comply with the post mining land use. Examples of the grading can be seen in Photos Three and Four. No significant erosional features were noted throughout the site. The vegetation, while adequate in density contained several species of state listed noxious weeds. Throughout the area to be released large populations of Hoary cress, Scotch thistle, and Canada thistle were noted. All species observed are on the B list of the Noxious Weeds of Colorado list. Photos Five and Six show examples of the weeds observed on site. Of the requested area, approximately 40-50% contains state listed noxious weeds, approximately 20% of that being Hoary cress.

Due to the large presence of state listed noxious weeds, the Division has determined the areas requested to be release do not meet the reclamation standards, therefore the Division is denying the operator's request for an Acreage Reduction, AR-1. The presence of noxious weeds is not being listed as a problem at this time as the operator has indicated that chemical treatment is ongoing. The operator is encouraged to increase the frequency of monitoring and treatment of the weeds. A consultation with your county weed administrator to review your plan is advised as well. Please find the enclosed denial letter for the operator's request for AR-1.
