**COLORADO**Division of Reclamation,
Mining and Safety

MINERALS PROGRAM INSPECTION REPORT**PHONE: (303) 866-3567**

MINE NAME: Costilla	MINE/PROSPECTING ID#: M-1980-233	MINERAL: Sand and gravel	COUNTY: Costilla
INSPECTION TYPE: Monitoring	INSPECTOR(S): Lucas J. West	INSP. DATE: October 6, 2016	INSP. TIME: 08:30
OPERATOR: Costilla County	OPERATOR REPRESENTATIVE: Trinidad Martinez	TYPE OF OPERATION: 110c - Construction Limited Impact	
REASON FOR INSPECTION: Normal I&E Program		BOND CALCULATION TYPE: None	
DATE OF COMPLAINT: NA		BOND AMOUNT: \$0.00	
WEATHER: Clear		POST INSP. CONTACTS: None	
INSPECTOR'S SIGNATURE:

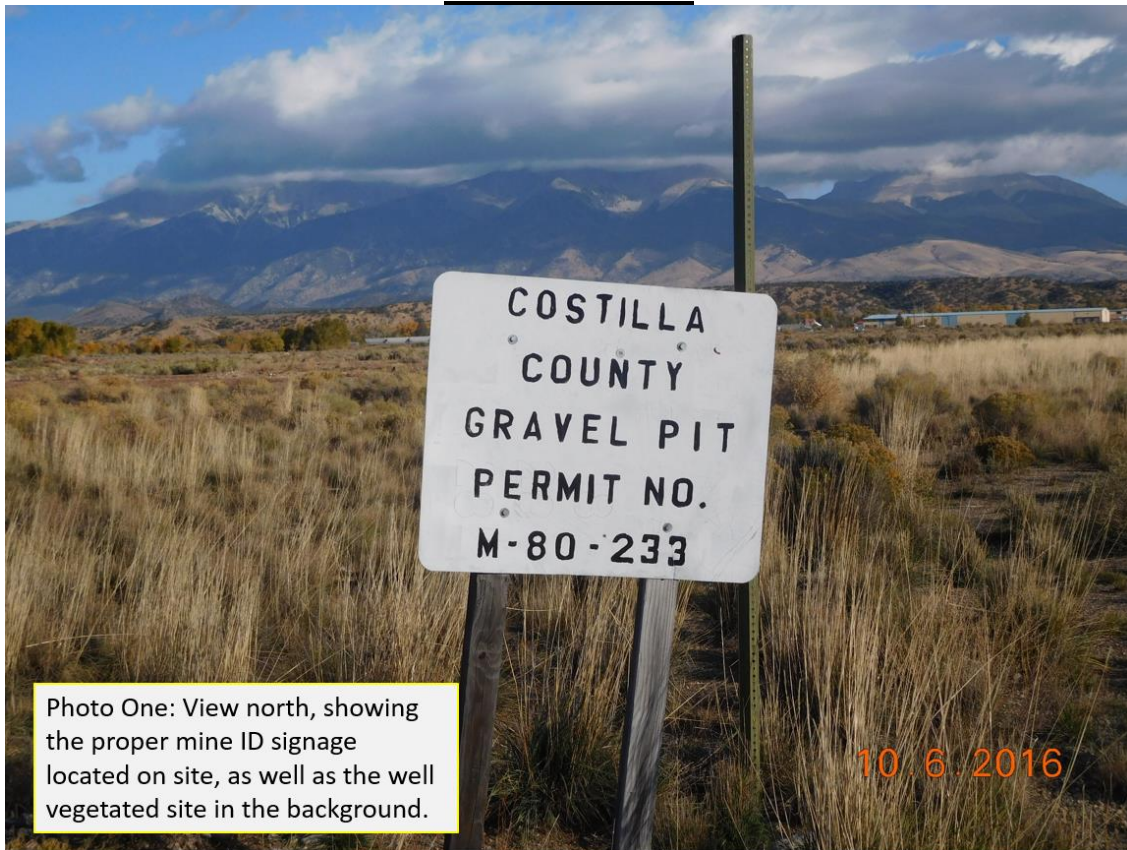
Proper mine identification signage was posted on site, shown in Photo One. Permit boundary markers were also observed on site. The site was not active nor was any equipment present on site. All backfilling and grading of the site has been completed, no evidence of settling, slumping or subsidence was observed. The site has been backfilled a near flat configuration shown in Photo Two. The area appears to be stable and in good condition, no signs of erosion were noted. The site is to be reclaimed to support an industrial / commercial post mining land use. On site discussions with the operator indicate that this site may be selected for the installation of a small solar farm operated by Costilla County.

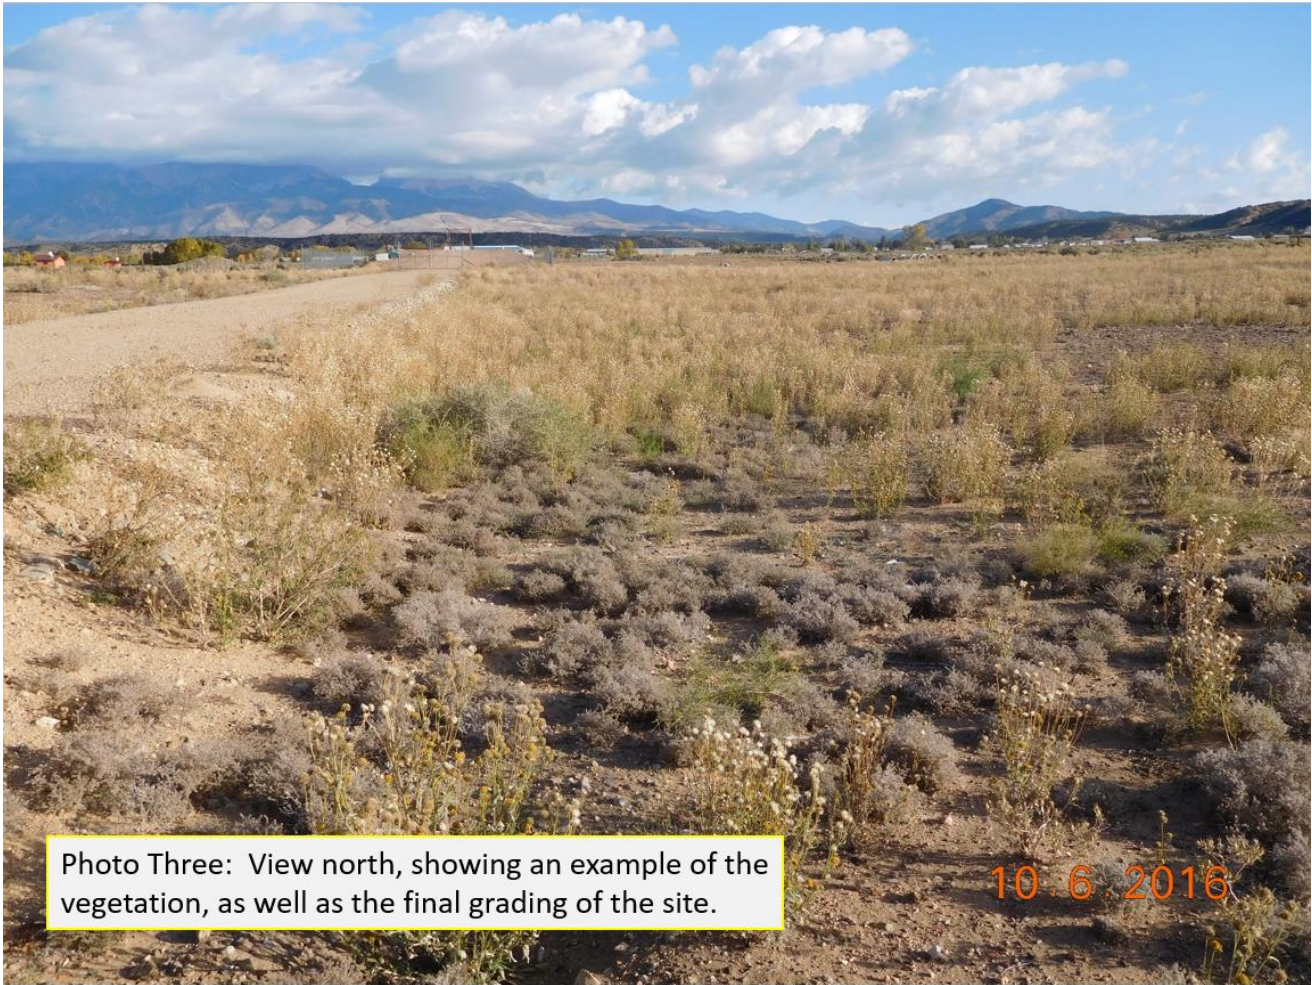
Reclamation of the site has been completed. The site is currently vegetated with range and bunch grasses, sage and rabbit brushes as well as a large population of sunflowers. The vegetation, shown in Photo Three, is diverse, and capable of self-regeneration. Discussions with the operator indicate that weed management is continuous and on-going at the site. The grading and earthwork, as well as the vegetation on site appear to be stable, and adequate when compared to adjacent undisturbed lands. The Division recommends that the operator submit a request for complete release of the permit. Enclosed with this report is the form for the request for full or partial release of permit area for the operator to complete and return to the Division. The request must be completed in accordance with Rule 4.17.1 of the Rules for the Extraction of Construction Materials, and sent via certified mail, separate from any other correspondence to the Division's Denver office. If the request is received within **60 days** of the date of this report, this inspection will be considered the release inspection, in accordance with Rule 4.17.2 (2).
