Bates-Hunter Mine Site
431 Gregory St.
Central City, CO 80427

George E. Otten
President
Central City Consolidated Mining Co.
11438 County Road 19
Fort Lupton, CO, 80621

Matt Collins, PE
General Manager
Black Fox Mining LLC

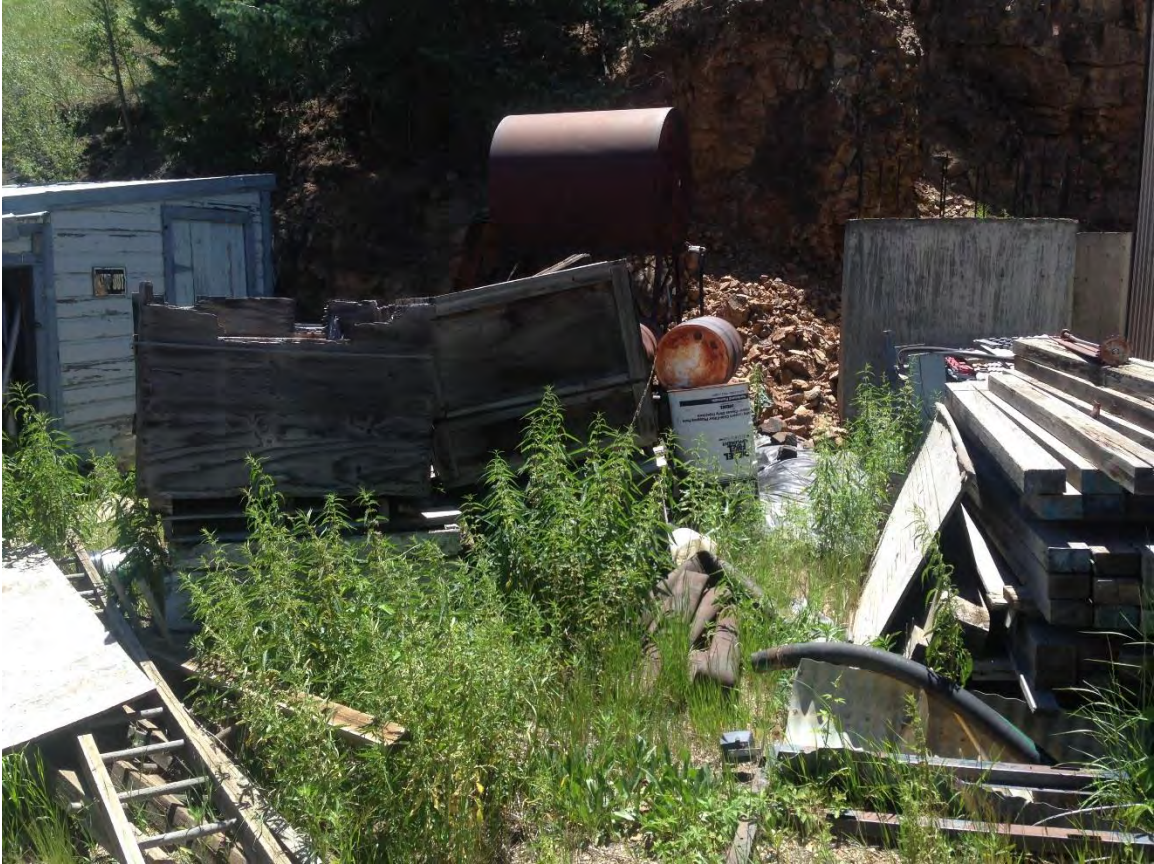
Photo 1 - Fuel Storage Area

This photo shows the fuel storage area, partially obstructed from view by crates of steel mine supplies. This photo was taken prior to the initiation of the remediation work. Note the building on the left and the concrete retaining wall on the right as landmarks for subsequent photos.

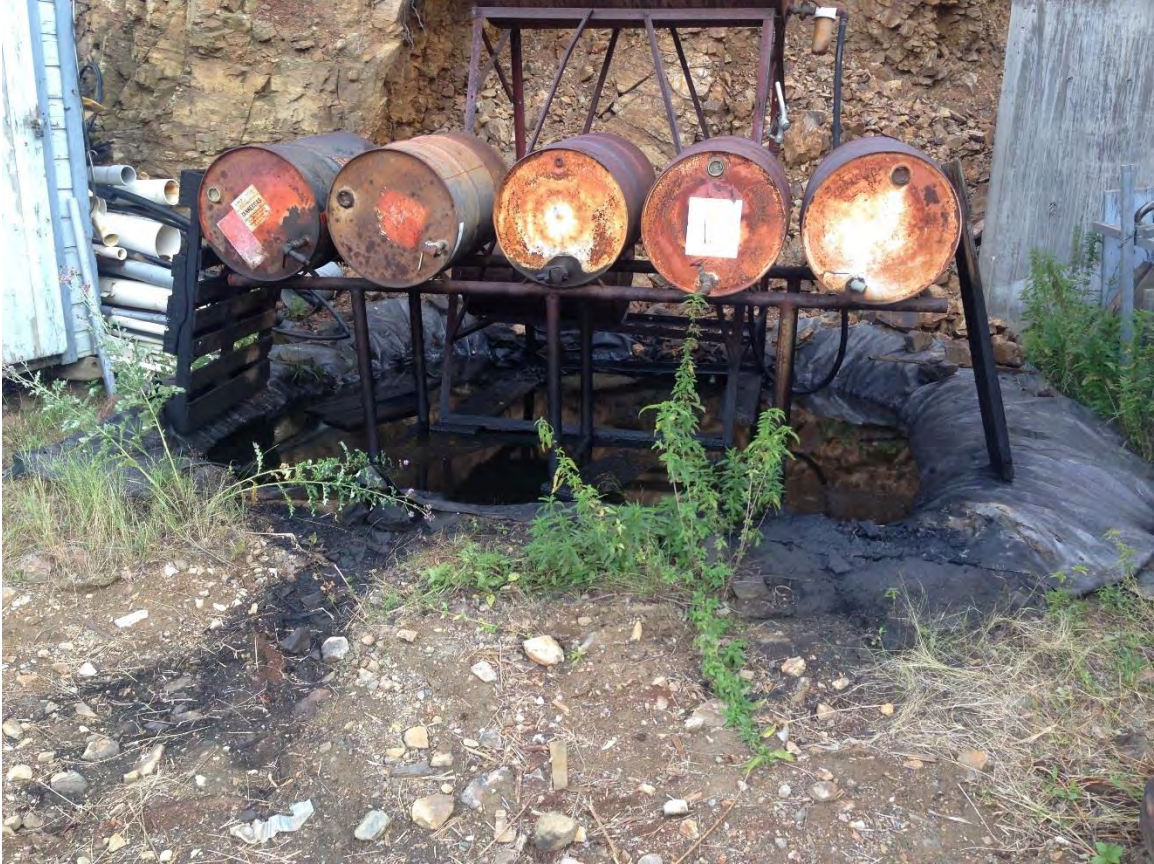
Photo 2 - Fuel Storage Area

This photograph shows the condition of the secondary containment and the evidence of localized spillage of oily fluids upon the soils after the obstructing crates of mine supplies have been removed.

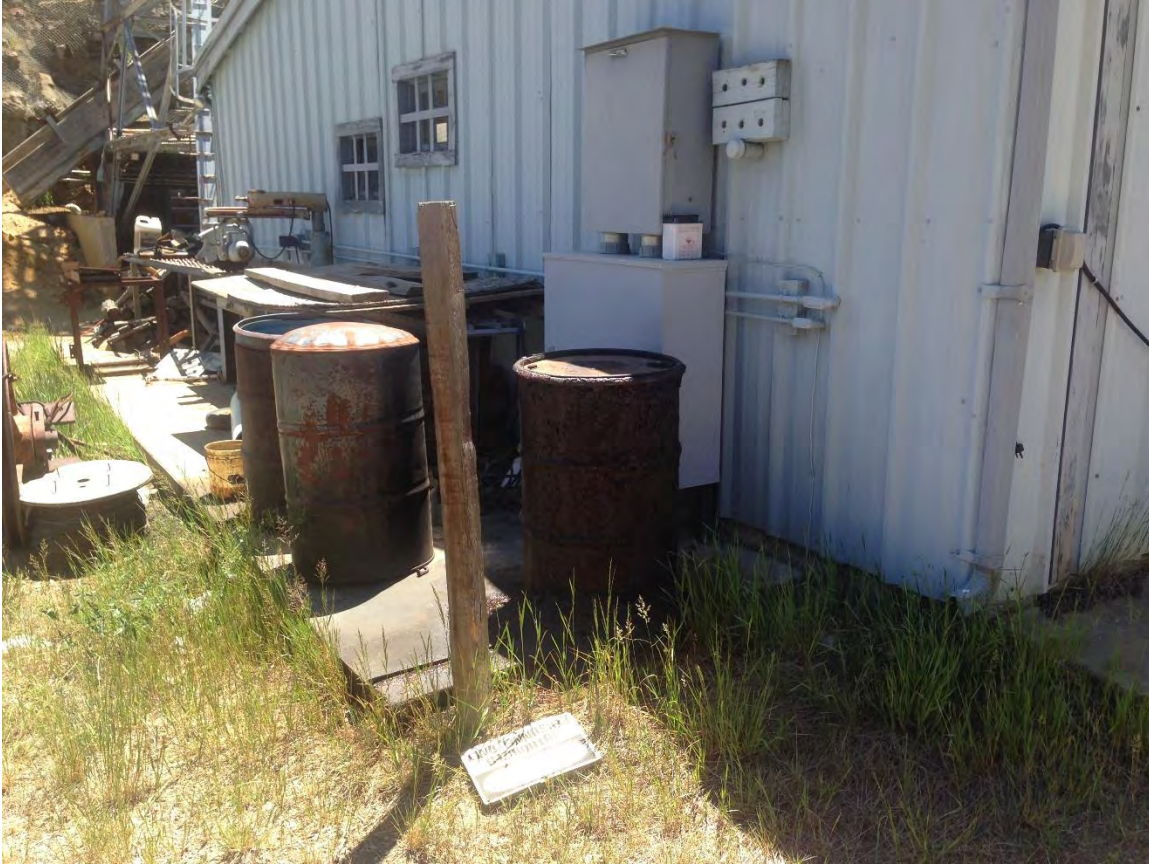
Photo 3 - Drum Storage Area

This photo shows the three drums located at the “drum storage area” prior to remediation work commencing.

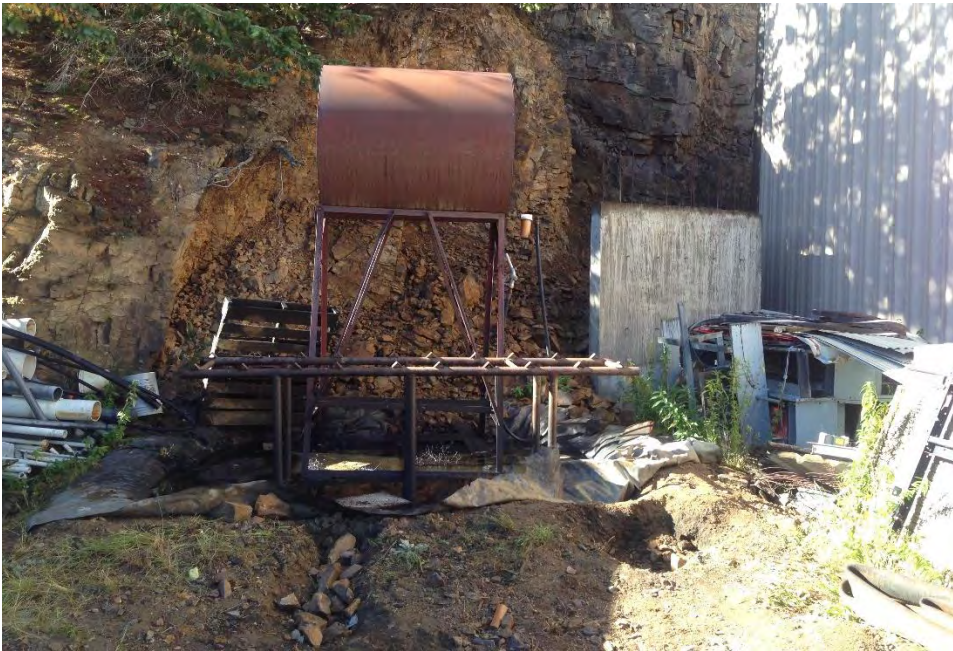
Photo 5 - Fuel Storage Area - Drums removed, some excavation complete

This image shows the work in progress. All drums have been removed, the rubber liner has been pulled back to expose the contaminated soils, which have been partially removed at this point.

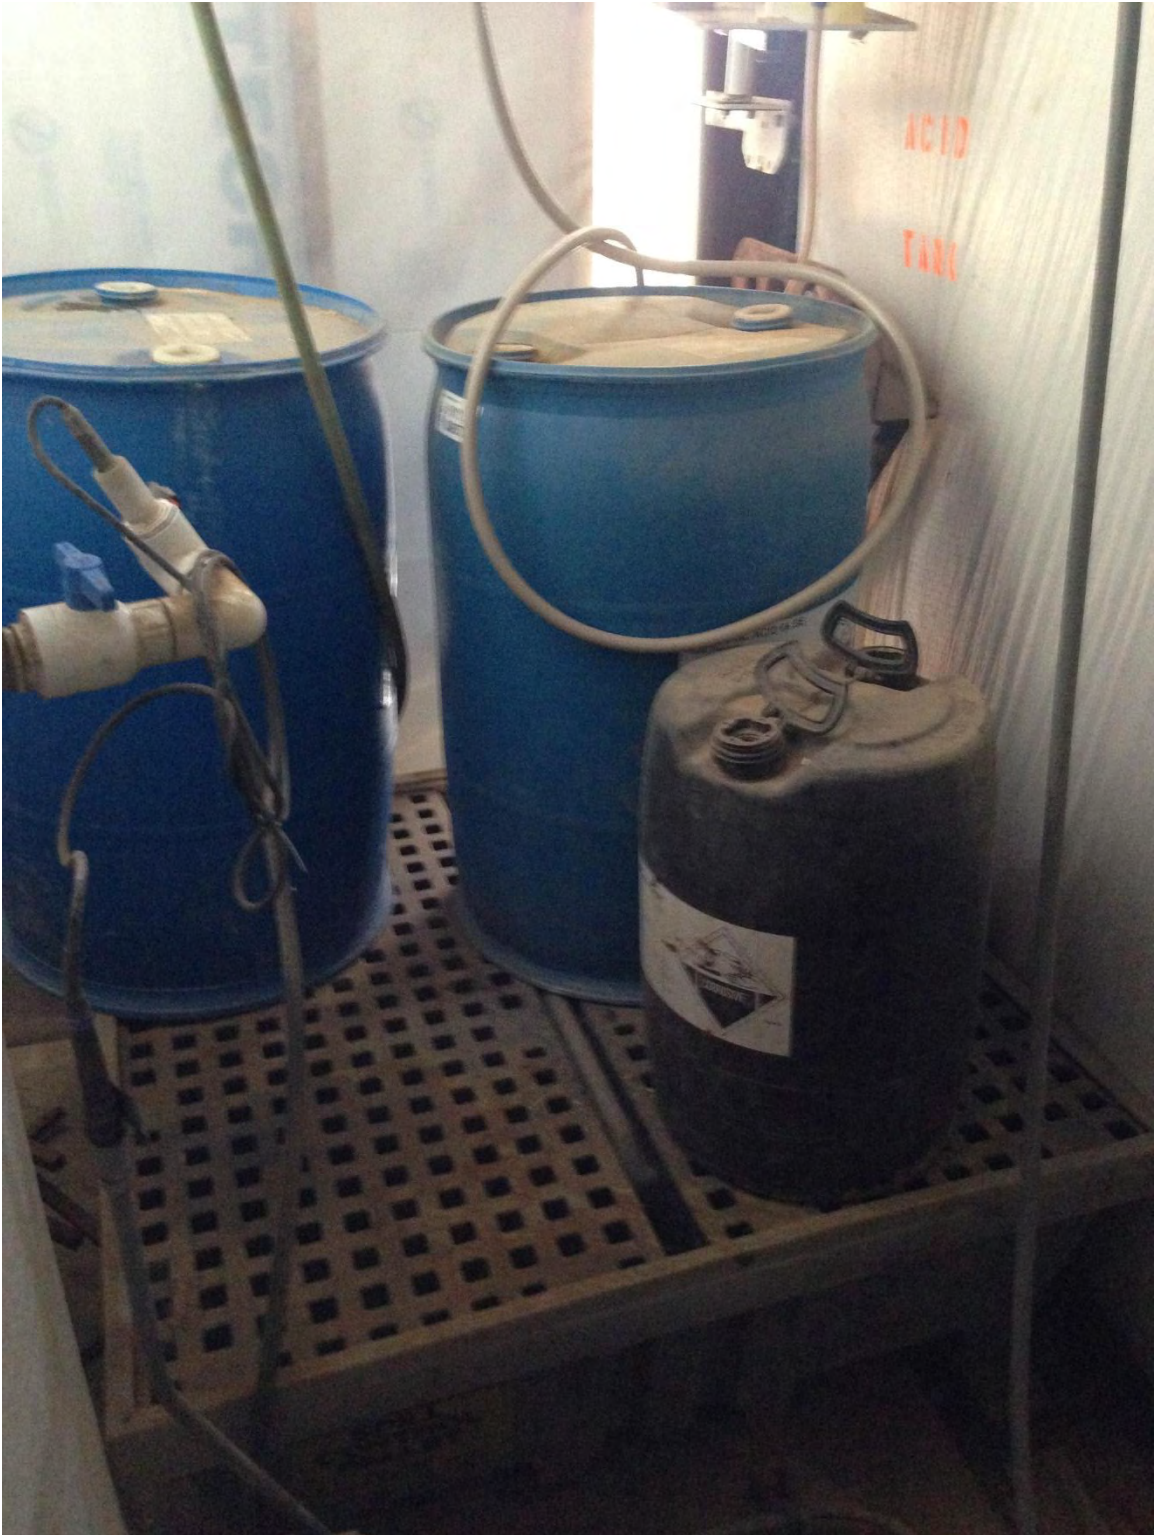
Photo 14 - Sulphuric Acid Storage

Total sulphuric acid stored is 837 pounds. The sulphuric acid is stored on its own four (4)-drum secondary containment (see photograph below) within the water treatment building.

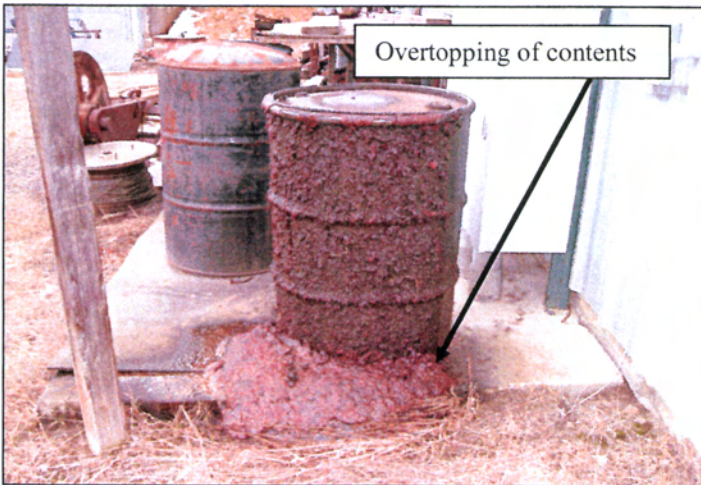
The Division observed three 55 gallon drums on the east side of the Hoist/Office Building; two unlabeled steel drums and one plastic drum with a Ferric Chloride label. The contents of one of the steel drums had overtopped the container and spread from the concrete pad to the ground. The lid of the second drum was bulged outward, indicating the drum was potentially pressurized. The Division did not move any of the drums or remove lids; all observations were visual.

1. Unlabeled 55 gallon drums on side of Hoist/Office Building.

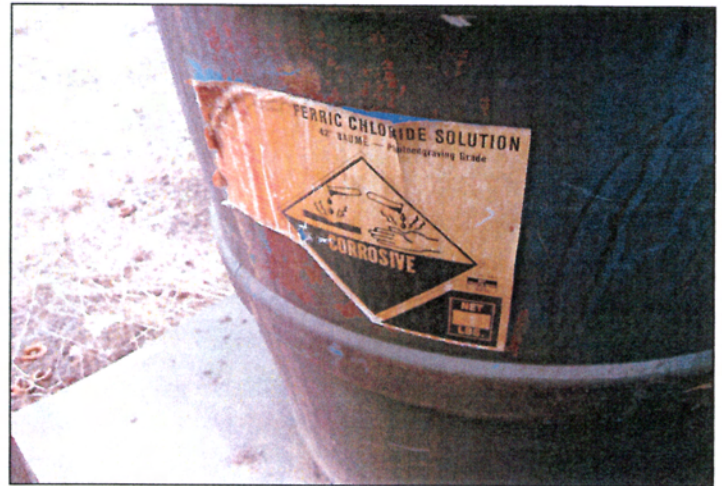
2. Plastic 55 gallon drum on side of Hoist/Office Building.

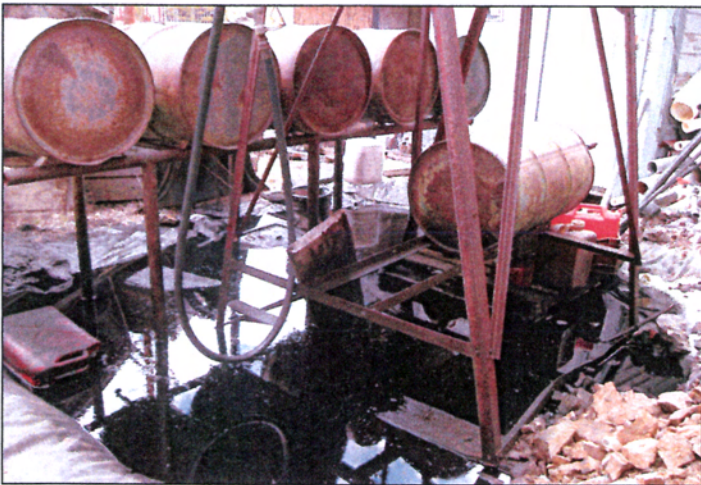
The Division observed a fuel containment area on the east side of the Water Treatment Building. The secondary containment for the fuel consists of an earthen impoundment with a liner. The liner was not anchored and did not appear to provide complete coverage over the impoundment. Two fuel racks were located within the fuel containment area. The fuel racks contained six 55 gallon steel drums and one larger steel drum. The drums were not labeled. In addition, the Division observed numerous plastic gas cans around the perimeter of the earthen impoundment. The secondary containment was at full capacity at the time of the inspection and had overtopped the impoundment in several areas as evidenced by the staining of soil around

3. Secondary containment for fuel.

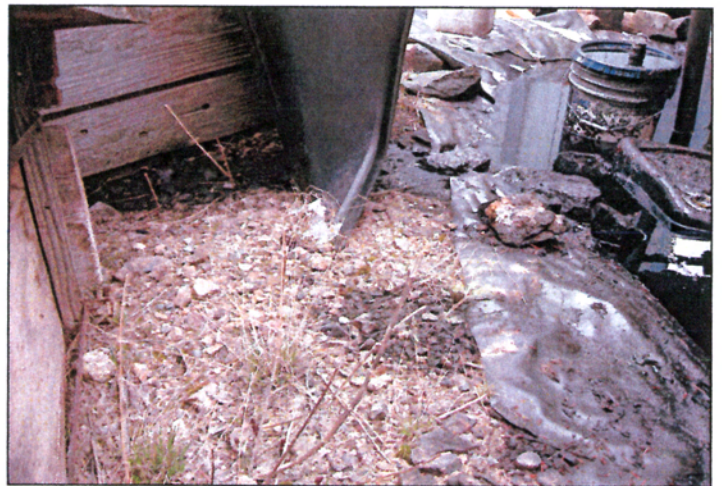
the impoundment. The black liquid within the secondary containment appeared to be a mixture of water, fuel, oil and lubricants.

4. Soil staining and overtopping of secondary containment.

- 3) Remove and properly dispose of the liquids within the secondary containment for the fuel storage area. Provide a description of how the liquids were removed and disposed of, including the total volume of liquids removed from the secondary containment and photo documentation of the remediation activities.

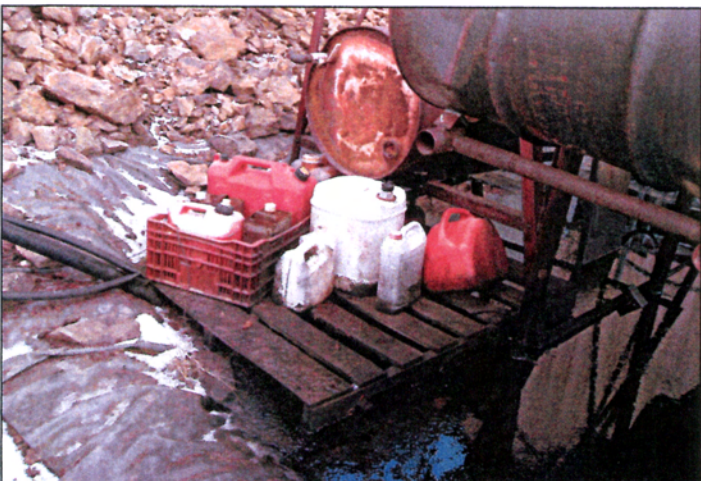
5. Various containers within secondary containment area.
