# **Reclamation Powell Gravel Pit 2016**

**(M1995012)**

**Located  
On The  
Vista Del Sol Ranch**

# Reclamation

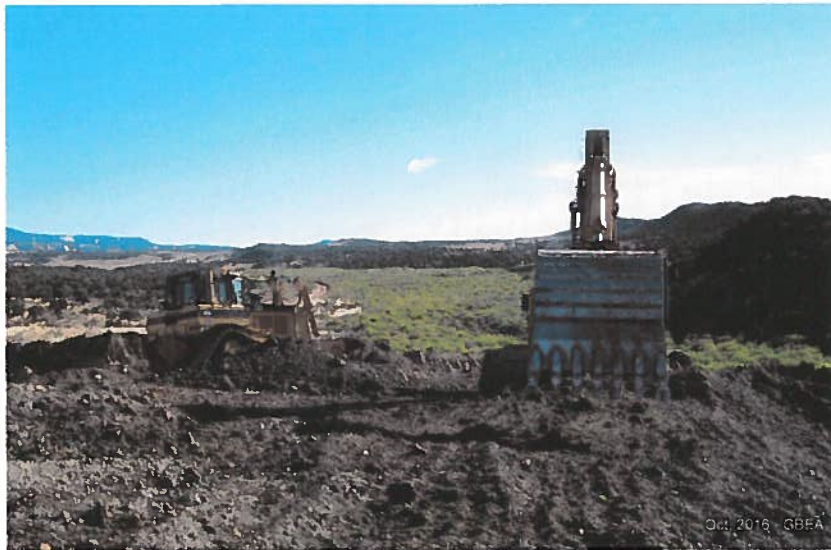
**Photo 1.** Earthwork in progress (see Photo 11 also).

On October 6, 2016 heavy equipment from W.C. Striegel, Inc. Rangely, Colorado, began working. Earthwork was finished on the 7th, with approximately 22 hours of equipment time between a CatD8R dozer and Cat345C excavator.

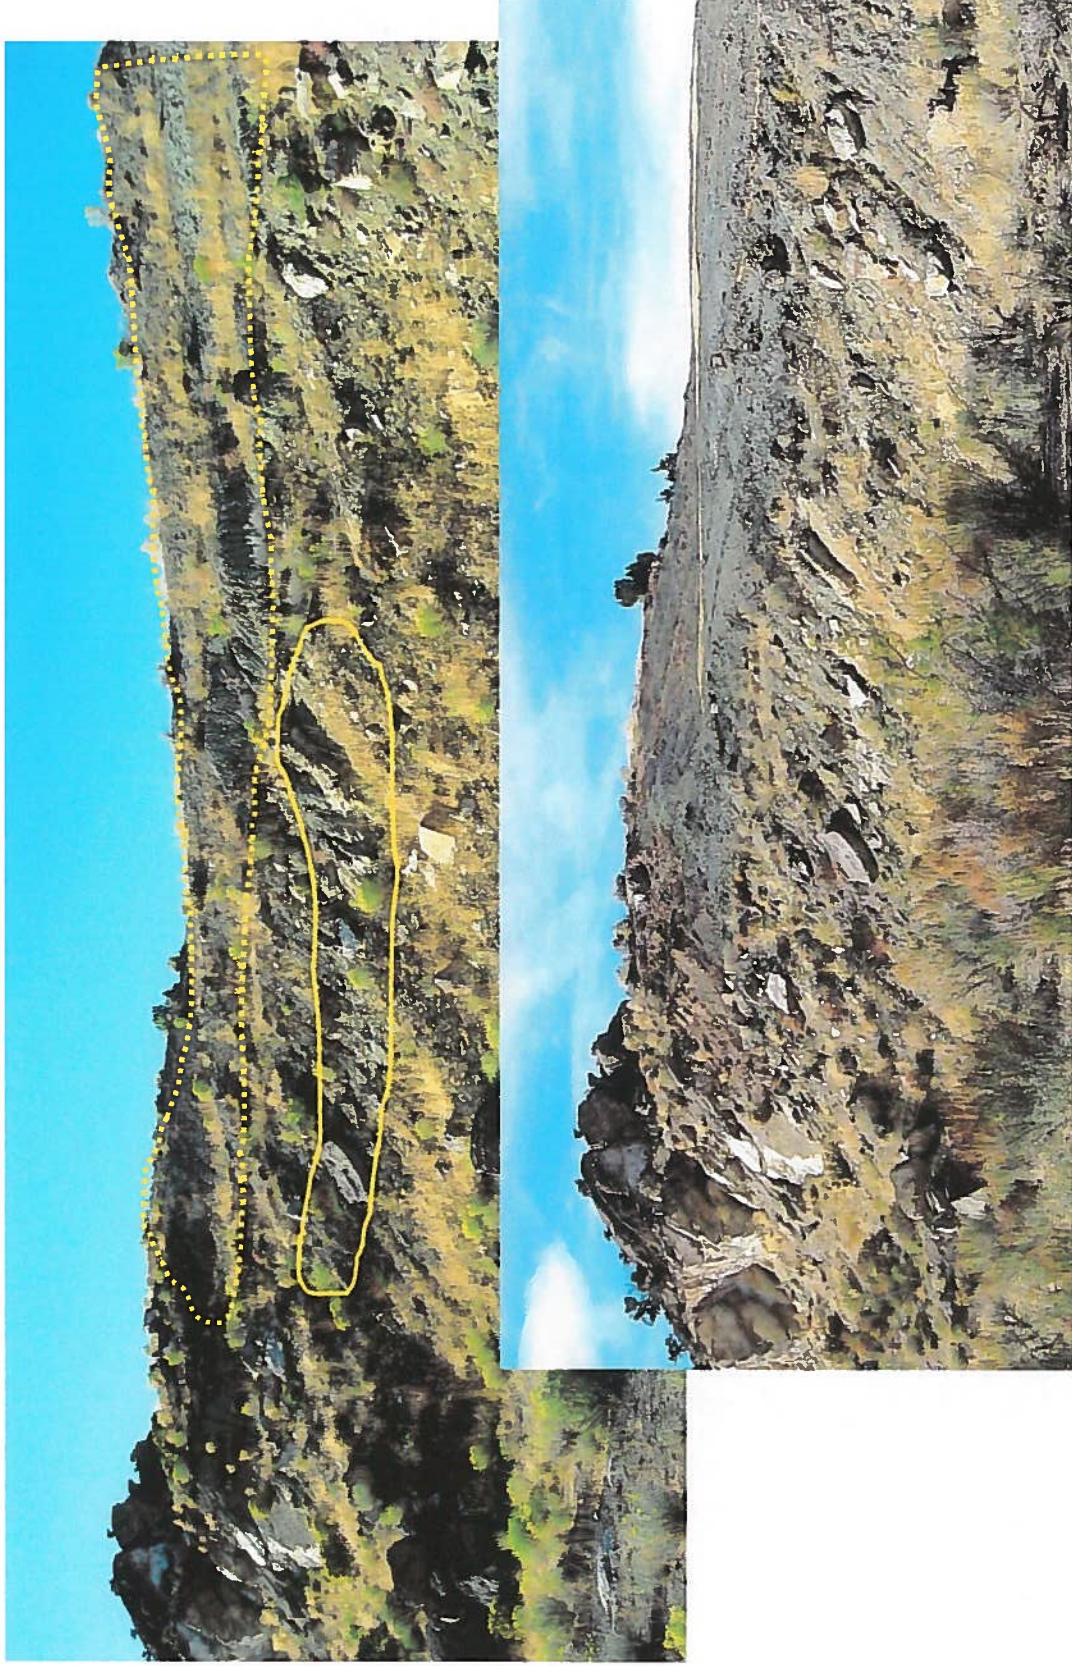
**Photo 2 and 3.** Bedrock, solid yellow line and the dashed line is the top of the hill that was reduced in height.  
Lower photo shows hill after contouring.

The lower portion of the south facing slope was not reduced in slope. This section has not been touched in over 40 years and has exhibited a high degree of stability under the current conditions. We believe that bedrock

provides stability, buttressing the hill, plus the soils are high in clays and exhibit minimal movement during precipitation and runoff events. The slope has also slowly re-vegetated over large portions and erosion has been minimal. The overall height of the hill was reduced and the slope was reduced above what appears to be a ledge of bedrock (Photos 2-3). This steep portion is approximately 0.25 acres and slopes range from 0.9/1 to 1.6/1 (see Map 1 and Appendix A, Map A4).

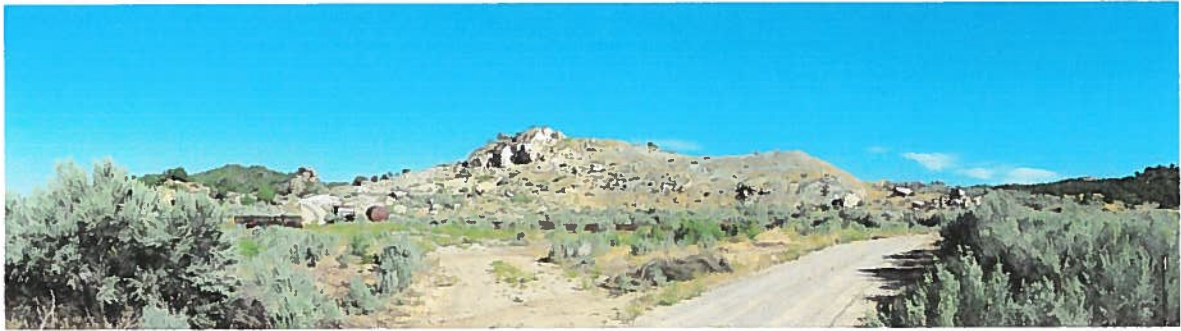
**Photo 4.** Hill before contouring to new configuration.

Photos 4-6 shows the original contour and the final as viewed from southeast boundary corner of the pit. Appendix B provides more photos of the before and after reclaiming.

- Some remaining areas are steeper than a 3/1, with the long easterly facing slope averaging 6.75/1 (see Photos 4–6 and Appendix A, Map A4).
- 290 feet of steep, 40 year old, terraces (2/1 to 1/1) were contoured to considerably less (Map 1).
