## MINERALS PROGRAM INSPECTION REPORT

<b>MINE NAME:</b> Midwestern Farms	<b>MINE/PROSPECTING ID#:</b> M-1993-059	<b>MINERAL:</b> Sand and gravel	<b>COUNTY:</b> Prowers
<b>INSPECTION TYPE:</b> Monitoring	<b>INSPECTOR(S):</b> Amy Eschberger	<b>INSP. DATE:</b> November 22, 2016	<b>INSP. TIME:</b> 13:00
<b>OPERATOR:</b> Midwestern Farms	<b>OPERATOR REPRESENTATIVE:</b> Mel DePra	<b>TYPE OF OPERATION:</b> 112c - Construction Regular Operation	
<b>REASON FOR INSPECTION:</b> Normal I&E Program	<b>BOND CALCULATION TYPE:</b> Complete Bond	<b>BOND AMOUNT:</b> \$1,583,000.00	
<b>DATE OF COMPLAINT:</b> NA	<b>POST INSP. CONTACTS:</b> None	<b>JOINT INSP. AGENCY:</b> None	
<b>WEATHER:</b> Cold, windy, light rain	<b>INSPECTOR'S SIGNATURE:</b>

# M1993-059 / Midwestern Farms / Midwestern Farms

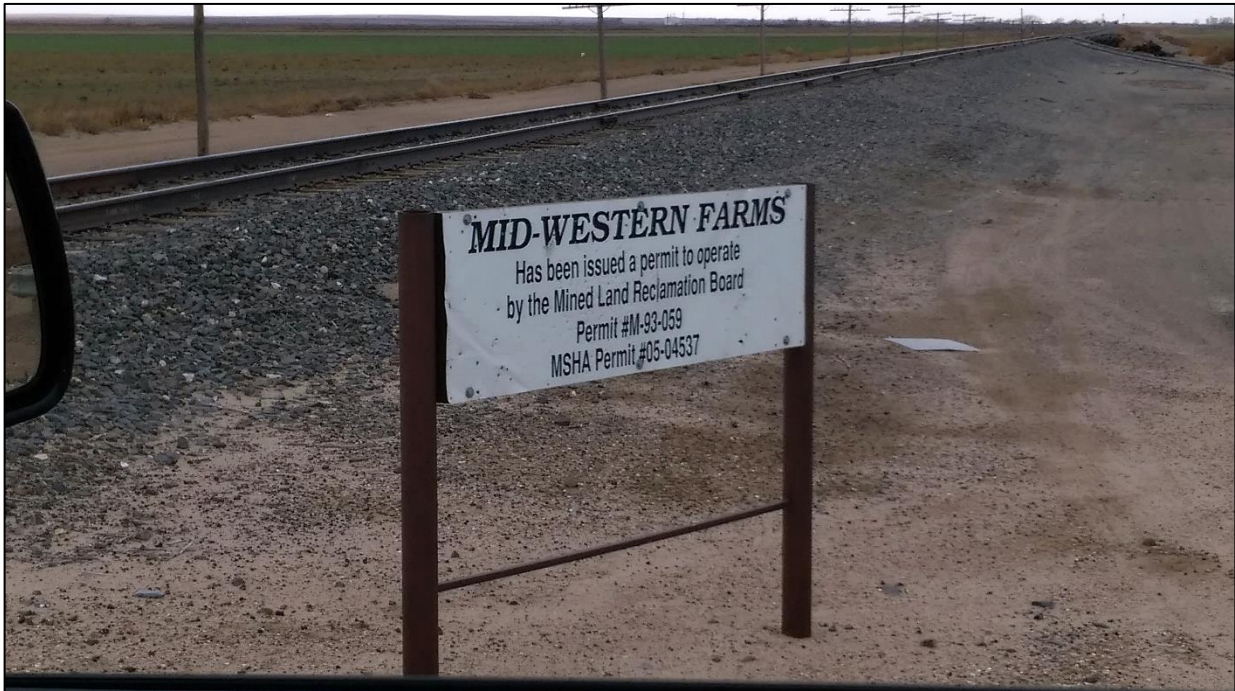
**Photo 1.** View of permit sign posted at main site entrance off of Co Rd 30.5.

At the time of the inspection, it was cold and windy with some light precipitation. A permit sign was posted at the main entrance to the site off of Co Rd 30.5 (**Photo 1**). The site was not active at the time of the inspection. Although the operation has mined only Phase 1 of the approved six mining phases, the operation has ceased mining in accordance with the landowner's wishes. Over the past few years, the permittee and landowner, Midwestern Farms, the operator and third party bond warrantor, ECA, and the potential future landowner,

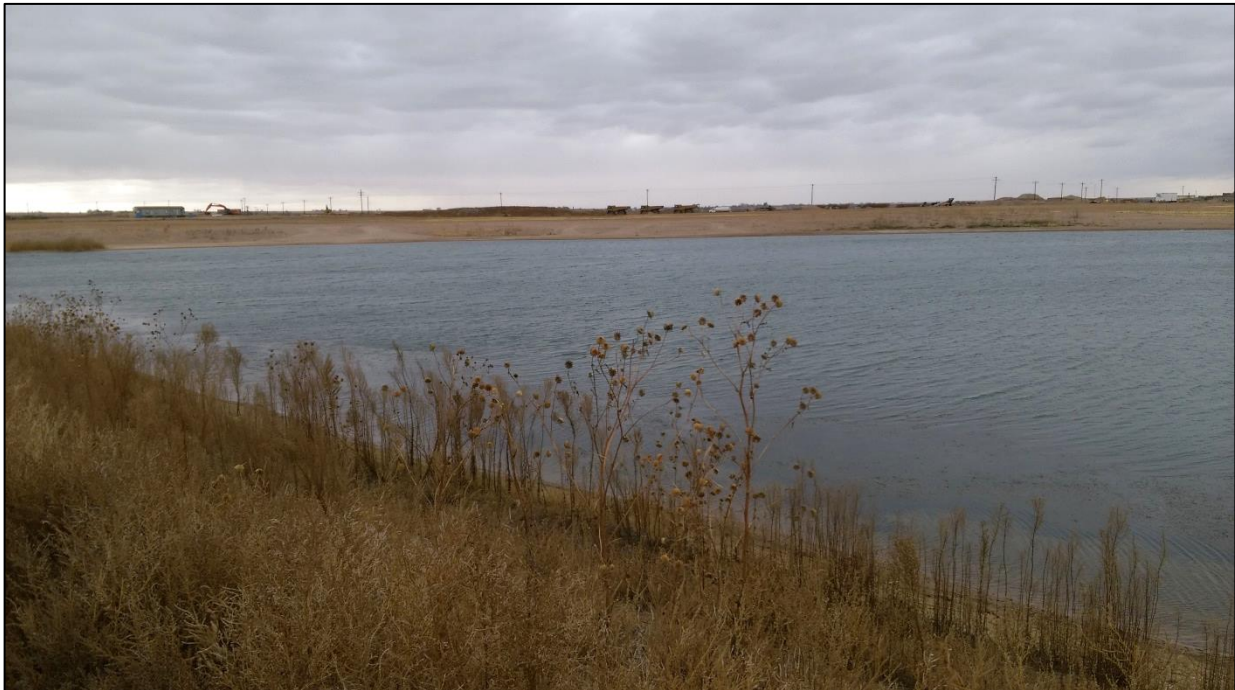
**Photo 2.** View looking northeast from western shoreline of western pond, showing slope gradients of 3H:1V or flatter.

During the inspection, the Division first observed the western pond, which is approximately 23.6 acres in surface area (**see enclosed Google Earth image of disturbed area**). This pond has been designated as a state wildlife area by CPW, where public fishing is allowed. The shoreline of this pond has slope gradients of mainly 3H:1V or flatter (**Photos 2-5**). The slope gradients below water line are undetermined. The Division was unable to observe slopes below water line during the inspection due to wave action in the ponds. The western and southern shorelines are well vegetated with native grasses, forbs, and some annual weeds (e.g., Russian thistle, wild sunflowers), and appeared to be stable (**Photos 6 and 7**). The eastern shoreline is flatter and remains sandy with no vegetative cover. Although the map that was submitted with TR-05 is difficult to read, it appears the operator is proposing to leave a portion of the eastern shoreline sandy for use by migratory birds (per CPW's recommendation).

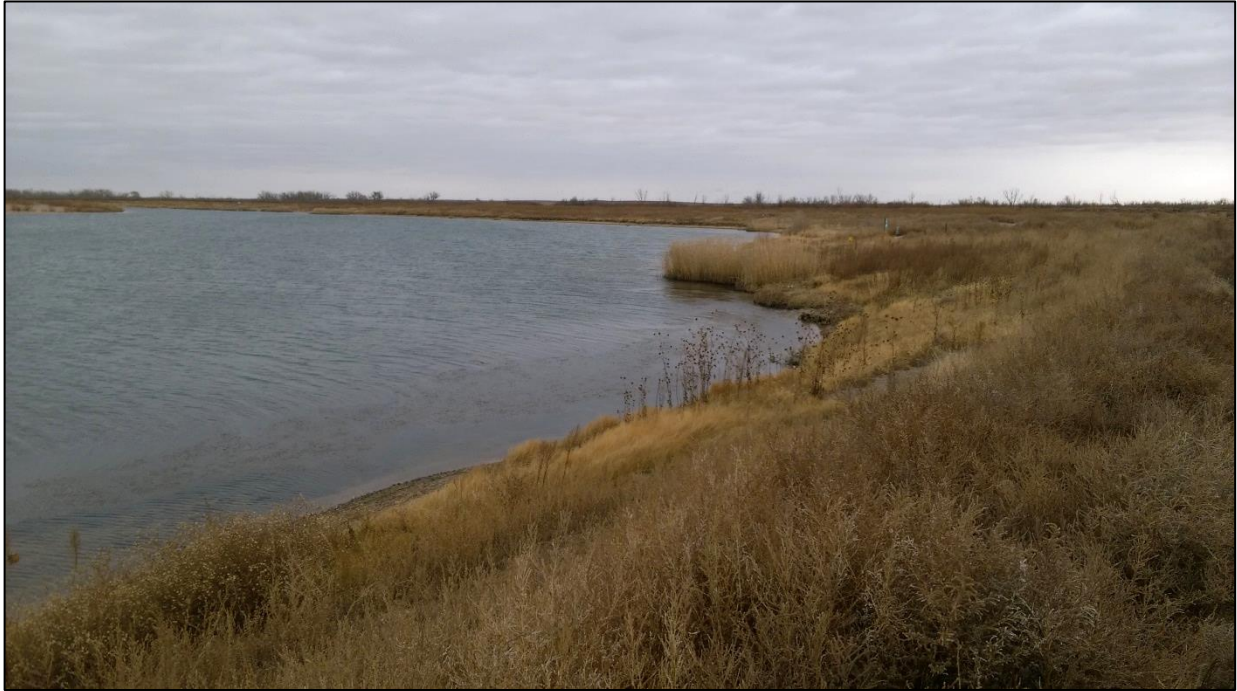
**Photo 3.** View looking south from western shoreline of western pond, showing slope gradients of 3H:1V or flatter.

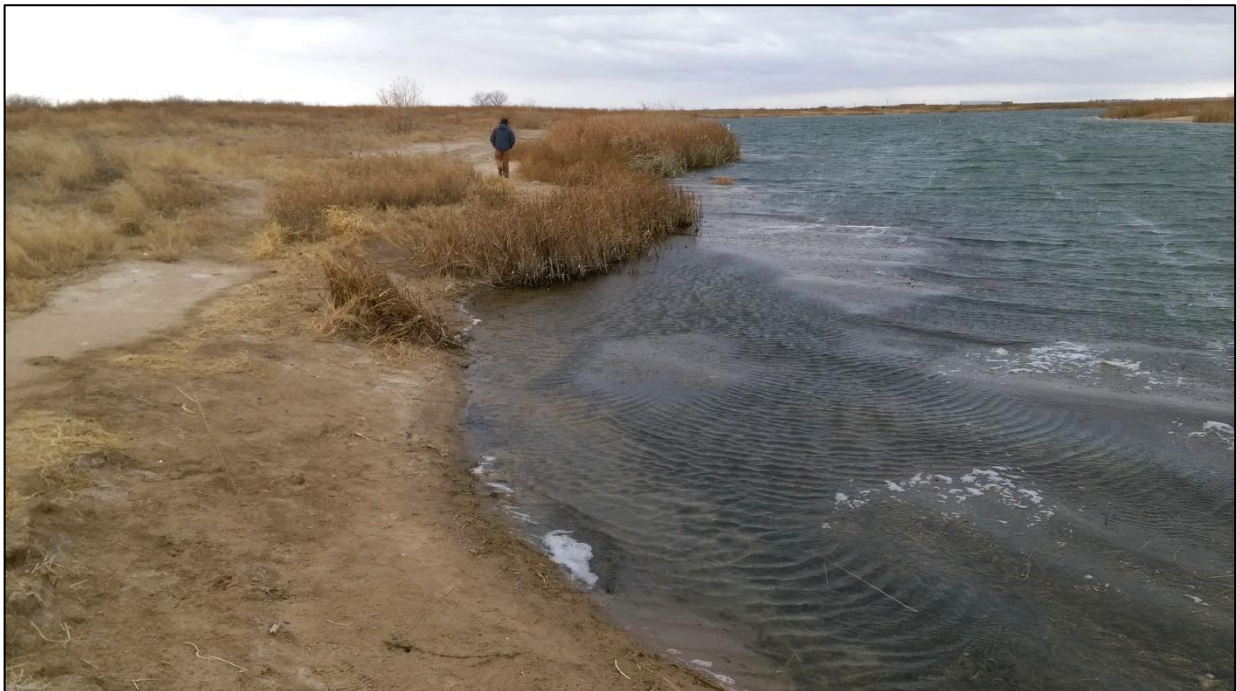
**Photo 4.** View looking west from southwestern shoreline of western pond, showing slope gradients of 3H:1V or flatter.

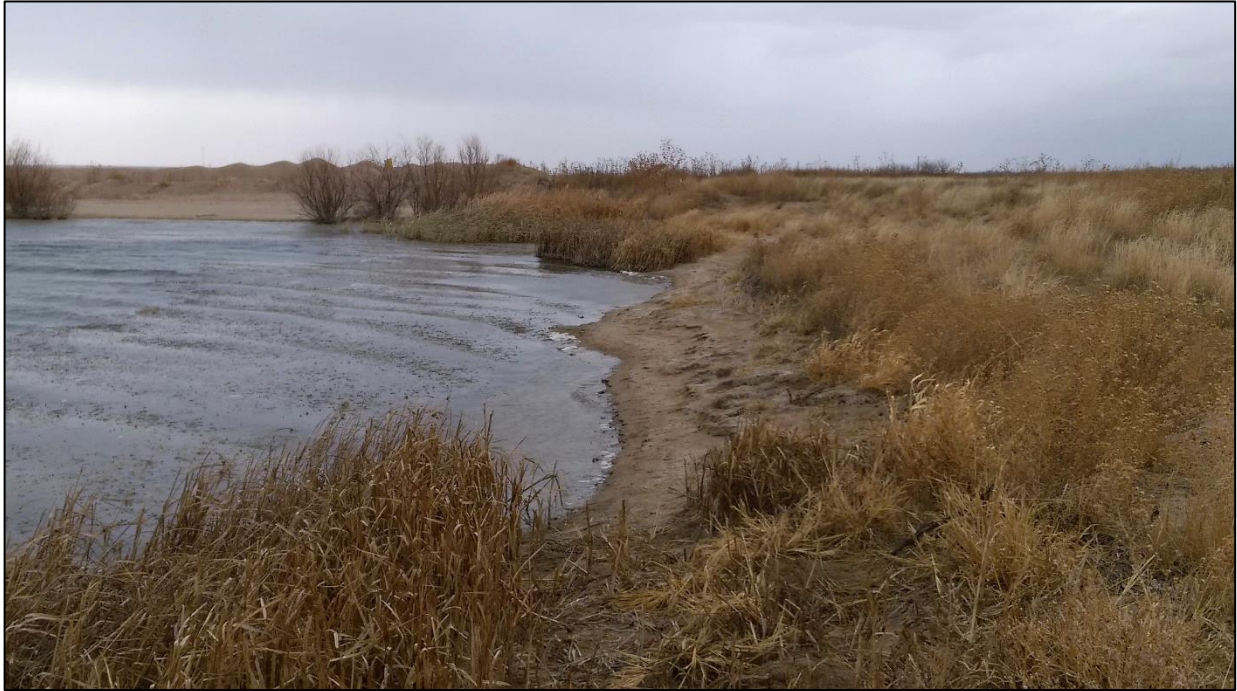
**Photo 5.** View looking east from southwestern shoreline of western pond, showing slope gradients of 3H:1V or flatter.

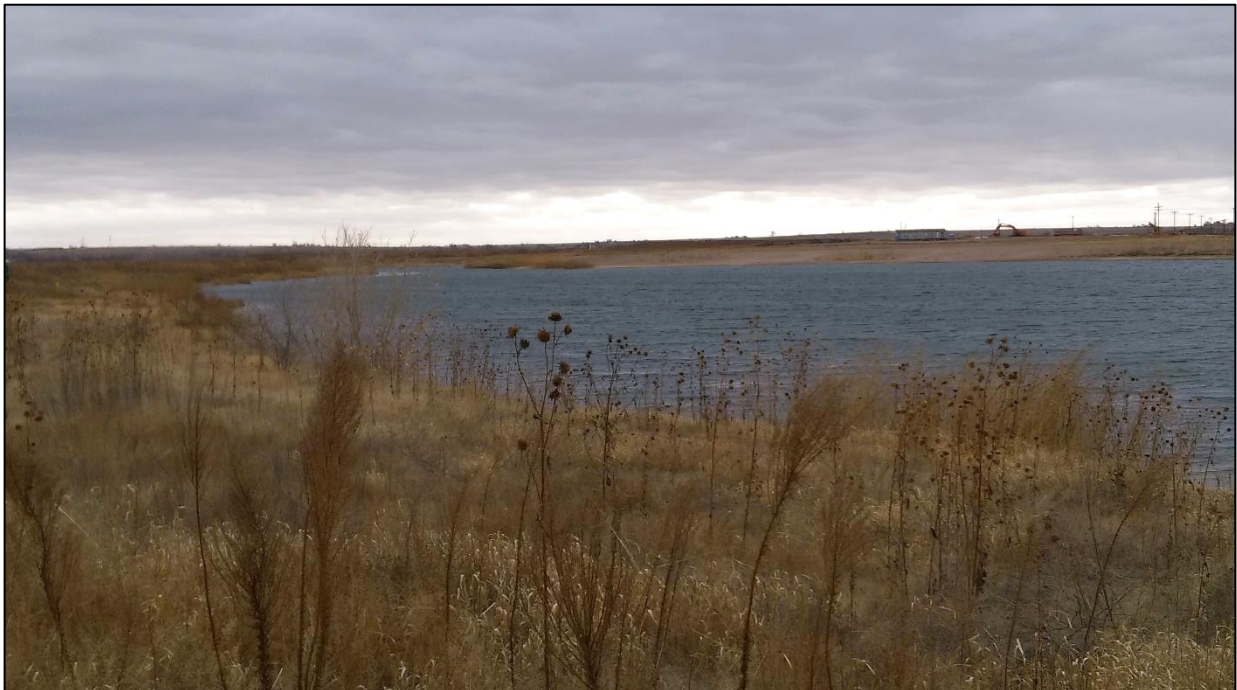
**Photo 6.** View looking north from southwestern shoreline of western pond, showing vegetation present along shoreline.

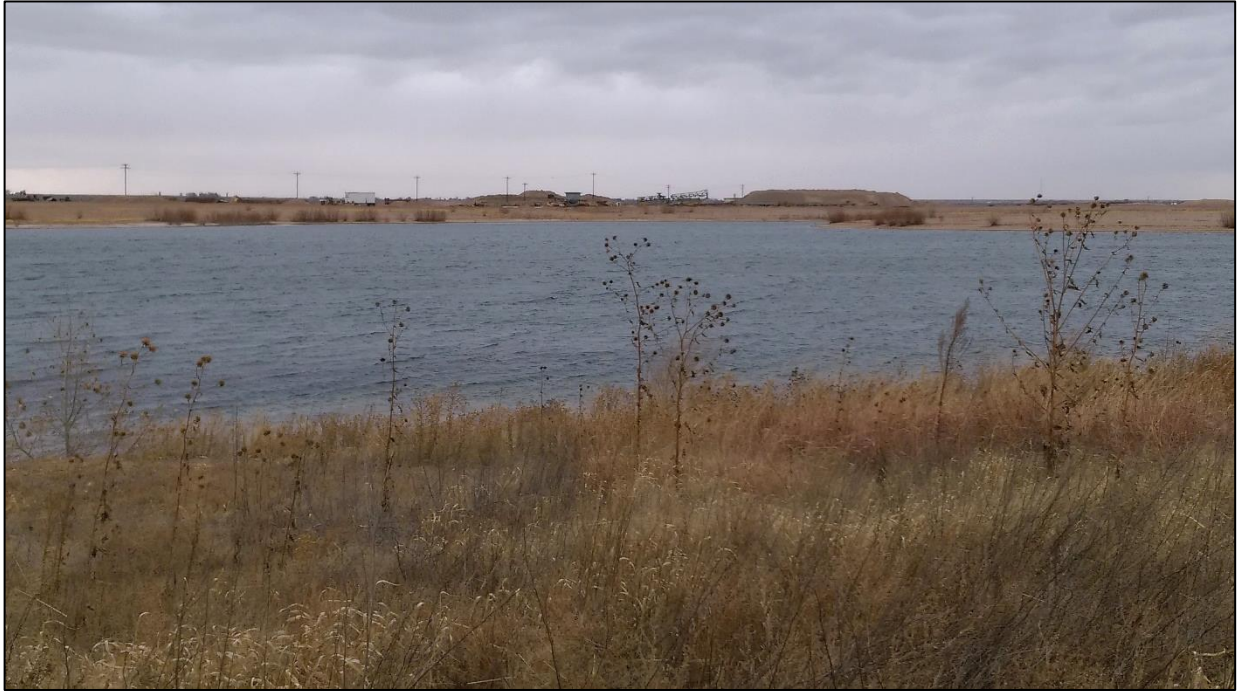
**Photo 7.** View looking east from southwestern shoreline of western pond, showing vegetation present along shoreline.

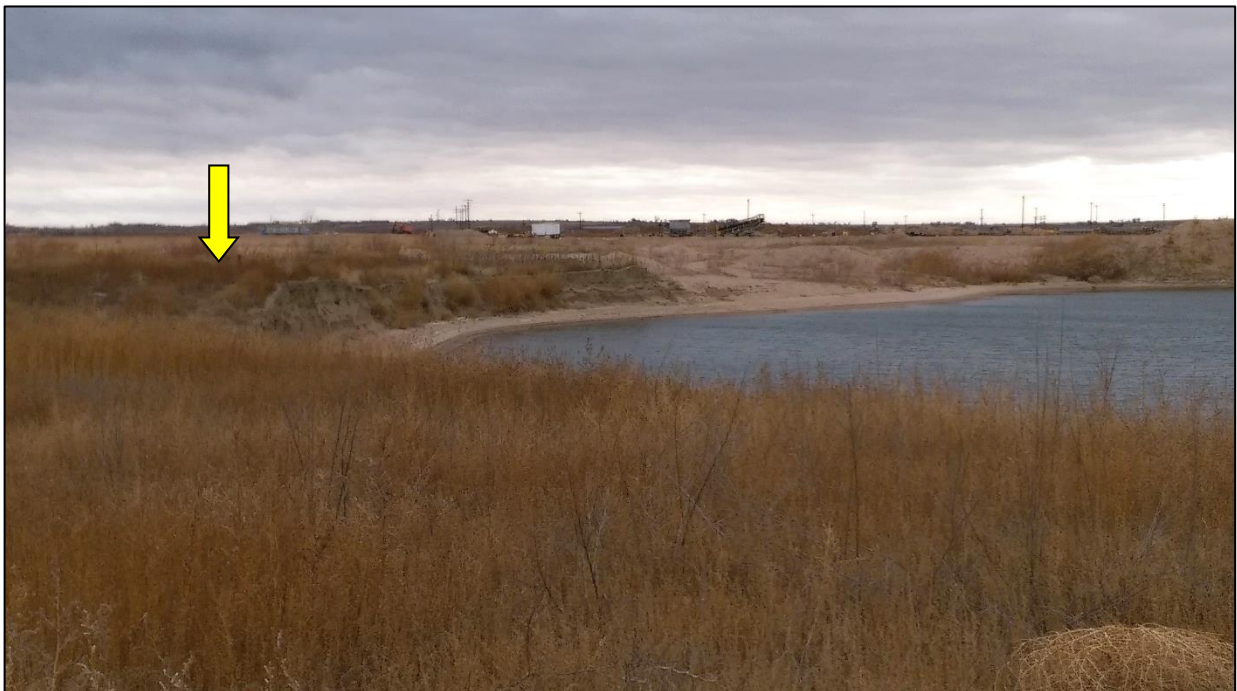
The Division next inspected the portion of land which separates the western pond from the eastern pond (**Photo 8**). The Division estimates this area to be approximately one acre in size. In TR-05, the operator proposes excavating this portion of land down to approximately 10 feet below water line, with a bottom width of approximately 40 feet, connecting the two ponds. The excavated material will be used on site to backfill shorelines to the required final slope gradient. Mr. DePra indicated the proposed 10 foot deep canal would provide shallow water habitat for warm water fish species. The shoreline slopes in this area will be graded to 6H:1V. In its adequacy review of TR-05, the Division inquired about the additional water rights required for increasing the pond surface area as proposed. In an email received on 11/27/2016, Ms. Jackie Corday of CPW informed the Division the parties have agreed to provide up to 15 LAWMA preferred shares to cover the increase in exposed groundwater. If additional shares are needed, CPW would contribute another three shares. The operator should be advised that the Division will not be able to release the site until the appropriate water rights are in place for all exposed groundwater on site. Additionally, until the proposed expansion of the pond is covered by LAWMA's plan for augmentation, the Division will require reclamation costs to backfill this portion of the pond.

**Photo 8.** View looking northwest from southwestern shoreline of eastern pond, showing portion of land between two ponds (indicated) which TR-05 proposes to extract to connect the two ponds.

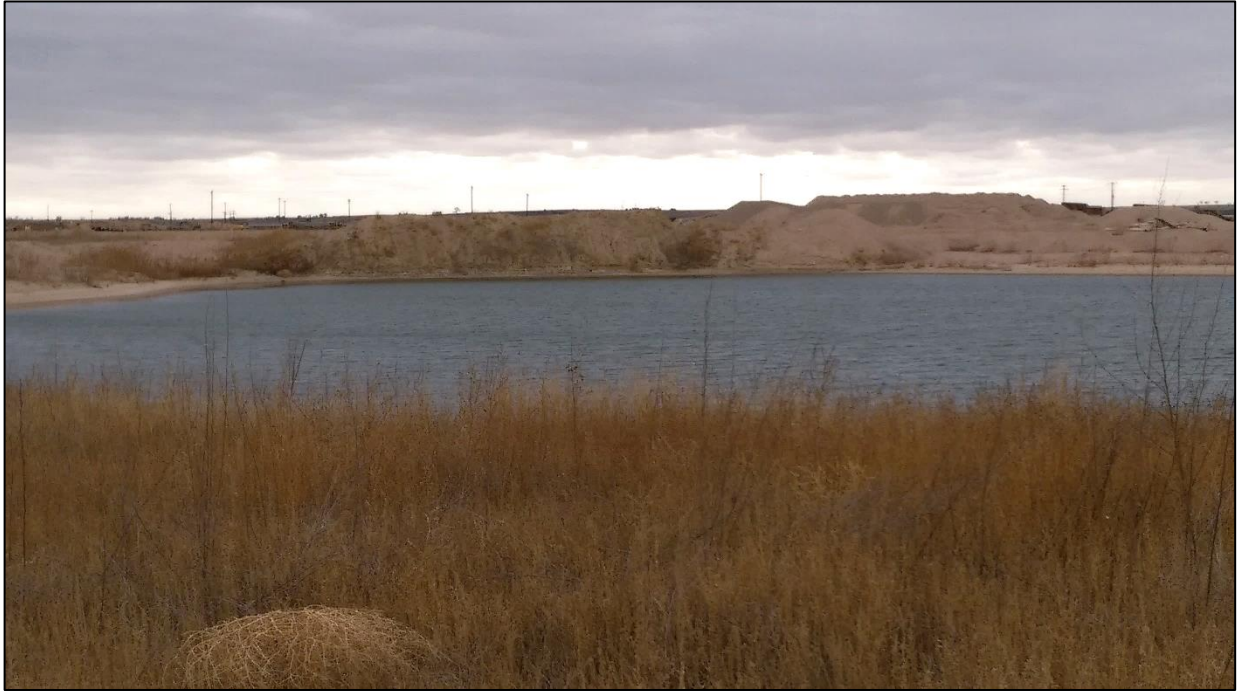
The Division inspected the larger eastern pond, which is approximately 71.9 acres in surface area. The Division observed material stockpiled along the western shoreline at the southwestern portion of the pond (**Photos 9 and 10**). Mr. DePra indicated this material would probably be used to backfill the shoreline in that area, and the rest would be pushed into the pond. The eastern and southern shorelines of the eastern pond have near vertical to 1H:1V slope gradients approximately 6-8 feet above water line (**Photos 11-13**). The Division estimates that approximately 6,800 linear feet of the eastern pond's shoreline will require additional grading for reclamation. In its adequacy review for TR-05, the Division inquired as to how the operator intends to grade the pond shorelines below water line as proposed. Mr. DePra indicated the operator may use the dredge (which remains on site) for backfilling the shorelines. The western shoreline that was backfilled by the dredge during operation has slope gradients flatter than 3H:1V (**Photos 14 and 15**). Although the map that was submitted with TR-05 is difficult to read, it appears the operator is proposing to leave the western shoreline sandy for use by migrating birds (per CPW's recommendation). The Division observed Tamarisk (salt cedar) trees growing mainly along

**Photo 9.** View looking north from southwestern shoreline of eastern pond, showing sand stockpiled along western shoreline which could be used for reclamation of pond shorelines.

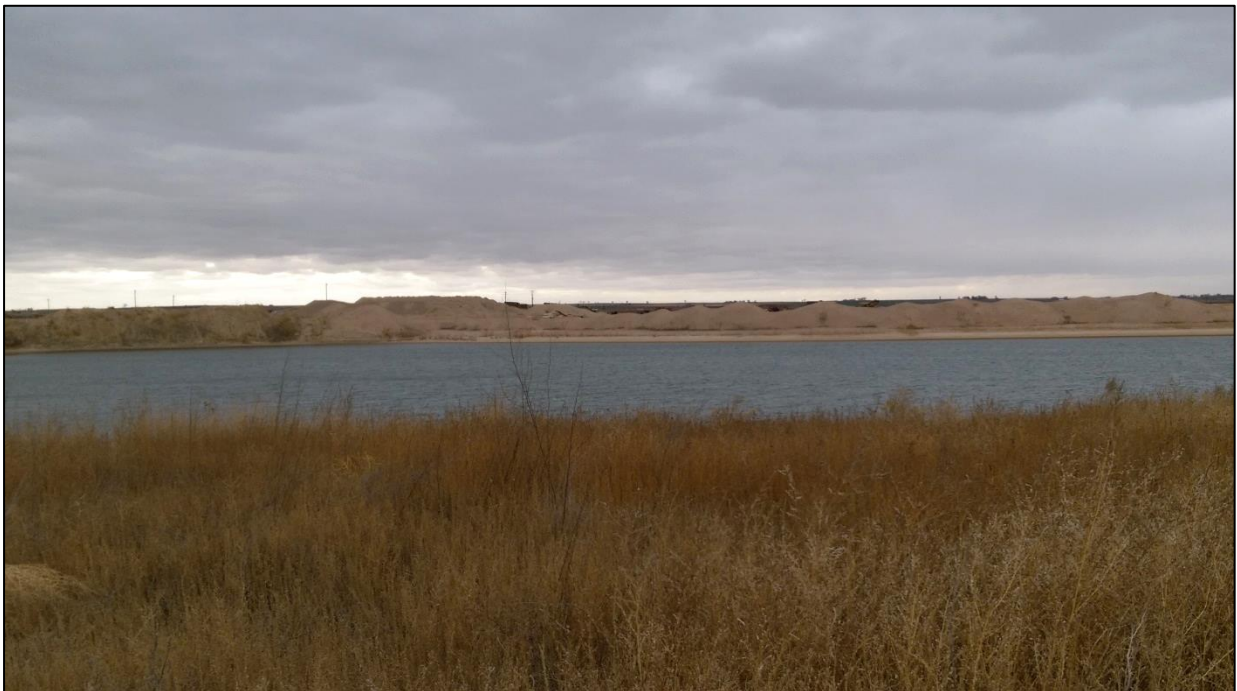
**Photo 10.** Another view looking north from southwestern shoreline of eastern pond, showing sand stockpiled along western shoreline which could be used for reclamation of pond shorelines.

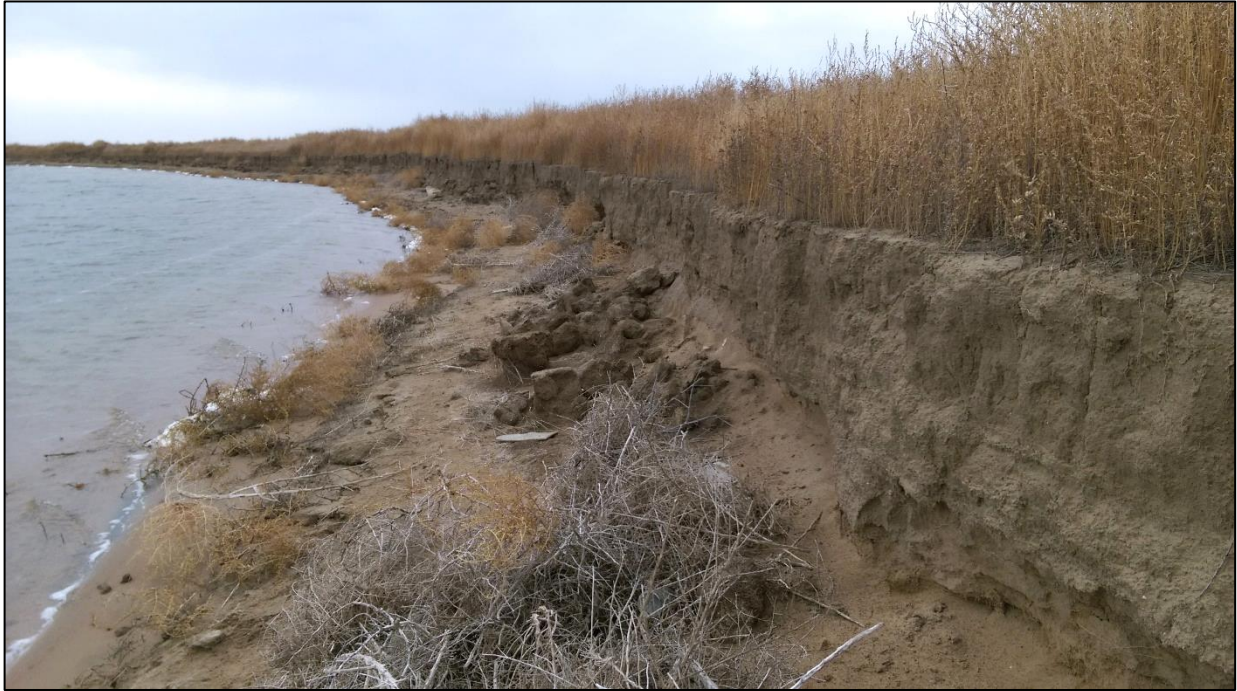
**Photo 11.** View looking east along southern shoreline of eastern pond, showing slope gradients of near vertical at approximately 6-8 feet above water line, which will require grading for reclamation.

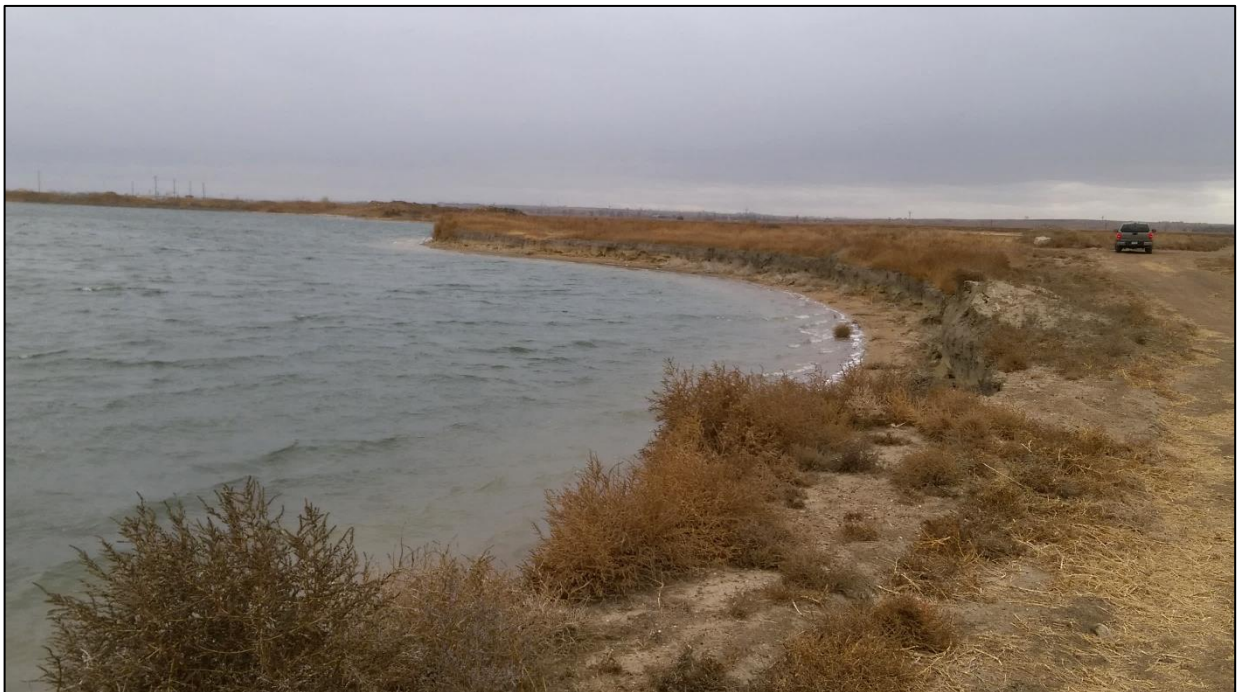
**Photo 12.** View looking north along eastern shoreline of eastern pond, showing slope gradients of near vertical at approximately 6-8 feet above water line, which will require grading for reclamation.

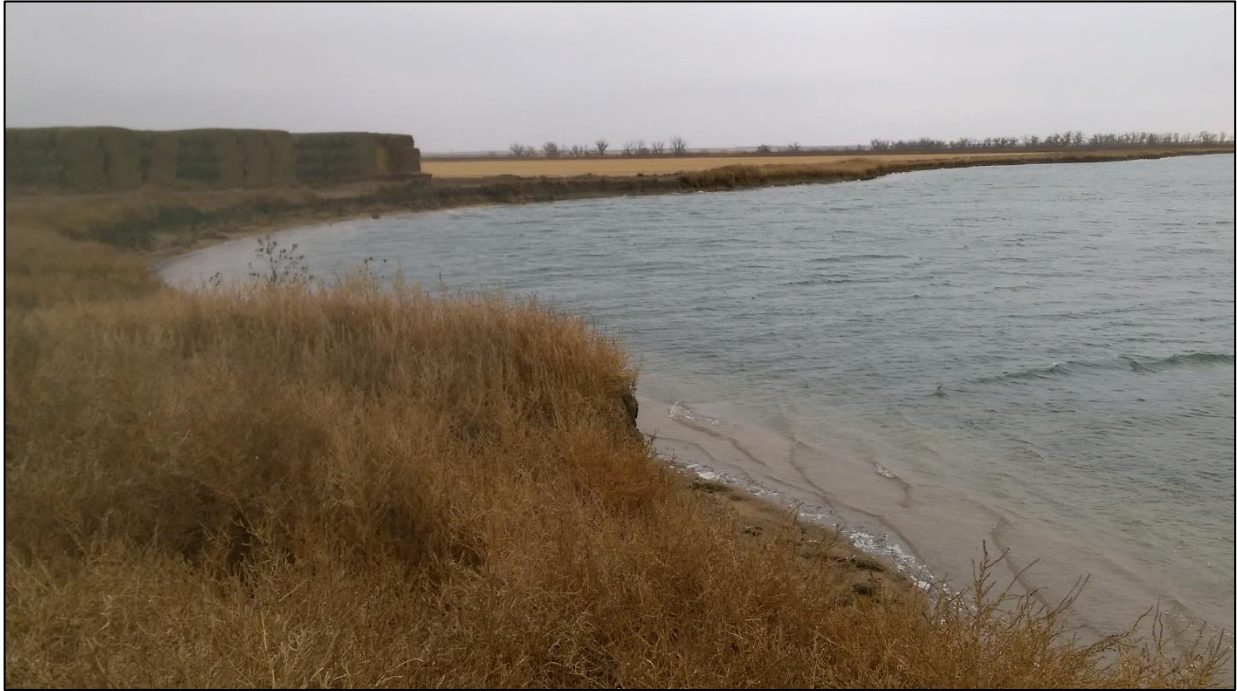
**Photo 13.** View looking south along eastern shoreline of eastern pond, showing slope gradients of near vertical at approximately 6 feet above water line, which will require grading for reclamation.

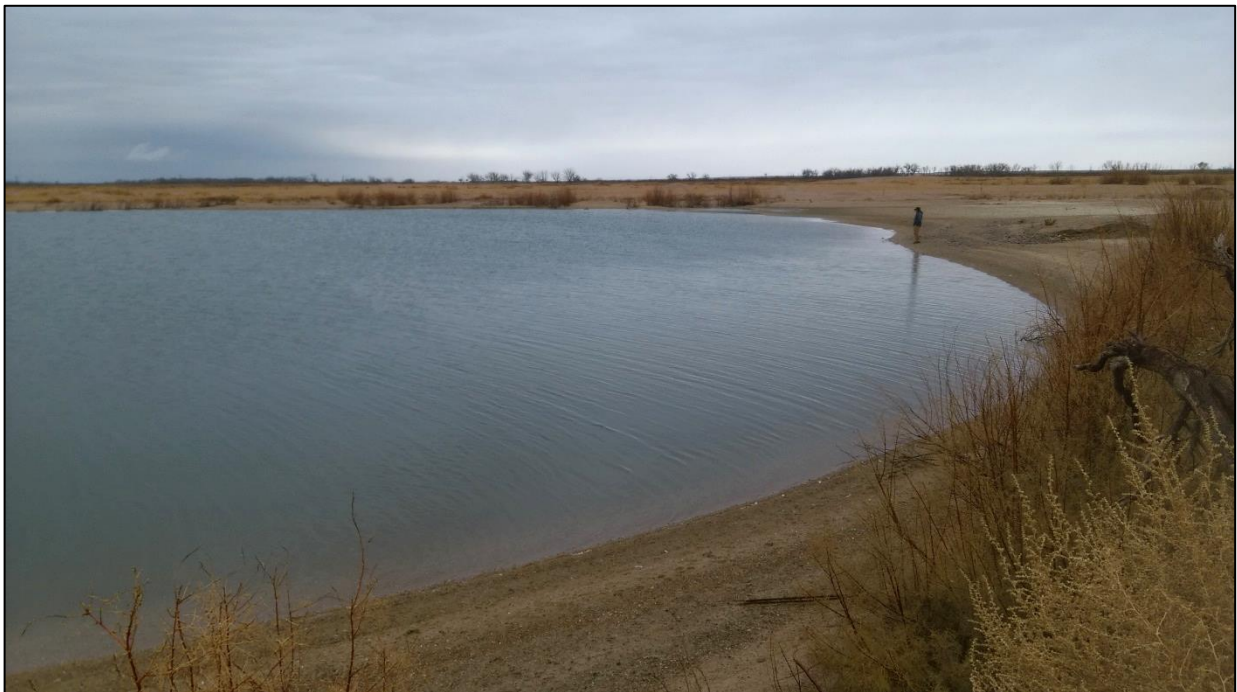
**Photo 14.** View looking south along western shoreline of eastern pond, showing slope gradients of flatter than 3H:1V created by dredge during operation.

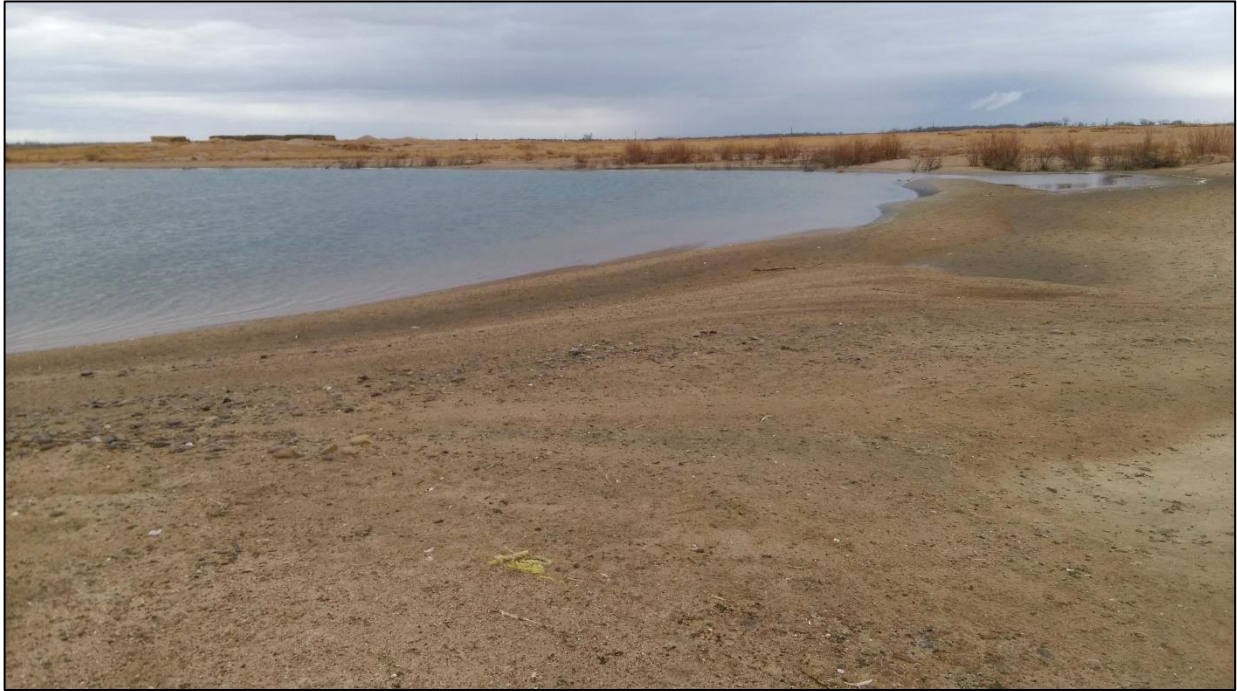
**Photo 15.** View looking southeast along western shoreline of eastern pond, showing slope gradients of flatter than 3H:1V created by dredge during operation.

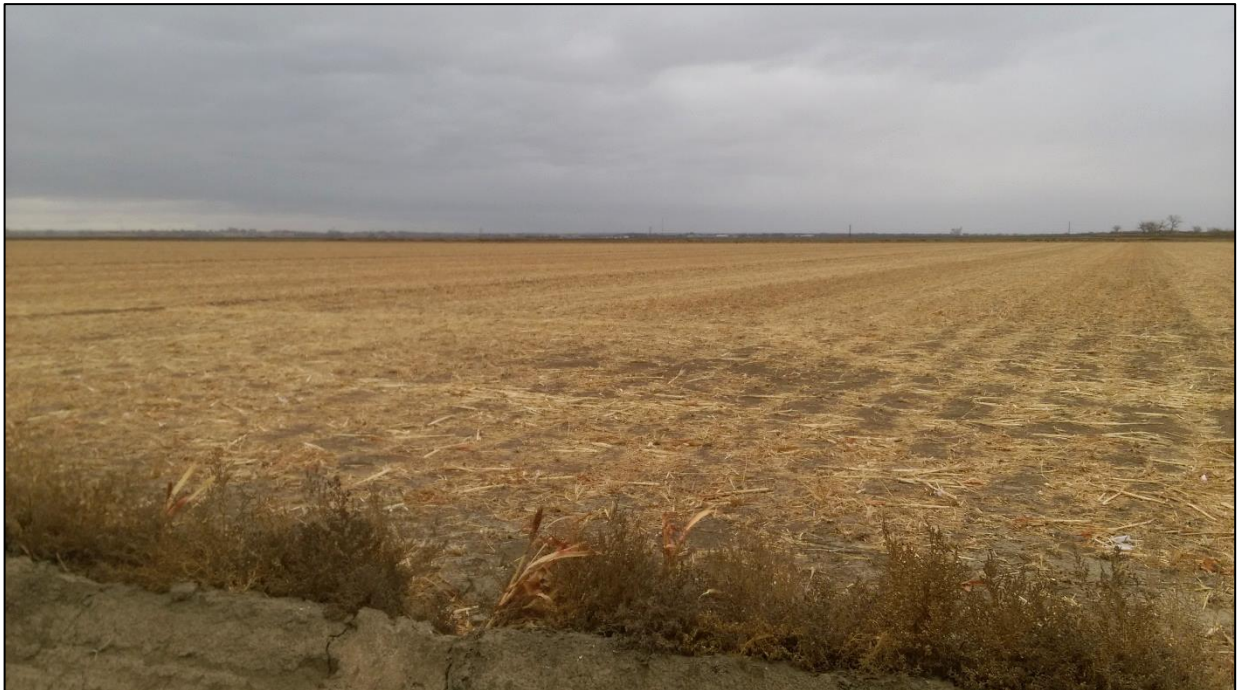
During the inspection, Mr. DePra pointed out areas located to the east (**Photo 16**) and northeast (**Photo 17**) of the eastern pond where TR-05 proposes borrowing some of the available topsoil to use for reclamation of other areas. The borrow areas are located in the adjacent agricultural fields. As mentioned previously, the map provided with TR-05 is difficult to read. Therefore, the Division was uncertain as to the proposed locations for this activity. The email received from Ms. Corday on 11/27/2016 states that CPW prefers topsoil be borrowed from north of the eastern pond and from a sliver of land along the eastern shoreline where slope grading will occur. Because borrowing topsoil disturbs the land, the operator will need to be sure this acreage is included in the maximum disturbance at any time (currently set at 390 acres). Additionally, the Division will require reclamation costs for revegetating these areas.

**Photo 16.** View looking east across agricultural land located east of eastern pond proposed in TR-05 as topsoil borrow area.

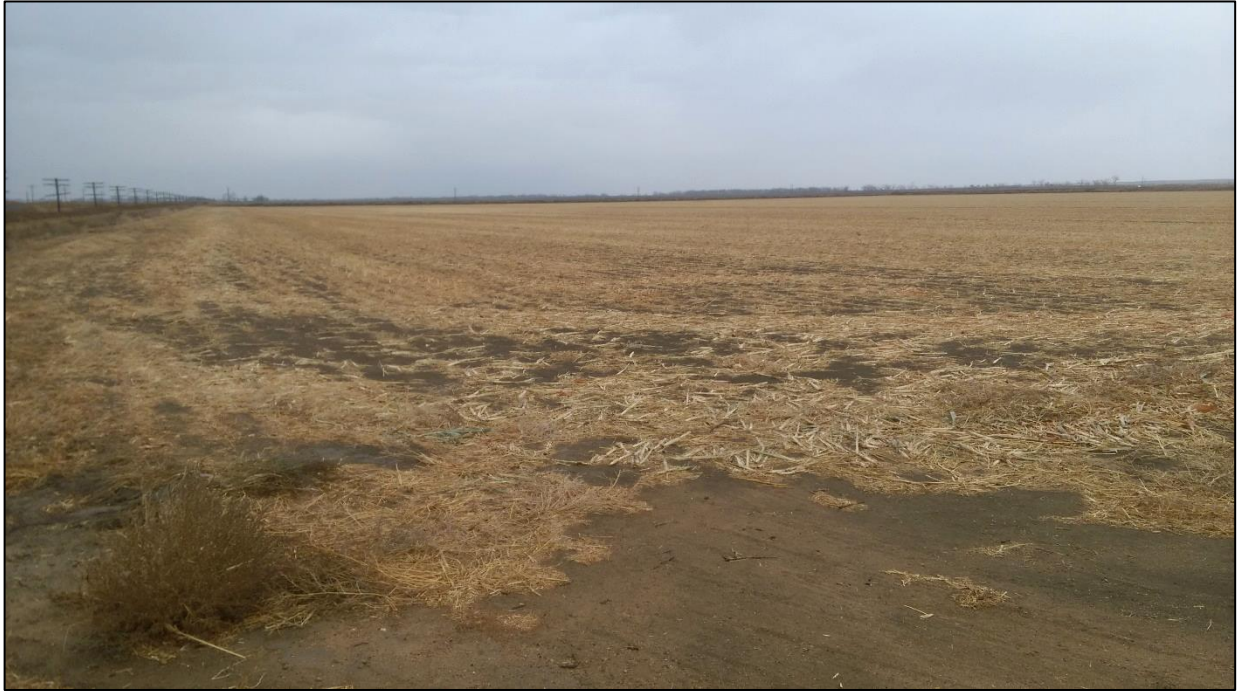
**Photo 17.** View looking east across agricultural land located northeast of eastern pond proposed in TR-05 as topsoil borrow area.

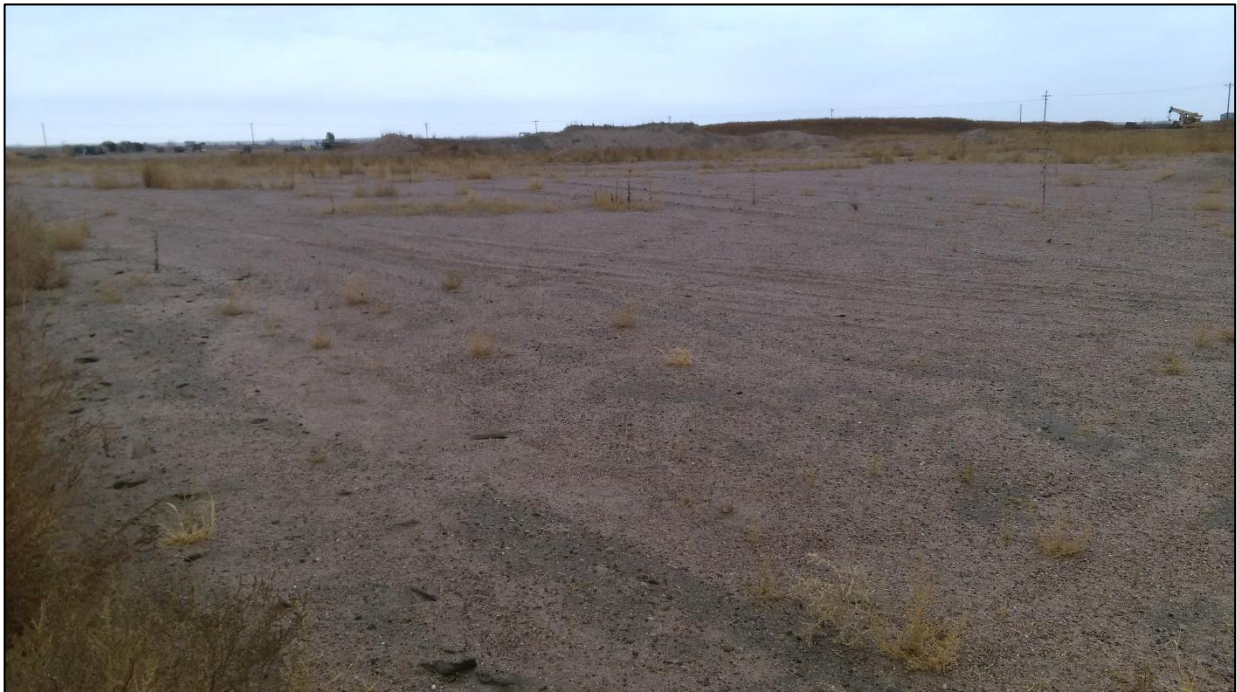
**Photo 18.** View looking southwest across area where large sand stockpile had been stored in central area, showing it has been removed from the site.

The Division inspected the central stockpiling and processing area located between the two ponds. This area is sandy and gravelly with some weedy vegetation present. The large sand stockpile that was present on site during the Division's last inspection (on 1/21/2015), estimated to consist of approximately 325,000 CY, has been removed from the site (**Photos 18-20**). According to the operator, this material was used to construct the new railroad overpass on Hwy 50 through a contract with CDOT. This activity was completed in 2015. The Division currently holds reclamation costs for removing this stockpile, which can be eliminated now that its removal has been verified. A few sand stockpiles remain in the central area (**Photos 21 and 22**), none as large as the stockpile that was removed. These stockpiles could be used to backfill pond shorelines and to achieve final reclamation grade in the central area. The Division also observed that the elevated conveyor which crossed the railroad tracks to the north had been demolished. Scraps from its demolition remained in the central area (**Photos 23 and 24**). The Division currently holds reclamation costs for demolishing this structure, which can be eliminated now that its demolition has been verified. The operator will need to specify in the adequacy response for TR-05 whether the scrap parts will be buried on site or removed from the site. If the parts will be buried on site, the operator will need to indicate on the revised reclamation plan map the proposed locations for burial.

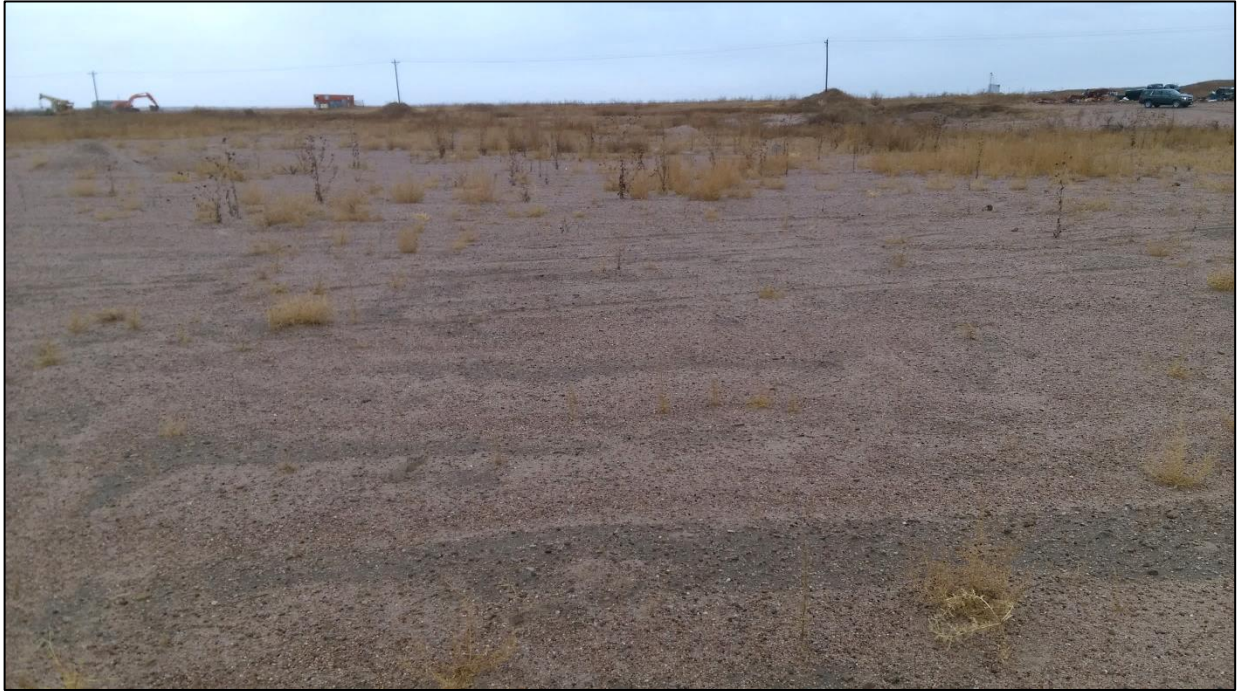
**Photo 19.** View looking west across area where large sand stockpile had been stored in central area, showing it has been removed from the site.

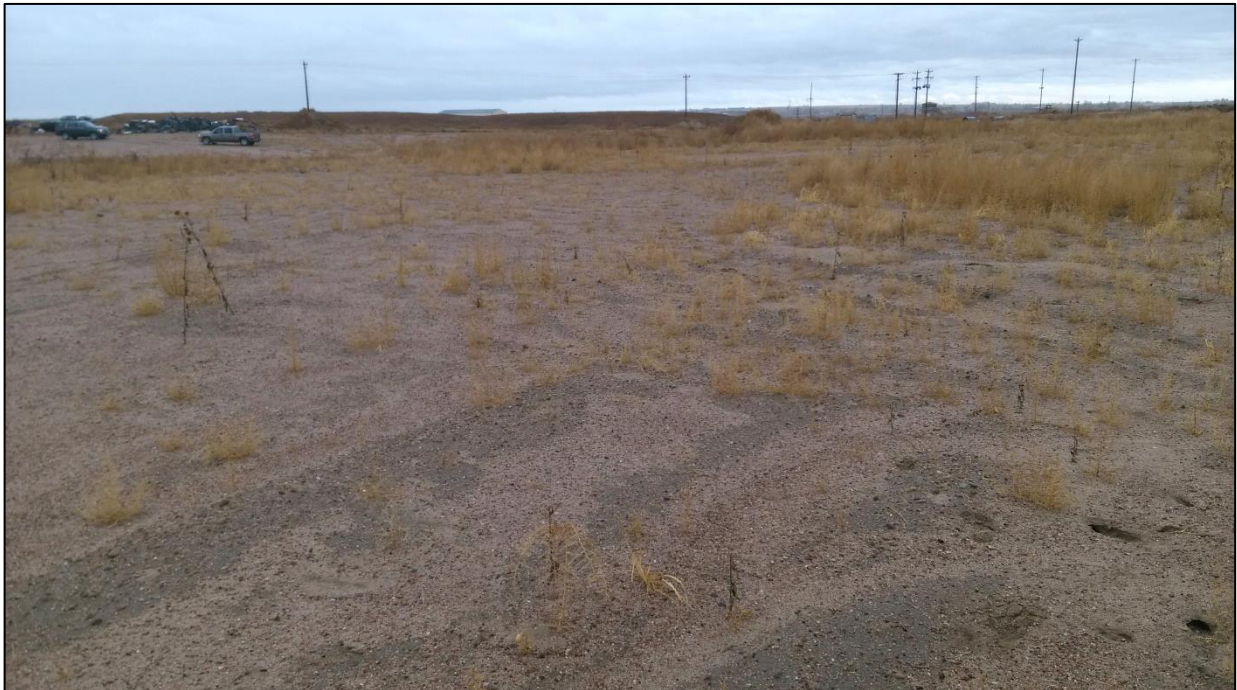
**Photo 20.** View looking northwest across area where large sand stockpile had been stored in central area, showing it has been removed from the site.

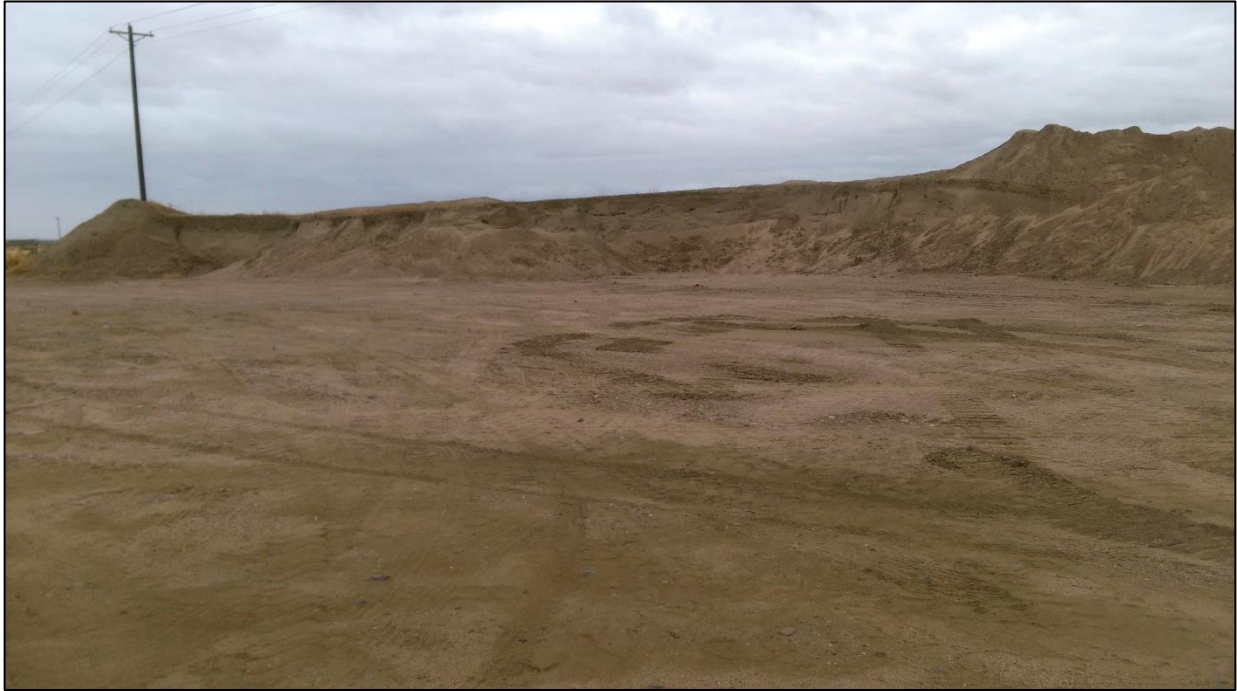
**Photo 21.** View of sand stockpile that remains on site in central stockpiling and processing area.

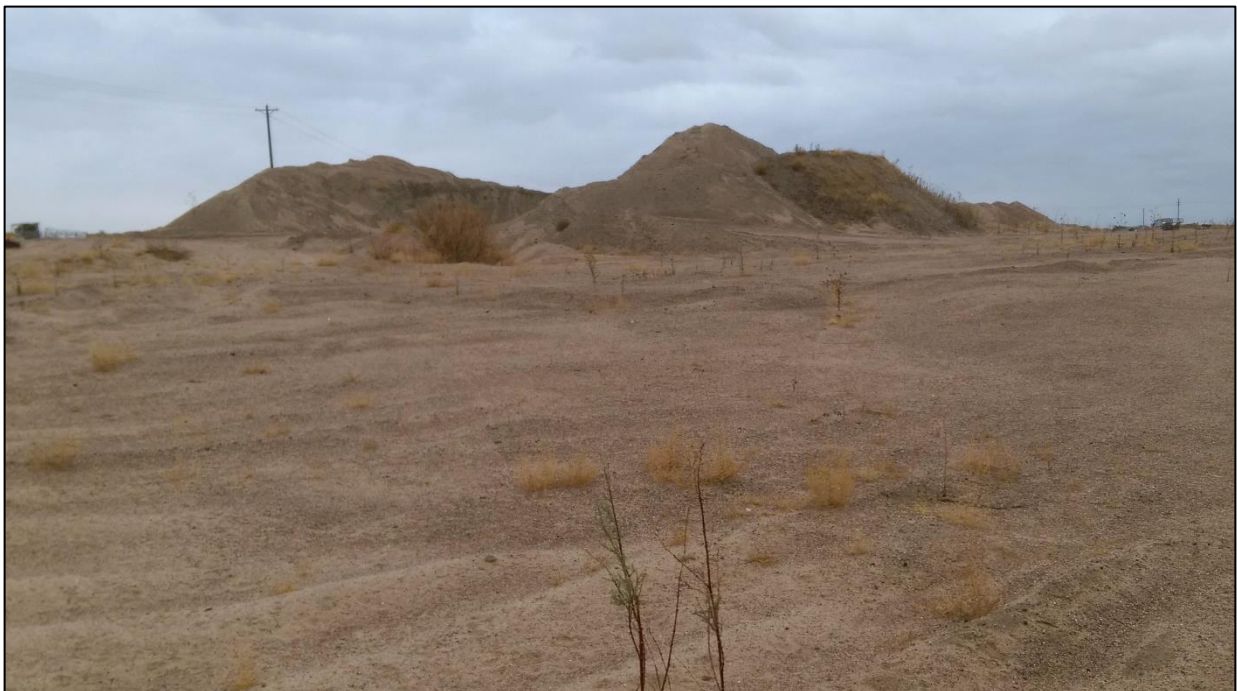
**Photo 22.** View of another sand stockpile that remains on site in central stockpiling and processing area.

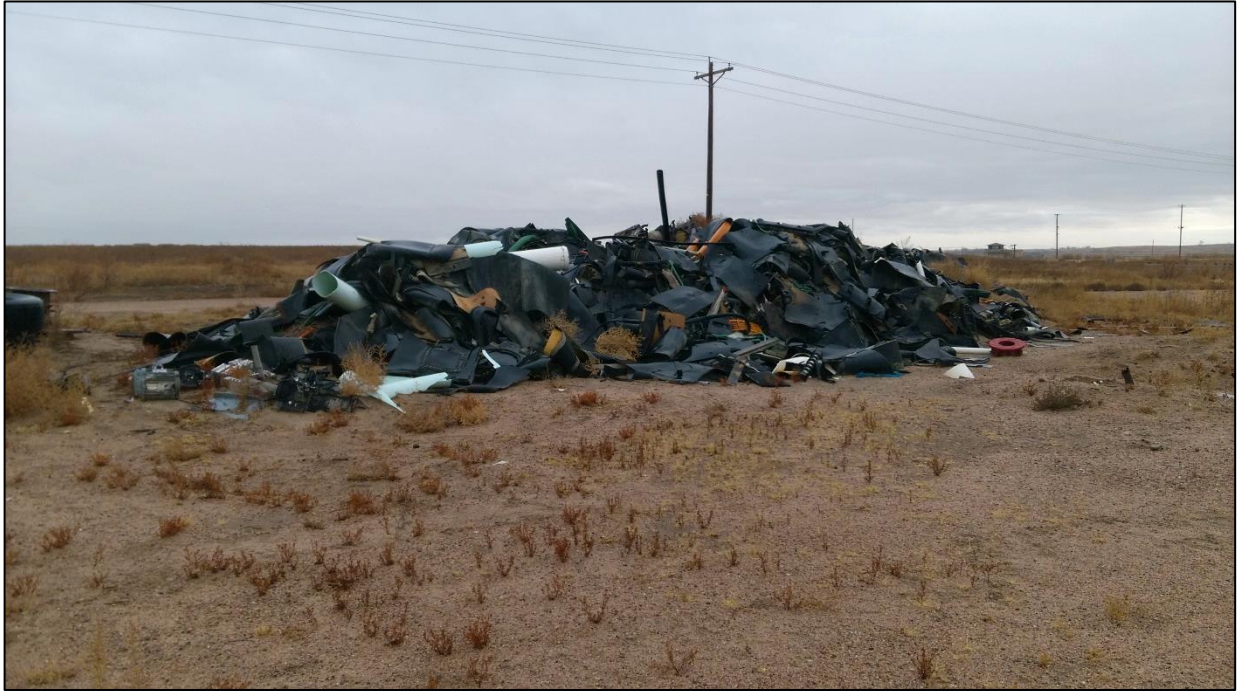
**Photo 23.** View of parts and scraps from demolished conveyor, stored in central stockpiling and processing area.

The Division observed that several pieces of equipment, hoses, pipes, and miscellaneous parts remain on site in the central area. The floating dredge remains on site, and is stored in the eastern pond (**Photo 25**). The main crusher has been dismantled. Three Caterpillar 773E haul trucks are being stored on site for use in reclamation (**Photo 26**). Mr. DePra indicated the operator brought the trucks in recently so that reclamation earthwork may be completed soon. According to TR-05, the operator intends to complete grading and soil preparation this winter, with cover crop seeding commencing as close to December 1, 2016 as possible. Permanent seeding is anticipated to be completed by June 15, 2017. In its adequacy review to TR-05, the Division points out that the suggested timetable is not consistent with either of the proposed cover crop methods and corresponding seed plans. The Division recommends the operator not rush implementation of the revegetation plan, but follow the appropriate timetable for greatest probability of success in plant establishment and development.
