## MINERALS PROGRAM INSPECTION REPORT

<b>MINE NAME:</b> Midwestern Farms	<b>MINE/PROSPECTING ID#:</b> M-1993-059	<b>MINERAL:</b> Sand and gravel	<b>COUNTY:</b> Prowers
<b>INSPECTION TYPE:</b> Monitoring	<b>INSPECTOR(S):</b> Amy Eschberger	<b>INSP. DATE:</b> November 22, 2016	<b>INSP. TIME:</b> 13:00
<b>OPERATOR:</b> Midwestern Farms	<b>OPERATOR REPRESENTATIVE:</b> Mel DePra	<b>TYPE OF OPERATION:</b> 112c - Construction Regular Operation	
<b>REASON FOR INSPECTION:</b> Normal I&E Program	<b>BOND CALCULATION TYPE:</b> Complete Bond	<b>BOND AMOUNT:</b> \$1,583,000.00	
<b>DATE OF COMPLAINT:</b> NA	<b>POST INSP. CONTACTS:</b> None	<b>JOINT INSP. AGENCY:</b> None	
<b>WEATHER:</b> Cold, windy, light rain	<b>INSPECTOR'S SIGNATURE:</b>

# M1993-059 / Midwestern Farms / Midwestern Farms

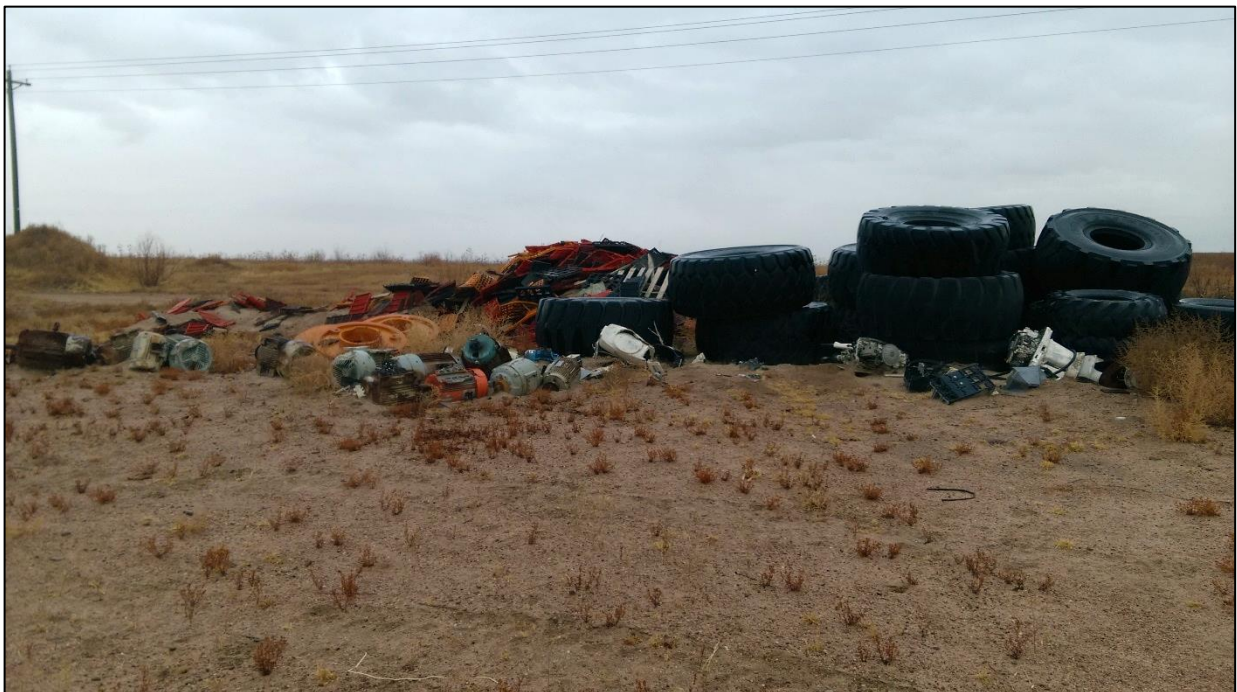
**Photo 24.** View of parts from demolished conveyor along with tires, stored in central stockpiling and processing area.

The Division observed that several pieces of equipment, hoses, pipes, and miscellaneous parts remain on site in the central area. The floating dredge remains on site, and is stored in the eastern pond (**Photo 25**). The main crusher has been dismantled. Three Caterpillar 773E haul trucks are being stored on site for use in reclamation (**Photo 26**). Mr. DePra indicated the operator brought the trucks in recently so that reclamation earthwork may be completed soon. According to TR-05, the operator intends to complete grading and soil preparation this winter, with cover crop seeding commencing as close to December 1, 2016 as possible. Permanent seeding is anticipated to be completed by June 15, 2017. In its adequacy review to TR-05, the Division points out that the suggested timetable is not consistent with either of the proposed cover crop methods and corresponding seed plans. The Division recommends the operator not rush implementation of the revegetation plan, but follow the appropriate timetable for greatest probability of success in plant establishment and development.

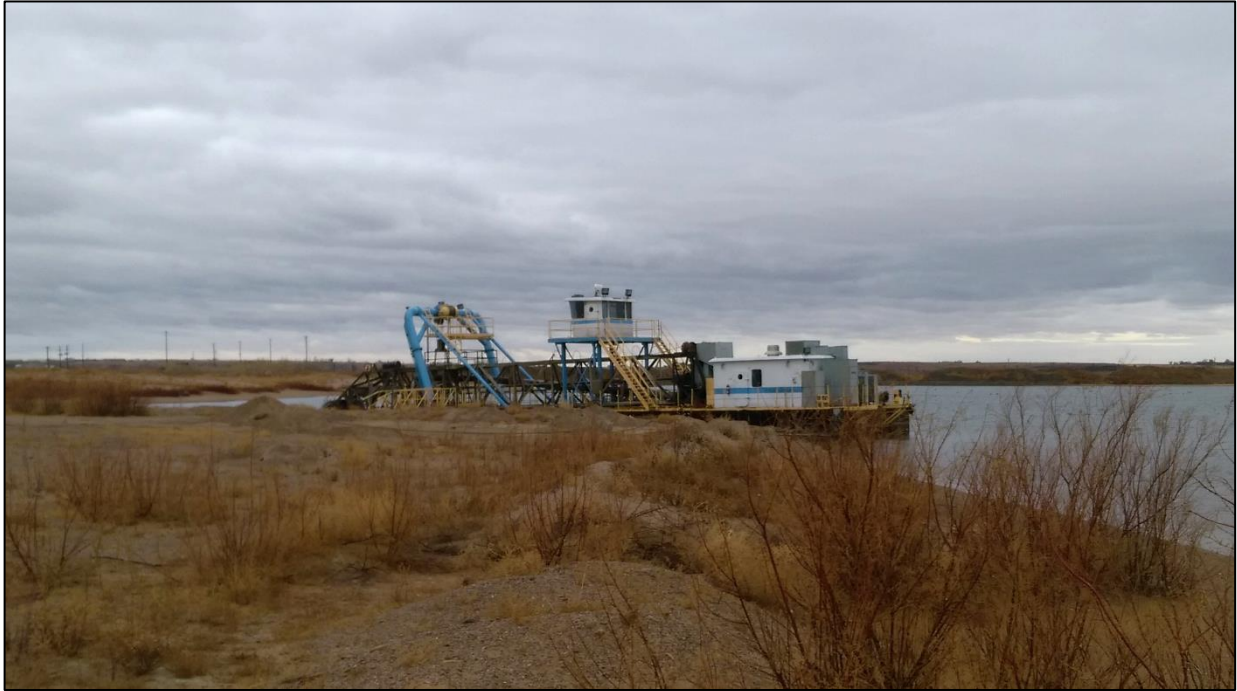
**Photo 25.** View of floating dredge that remains on site, stored in eastern pond.

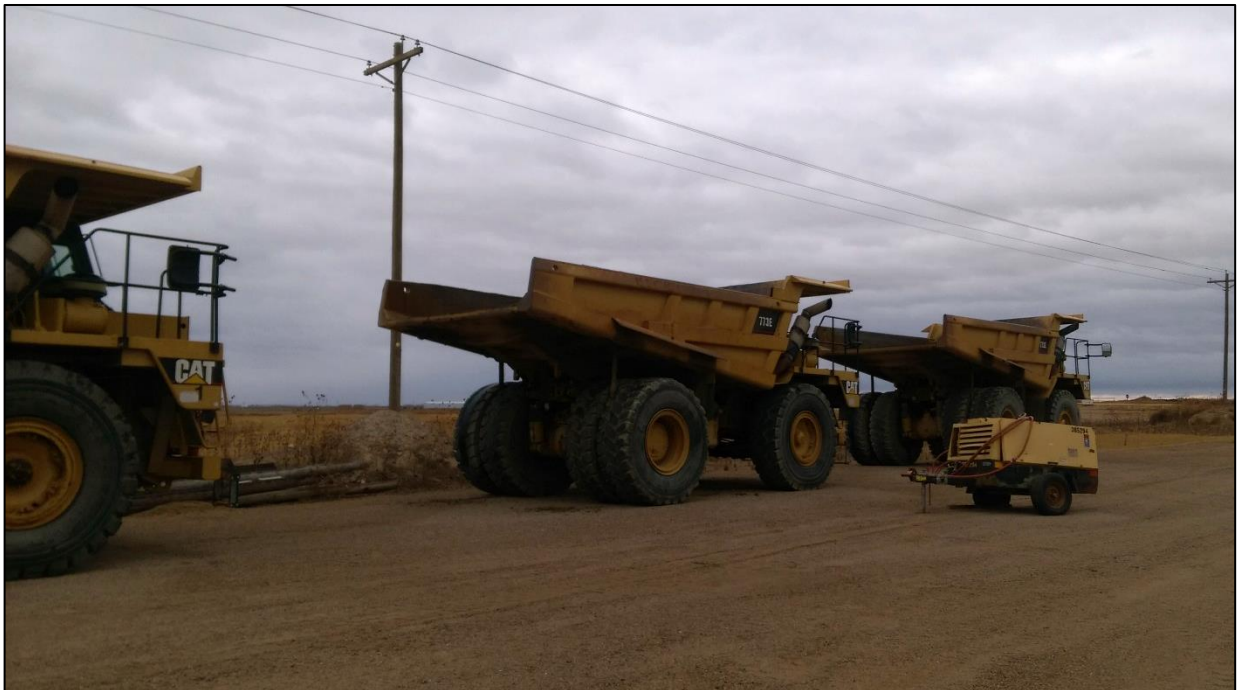
**Photo 26.** View of three Caterpillar 773E haul trucks stored on site for use in reclamation.

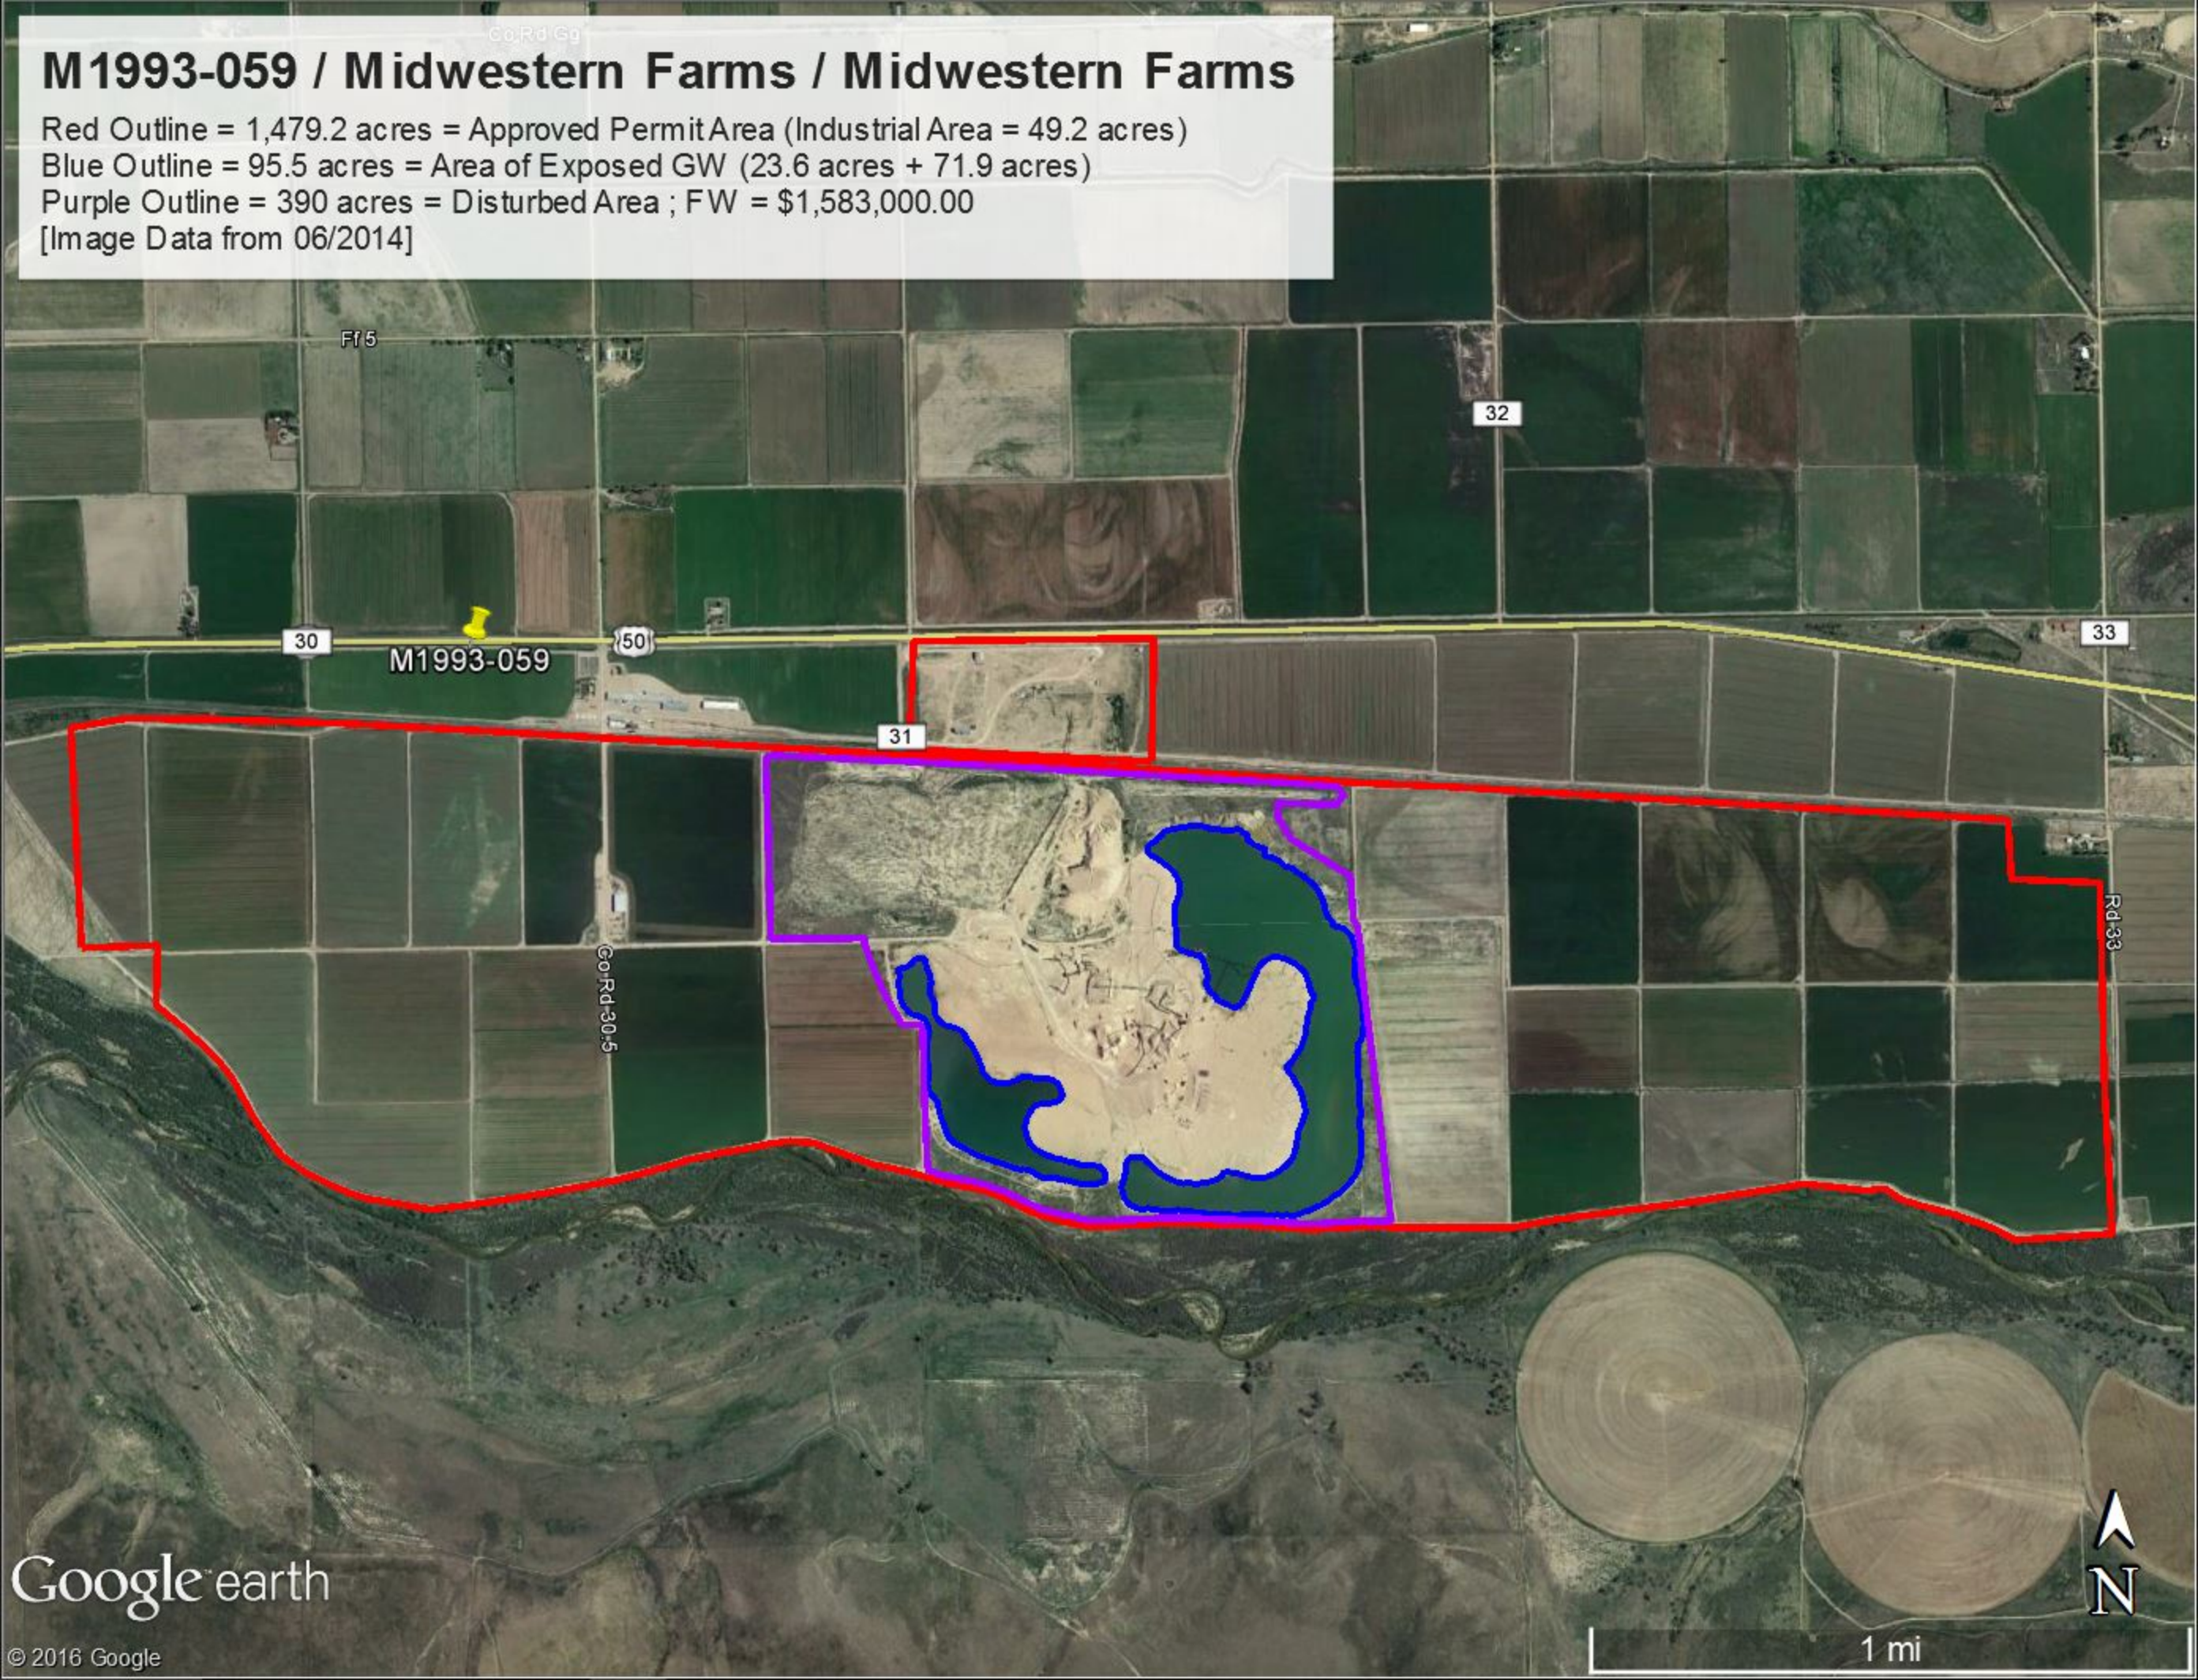
Red Outline = 1,479.2 acres = Approved Permit Area (Industrial Area = 49.2 acres)  
Blue Outline = 95.5 acres = Area of Exposed GW (23.6 acres + 71.9 acres)  
Purple Outline = 390 acres = Disturbed Area ; FW = \$1,583,000.00  
[Image Data from 06/2014]

This is a 112c operation permitted for 1,479.2 acres (see enclosed Google Earth image of site) to mine sand and gravel via the floating suction dredge method to maximum depths of 60 feet. The maximum allowed disturbed acreage at any time is 390 acres, as approved in Revision No. TR-03 on March 02, 2015. A surety increase was issued in 2014 to account for 245 acres of disturbance more than what was approved at that time, and included the removal of a large sand stockpile stored on site. The approved mining plan calls for mining in six major phases, with concurrent reclamation to occur. The approved reclamation plan calls for leaving two ponds per mined phase, each approximately 10-15 acres in size, with a 40 foot wide shallow shelf area (wetlands) created along the shoreline of each pond at 6H:1V slopes. The approved post-mining land use is industrial/commercial for 49.2 acres located north of the railroad tracks, general agriculture (dryland farmland) for 64.2 acres disturbed south of the railroad tracks, wildlife habitat and recreation for the pond areas, and rangeland for the remainder of the site.

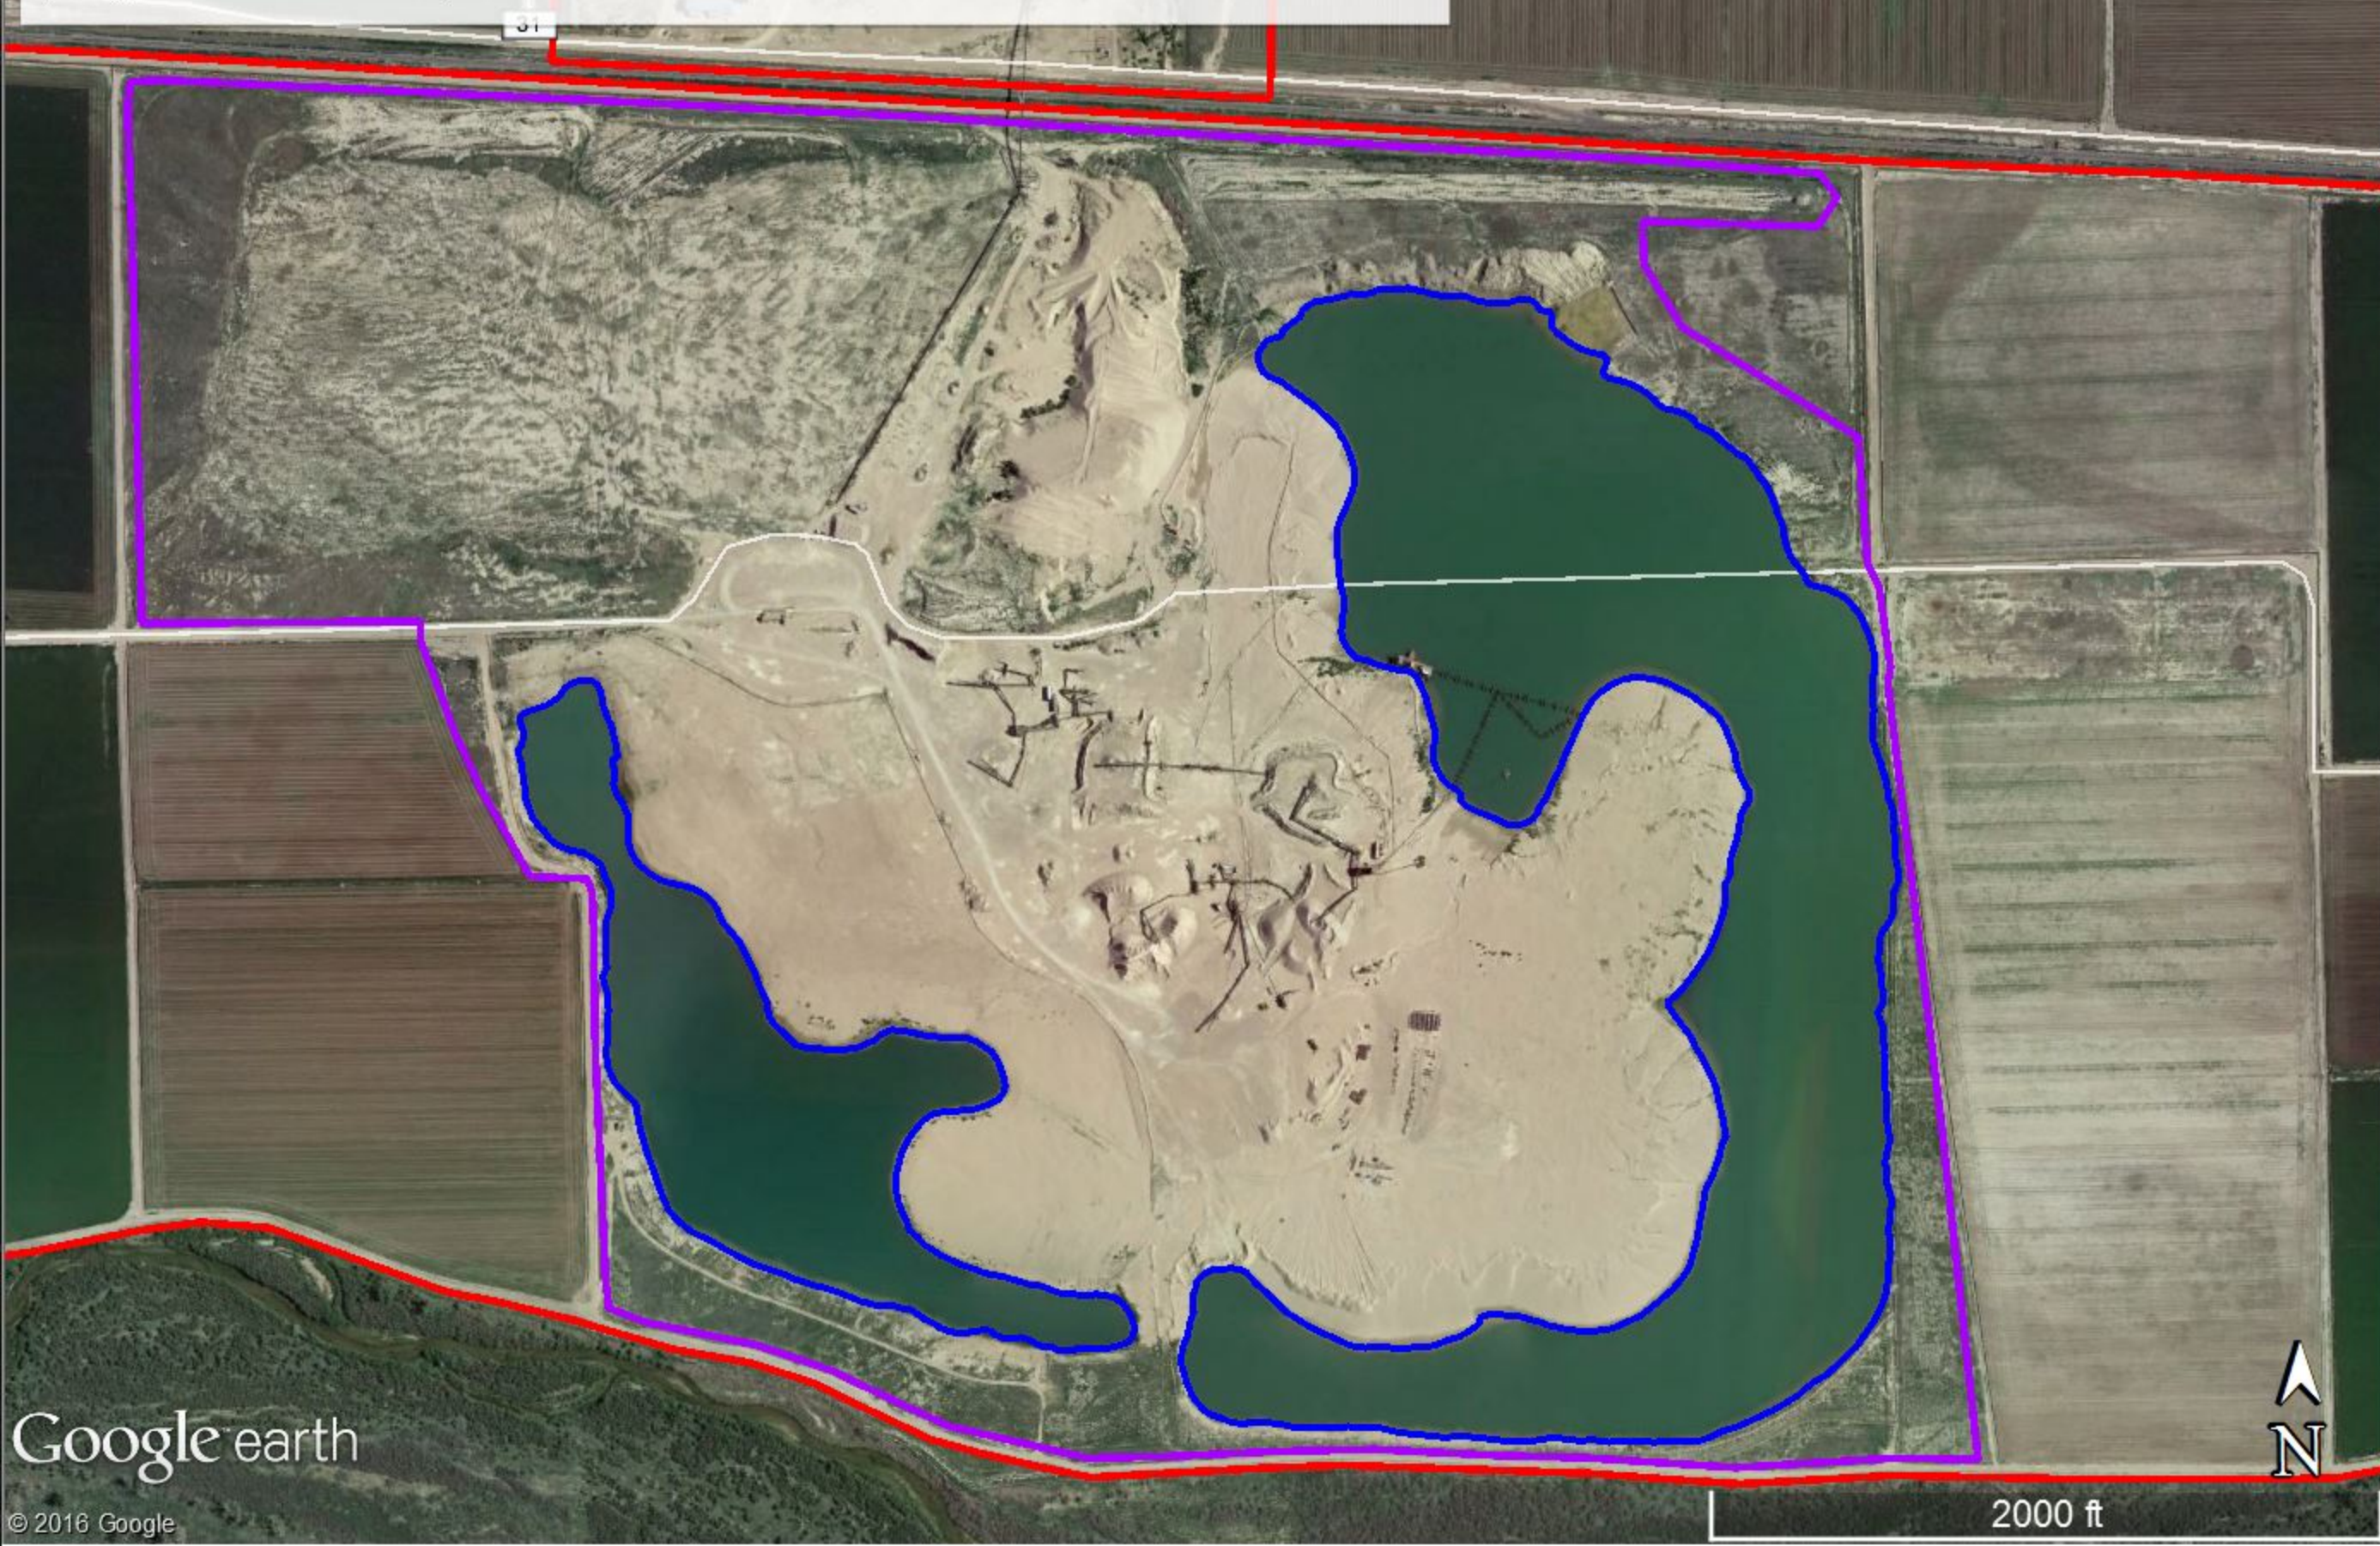
# M1993-059 / Midwestern Farms / Midwestern Farms

Red Outline = 1,479.2 acres = Approved Permit Area (Industrial Area = 49.2 acres)

Blue Outline = 95.5 acres = Area of Exposed GW (23.6 acres + 71.9 acres)

Purple Outline = 390 acres = Disturbed Area ; FW = \$1,583,000.00

During the inspection, the Division first observed the western pond, which is approximately 23.6 acres in surface area (**see enclosed Google Earth image of disturbed area**). This pond has been designated as a state wildlife area by CPW, where public fishing is allowed. The shoreline of this pond has slope gradients of mainly 3H:1V or flatter (**Photos 2-5**). The slope gradients below water line are undetermined. The Division was unable to observe slopes below water line during the inspection due to wave action in the ponds. The western and southern shorelines are well vegetated with native grasses, forbs, and some annual weeds (e.g., Russian thistle, wild sunflowers), and appeared to be stable (**Photos 6 and 7**). The eastern shoreline is flatter and remains sandy with no vegetative cover. Although the map that was submitted with TR-05 is difficult to read, it appears the operator is proposing to leave a portion of the eastern shoreline sandy for use by migratory birds (per CPW's recommendation).
