**COLORADO**Division of Reclamation,
Mining and Safety

MINERALS PROGRAM INSPECTION REPORT**PHONE: (303) 866-3567**

MINE NAME: Peck Pit	MINE/PROSPECTING ID#: M-1992-049	MINERAL: Gravel	COUNTY: Ouray
INSPECTION TYPE: Monitoring	INSPECTOR(S): Travis H. Marshall	INSP. DATE: March 8, 2017	INSP. TIME: 11:30
OPERATOR: Vista Verde Village, LLC.	OPERATOR REPRESENTATIVE: NA	TYPE OF OPERATION: 110c - Construction Limited Impact

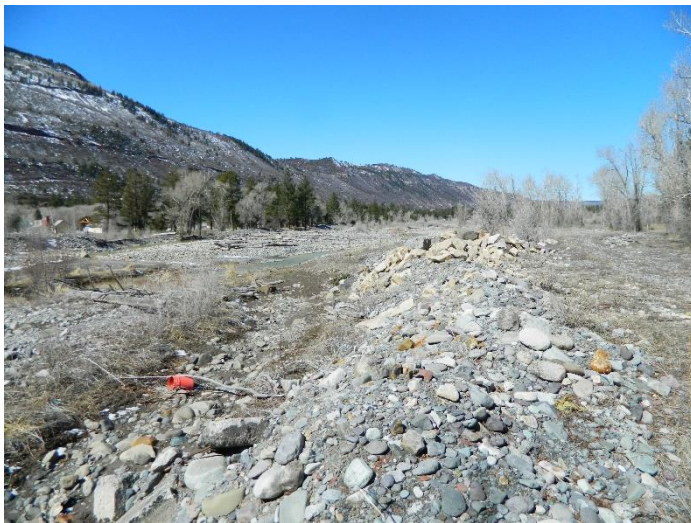
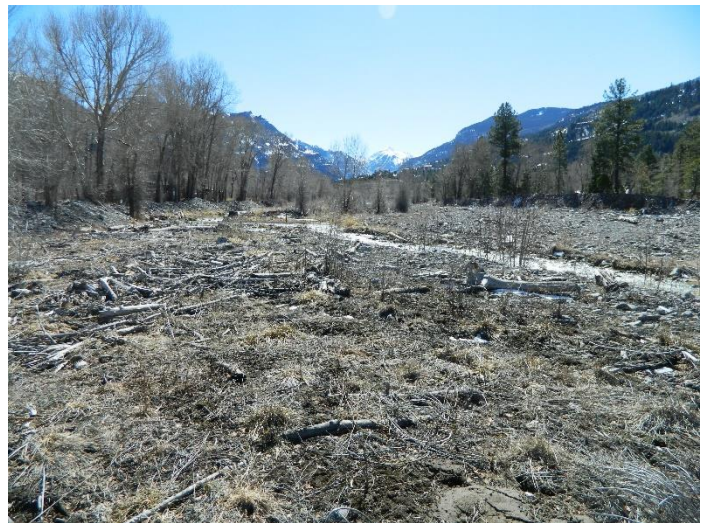
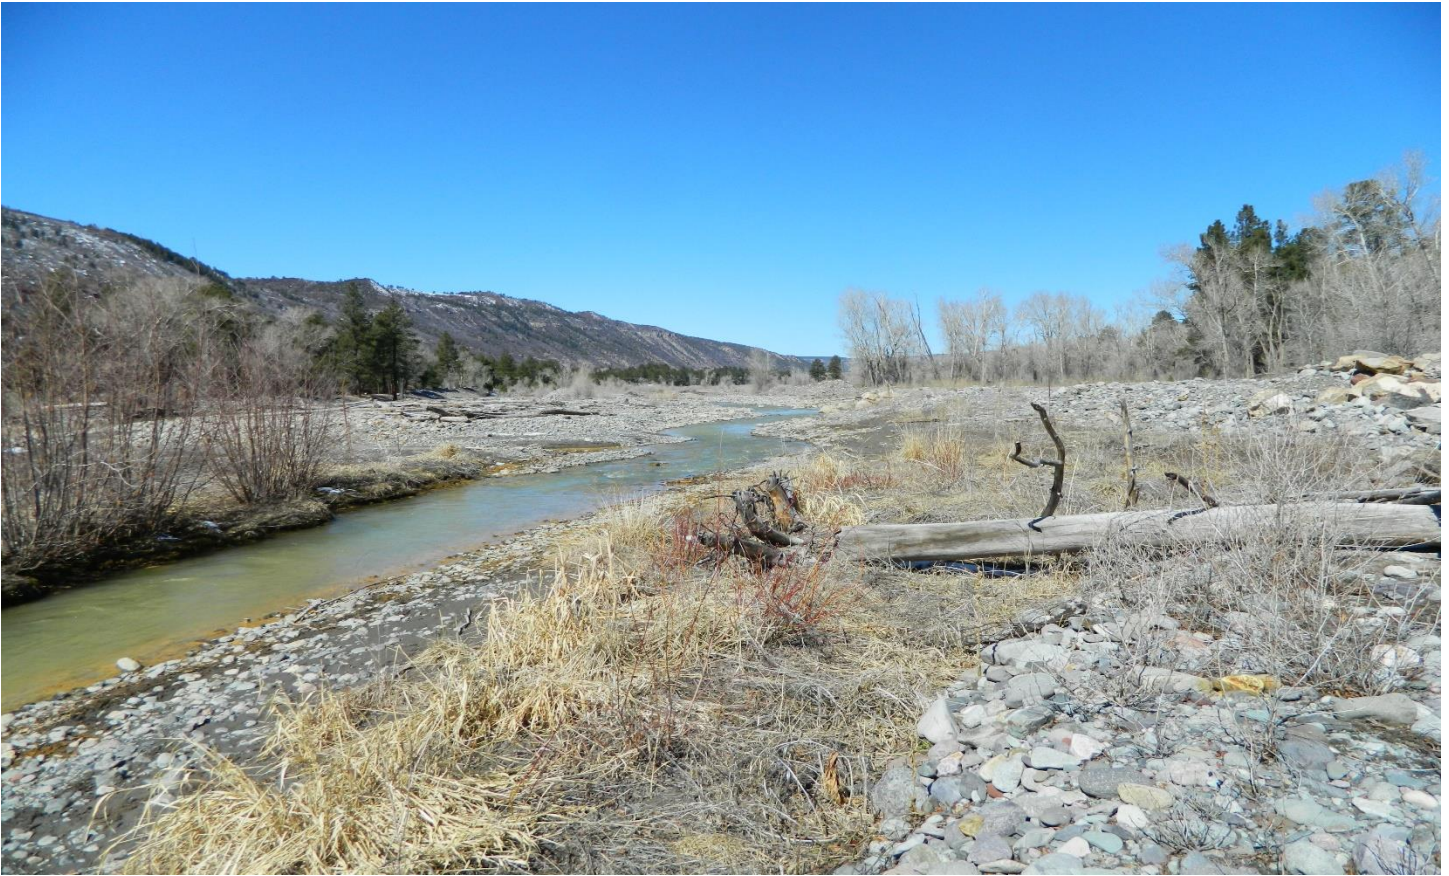
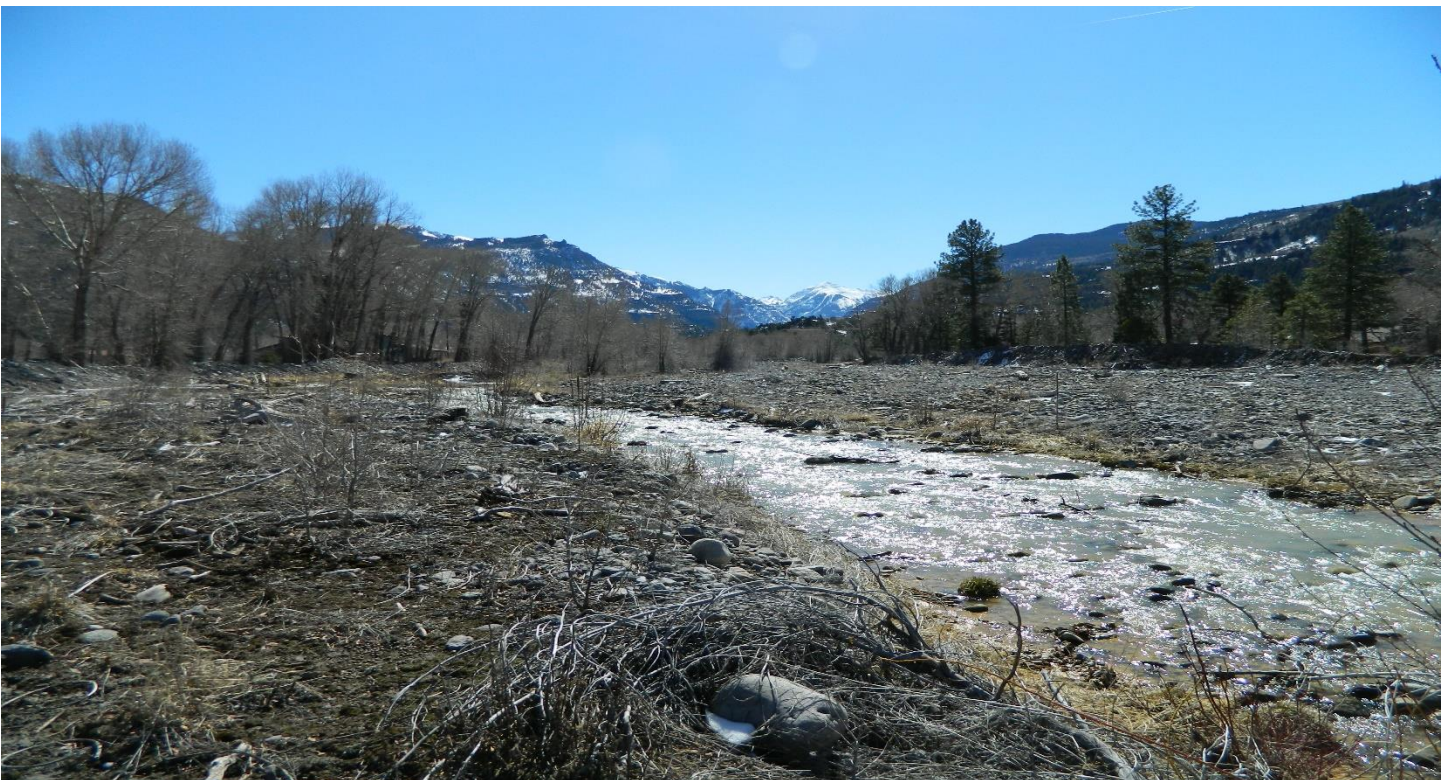
PHOTOGRAPHS

The mine site has yet to be active. No mining related disturbance was observed during the inspection. The currently held reclamation bond of \$3,000.00 is considered sufficient to ensure reclamation.

Neither a mine identification sign nor permit boundary markers were observed during the inspection. In order to bring the site in compliance with Rule 3.1.12 the operator must post a mine identification sign at the main entrance and permit boundary markers clearly delineating the permit boundary. The lack of sign and permit boundary markers is considered a problem at this time. In order to avoid enforcement action photo-documentation of the mine sign and permit boundary markers must be submitted to this office no later than April 28, 2017.

Photos that show the conditions observed on March 8, 2017 are included with this report.

CORRECTIVE ACTIONS: The operator must post a sign at the entrance to the mine site which shall be clearly visible from the access road and specify the following; the name of the operator, indicate that a reclamation permit for the operation has been issued by the Colorado Mined Land Reclamation Board, and the permit number. The boundaries of the affected area must be marked by monuments or other markers that are clearly visible and adequate to delineate such boundaries.
