**COLORADO**Division of Reclamation,  
Mining and Safety

**MINERALS PROGRAM INSPECTION REPORT****PHONE: (303) 866-3567**

<b>MINE NAME:</b> North R-34 Pit	<b>MINE/PROSPECTING ID#:</b> M-1996-008	<b>MINERAL:</b> Sand and gravel	<b>COUNTY:</b> Montrose
<b>INSPECTION TYPE:</b> Monitoring	<b>INSPECTOR(S):</b> Dustin M. Czapla	<b>INSP. DATE:</b> March 16, 2017	<b>INSP. TIME:</b> 11:15
<b>OPERATOR:</b> Western Gravel, Inc.	<b>OPERATOR REPRESENTATIVE:</b> Shauna Hovey	<b>TYPE OF OPERATION:</b> 112c - Construction Regular Operation

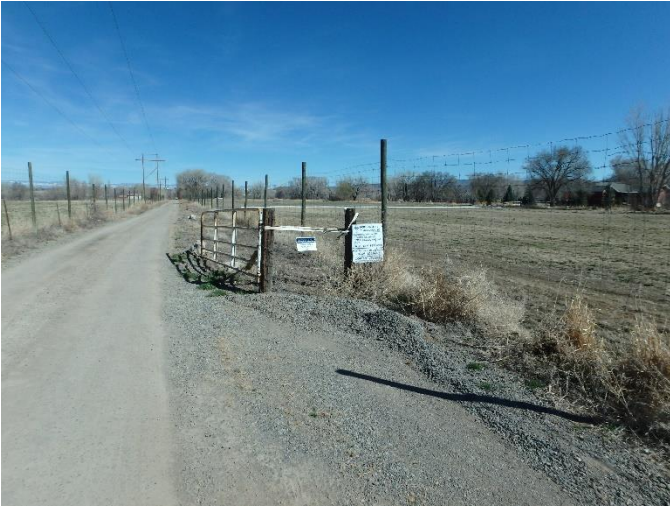
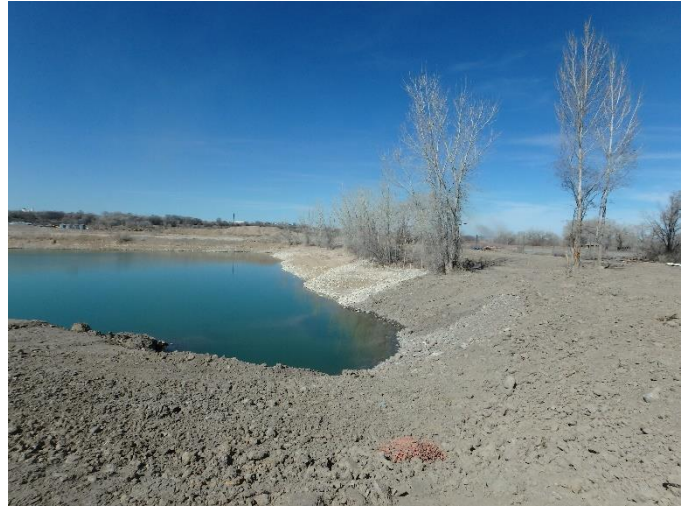
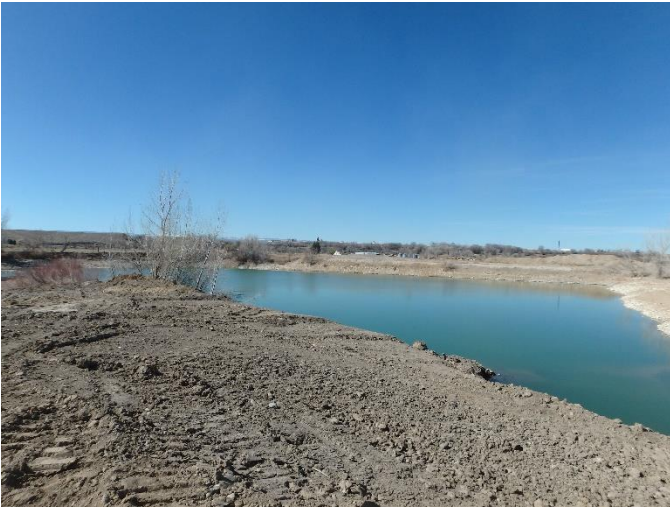
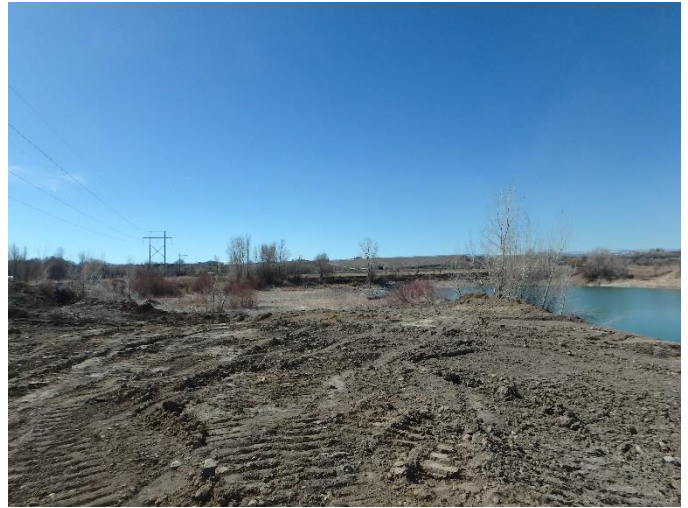
## **PHOTOGRAPHS**

Disturbance is still contained within the Phase 1 area. The pond includes approximately 2.5 acres. The slopes are left at approximately 2H:1V. Approximately two acres are disturbed on the west side of the pond where stripping and stockpiling have occurred.

Adequate mine identification signage was noted at the entrance to the site.

The affected area was marked by fencing and posts that was clearly visible and adequate to delineate the affected area boundary.
