**MINERALS PROGRAM INSPECTION REPORT****PHONE: (303) 866-3567**

<b>MINE NAME:</b> Newett Quarry	<b>MINE/PROSPECTING ID#:</b> M-1978-093	<b>MINERAL:</b> Limestone (general)	<b>COUNTY:</b> Chaffee
<b>INSPECTION TYPE:</b> Monitoring	<b>INSPECTOR(S):</b> Dustin M. Czapla	<b>INSP. DATE:</b> April 19, 2017	<b>INSP. TIME:</b> 12:00
<b>OPERATOR:</b> Colorado Lien Company	<b>OPERATOR REPRESENTATIVE:</b> Rob Kisner	<b>TYPE OF OPERATION:</b> 112c - Construction Regular Operation

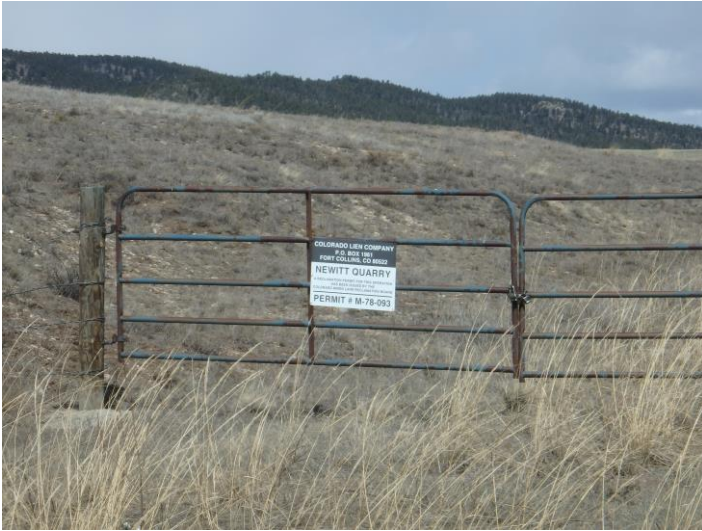
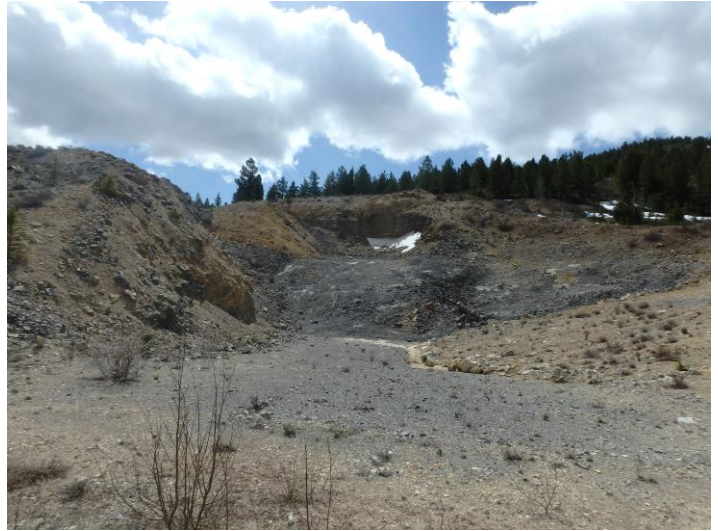
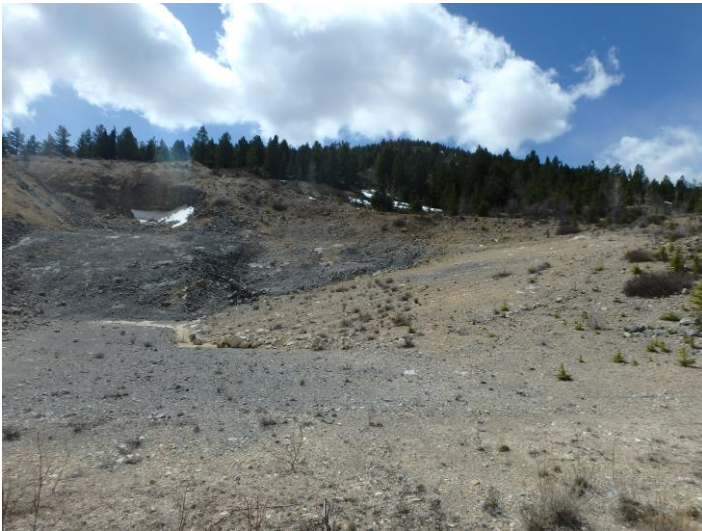
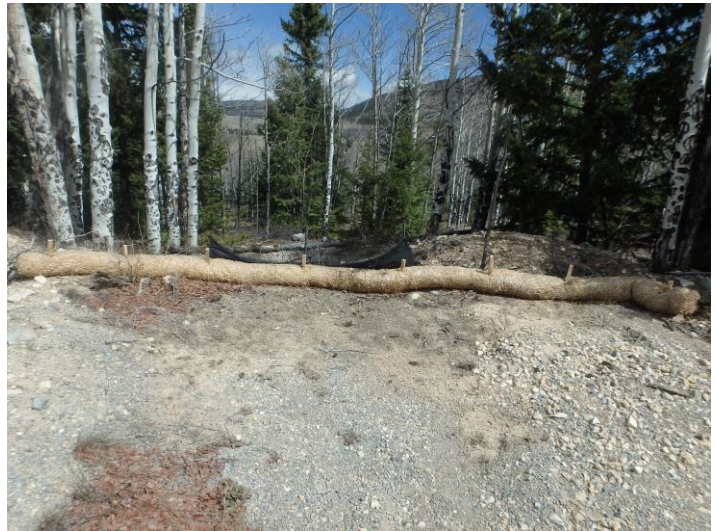
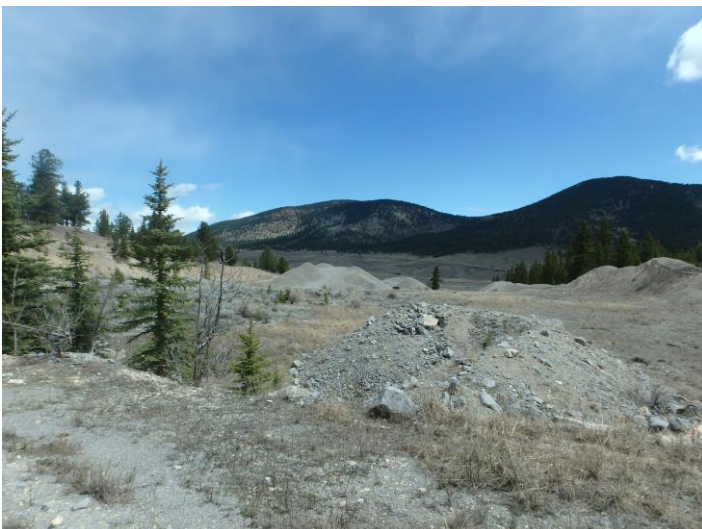
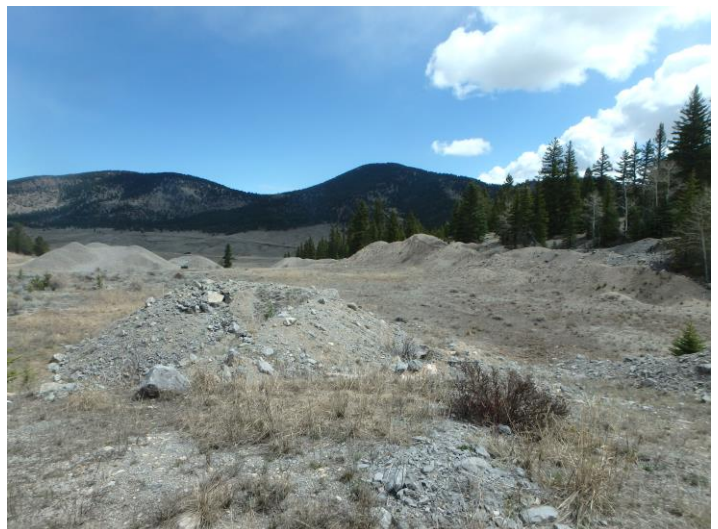
## PHOTOGRAPHS

Adequate mine identification signage was noted at the entrance to the site.

The affected area was marked by posts that were clearly visible and adequate to delineate the affected area boundary.

Several stockpiles of crushed limestone are still located in the stockpile area. No other equipment or materials are located at the site.

Some reclamation grading in mining area B took place years ago. There has been no change since the 2013 when the Division last inspected the site. A vertical highwall still exists in this area.

Although there has been no mining activity, the stormwater controls have been maintained at the site. Straw wattles and newer silt fences were noted in several areas.
