**COLORADO**  
Division of Reclamation,  
Mining and Safety  
Department of Natural Resources

| <b>Permit Number:</b> C-2010-089<br><b>Mine Name:</b> New Horizon North Mine<br><b>Operator:</b> Elk Ridge Mining and Reclamation, LLC<br><b>Operator Address:</b><br>Mr. Tony Tennyson<br>5731 State Highway 13<br>Meeker, CO 81641 | <b>County:</b> Montrose<br><b>Operation Type:</b> Surface<br><b>Permit Status:</b> Active<br><b>Ownership:</b> Private |

| <b>Inspection Start Date:</b> May 2, 2017<br><b>Inspection Start Time:</b> 08:00<br><b>Inspection End Date:</b> May 2, 2017<br><b>Inspection End Time:</b> 12:00 | | <b>Inspection Type:</b> Coal Complete Inspection<br><b>Inspection Reason:</b> Normal I&E Program<br><b>Weather:</b> Cloudy | |

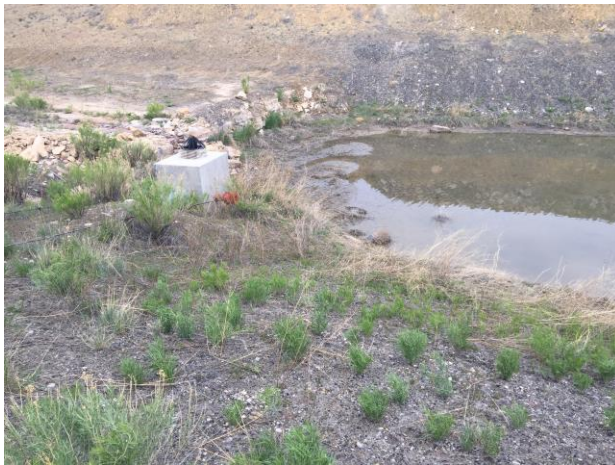
Photo 1 – Pond 001 Primary Spillway

Pond 001 contained water but was not discharging. Water was not being pumped into Pond 001 from the pit. The primary spillway (photo 1), emergency spillway and discharge flume were free and clear of obstructions. The west ditch was in good condition (photo 2). The east ditch was recently cleaned to remove tumble weeds.

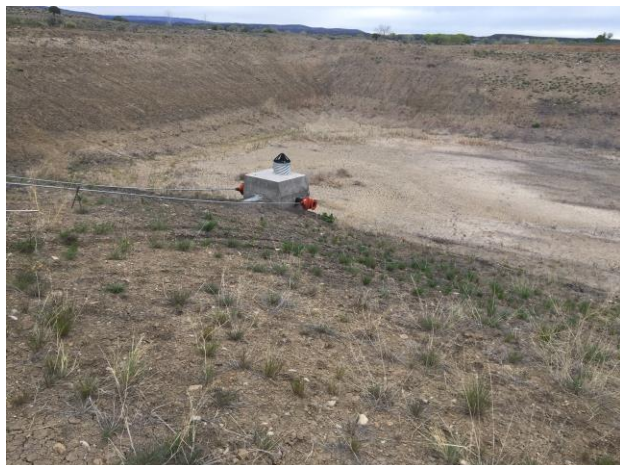
Photo 3 – Pond 002 – Primary Spillway

Pond 002 did not contain water. The primary (photo 3) and emergency spillways were free and clear of obstructions. The north ditch was in good condition.

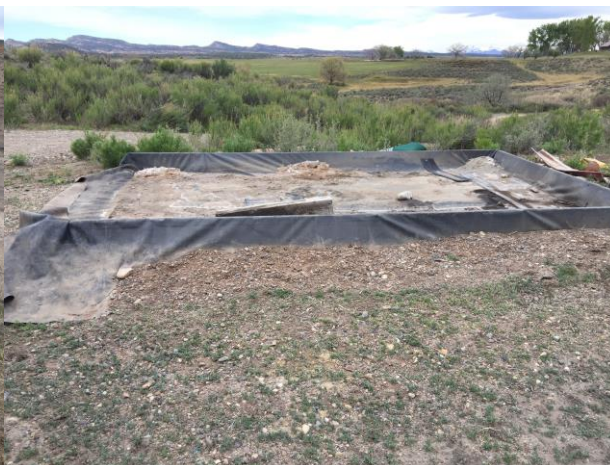
Photo 4 – Pond NH1 Pump Station

The water pump at NH1 Pond had been removed. The spill containment structure was in place (photo 4).

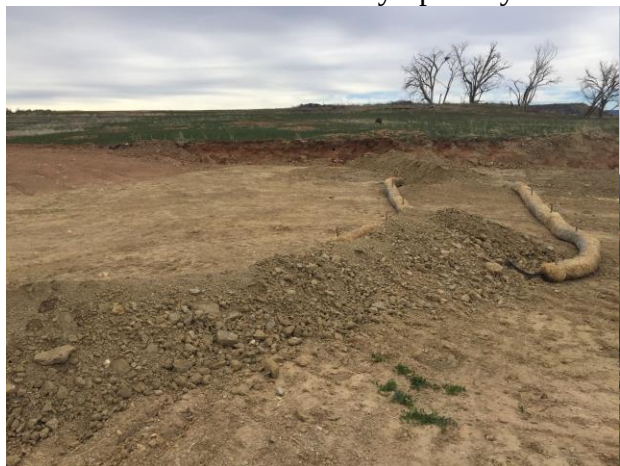
Photo 5 – End of Pond 002 North Ditch

A berm and wattles were set up in the Pond 002 north ditch where the backfill and topsoiling stopped (photo 5). This will prevent topsoil from being lost during a rain event.

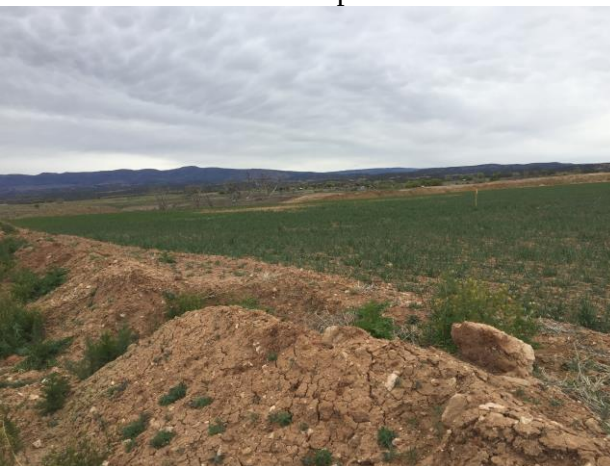
Photo 6 – Replaced Topsoil SW of Pit

The vegetation on the replaced topsoil southwest of the mine pit was beginning to sprout (photo 6). This topsoil was live hauled from in front of the pit over the last several years and was planted with a cover crop.
