**MINERALS PROGRAM INSPECTION REPORT****PHONE: (303) 866-3567**

<b>MINE NAME:</b> Porco Pit	<b>MINE/PROSPECTING ID#:</b> M-2004-042	<b>MINERAL:</b> Aggregate	<b>COUNTY:</b> Conejos
<b>INSPECTION TYPE:</b> Monitoring	<b>INSPECTOR(S):</b> Dustin M. Czapla	<b>INSP. DATE:</b> May 15, 2017	<b>INSP. TIME:</b> 14:00
<b>OPERATOR:</b> Ralph Porco, Randy Porco	<b>OPERATOR REPRESENTATIVE:</b> None	<b>TYPE OF OPERATION:</b> 110c - Construction Limited Impact

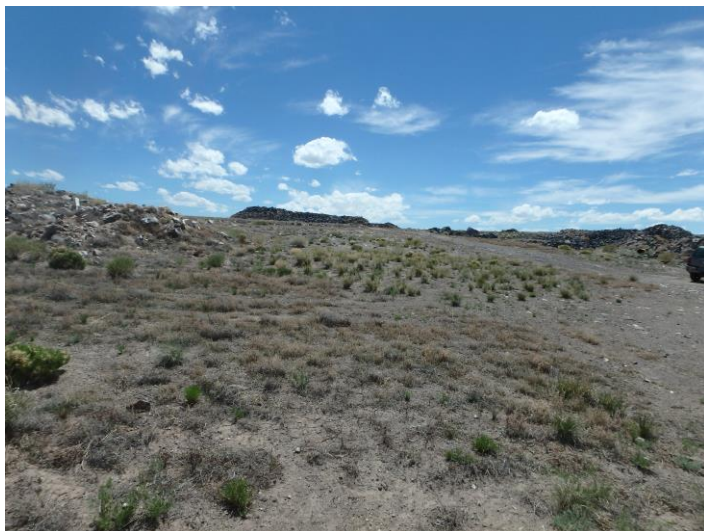
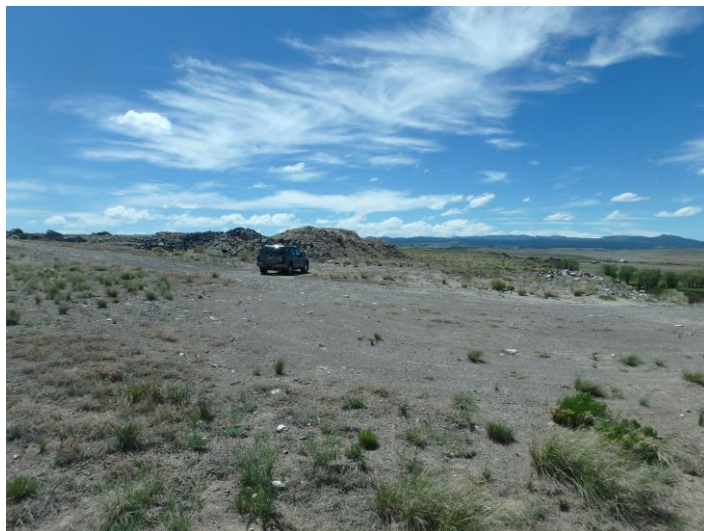
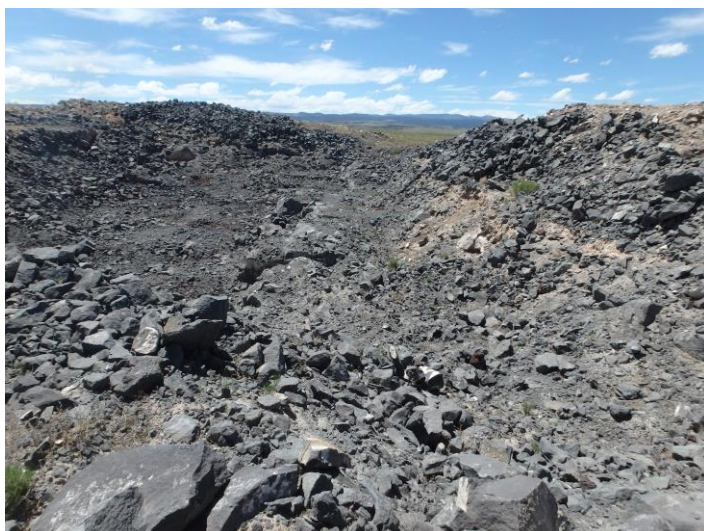
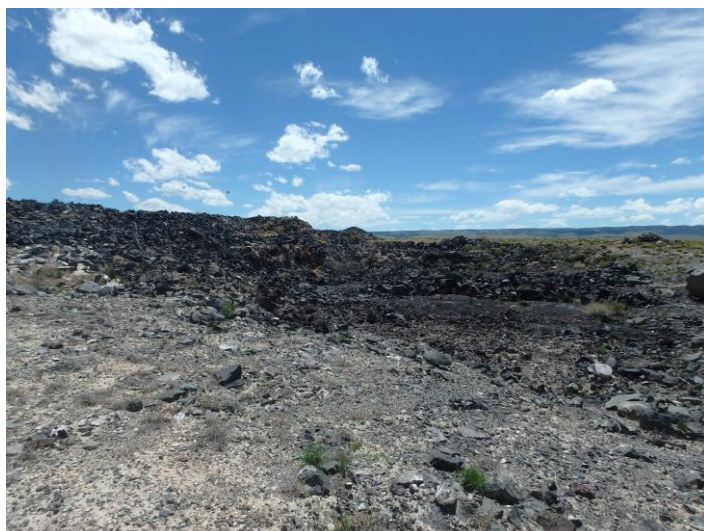
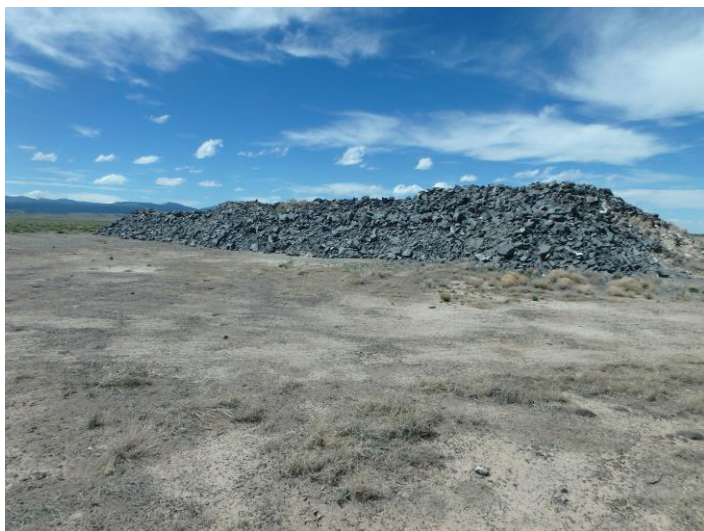
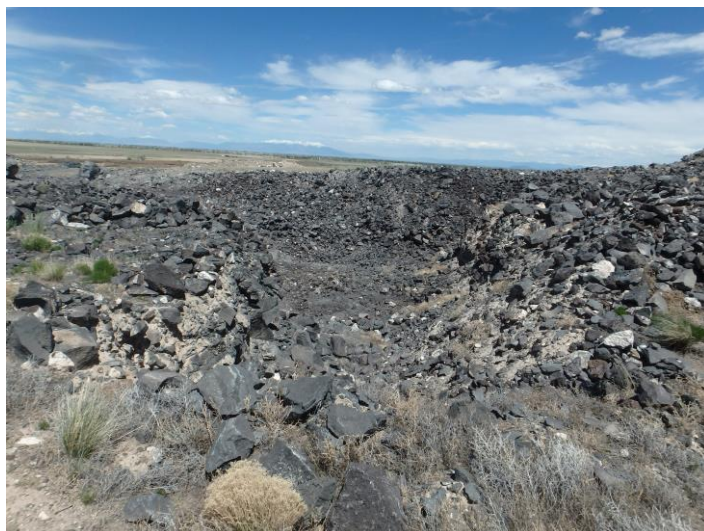
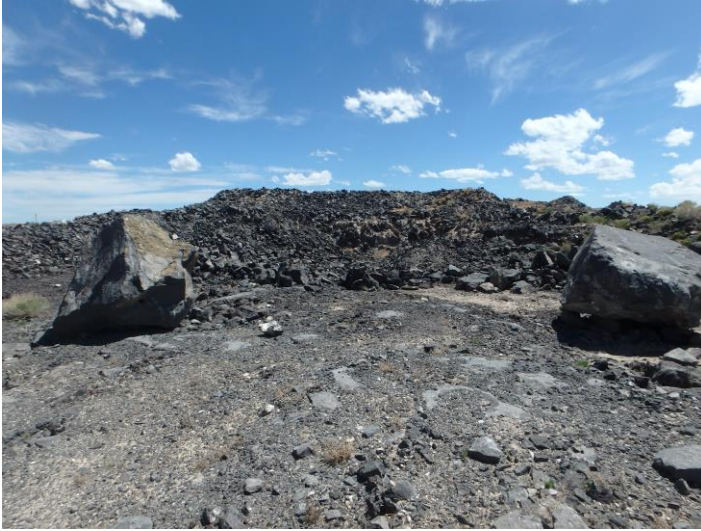
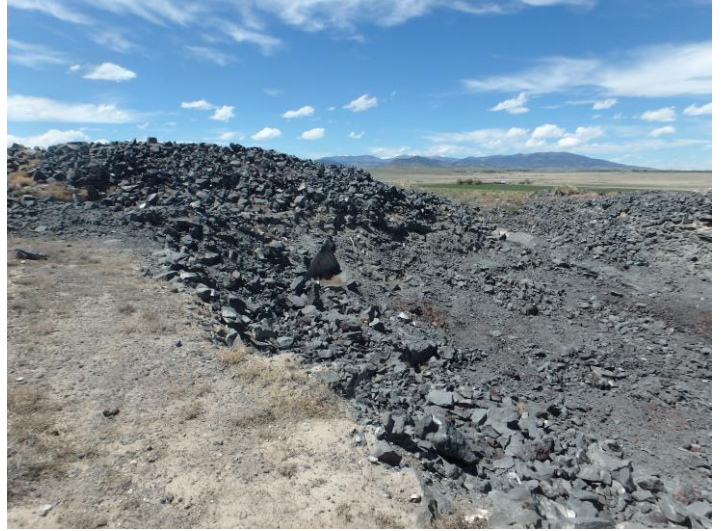
Adequate mine identification signage was not noted at the entrance to the site. This is listed as a problem on page one of this report.

The permit boundary was not clearly marked. This is listed as a problem on page one of this report.

The pit area currently covers approximately two acres. The pit is located in a basalt outcrop on top of a flat mesa. The dig areas are approximately 10 feet deep. No stability issues or erosion concerns were noted.

**CORRECTIVE ACTIONS:** The operator must post a sign at the entrance to the mine site which shall be clearly visible from the access road and specify the following; the name of the operator, indicate that a reclamation permit for the operation has been issued by the Colorado Mined Land Reclamation Board, and the permit number. The boundaries of the affected area must be marked by monuments or other markers that are clearly visible and adequate to delineate such boundaries.
