MINERALS PROGRAM INSPECTION REPORT

MINE NAME: Thomeczek Pit	MINE/PROSPECTING ID#: M-1995-007	MINERAL: Sand and gravel	COUNTY: Bent
INSPECTION TYPE: Monitoring	INSPECTOR(S): Amy Eschberger	INSP. DATE: May 12, 2017	INSP. TIME: 09:00
OPERATOR: Bent County	OPERATOR REPRESENTATIVE: Calvin Feik	TYPE OF OPERATION: 110c - Construction Limited Impact	
REASON FOR INSPECTION: Normal I&E Program	BOND CALCULATION TYPE: NA	BOND AMOUNT: NA	
DATE OF COMPLAINT: NA	POST INSP. CONTACTS: None	JOINT INSP. AGENCY: None	
WEATHER: Clear	INSPECTOR'S SIGNATURE:

M1995-007 / Thomeczek Pit / Bent County

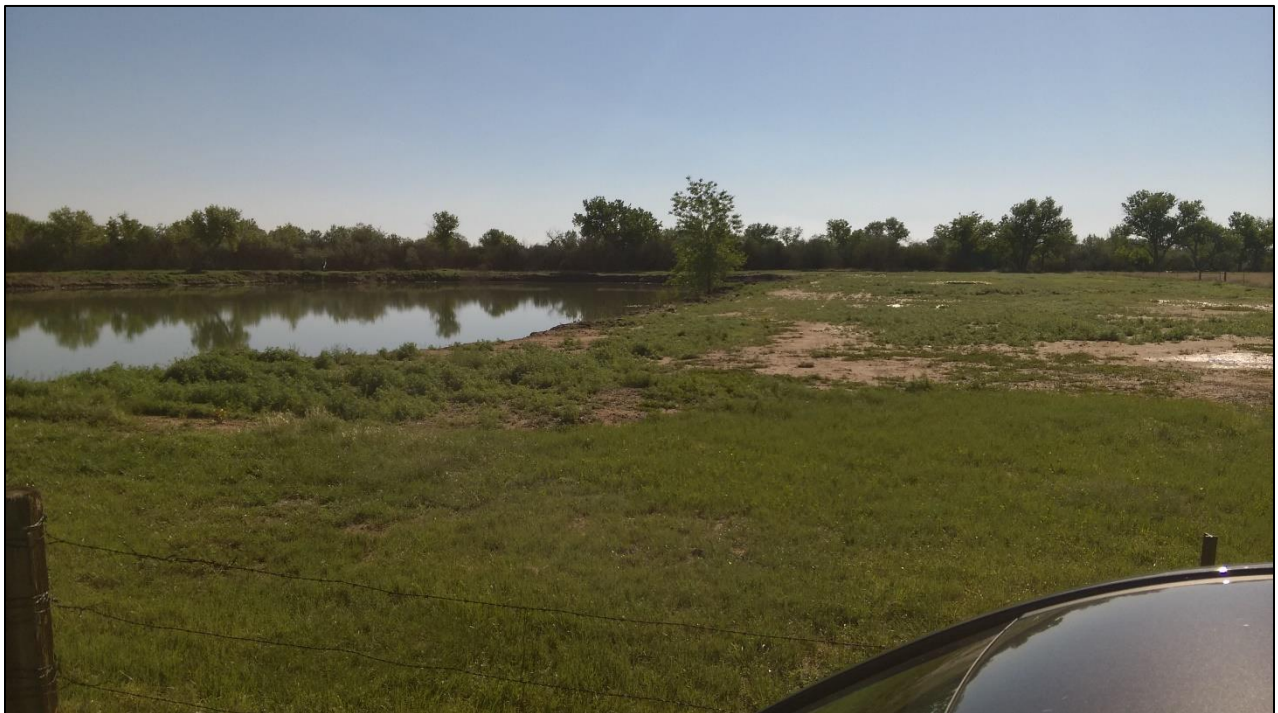
Photo 2. View looking east from southwestern edge of site, showing area where large overburden stockpile was removed (right of pond).

During the inspection, the Division observed that the large overburden stockpile which was present along the southern permit boundary had been removed and used as backfill material on site (**Photos 1-3**). The area beneath the old stockpile had been graded to nearly flat. The material was used to backfill the southern, eastern, and northern portions of the excavation (**Photos 4-13**). According to Mr. Feik, this work was completed in December of 2016. Because there was not enough material on site to fill the pond in by two acres, the county submitted a Technical Revision (TR-2) on April 3, 2017 to import up to 15,000 CY of inert material to backfill portions of the excavation. The Division approved TR-2 on April 26, 2017. The county found the northern portion of the pond to be the deepest at approximately 20 feet deep. Therefore, the county will focus on backfilling other portions of the pond, particularly the eastern portion, in efforts to reduce the pond size.

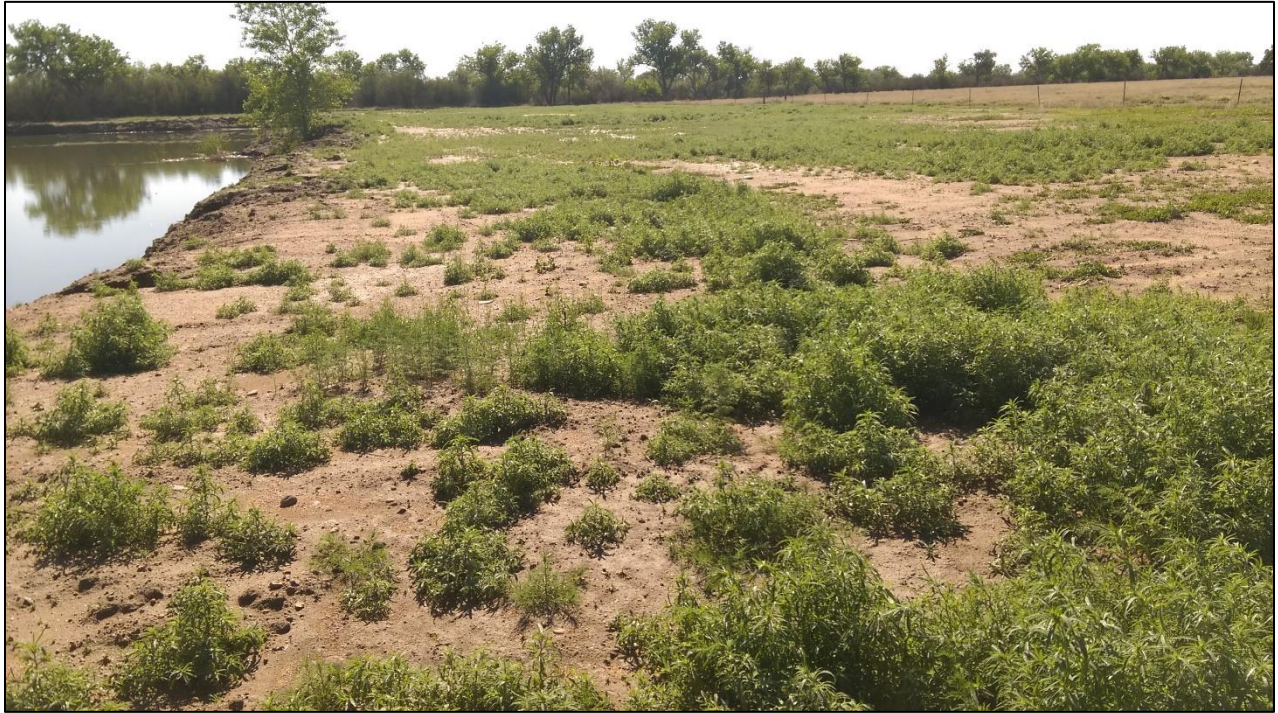
Photo 3. View looking east from southwestern portion of site, showing closer view of area where large overburden stockpile was removed. Note ground surface beneath removed stockpile has been graded to near flat.

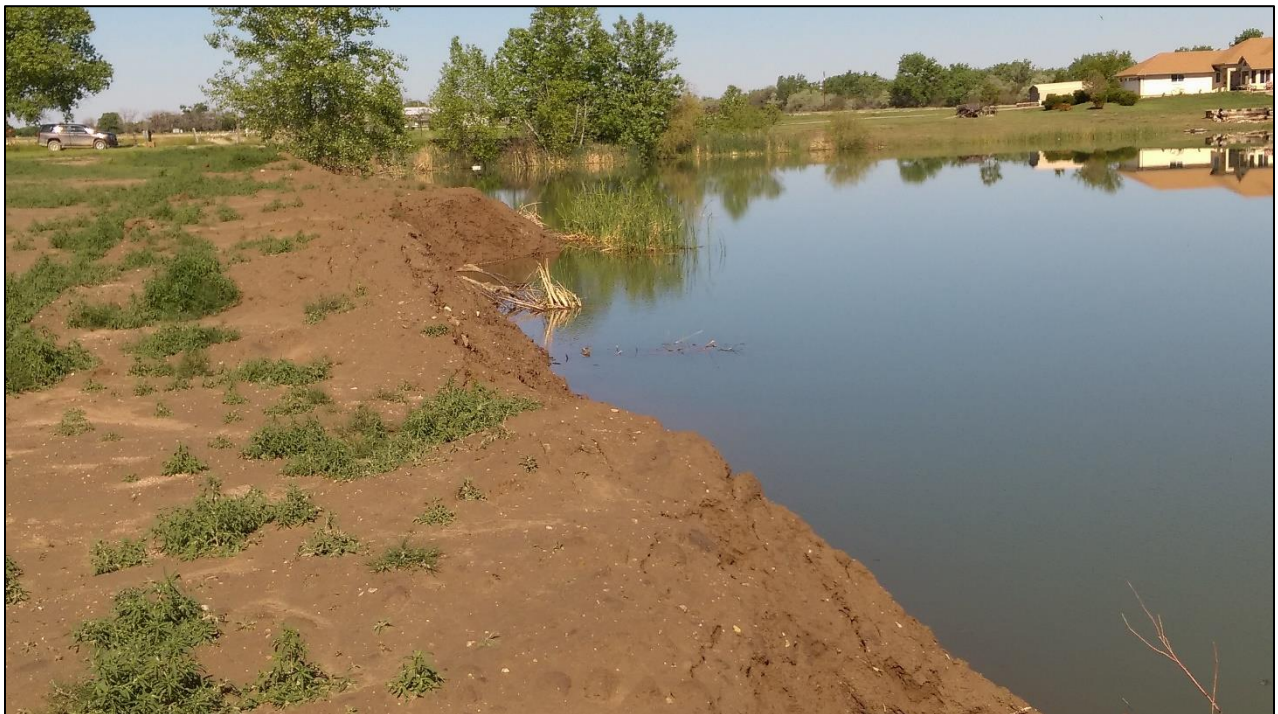
Photo 4. View looking west across southern pond shoreline. Note current slope gradient of shoreline ranges from near vertical to 1H:1V due to material being pushed in to close the pond surface. All shorelines will be graded to 3H:1V or flatter for final reclamation.

According to the required reclamation plan, remaining reclamation includes grading pond shorelines to a final slope configuration of 3H:1V or flatter, and revegetating all disturbed areas around the pond. The Division

observed much of the pond shorelines to currently have slope gradients of near vertical to 1H:1V where material was pushed toward the pond. The pond shorelines rise approximately 3-4 feet above the waterline. The northwestern portion of the pond shoreline has slope gradients of 4H:1V or flatter. According to Mr. Feik, the county intends to complete all grading work this fall when the county's equipment is available again for the project. Over the summer, the county will import additional inert material to store on site for reclamation. During the fall, the county will use the material to backfill portions of the pond and grade shorelines to the approved final slope configuration.

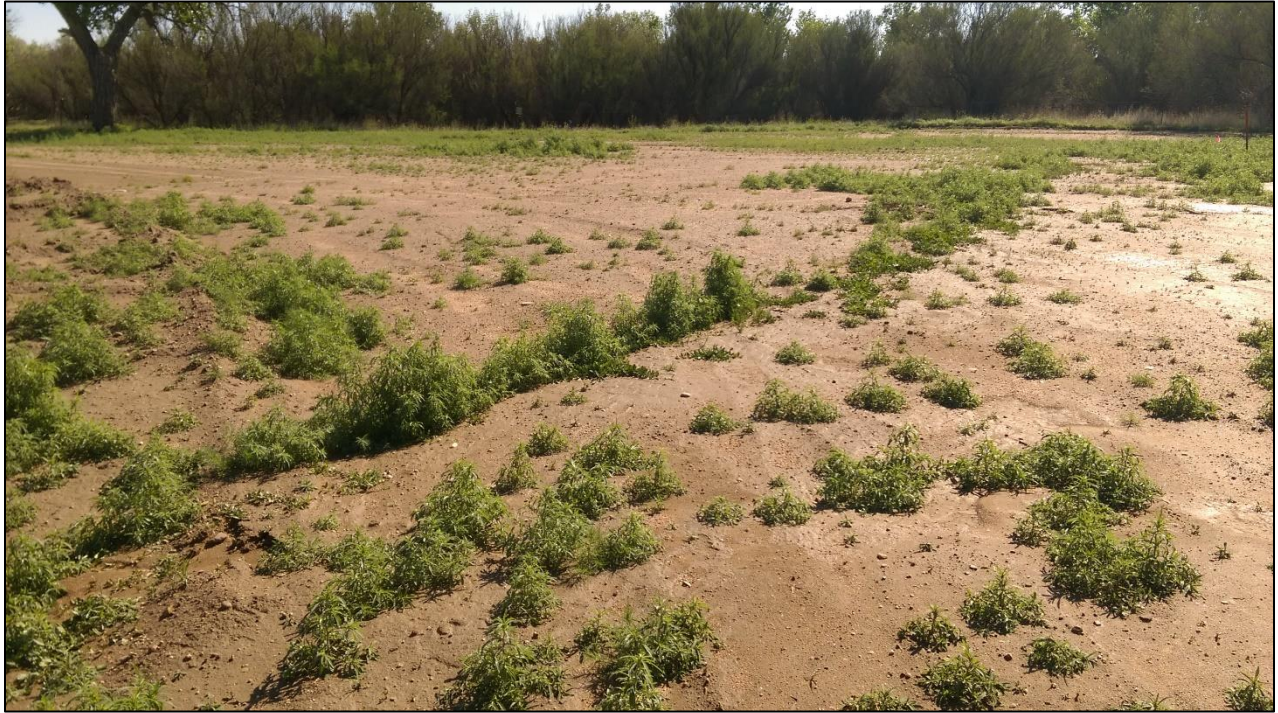
Photo 5. View looking east across southeastern portion of pond that was backfilled with overburden available on site.

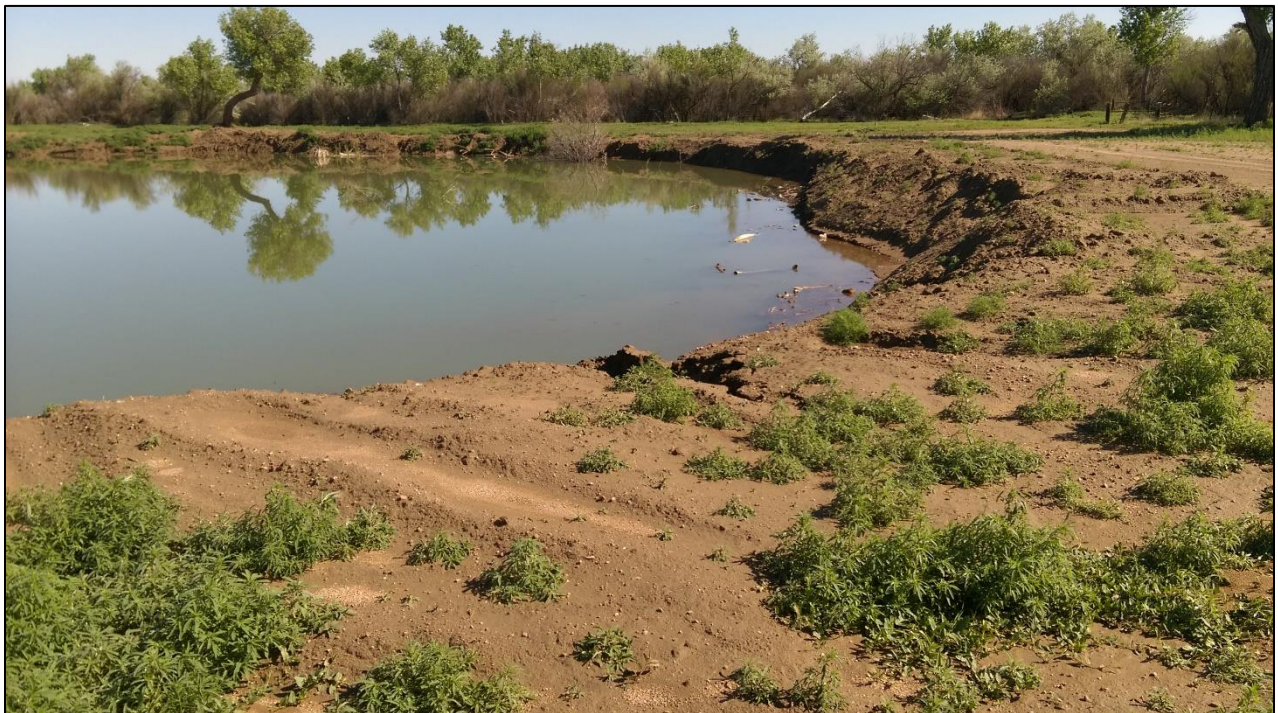
Photo 6. View looking north across southeastern portion of pond that was backfilled with overburden available on site. Note current slope gradient of shoreline ranges from near vertical to 1H:1V due to material being pushed in to close the pond surface. All shorelines will be graded to 3H:1V or flatter for final reclamation.

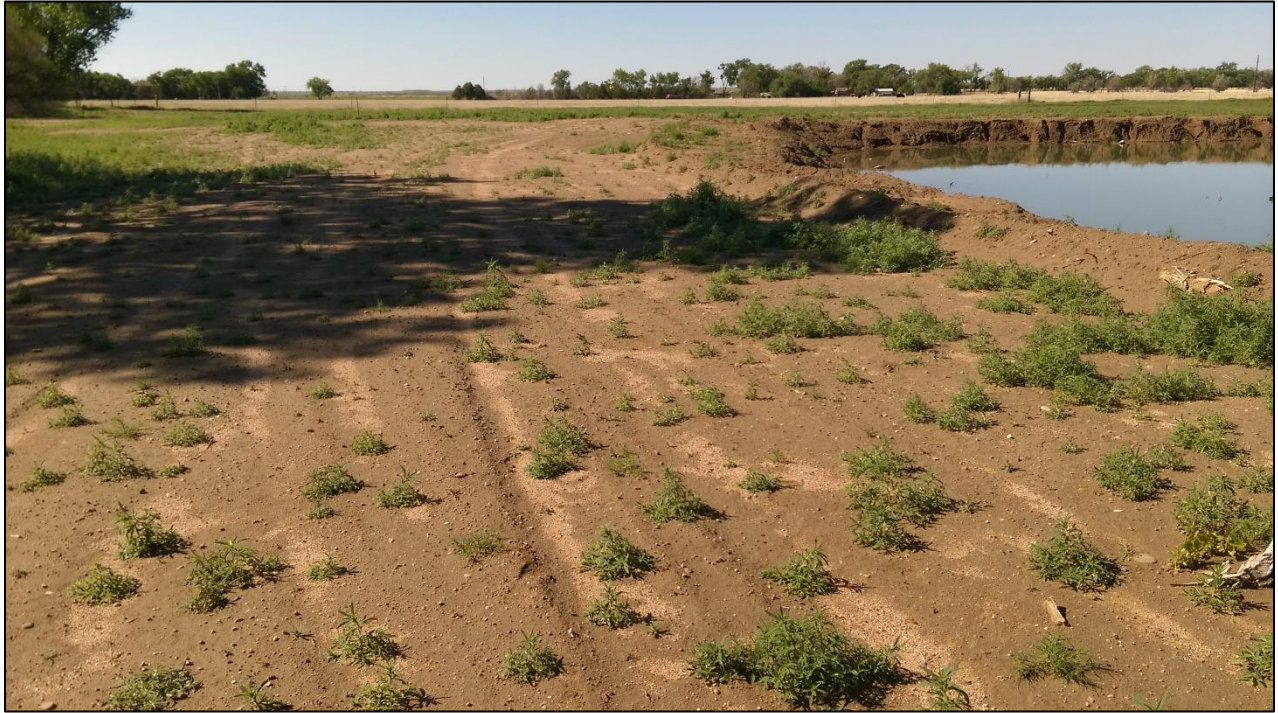
Photo 7. View looking south across eastern portion of pond that was backfilled with overburden available on site.

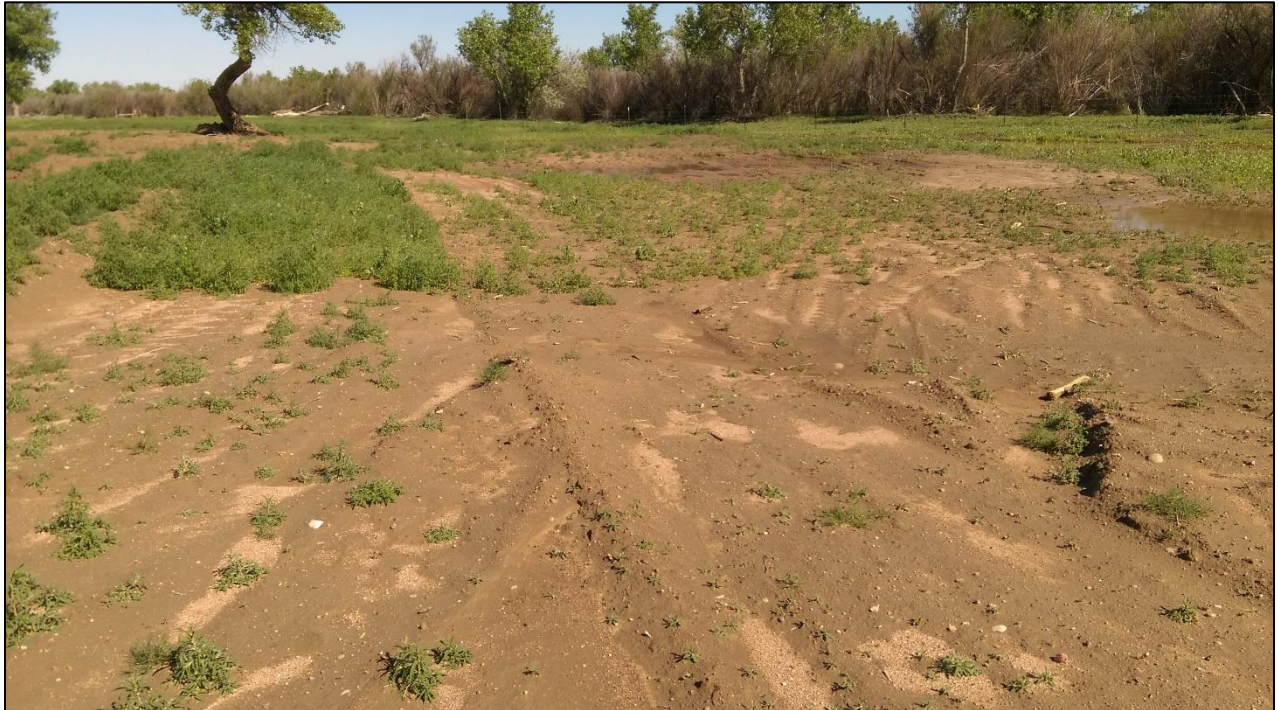
Photo 8. View looking northwest across northeastern portion of pond that was backfilled with overburden available on site. The county intends to conduct additional grading in this area to level it out a bit more.

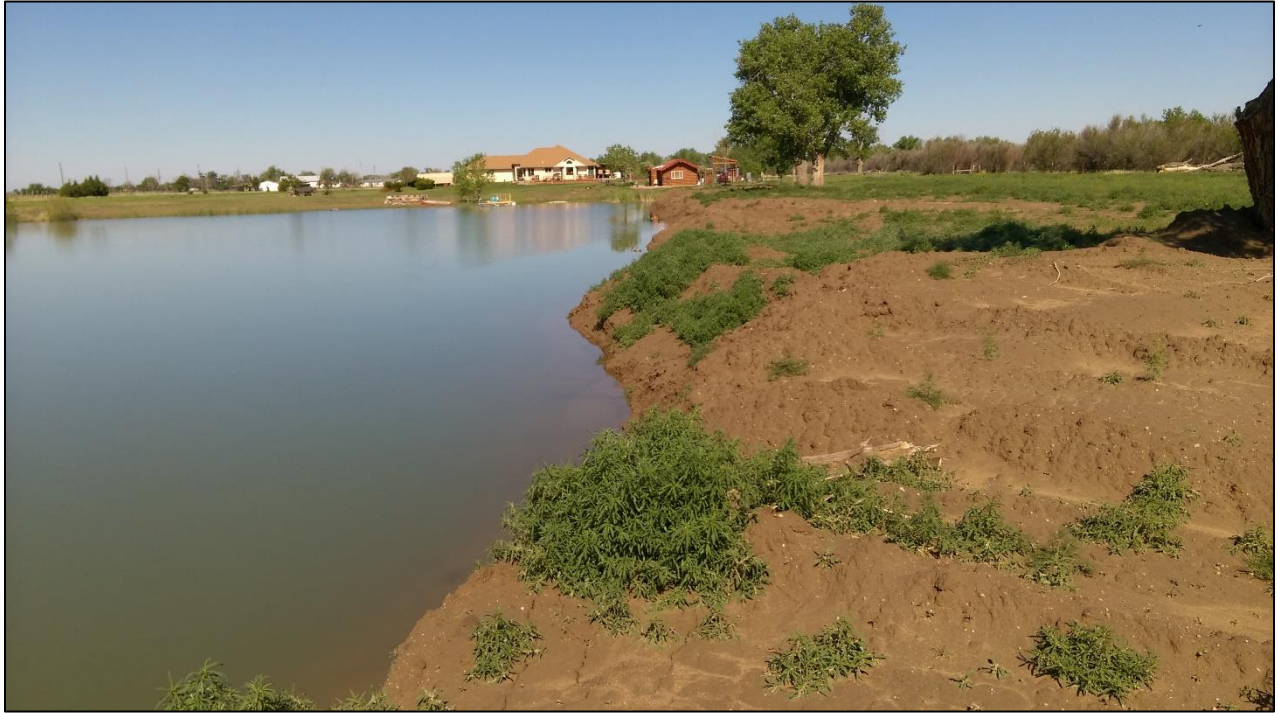
Photo 9. View looking west across northern pond shoreline. Note current slope gradient of shoreline ranges from near vertical to 1H:1V due to material being pushed in to close the pond surface. All shorelines will be graded to 3H:1V or flatter for final reclamation.

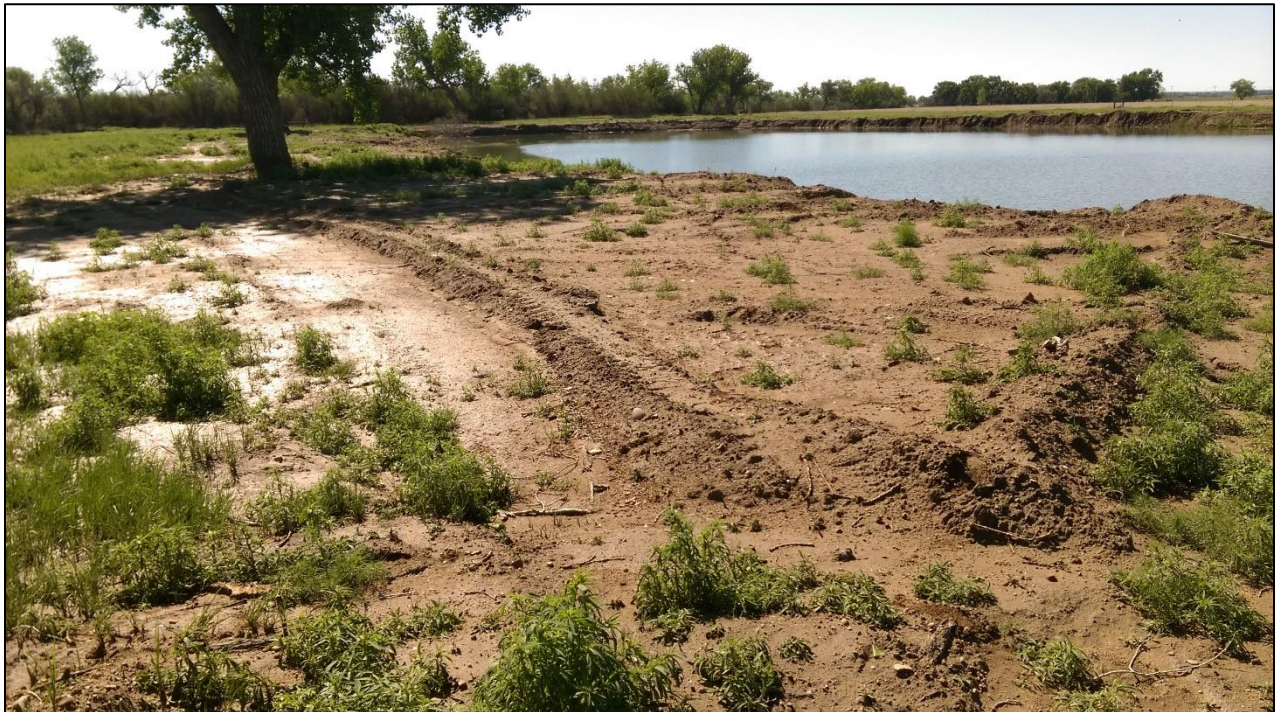
Photo 10. View looking east across northern portion of pond that was backfilled with overburden available on site.

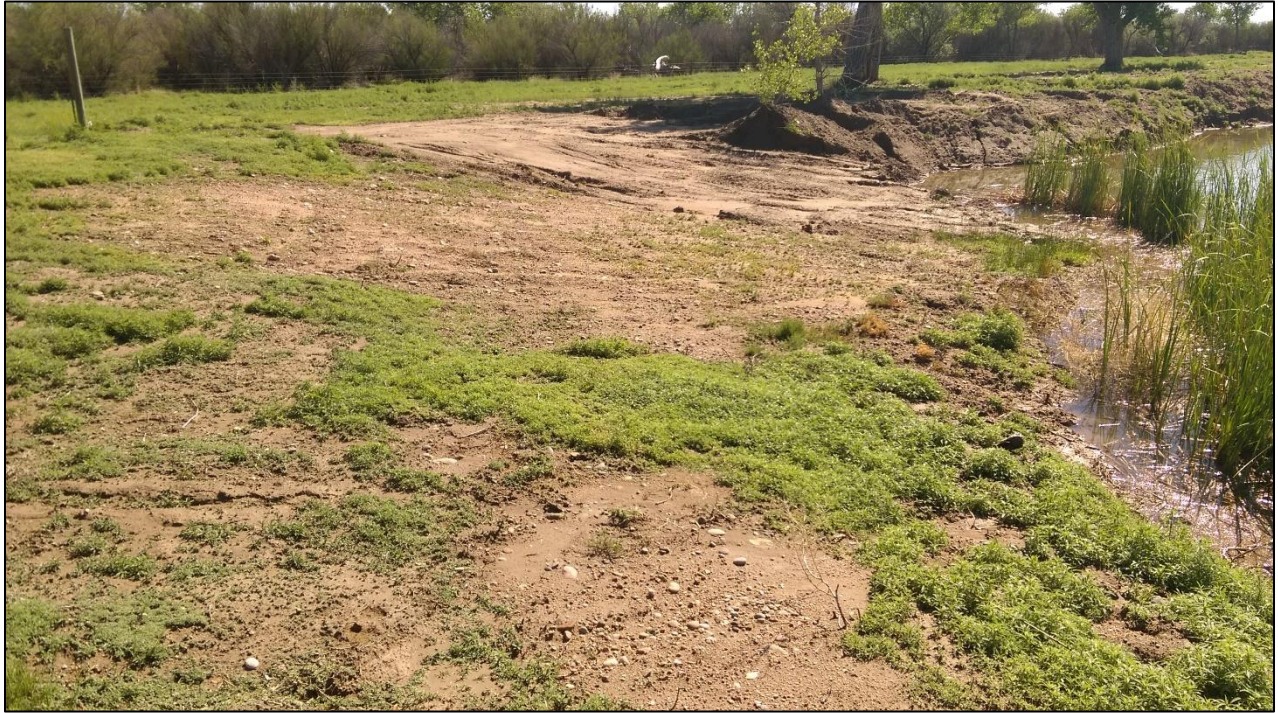
Photo 11. View looking northeast across northwestern portion of pond shoreline that was graded to 4H:1V or flatter by the landowner.

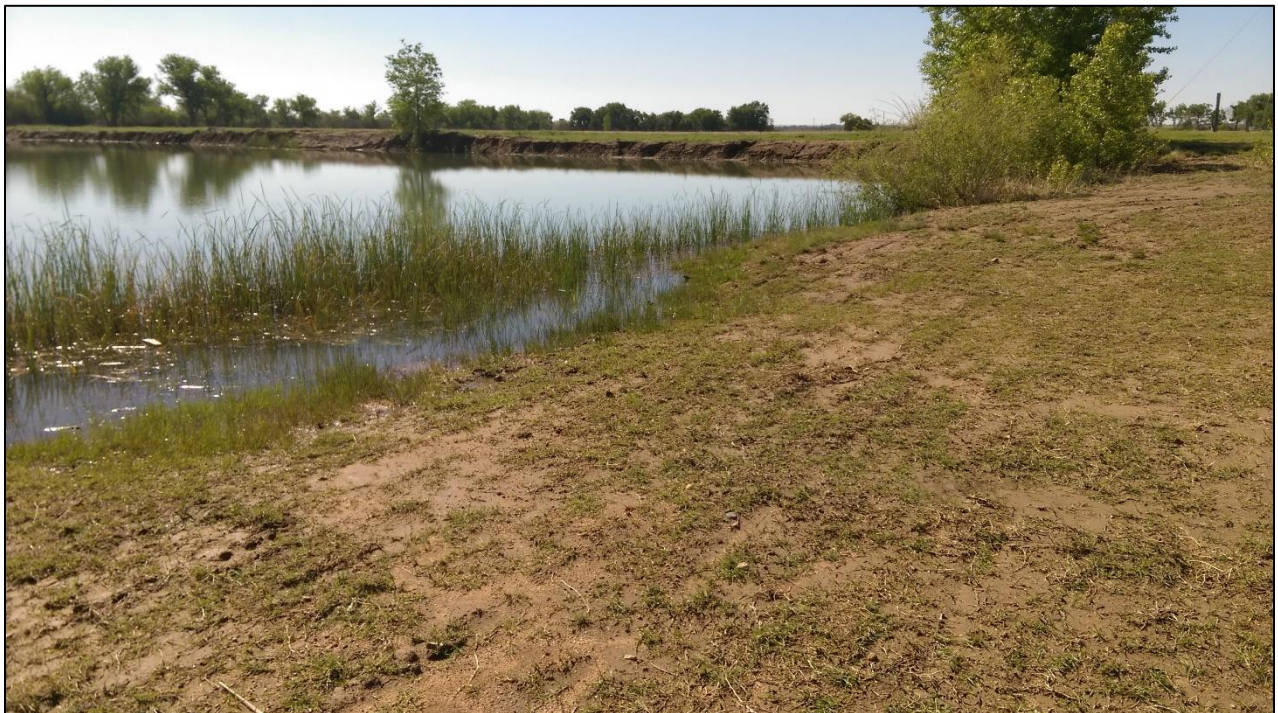
Photo 12. View looking southeast across western shoreline that already has slope gradients of 3H:1V or flatter, except for at the steeper southwestern corner.

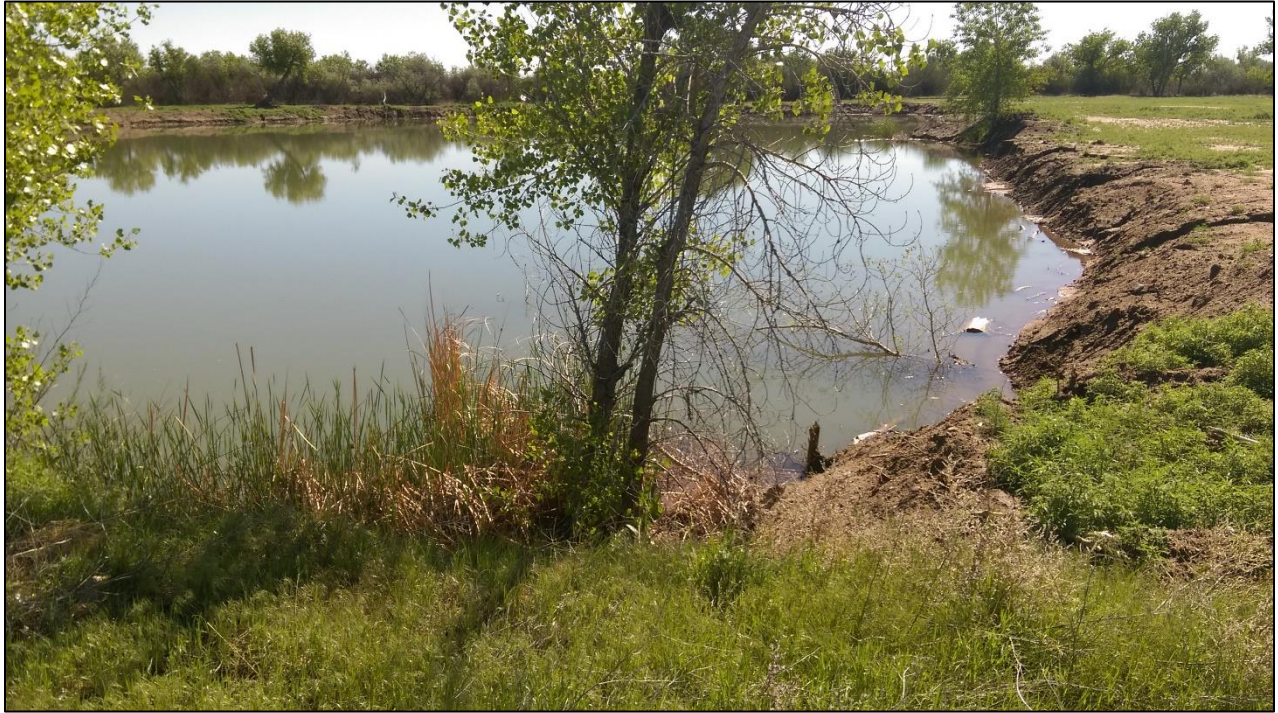
Photo 13. View looking east across southwestern portion of pond with slope gradients steeper than 3H:1V.
